GODDARD SPACE FLIGHT CENTER

Test Lab Report Summary

<i>Report Number:</i>	Q10162DPA	<i>Project:</i>	SWIFT
<i>Part Type:</i>	Microcircuit	<i>System:</i>	BAT
<i>Part Number:</i>	OP284ES	<i>Initiated Date:</i>	05/01/2001
<i>Date Code:</i>	0041	<i>Report Date:</i>	07/19/2001
<i>Manufacturer:</i>	Analog Devices	<i>Investigator:</i>	C. Greenwell (562)
<i>Generic Number:</i>	OP284	<i>Requester:</i>	B. Meinhold (562)
<i>Purchase Spec:</i>	Commercial	<i>Approval / Date:</i>

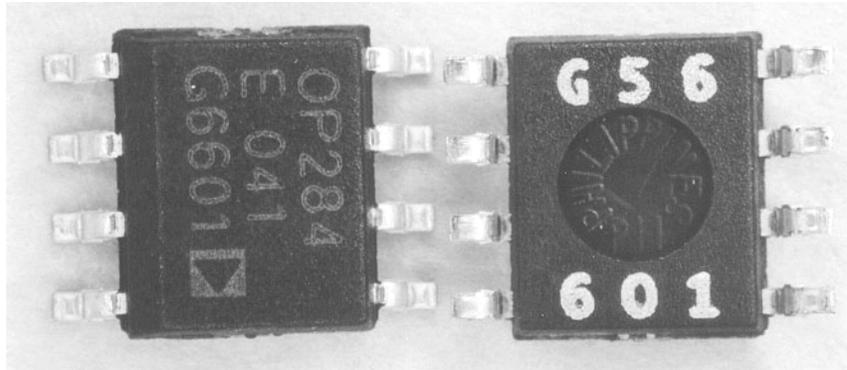
Figure 1. External top and bottom views of the OP284ES devices. Although difficult to see in this image, the bottom of the devices have embossed markings. Each device had a unique two or three character alphanumeric code that was used for reference designations during this analysis. 8X

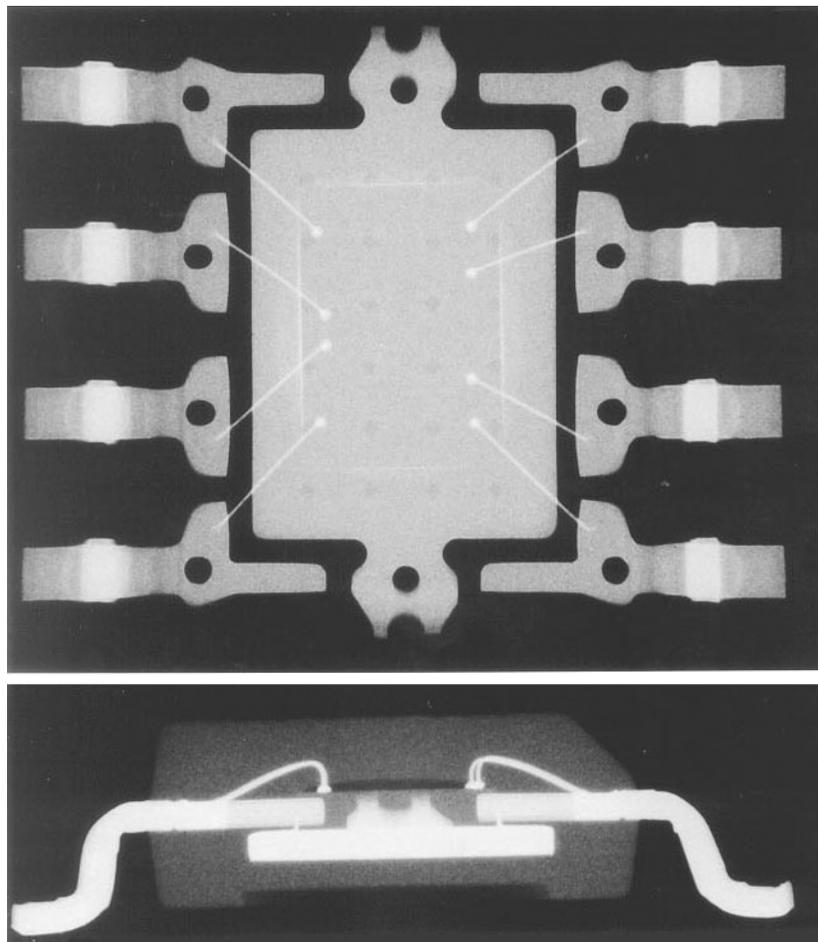
Figure 2. Top and side view radiographic images. The side view reveals a glob-top coating on the die. 16X

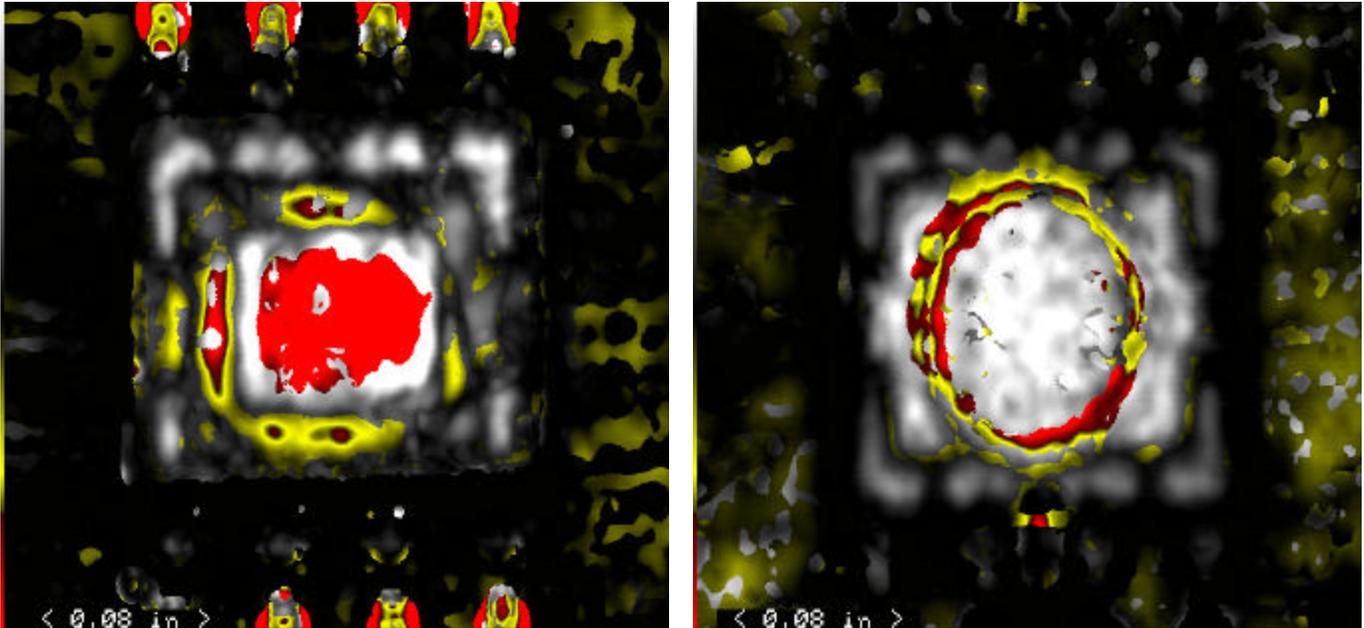
Figure 3. Top (left) and bottom C-SAM images of SN A4. Minor delaminations are indicated between the plastic and die paddle on three sides of the die in the top view image. The red area on the die surface is due to the die coat material.

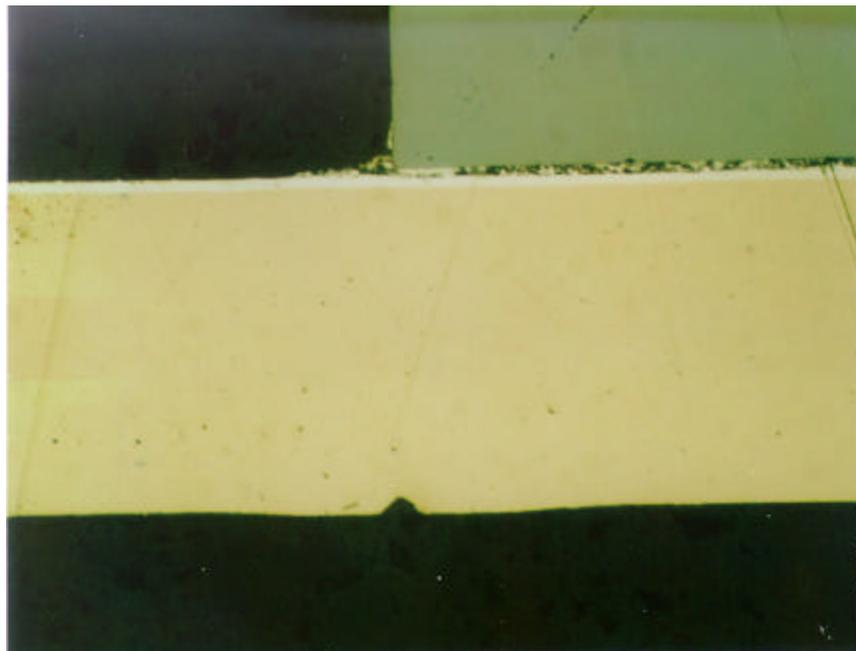
Figure 8. Cross-section image of SN O17. No delaminations or anomalies were observed, consistent with the C-SAM inspection results. $\approx 200X$.

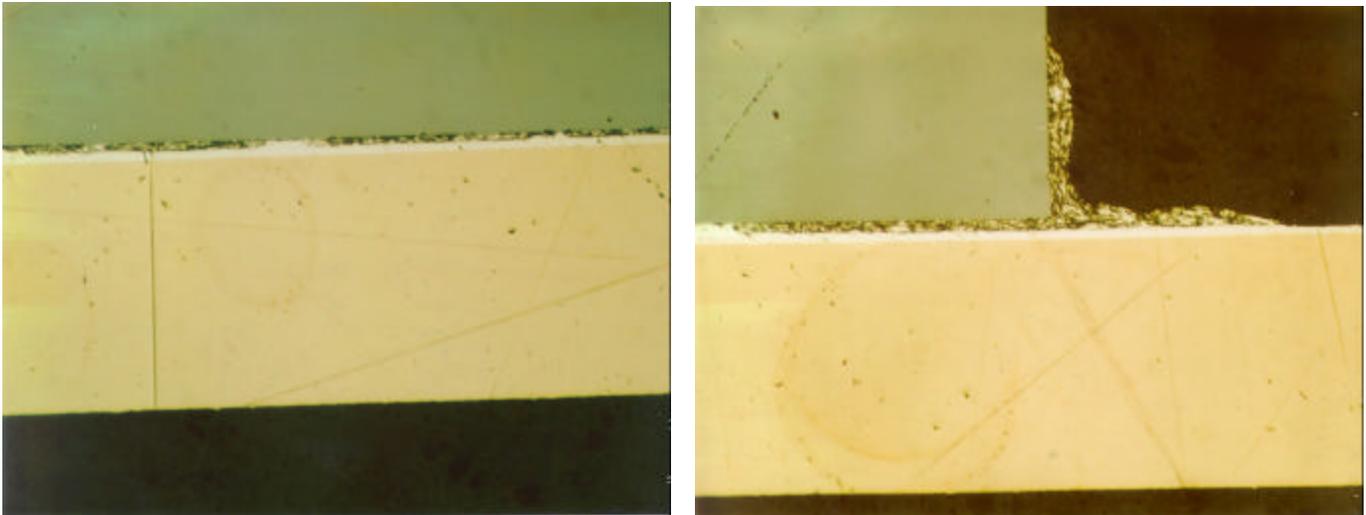
Figure 9. Cross-section images of SN W1, taken at different section planes. No delaminations or anomalies were observed. Both images $\approx 200X$.

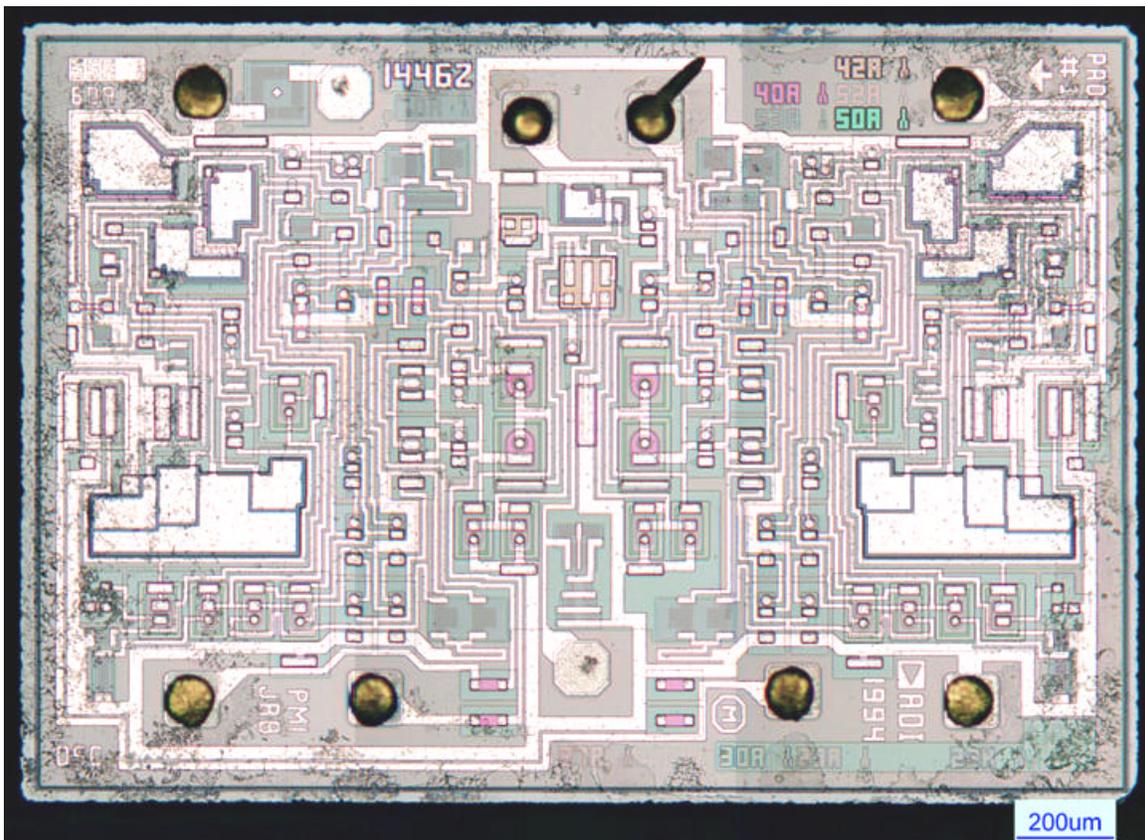
Figure 10. Overall image of OP284ES die in SN P11. Deprocessing residue is present on the die surface. The glob-top material was very difficult to remove with the available chemicals.

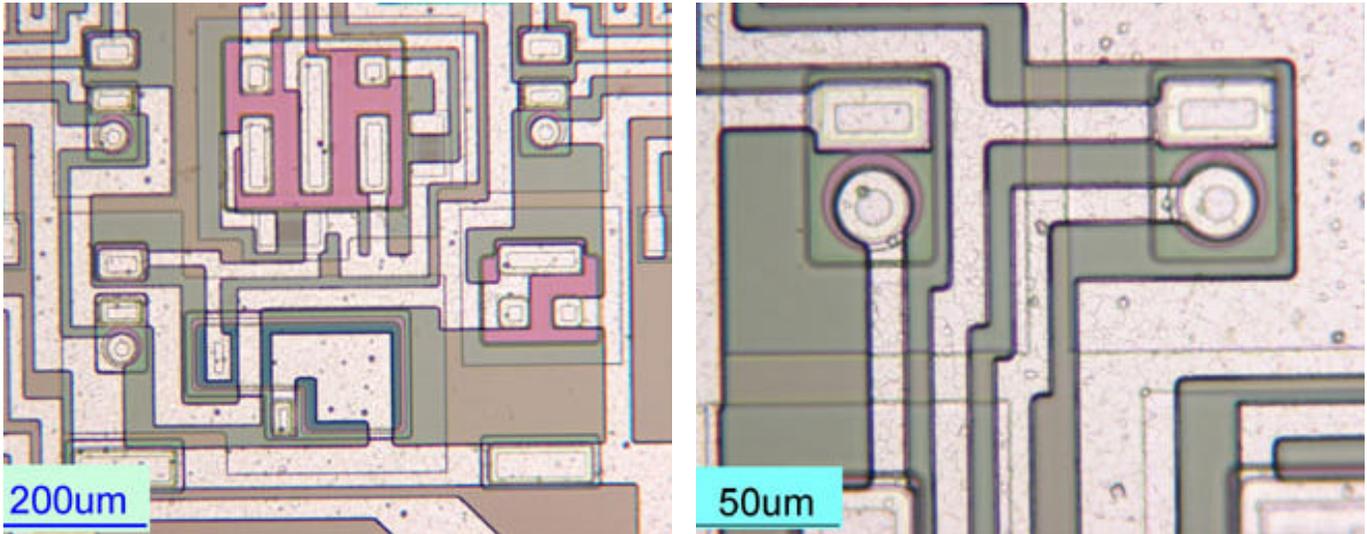
Figure 11. Optical micrograph images of SN A4 show general device features.

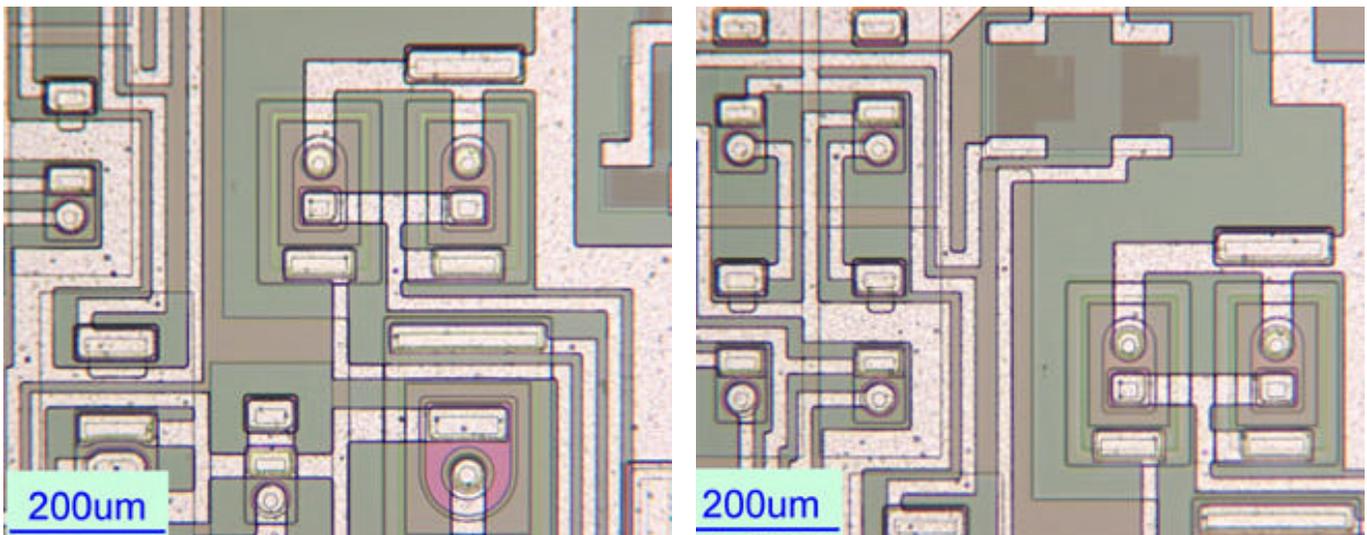
Figure 12. Optical micrograph images of SN P13 show general device features.

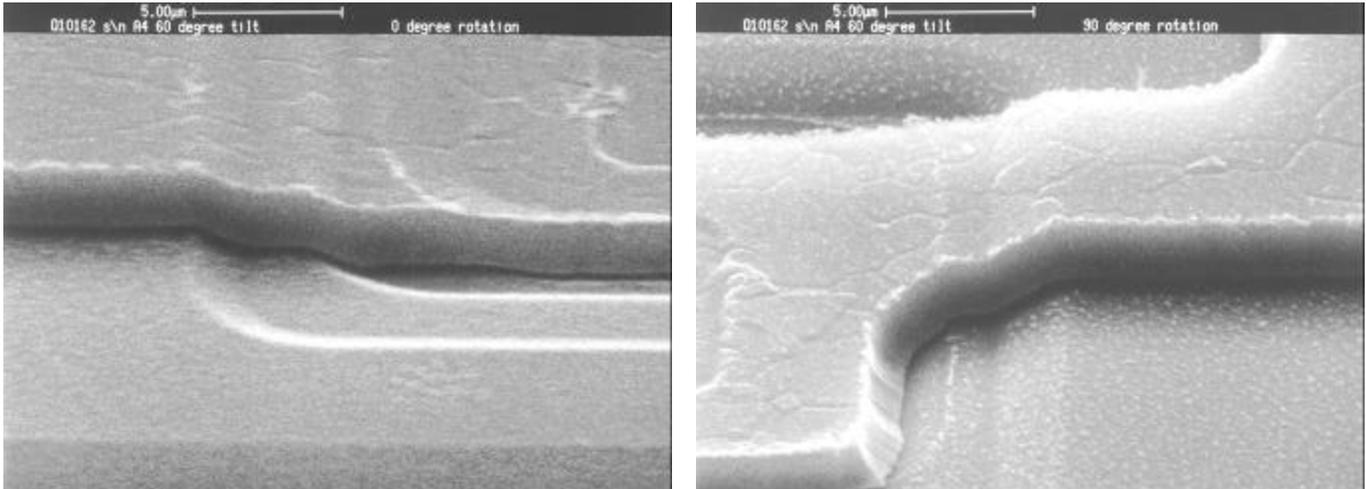
Figure 13. SEM micrographs of SN A4. The metallization has excellent step coverage.
