# GODDARD SPACE FLIGHT CENTER

## Test Lab Report Summary

<i>Report Number:</i>	Q10163	<i>Project:</i>	SWIFT
<i>Part Type:</i>	Microcircuit	<i>System:</i>	BAT
<i>Part Number:</i>	OP290GS	<i>Initiated Date:</i>	05/01/2001
<i>Date Code:</i>	9739/7P36564.2	<i>Report Date:</i>	06/21/2001
<i>Manufacturer:</i>	Analog Devices	<i>Investigator:</i>	C. Greenwell (562)
<i>Generic Number:</i>	OP290	<i>Requester:</i>	B. Meinhold (562)
<i>Purchase Spec:</i>	Commercial	<i>Approval / Date:</i>

### Step 2: DESTRUCTIVE PHYSICAL ANALYSIS

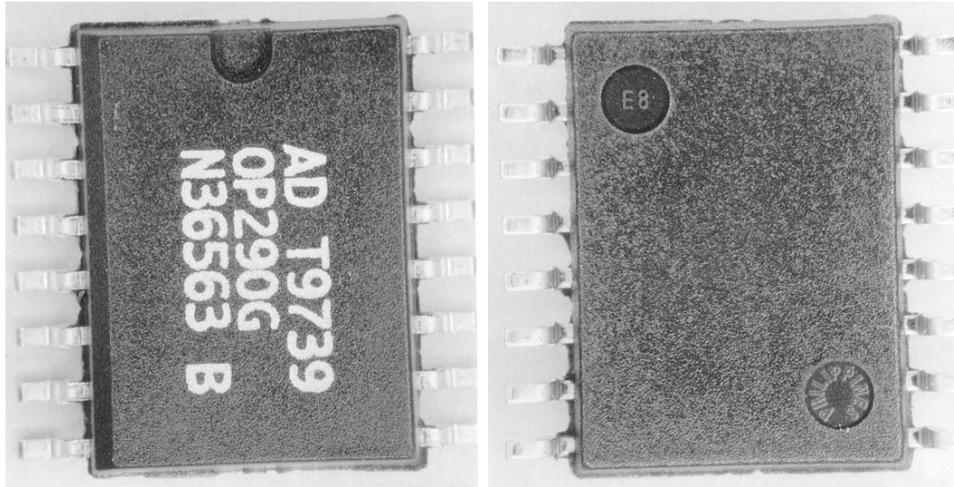
Figure 1. External top and bottom views of the OP290GS devices. Each device had a unique two or three character alphanumeric code that was used for reference designations during this analysis. 6X

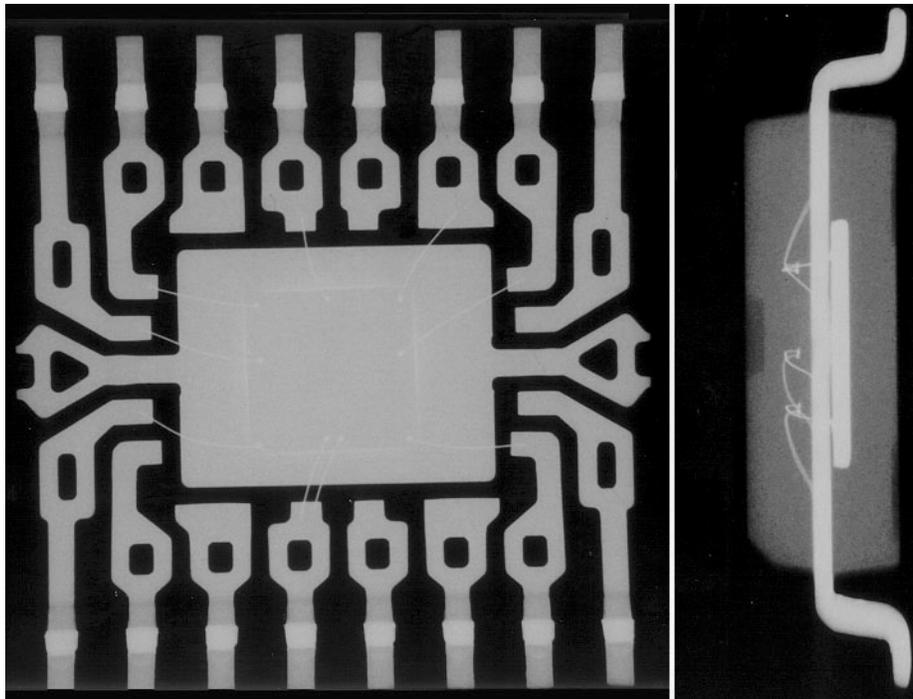
Figure 2. Top and side view radiographic images. 8X

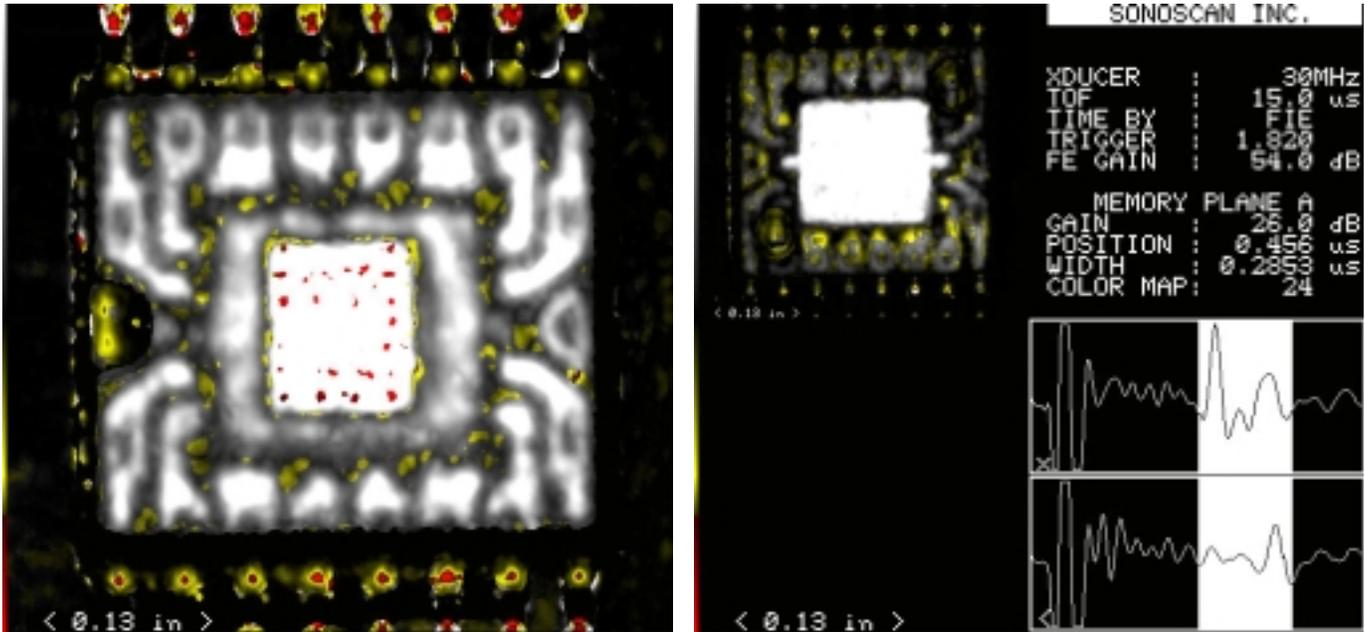
Figure 3. Top (left) and bottom C-SAM images of SN E8. Tools settings are shown for the bottom view.

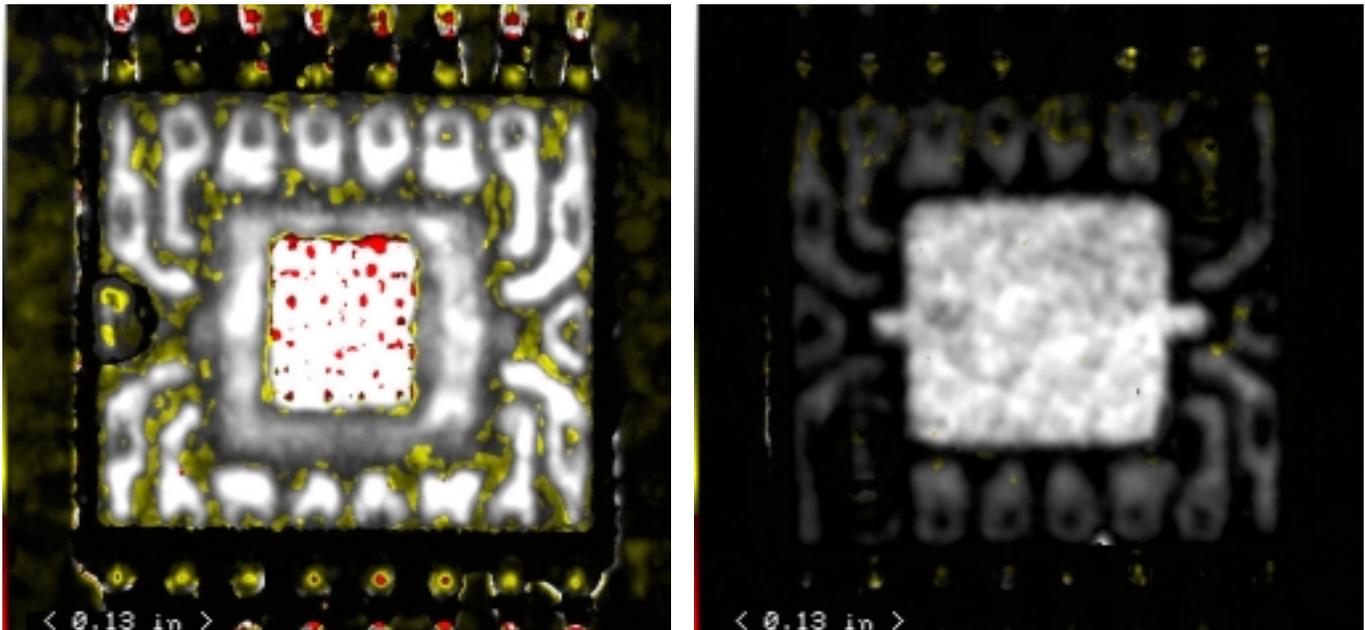
Figure 4. Top (left) and bottom C-SAM images of SN E10.

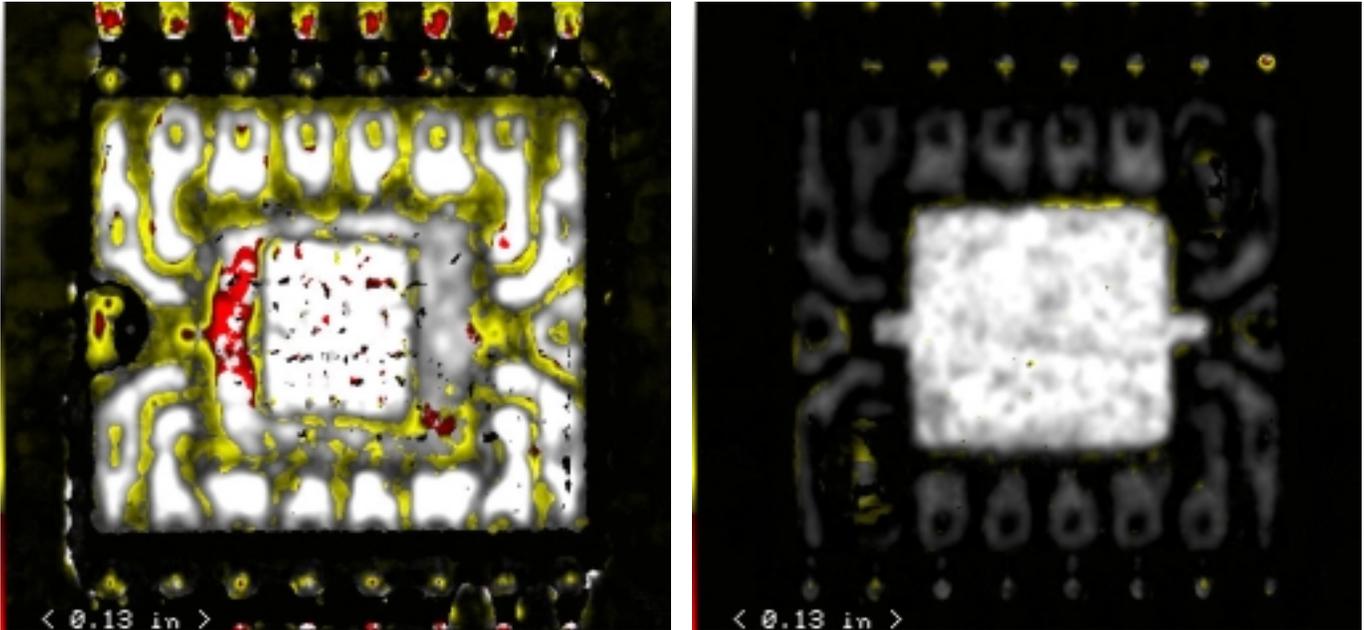
Figure 5. Top (left) and bottom C-SAM images of SN F8. The red area to the left of the die in the topside view is likely to be minor delamination between the plastic and die paddle. The speckles in the area of the die are artifact of the package surface.

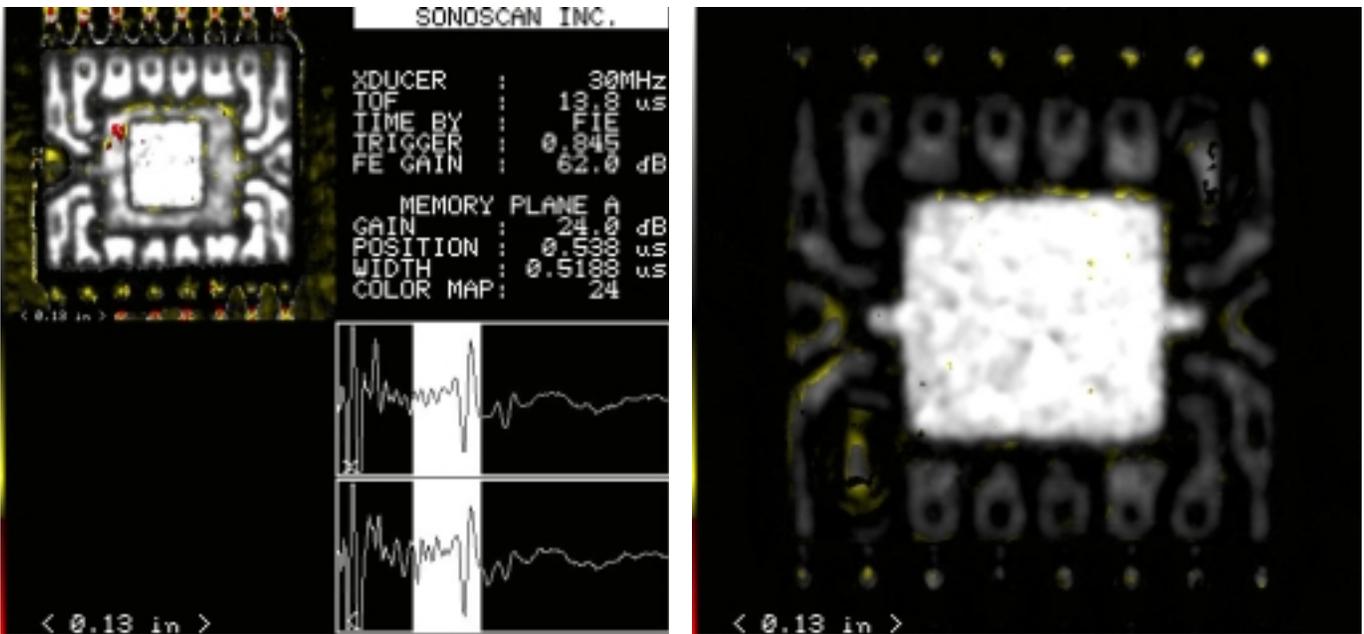
Figure 6. Top (left) and bottom C-SAM images of SN F10.

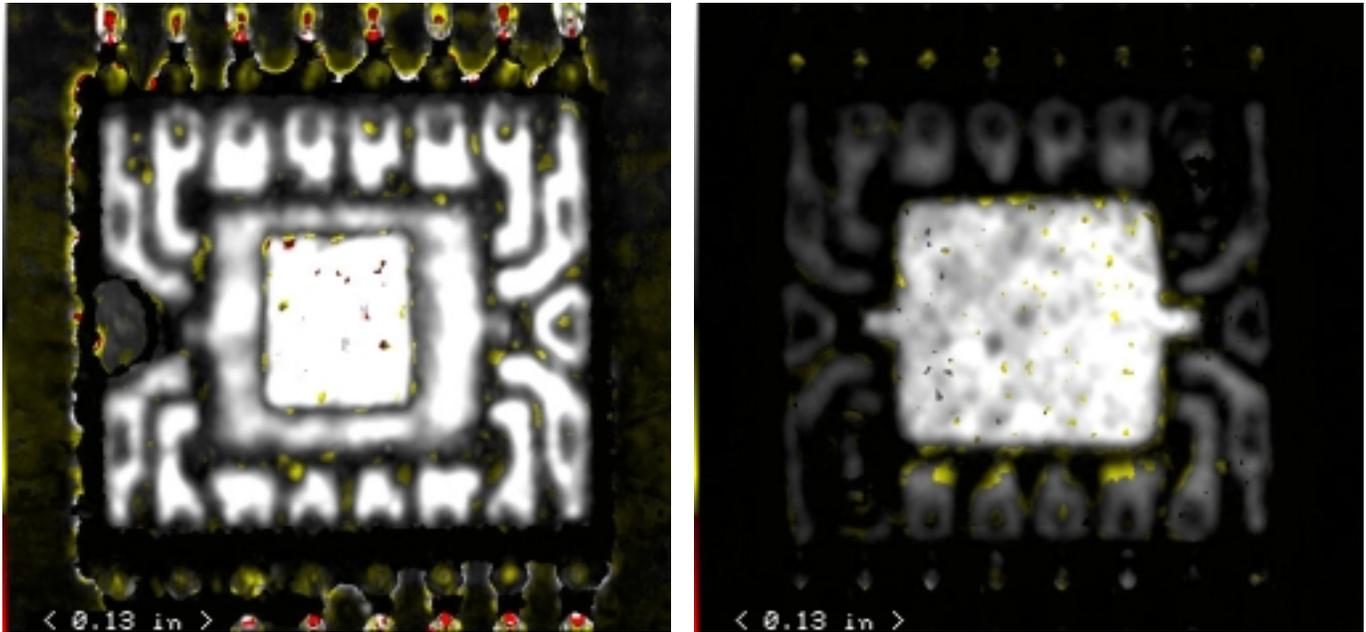
Figure 7. Top (left) and bottom C-SAM images of SN U2.

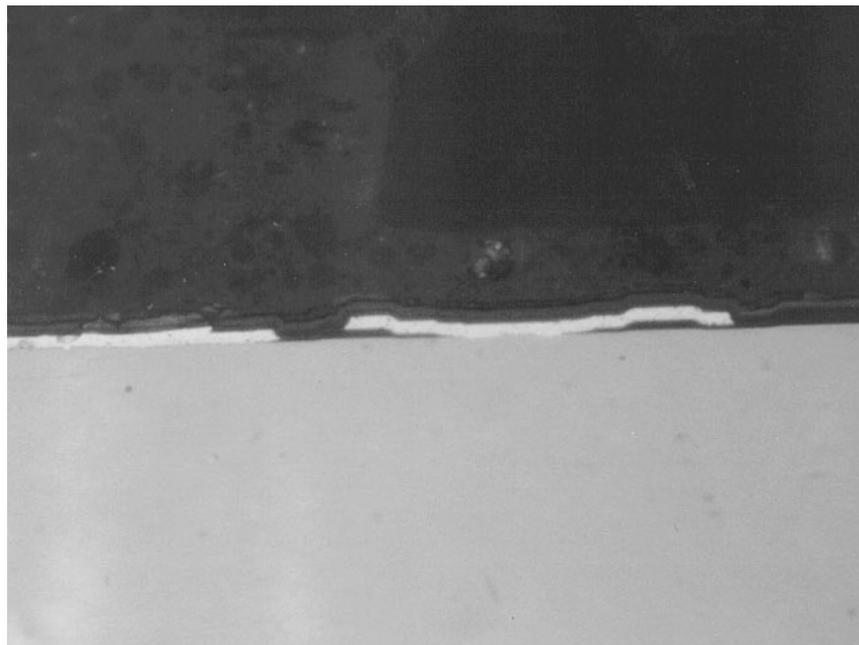
Figure 8. Cross-section images of SN F8 showing die surface and plastic interface. No delaminations or anomalies were observed, consistent with the C-SAM inspection results. 1000X

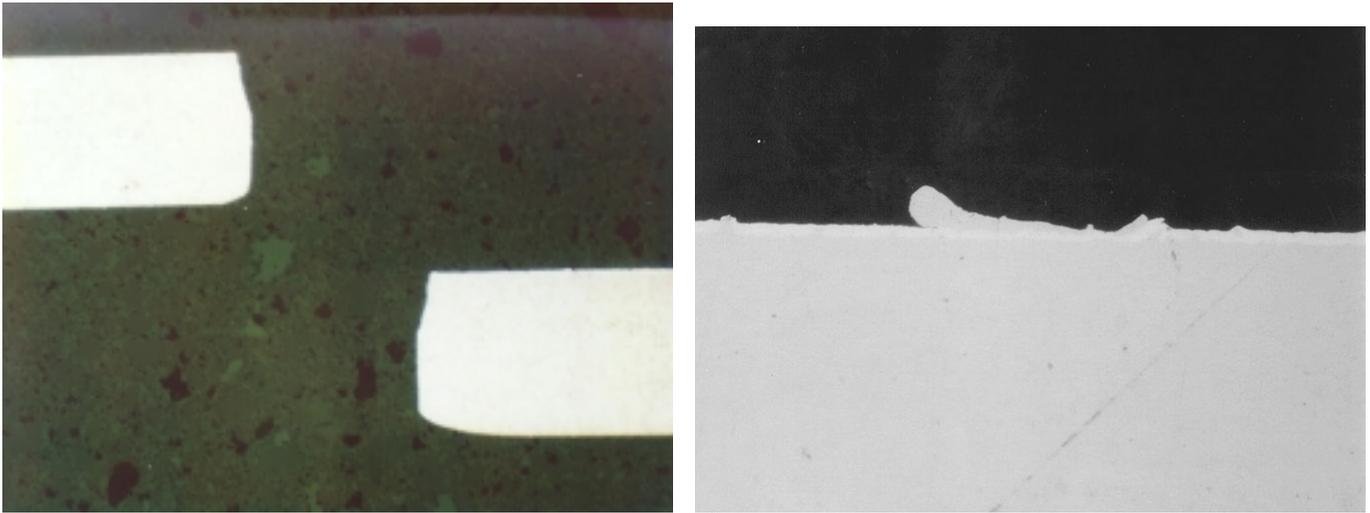
Figure 9. Cross-section images of SN F10. No delaminations or anomalies were observed. Left image  $\approx 100X$ ; right  $\approx 400X$ .

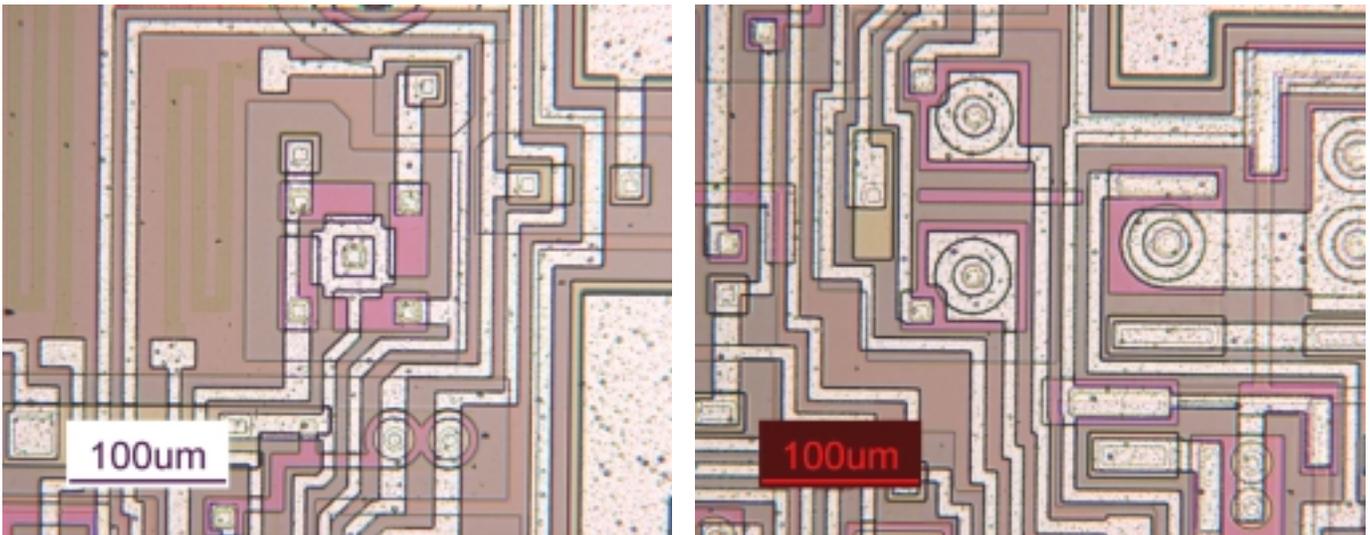
Figure 10. Optical micrograph images of SN E8 die features.

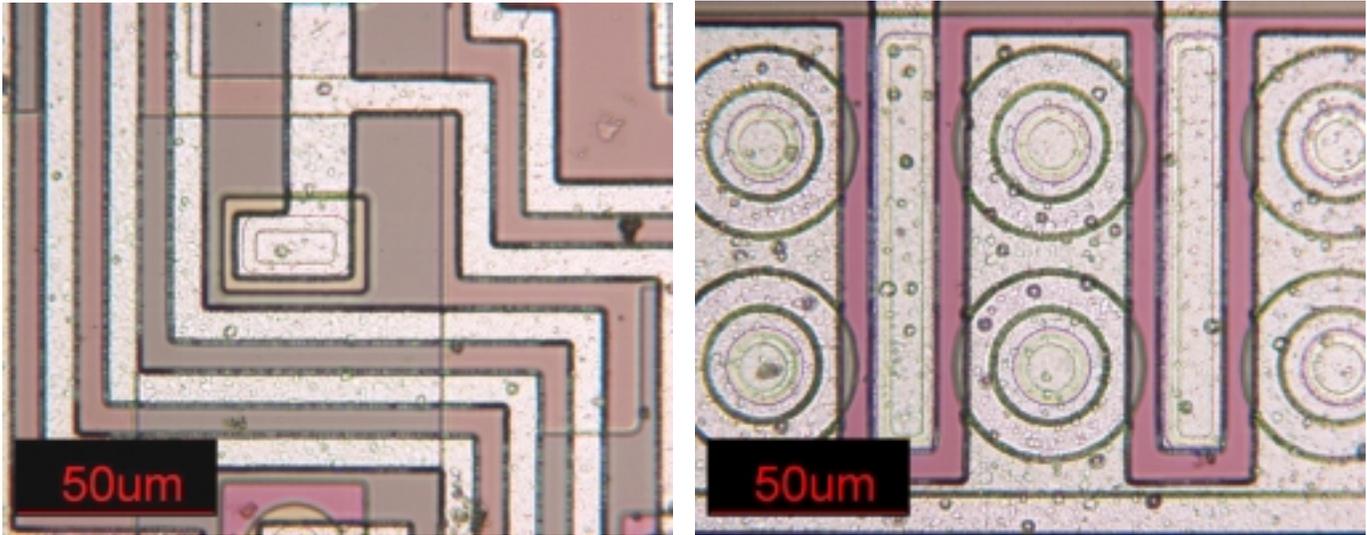
Figure 11. Optical micrograph images of SN E10 die features.

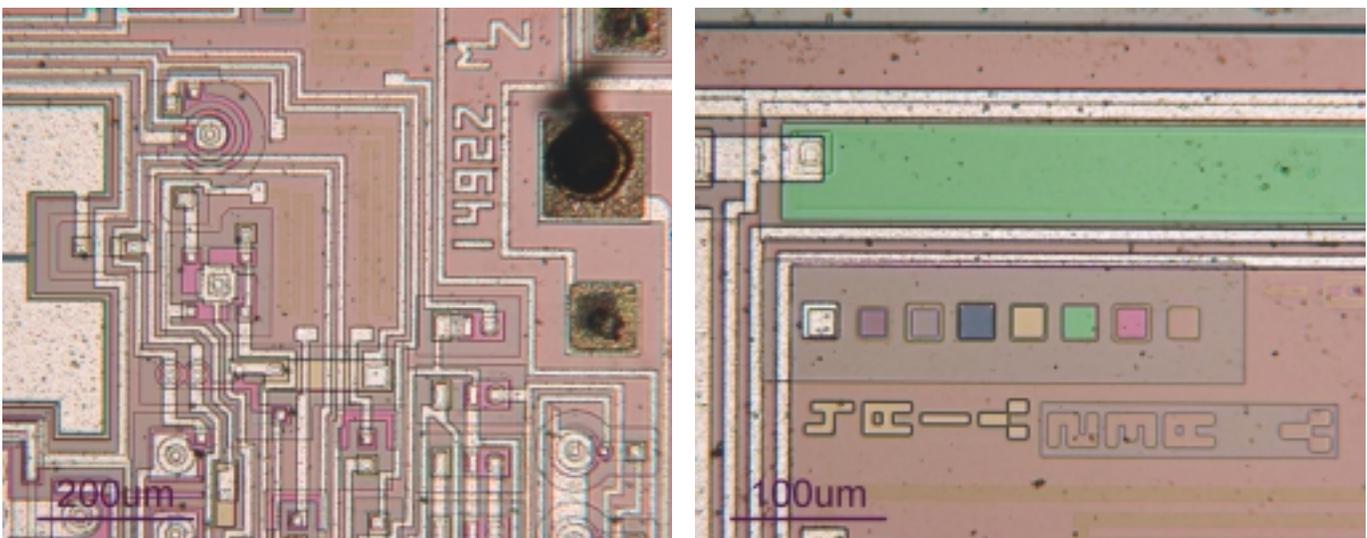
Figure 12. Optical micrograph images of SN U2 shows worst case bond placement and general device features and markings. The discolored bond pads are a result of the acid deprocessing.

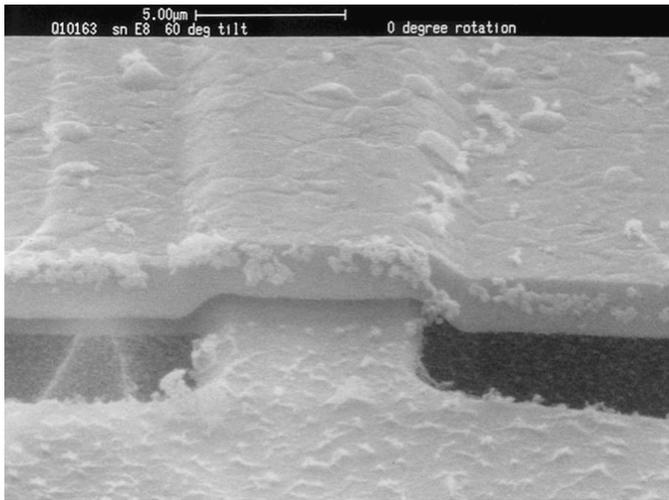
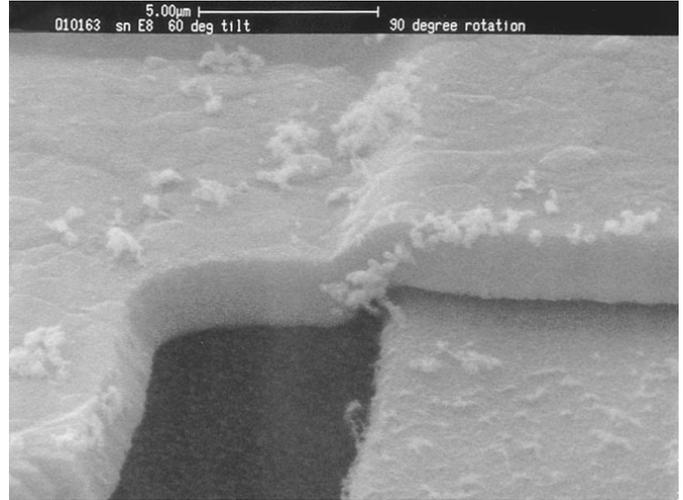
Figure 13. SEM micrographs of SN E8. The metallization has excellent step coverage.

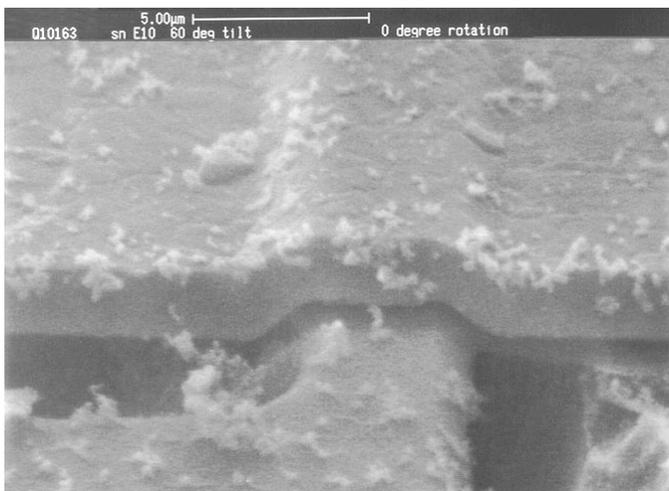
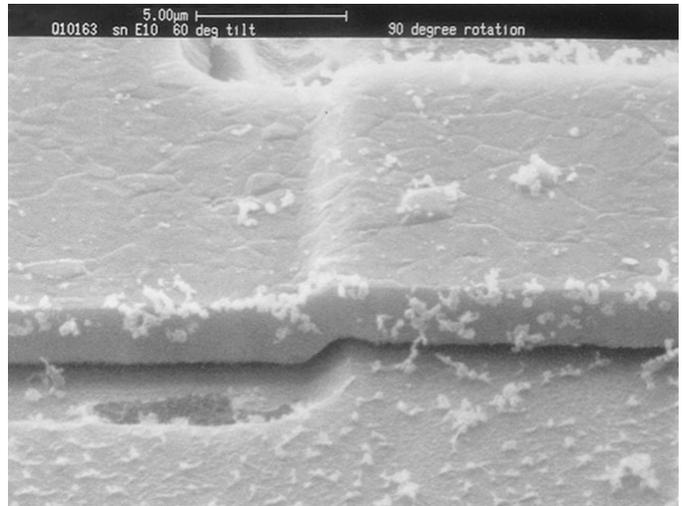
Figure 14. SEM micrographs of SN E10.

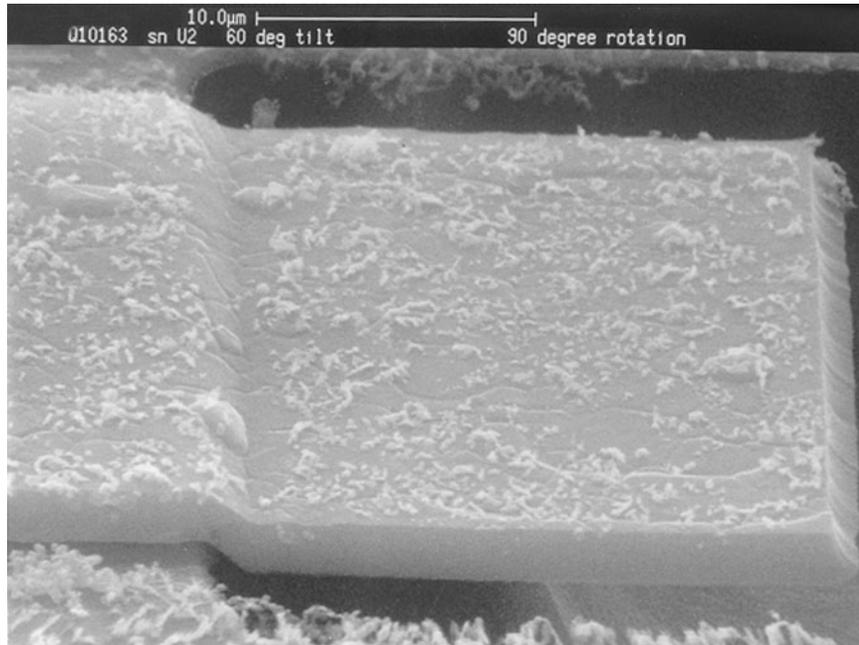
Figure 15. SEM micrograph of SN U2.

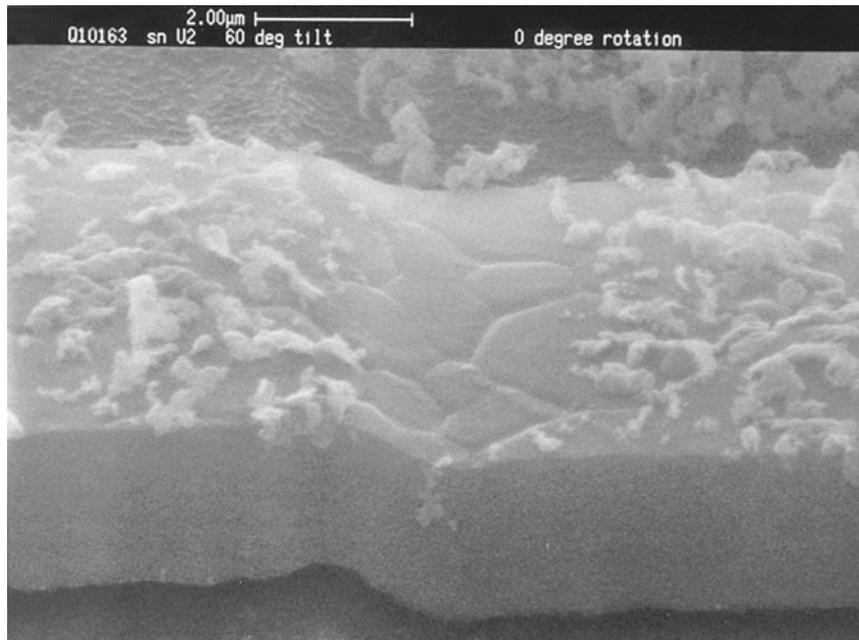
Figure 16. SEM micrograph of SN U2.
