# Solder Reflow Failures in Electronic Components during Manual Soldering

Alexander Teverovsky, Chris Greenwell,  
Frederick Felt

Perot Systems/NASA GSFC, code 562,  
Parts, Packaging, and Assembly Technologies Office

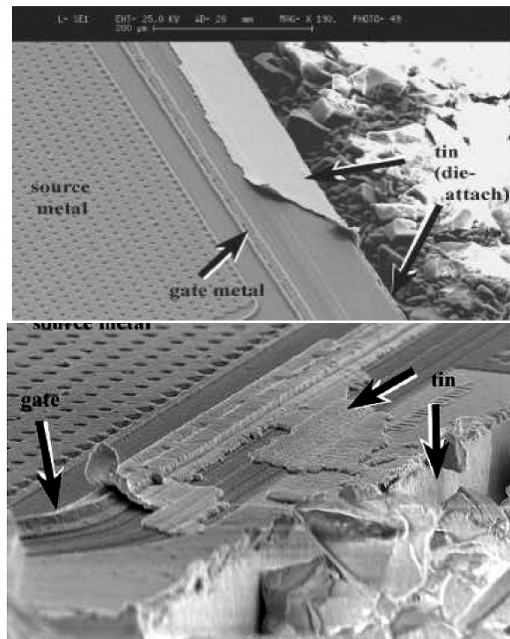
- ❑ Molten solder squeezed up to the die surface along the die-molding compound interface.
- ❑ The dies were not protected with glassivation allowing solder to short gate and source to the drain contact.

Conclusion: the parts failed due to overheating during manual soldering.

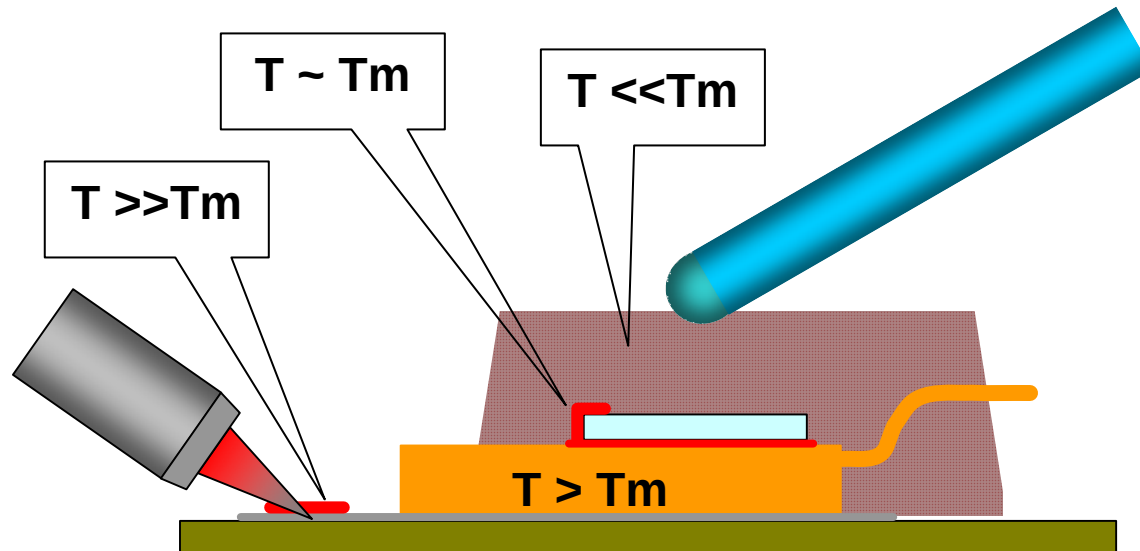
- ❑ Manual soldering caused fast heating of the copper heat sink while MC remained cool thus forcing molten solder to create and fill top-of-die delamination.
- ❑ Fixing a part on a board by applying a force to the package increases the probability of failure.

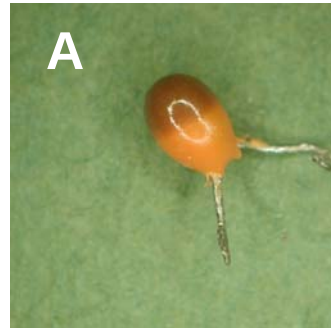
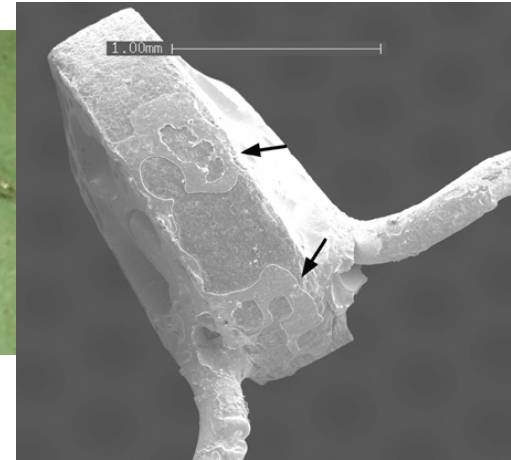
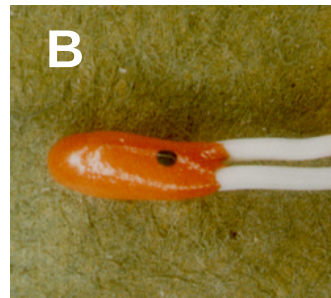
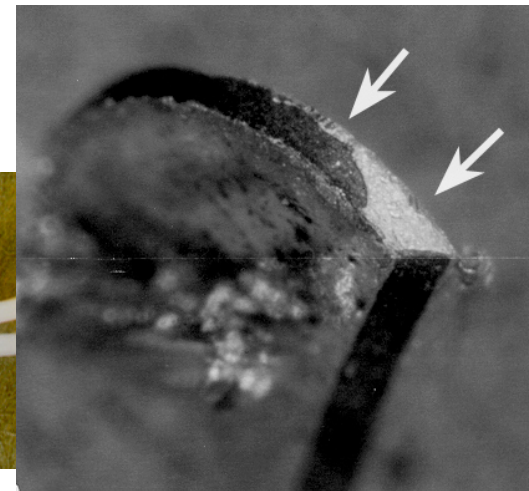
- ❑ Case A: failed during board-level testing.
- ❑ Case B: failed after rework on the adjacent microcircuit.
- ❑ FA: short is due to solder reflow caused by overheating.

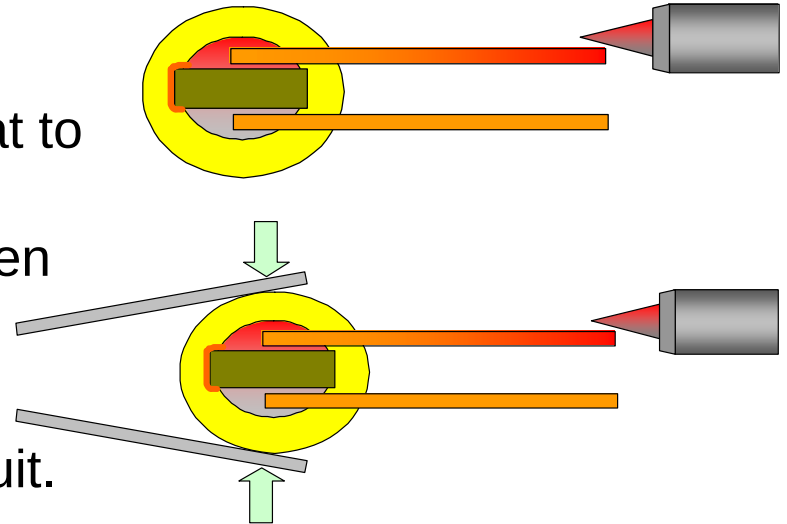
## Case A:

Short Cu wire transfer quickly the heat to one side of the sensor forcing melted solder to expand and squeeze between cold MC and die.

Holding a sensor with tweezers increases the probability of short circuit.

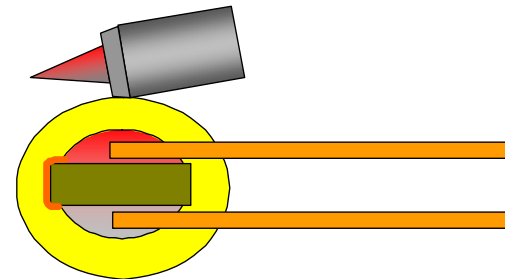
## Case B:

A touch with a soldering iron creates temperature gradient allowing solder melting on one side while another side remains cool.

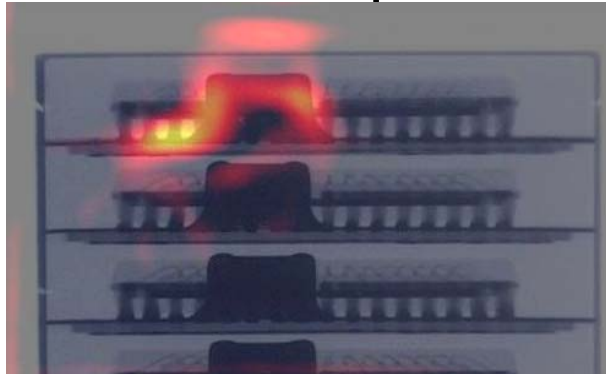
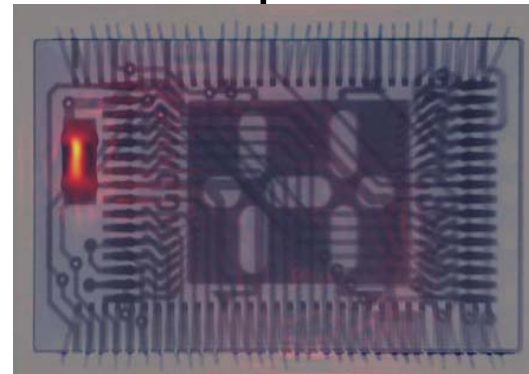
- ❑ Results of MCI indicated the short through a ceramic capacitor on the top board inside 3D-plus cube.
