# GODDARD SPACE FLIGHT CENTER

## Test Lab Report Summary

<i>Report Number:</i>	Q20102DPA	<i>Project:</i>	SORCE
<i>Part Type:</i>	Microcircuit	<i>System:</i>	
<i>Part Number:</i>	RT54SX16-1CQ208BX3	<i>Initiated Date:</i>	03/15/02
<i>Date Code:</i>	0101 (1), 0113 (1)	<i>Report Date:</i>	03/29/02
<i>Manufacturer:</i>	Actel	<i>Investigator:</i>	C. Greenwell (562)
<i>Generic Number:</i>	RT54SX16	<i>Requester:</i>	T. Perry (562)
<i>Purchase Spec:</i>	Mfg. 883 Flow	<i>Approval / Date:</i>

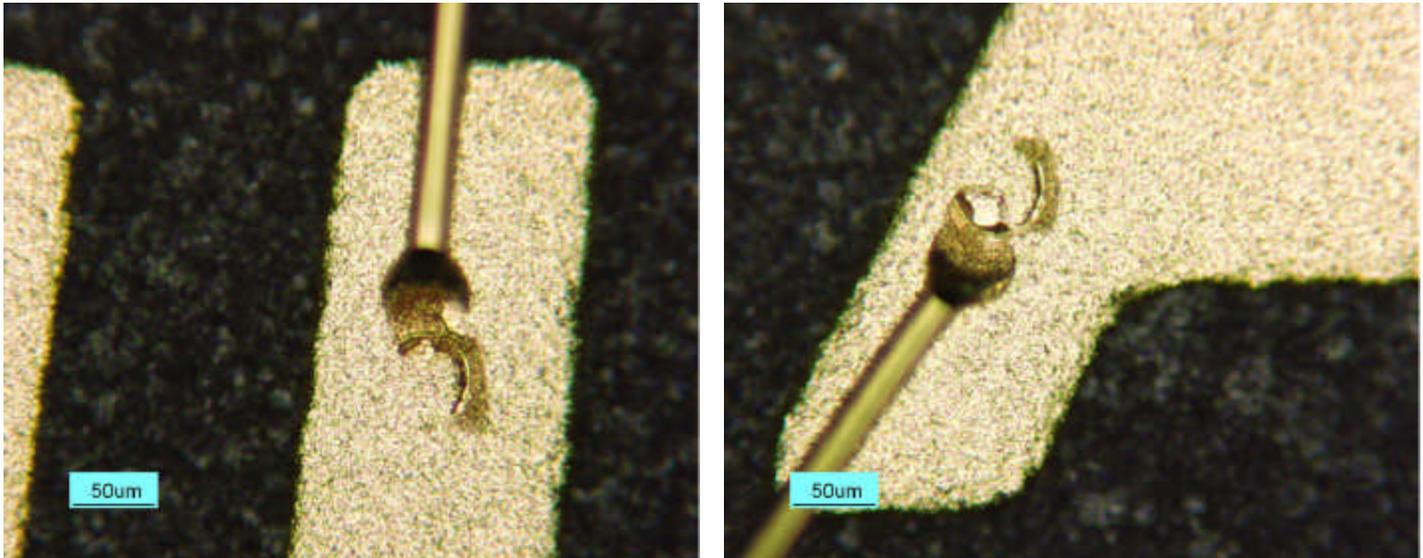
Figure 8. High-mag optical images show worst-case lead frame bonds in SN 003. Lead frame bonds in SN 004 were very similar.

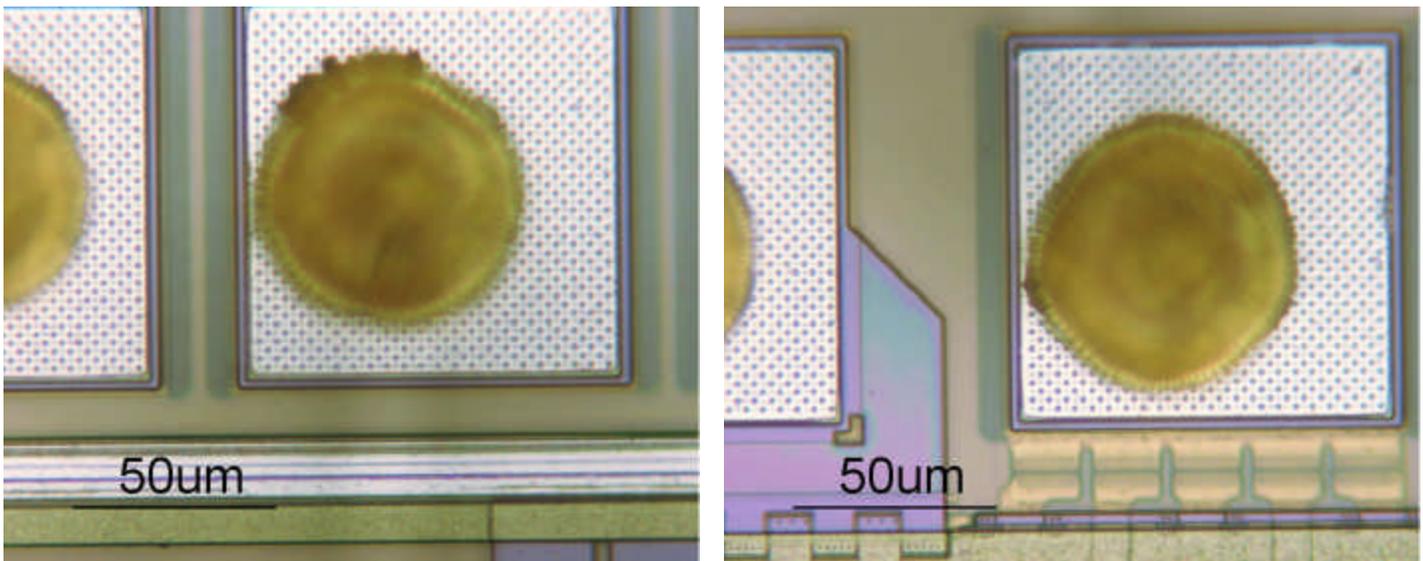
Internal examination revealed intermetallic halo visible around several of the gold ball bonds in SN 003 (dc 0101) (see Figures 9 and 10). As observed, no conditions were deemed to violate MIL-STD-883 Method 2010, Paragraph 3.2.1.4(k) inspection criteria – no device shall be acceptable that exhibits “*Intermetallic formation extending radially more than 0.1 mil completely around the periphery of that portion of the gold bond located on metal.*” Similar optical inspection of SN 004 (dc 0113) revealed no evidence of the intermetallic halo condition (see Figure 11).

Figure 9. High-mag optical images of SN 003 show gold ball bonds with discernable indications of intermetallic around portions of the bond periphery.

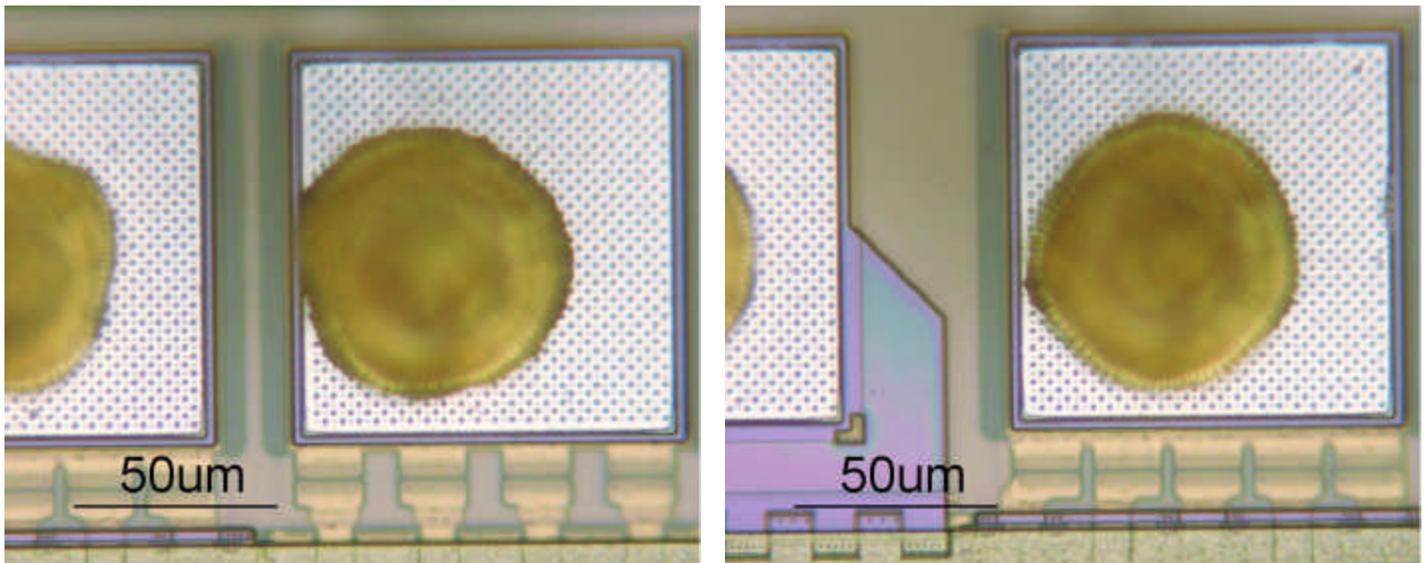
Figure 10. High-mag optical images of SN 003 show typical gold ball bonds. The halo of intermetallic is discernable around these bonds.

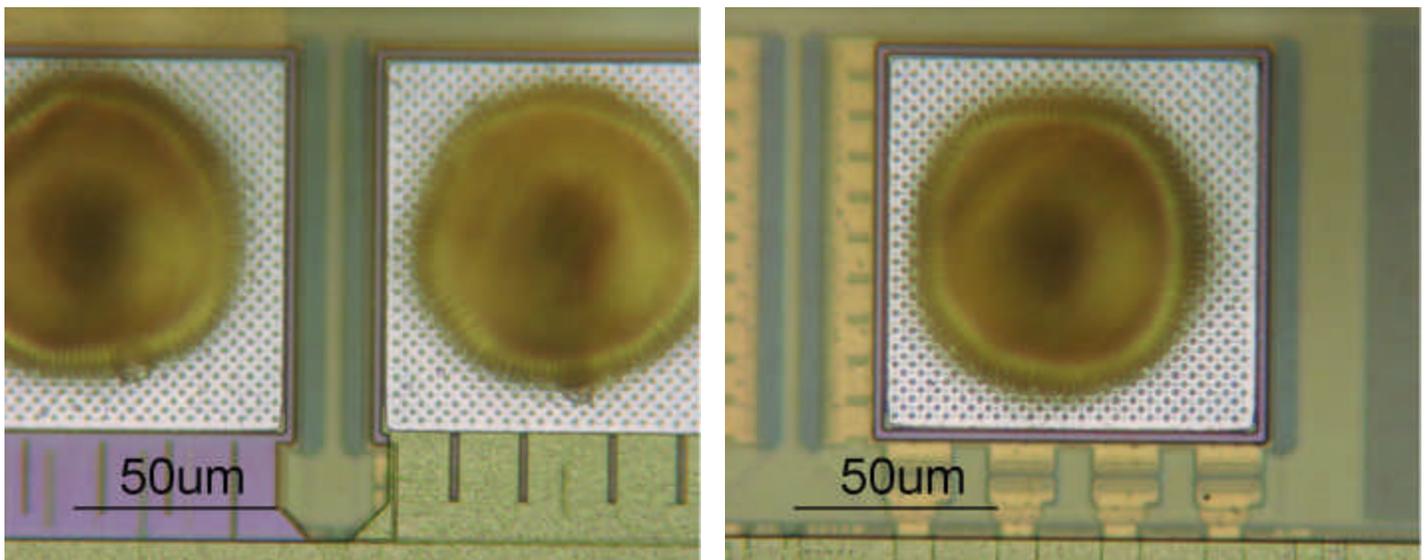
Figure 11. High-mag optical images of SN 004 (dc 0113) gold ball bonds. This device did not exhibit optically-visible evidence of intermetallic halo around the bonds. The features visible in the left two bonds at approximately the six o'clock position are wafer probe damage; very normal features.

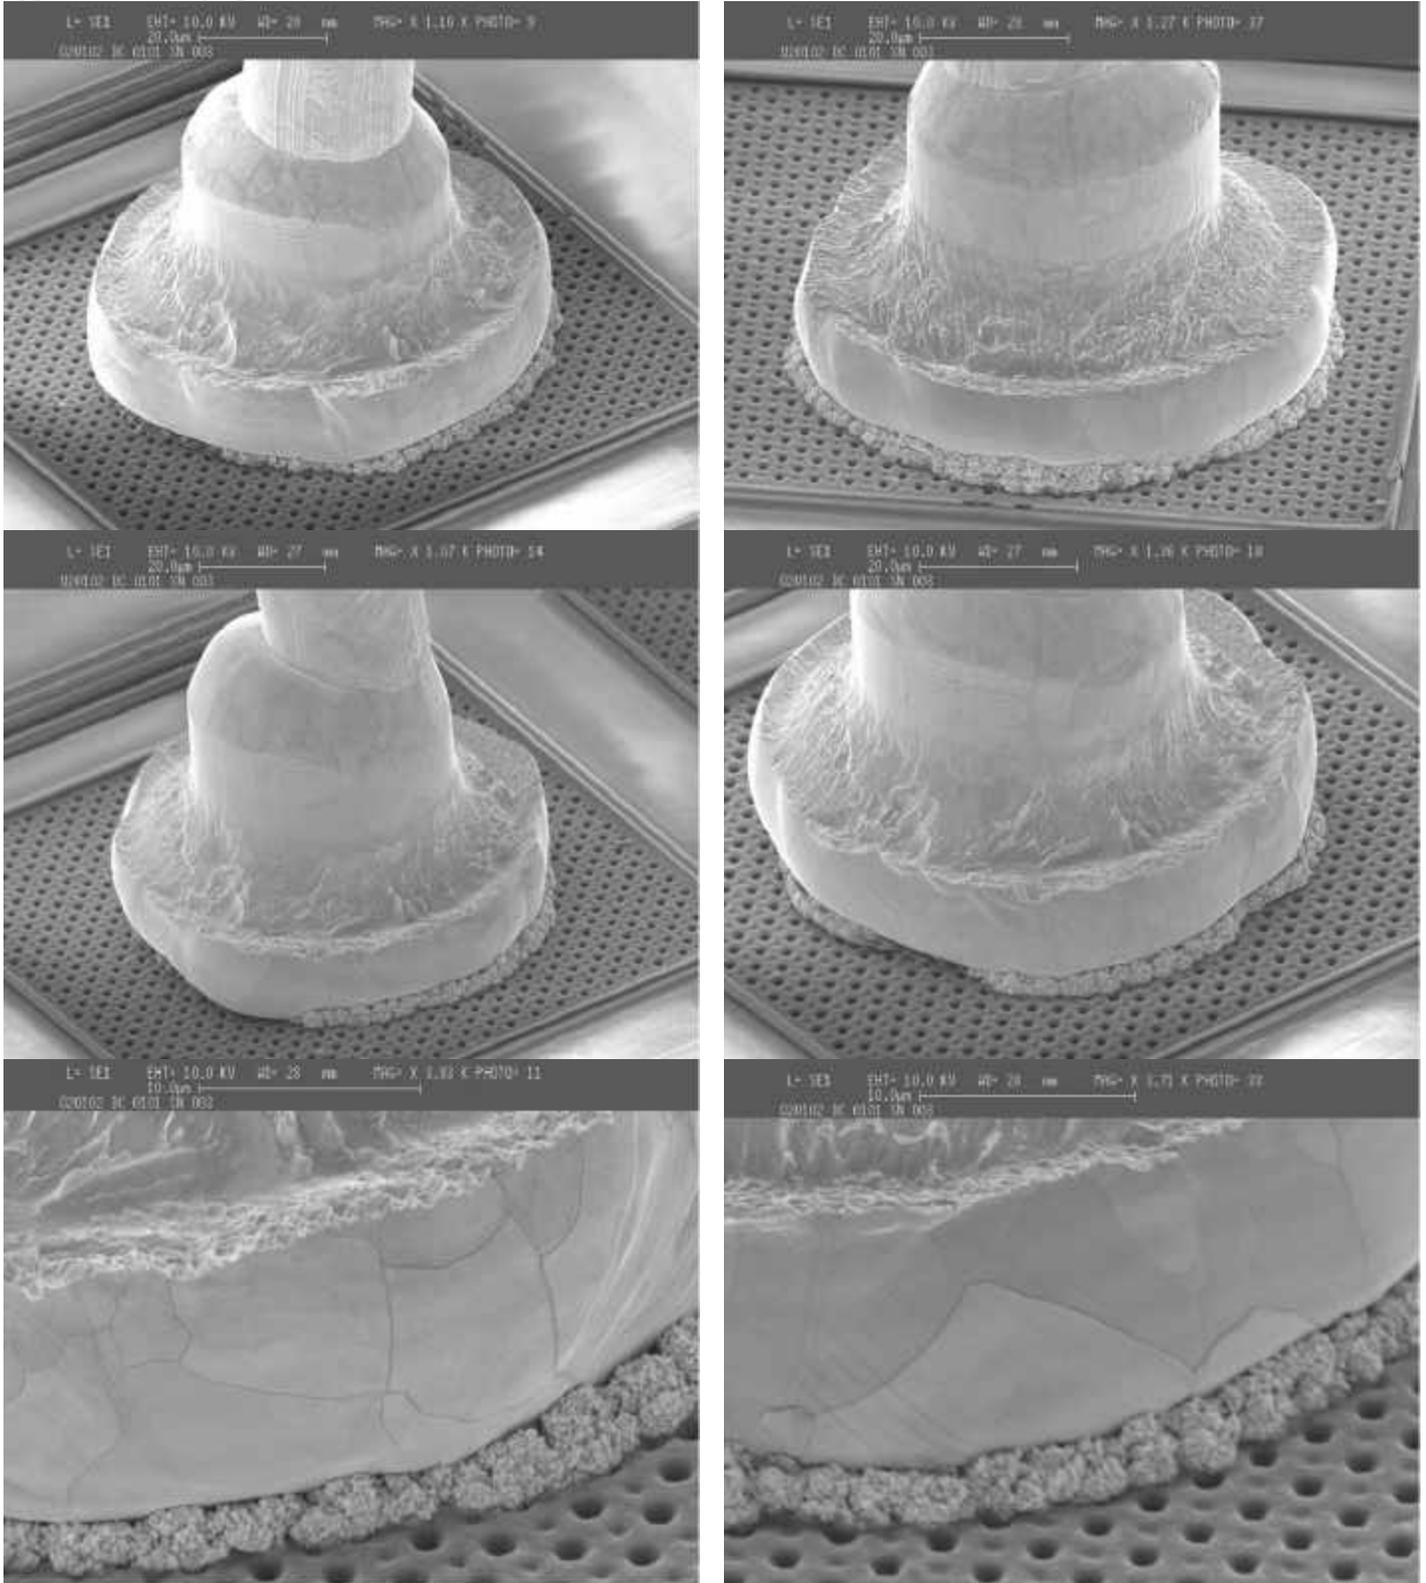
SEM inspection (before and after bond strength testing) revealed the extent of intermetallic halo around the bonds in SN 003 (see Figure 12). A few of the bonds in SN 003 also had evidence of ‘watermelon stripes’ or otherwise visible grain boundaries, similar but less pronounced than those documented in Failure Analysis Q20024FA (see bottom two images in Figure 12). Some intermetallic was revealed at locations around some of the bonds in SN 004 (see Figure 13).

Figure 12. SEM images of SN 003 showing detailed views of ball bond intermetallics.

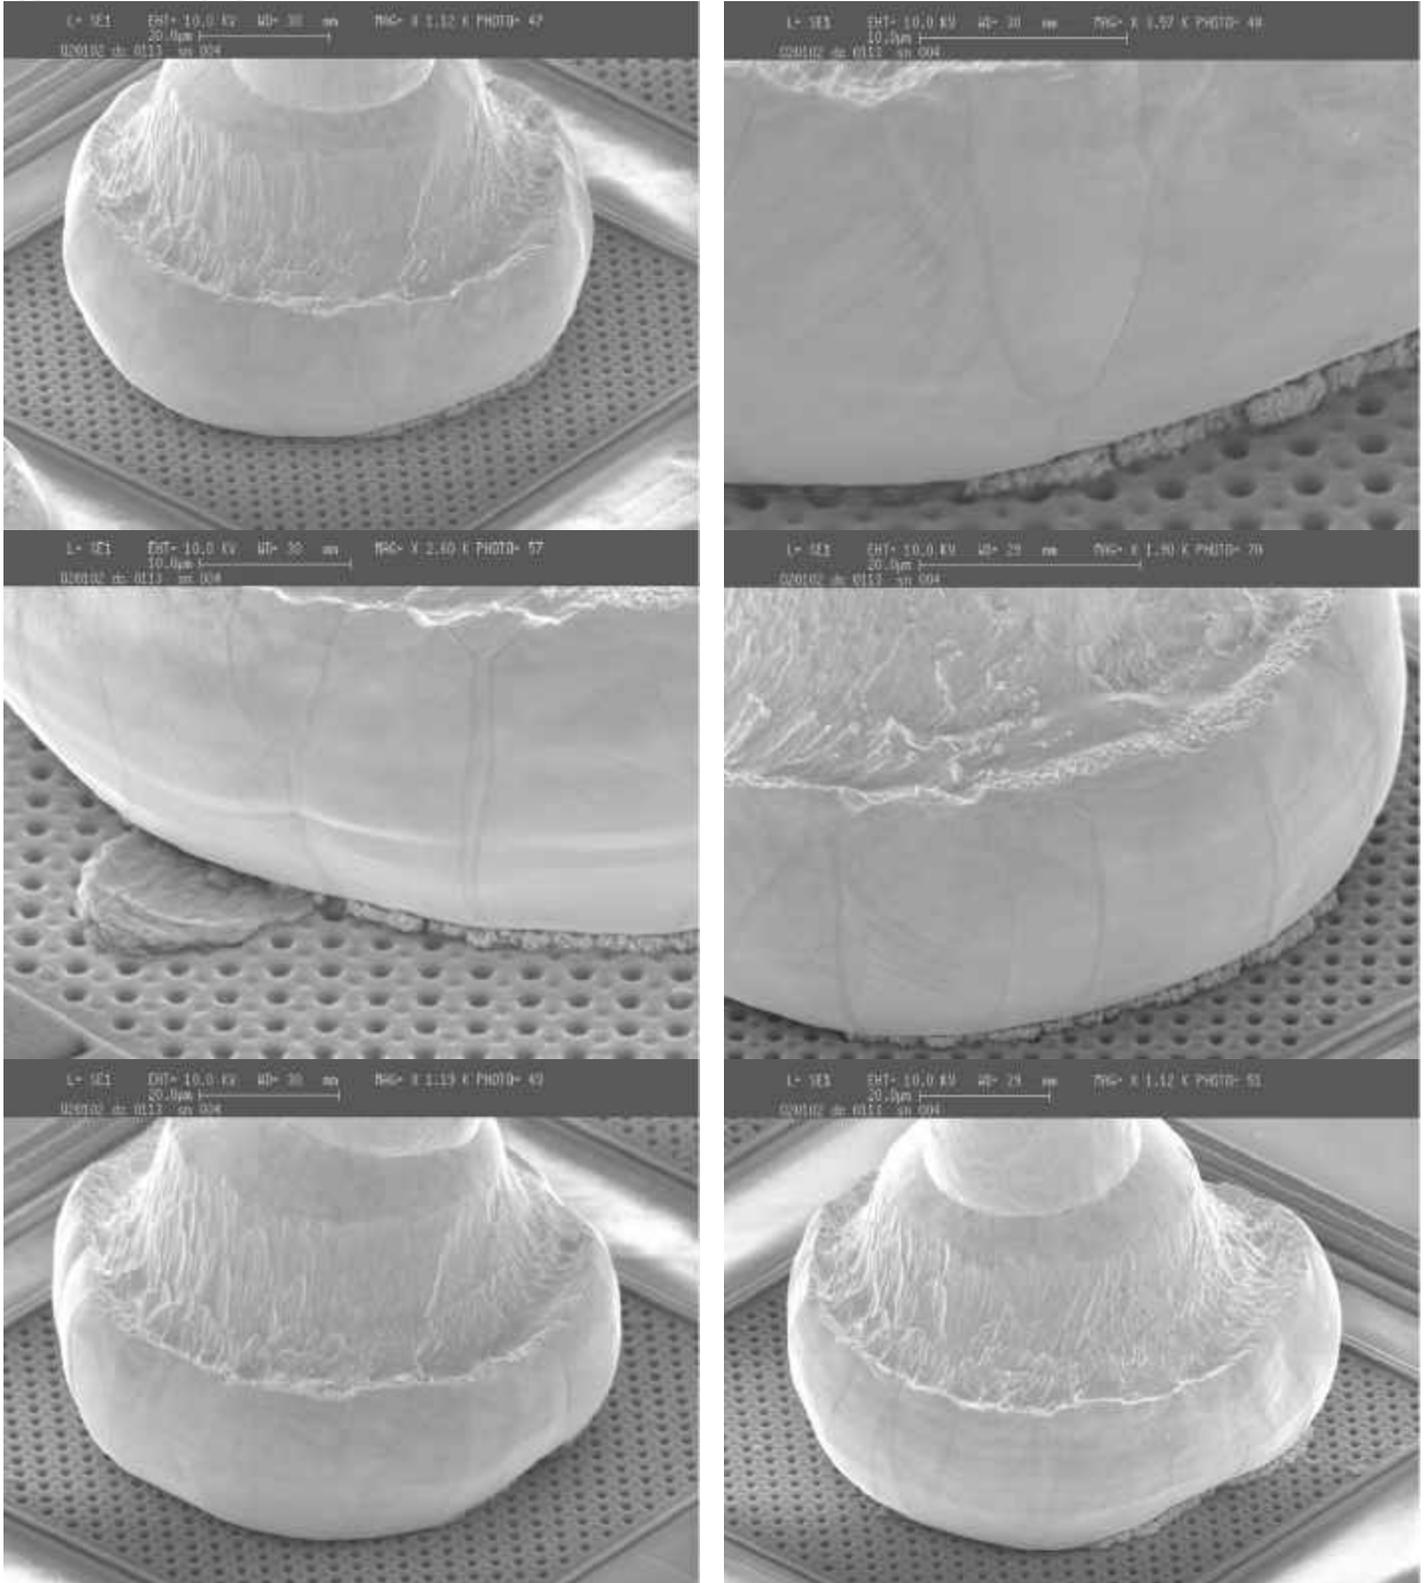
Figure 13. SEM images of SN 004 ball bonds. Significantly less intermetallics are present in this device.

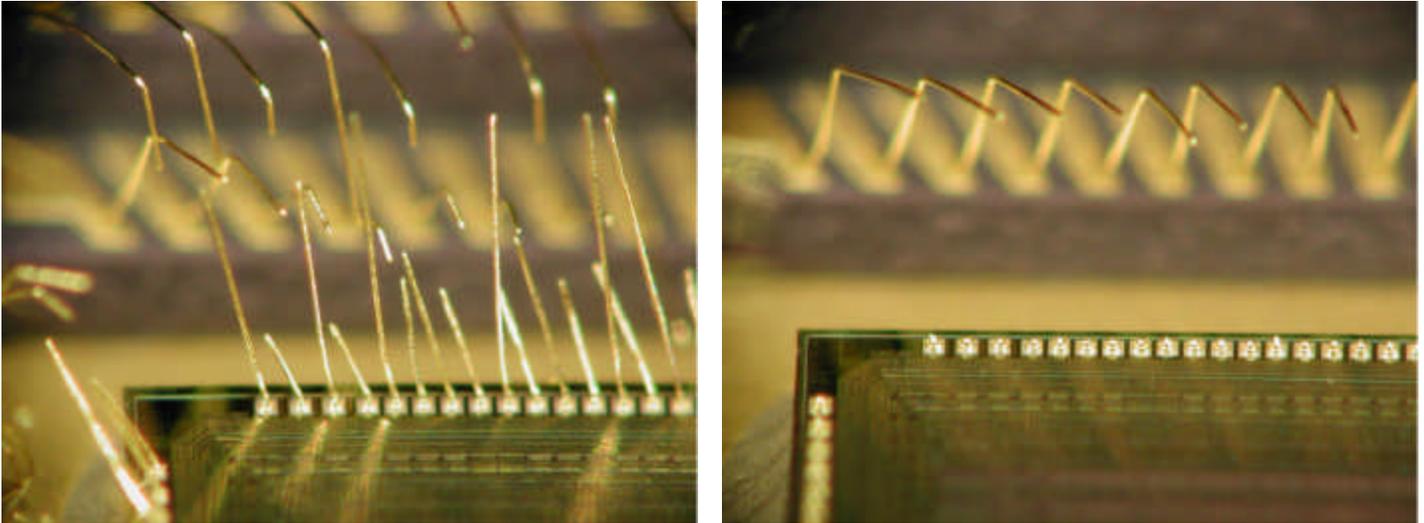
While no actual failures occurred, bond strength testing per 883-Method 2011 Condition D produced uniquely different results for the two devices. In SN 003, of 223 wires tested (one wire was inadvertently broken prior to testing), 220 broke somewhere along the wire span and three broke at the ball neckdown area (HAZ - heat affected zone) (see Figure 14). Span and neckdown breaks are both very common, but the ratio of one to the other is usually not so one sided. The average breaking load for all these wires was 5.78 grams-force (g-f), with a Std Dev of 0.35. The wires in SN 003 measured nominally 1.0 mil; per 883-Method 2011, the corresponding minimum break force is 2.5 g-f.

Bond strength testing SN 004 resulted in 219 of 224 wires breaking at the ball neckdown, a somewhat unusual event (see Figure 14). The remaining five bonds lifted, pulling areas of the die bond pad metallization with them (see Figures 15 through 20). This is an unusual occurrence. The five lifts occurred at loads of 6.7, 8.1, 8.7, 9.7 and 10.6 g-f. All five lifts left significant amounts of intermetallic on the bond pads. The average breaking load for all the wires in SN 004 was 10.28 g-f, with a Std Dev of 0.89. The wires in SN 004 measured nominally 1.3 mil; with a corresponding minimum break force of 3.0 g-f.

Figure 14. Optical images show bond pull results for SN 003 (left) and SN 004 (right). Except for three neckdown breaks (at the ball), all the wires in SN 003 broke somewhere along the wire span with an average of 5.78 grams-force. In SN 004, all wires except five broke at the ball neckdown (heat affected zone) with an average of 10.28 g-f. There are 224 wires in each device.

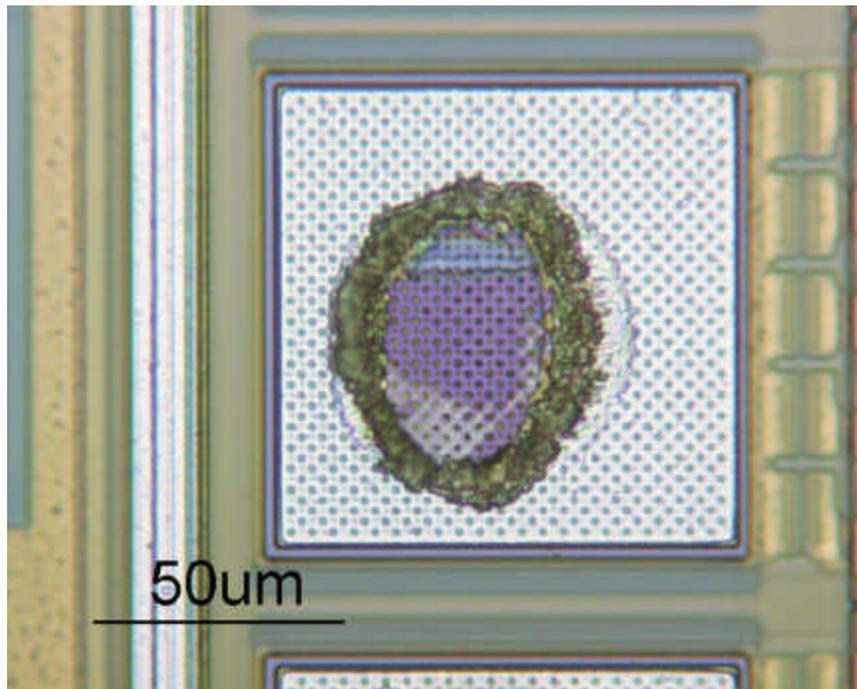
Figure 15. High-mag optical image shows bond pull test result for a wire in SN 004. This bond lifted metallization from the die with an applied load of 10.6 g-f. Note the significant halo of intermetallic remaining on the pad.

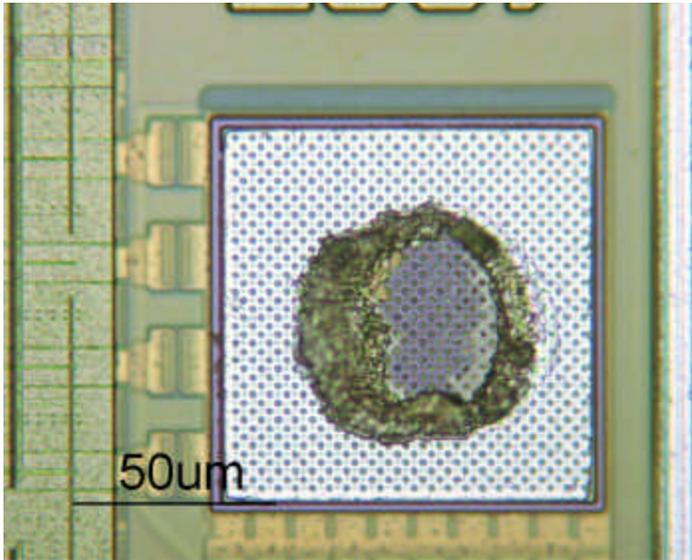
6.7 g-f

Figure 16. High-mag optical images of the remaining four bond lifts in SN 004.

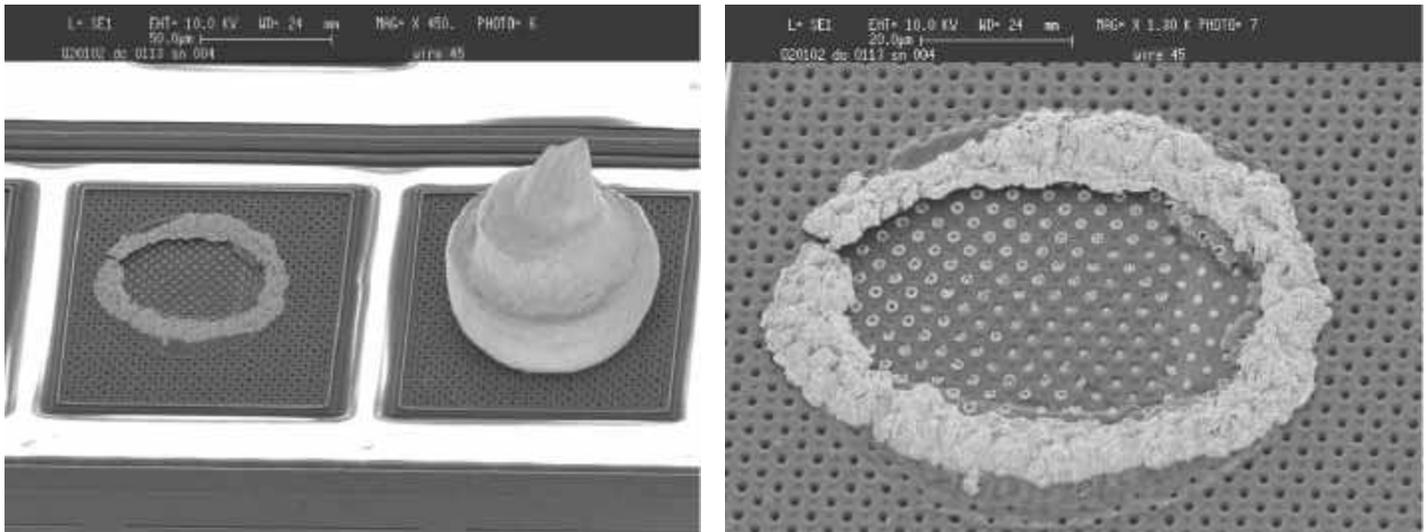
Figure 17. SEM micrograph images shows results of the bond that lifted at 10.6 g-f.

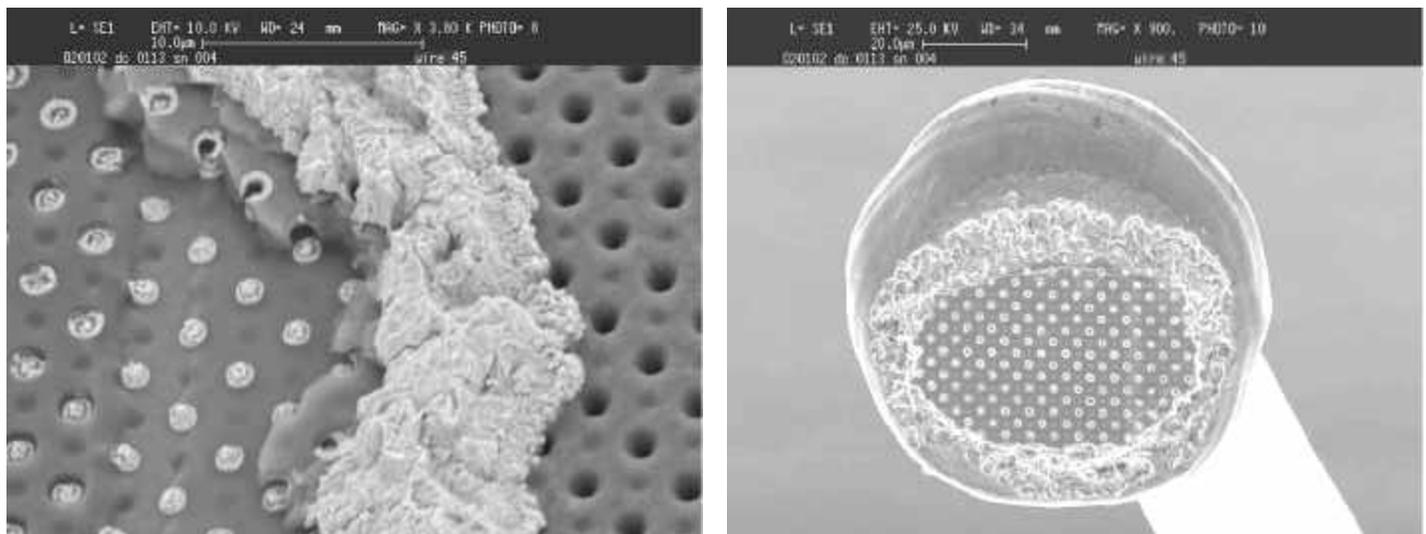
Figure 18. SEM images show a close-up area of the pad shown above and the corresponding underside of the ball that lifted from this pad.

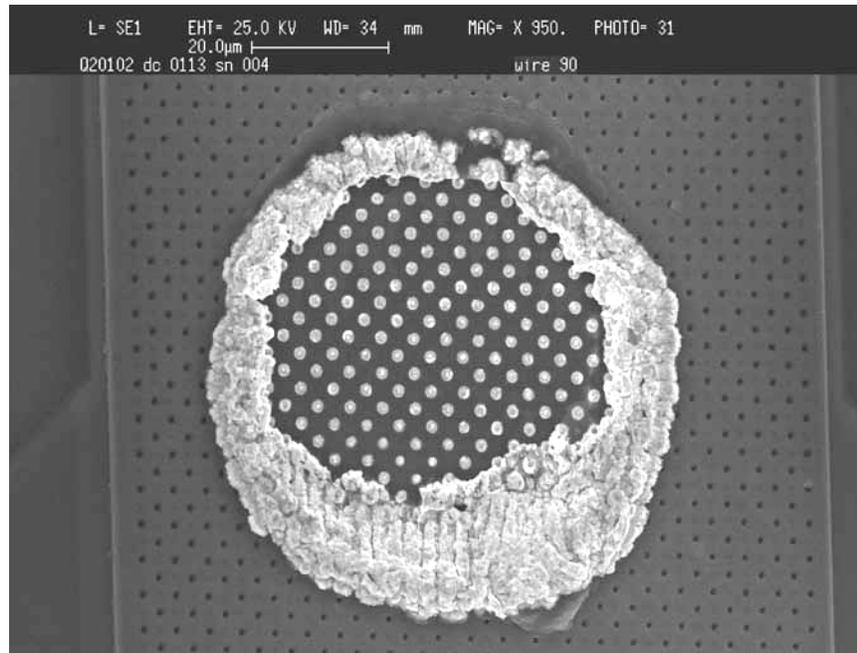
Figure 19. SEM image shows pad area for wire that lifted at 8.1 g-f. Note the ‘straight line’ pattern in the intermetallics, particularly noticeable in the wider bottom half of the halo.

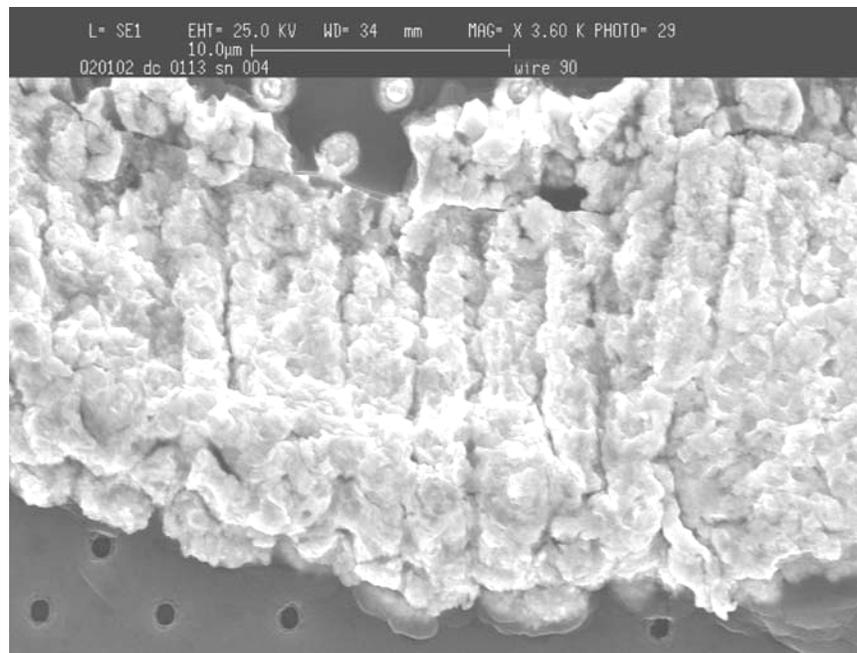
Figure 20. Close-up SEM image of the area indicated above. It is not known what these features indicate.

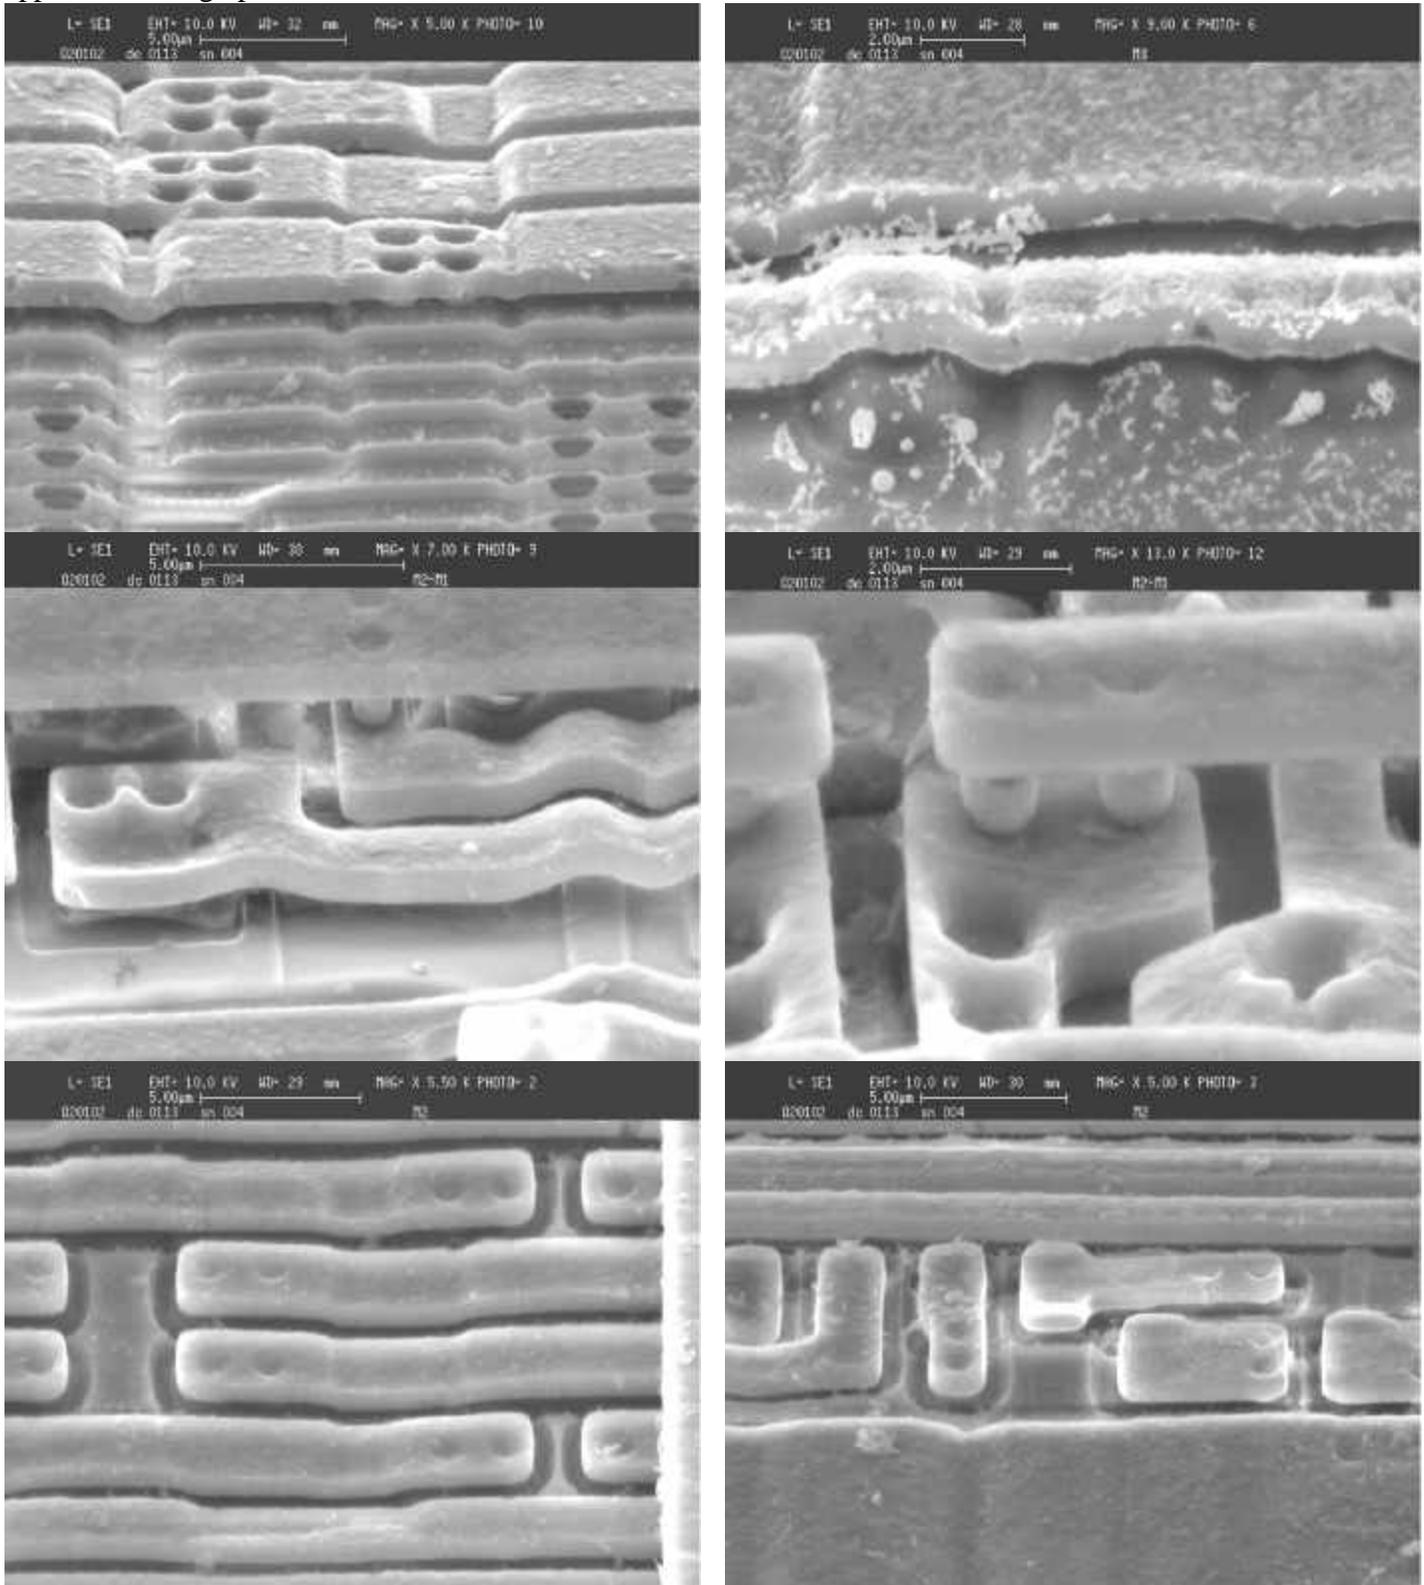
Figure 22. SEM images of die metallization on SN 004. Etch artifact is visible in several areas.
