# Destructive Single-Event Effects in Diodes

Megan C. Casey<sup>1</sup>, Jean-Marie Lauenstein<sup>1</sup>,  
Michael J. Campola<sup>1</sup>, Edward P. Wilcox<sup>2</sup>, Anthony M. Phan<sup>2</sup>,  
and Kenneth A. LaBel<sup>1</sup>

<sup>1</sup>NASA Goddard Space Flight Center

To be presented by Megan C. Casey at the NASA Electronics Parts and Packaging (NEPP) Electronics Technology Workshop (ETW), Greenbelt, MD, June 26-29, 2017.

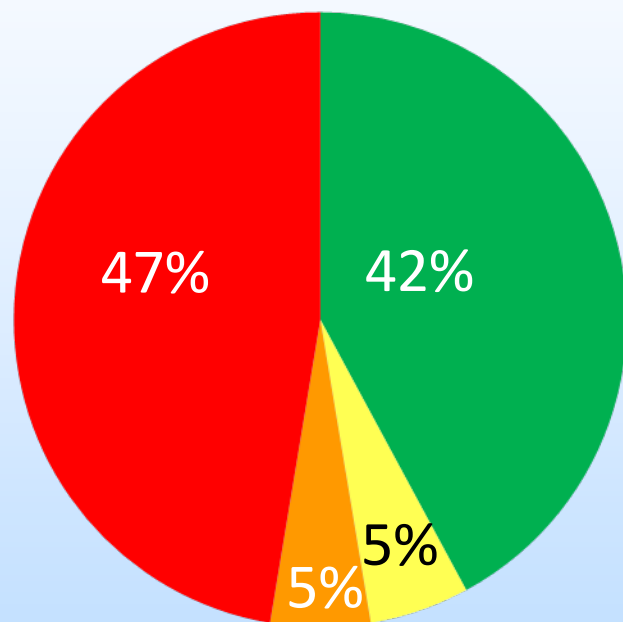
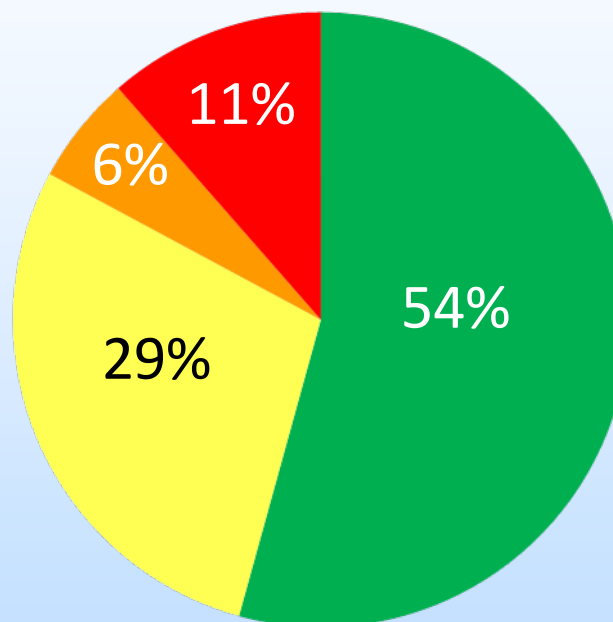
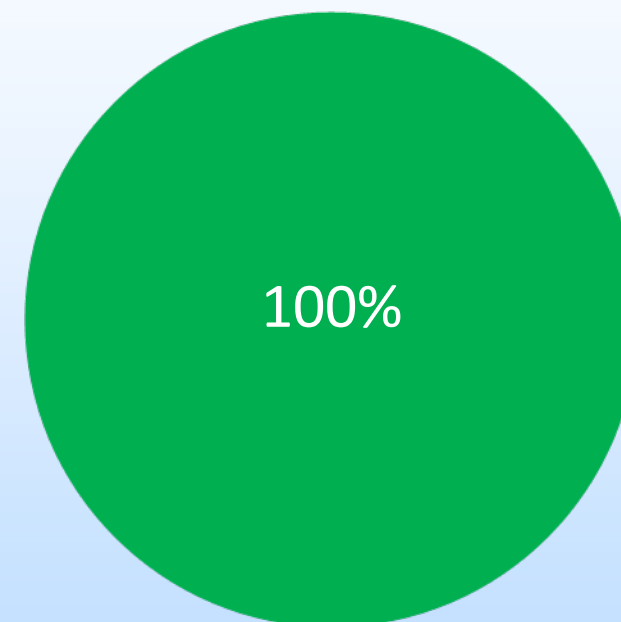
By derating to 50% of the reverse voltage, all failures are eliminated for the parts tested

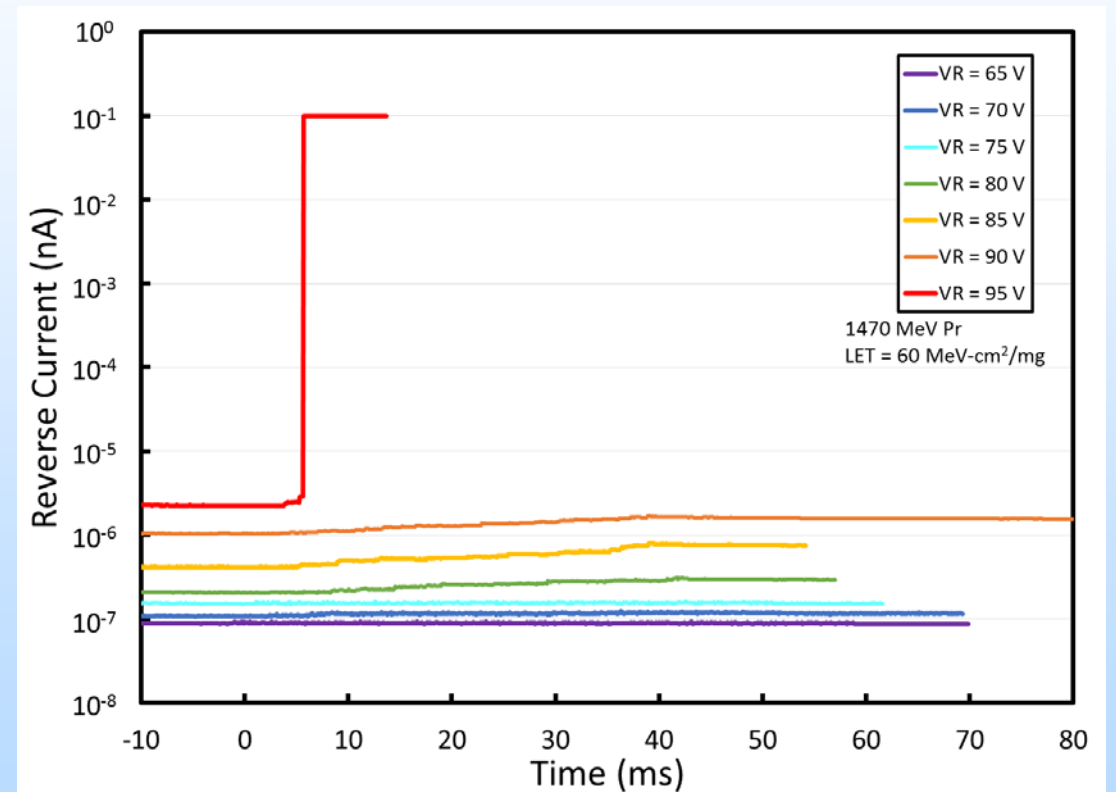
- SN5 was irradiated with 1470 MeV Pr (LET = 60 MeV-cm<sup>2</sup>/mg) in 5 V steps starting at 50 V (50% of the rated reverse voltage)
- Only charge collection was observed up to the 65-V irradiation
- When biased at 70 V, small increases in the reverse current were observed during the beam run
  - Post-irradiation electrical parameter measurements all remained within specification
  - Increases in reverse current were on the order of 100 nA
- At 95 V, the increase in reverse current was 100s of nA

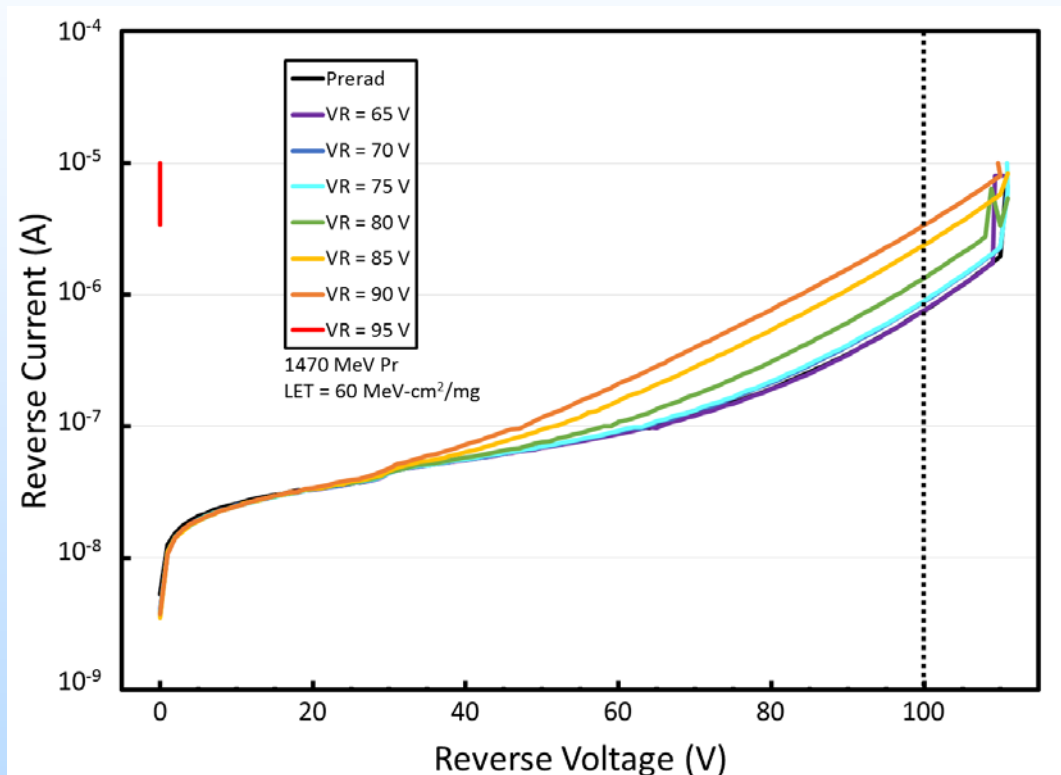
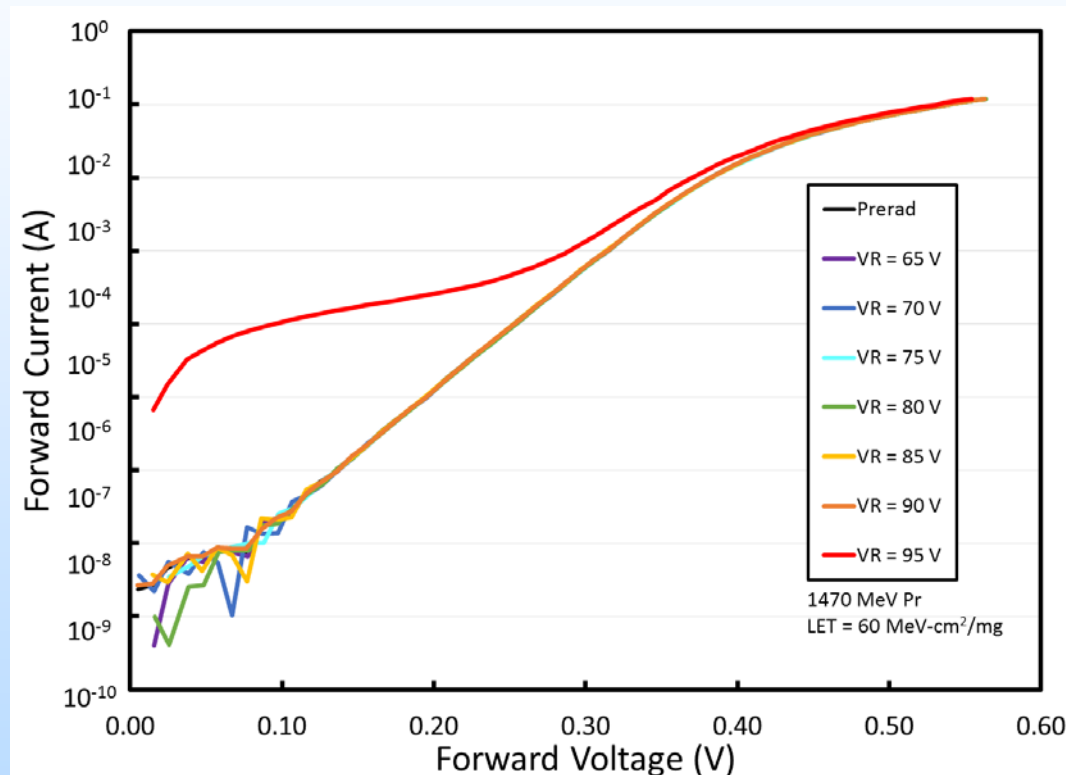
Part was degrading until after the 95-V run, and then  $I_R$  exceeded 10  $\mu$ A at less than 1 V

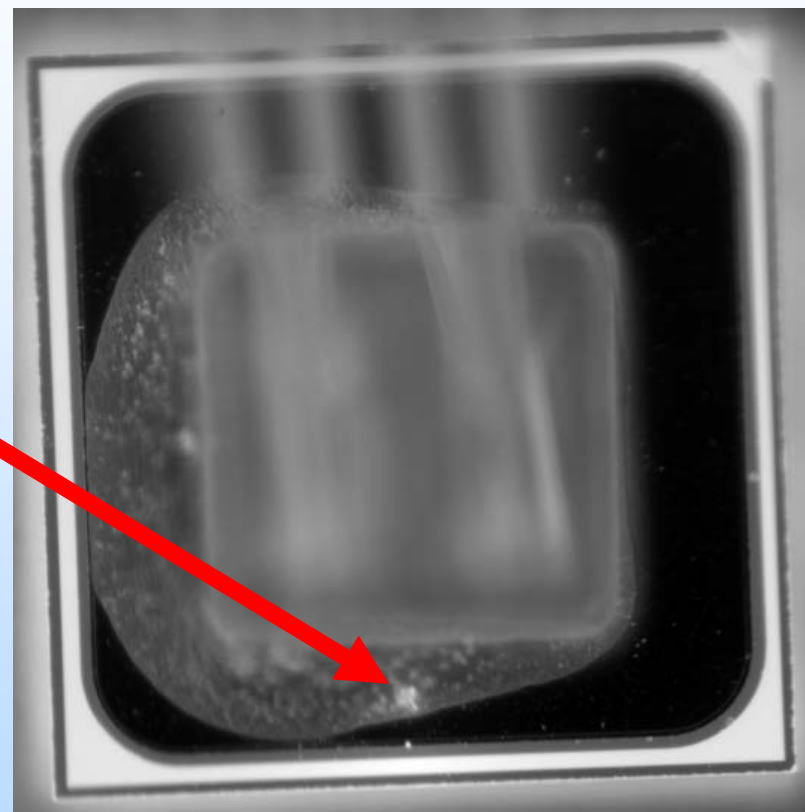
- Diode was examined using an IR camera and pictures were taken with a small voltage applied
  - Bright white spot just below the wirebond contact is the location of the failure
- Low-magnitude and high-magnitude optical images of the surface of the DUT did not show anything unusual at the location identified in the IR image

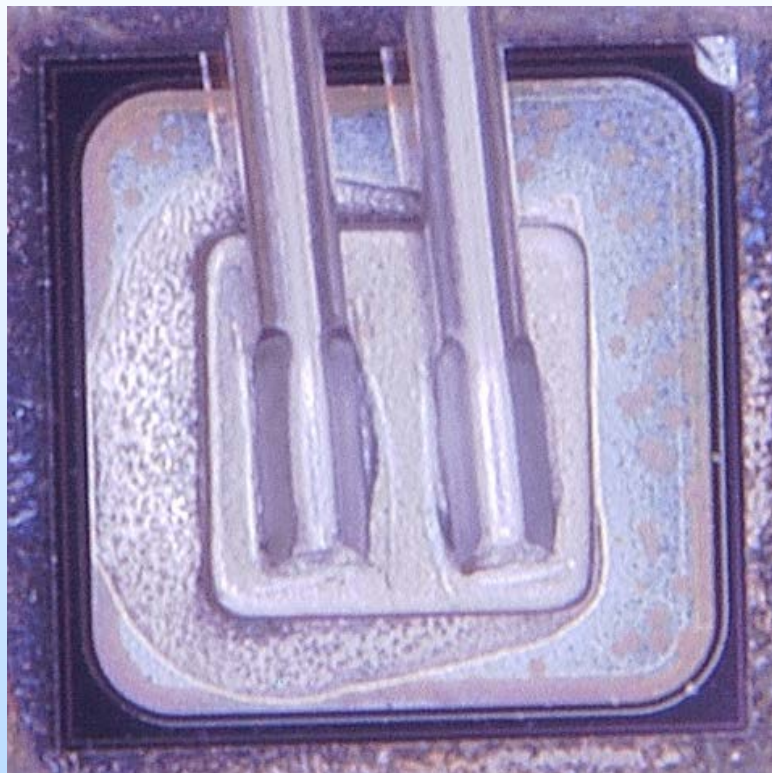
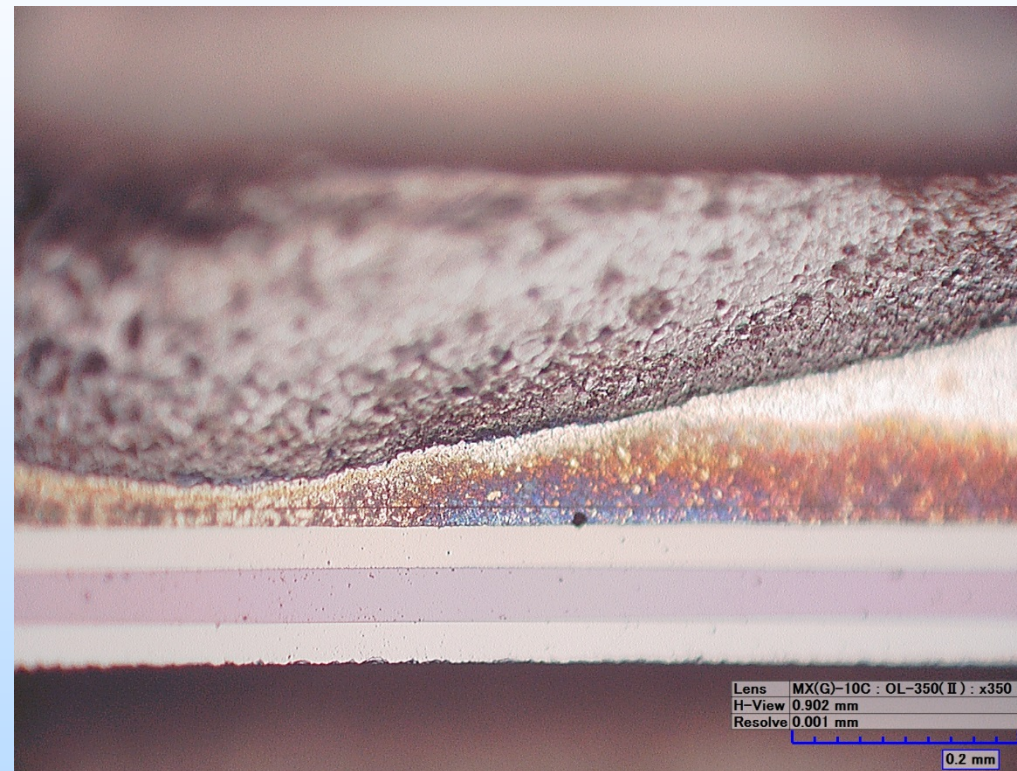
Failure location is not visible in optical images

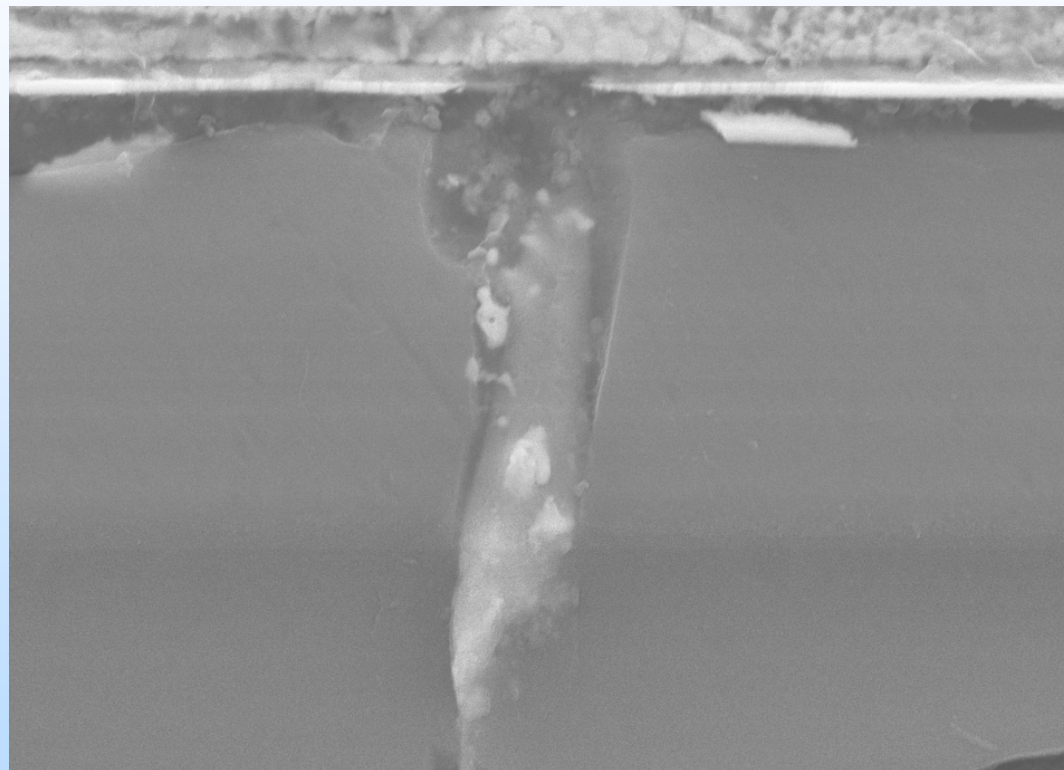
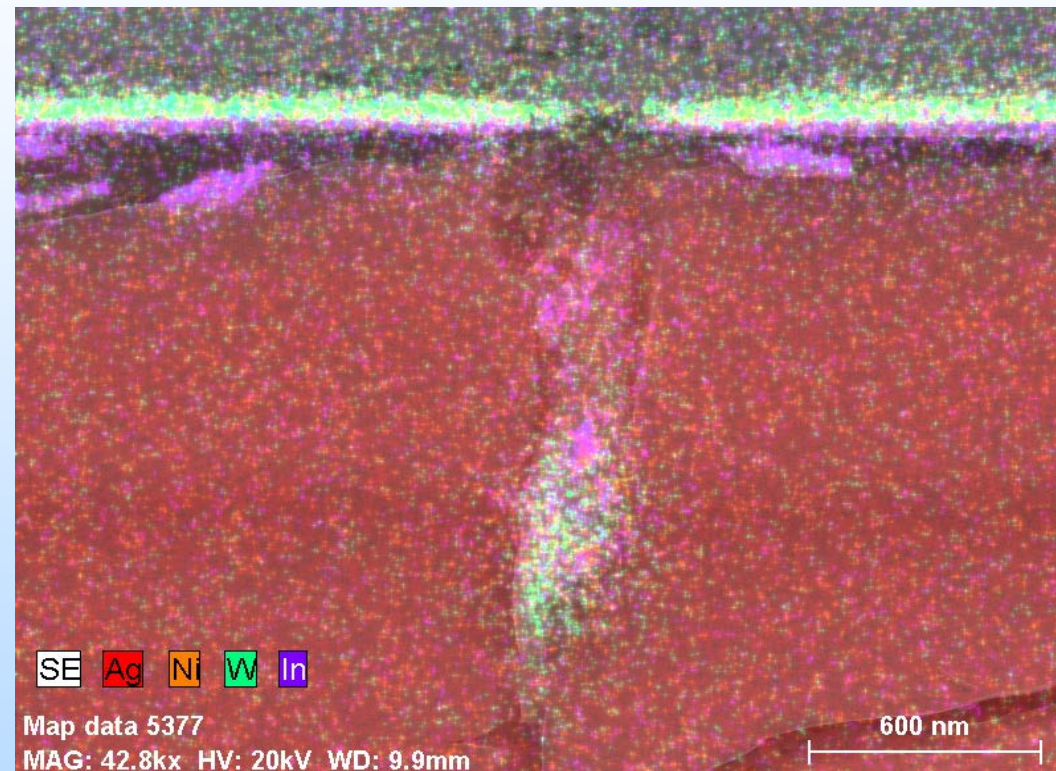
Metal has clearly displaced from Schottky junction into void  
formed from high current

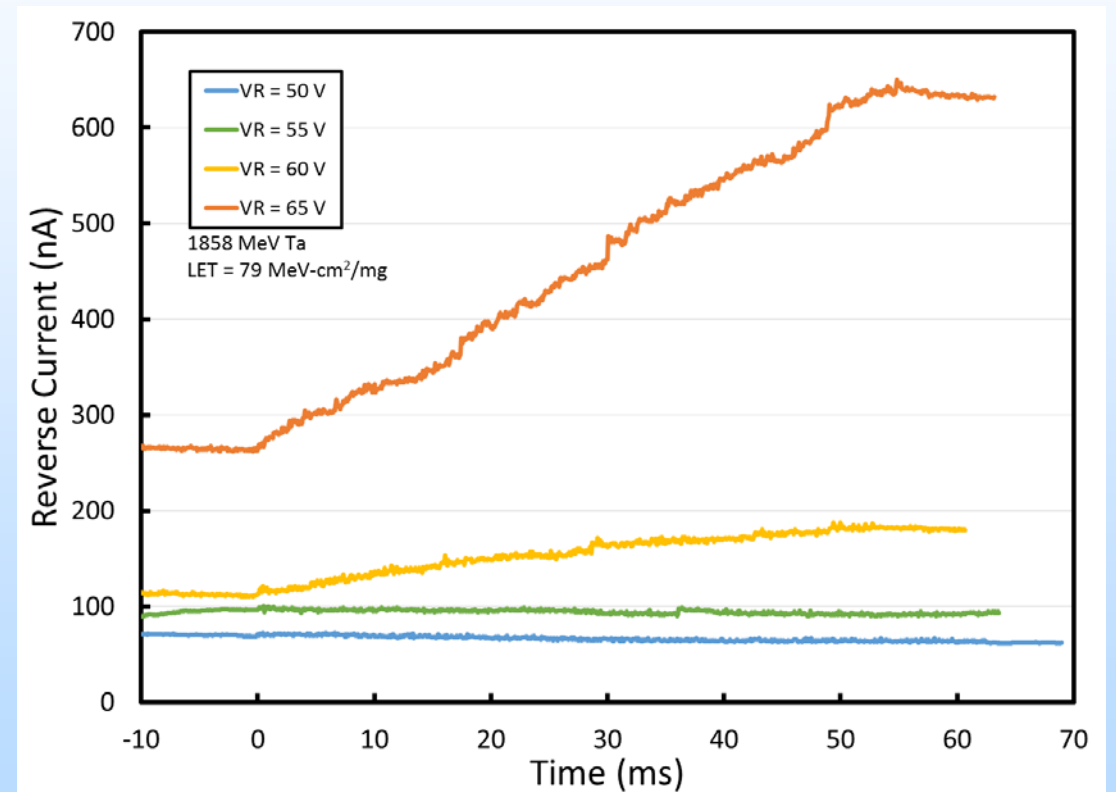
- SN2 was irradiated with 1858 MeV Ta (LET = 79 MeV-cm<sup>2</sup>/mg) in 5 V steps starting at 50 V (50% of the rated reverse voltage)
- Only charge collection was observed up to the 55-V irradiation
- When biased at 60 V, a ~60 nA increase in  $I_R$  was observed
  - All post-irradiation parameter measurements remained within specification
- At 65 V, however, DUT experienced 100s of nA in degradation and post-irradiation  $I_R$  measurement was out of specification

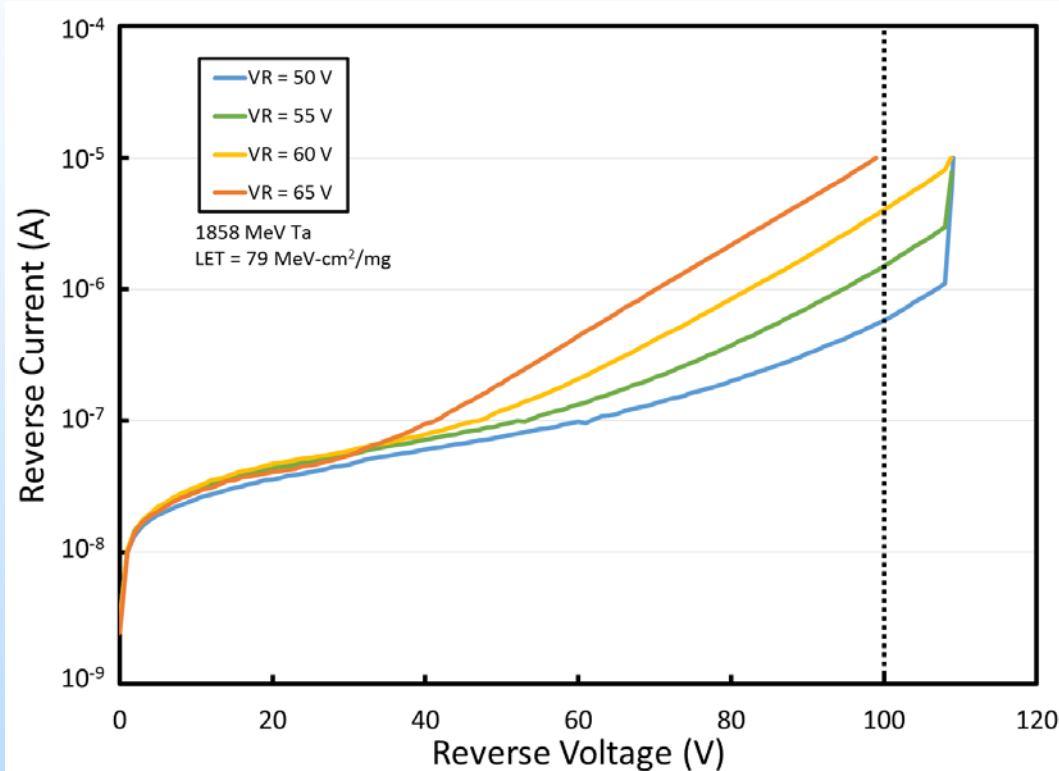
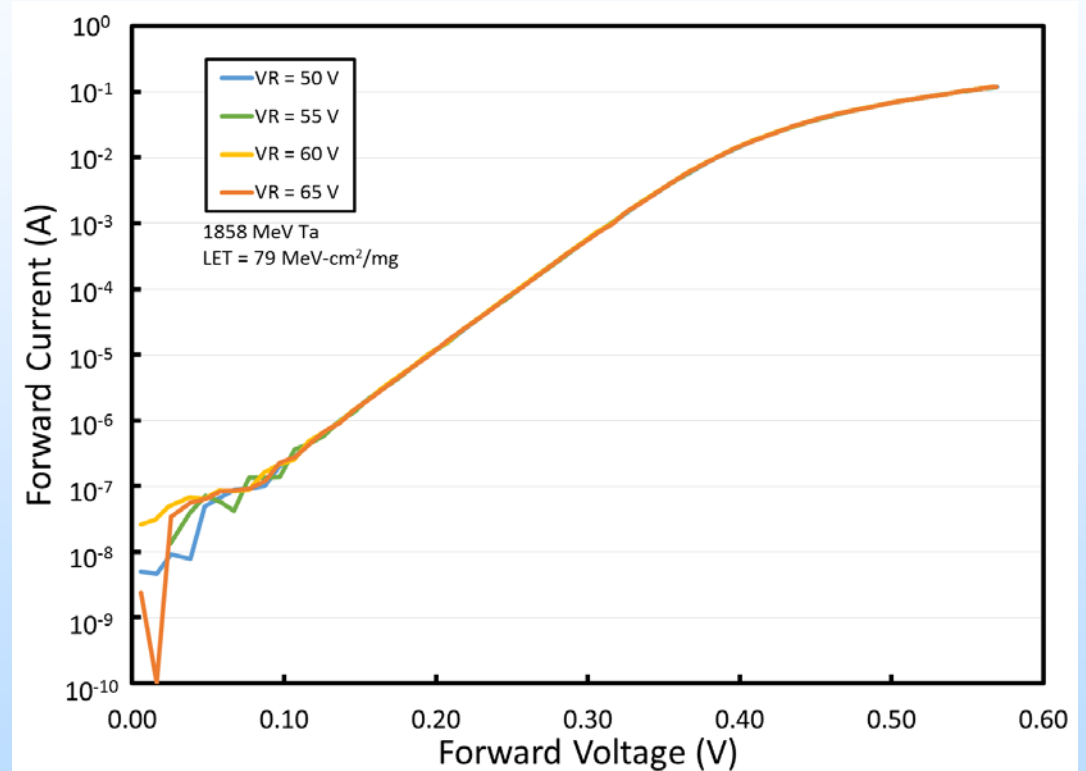
No significant changes were observed in the  $I_F$ - $V_F$  curves, but  $I_R$  exceeded specification at less than 100 V

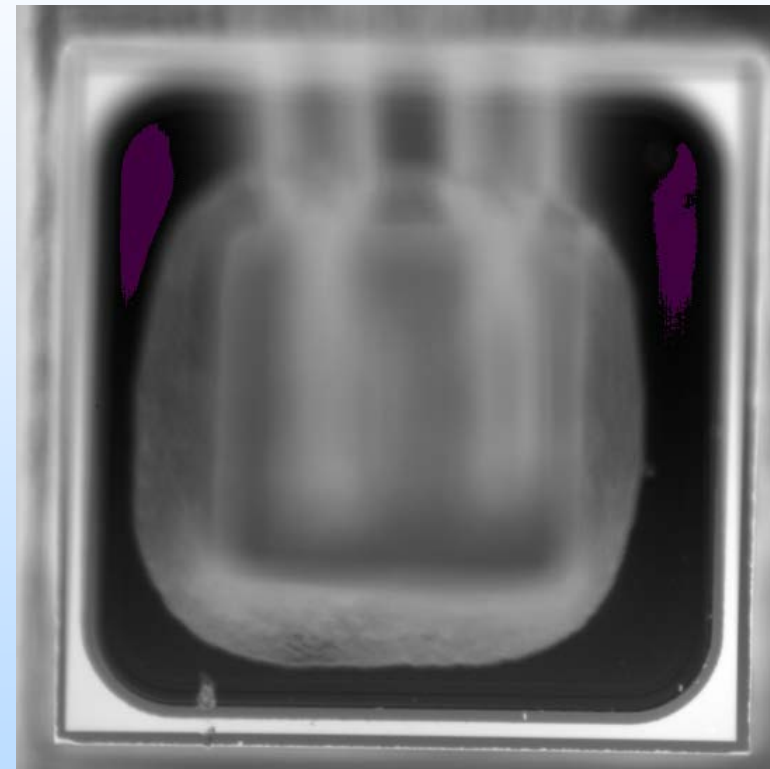
- Diode was examined using an IR camera and pictures were taken with a small voltage applied
  - No failure locations could be identified
- Low-magnitude and high-magnitude optical images of the surface of the DUT also did not show anything unusual
- Because no failure locations were identified, a different technique had to be used
  - A series of chemical etches were used to remove the contact pad, solder connection, and Schottky barrier metal

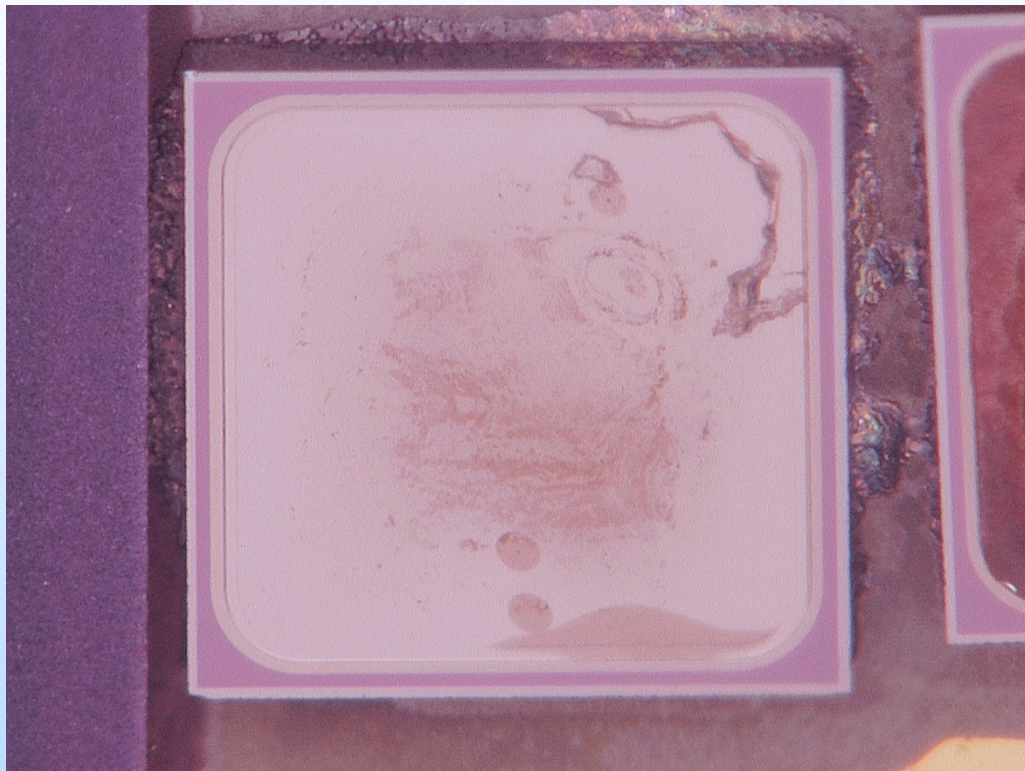
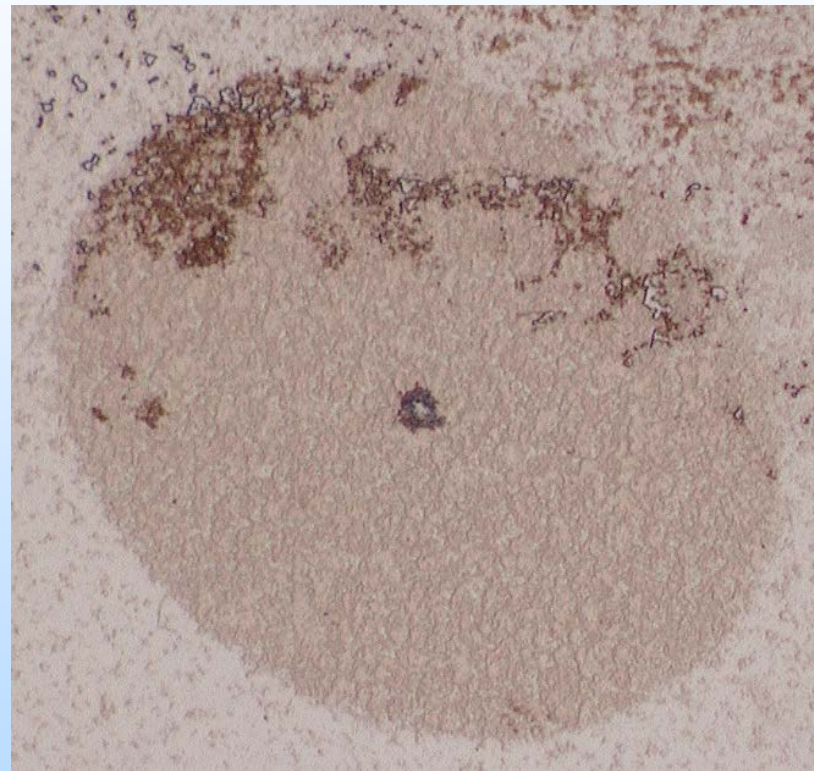
After chemical etches, a few small discolored locations were identified with displaced silicon at the center

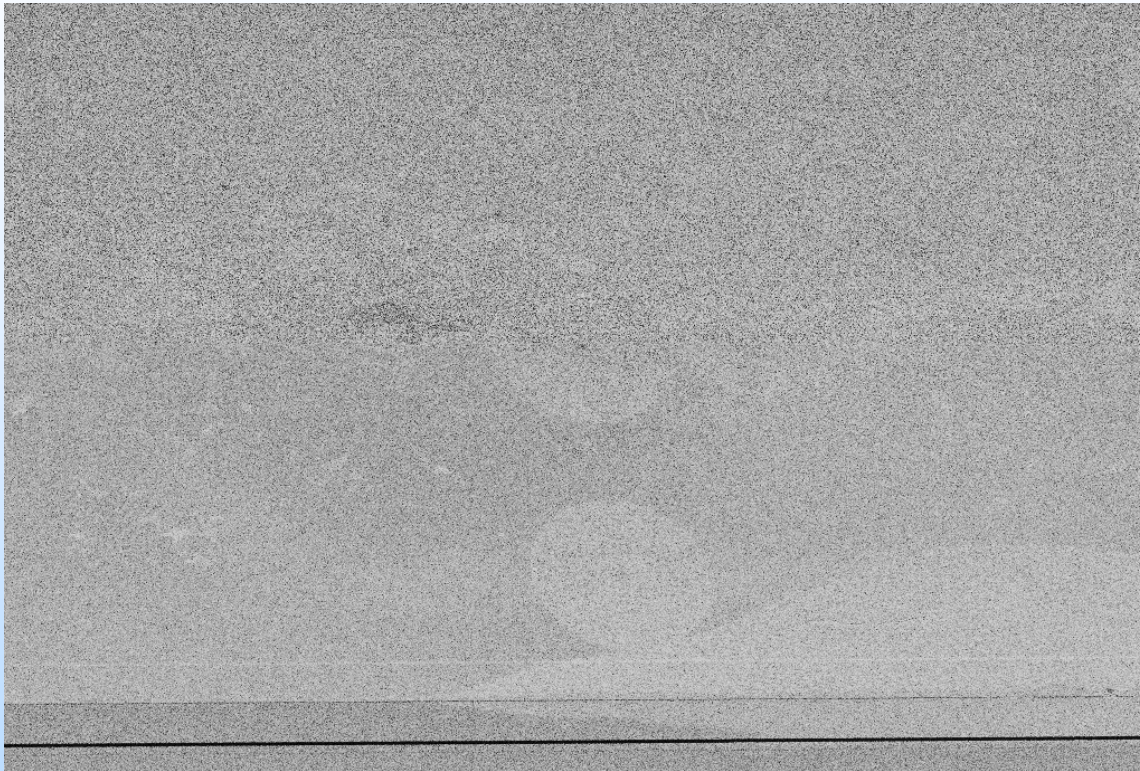
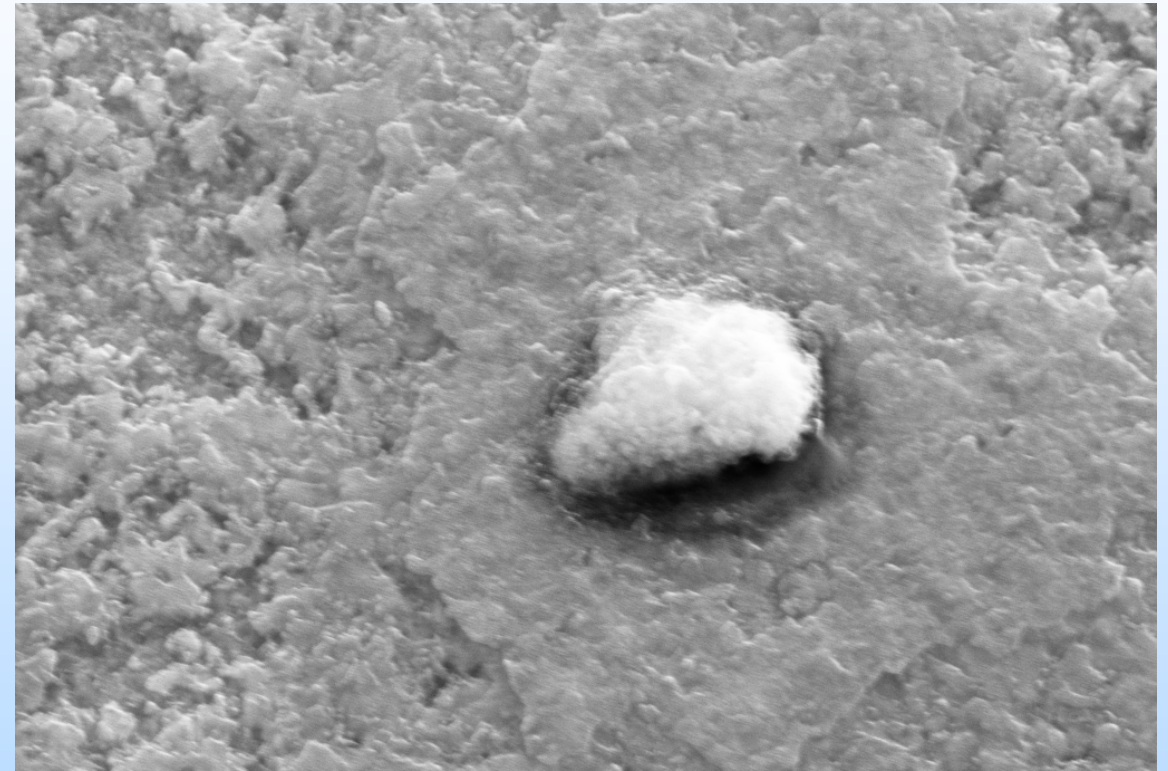
Displaced silicon ball was unable to be removed from surface  
of the diode

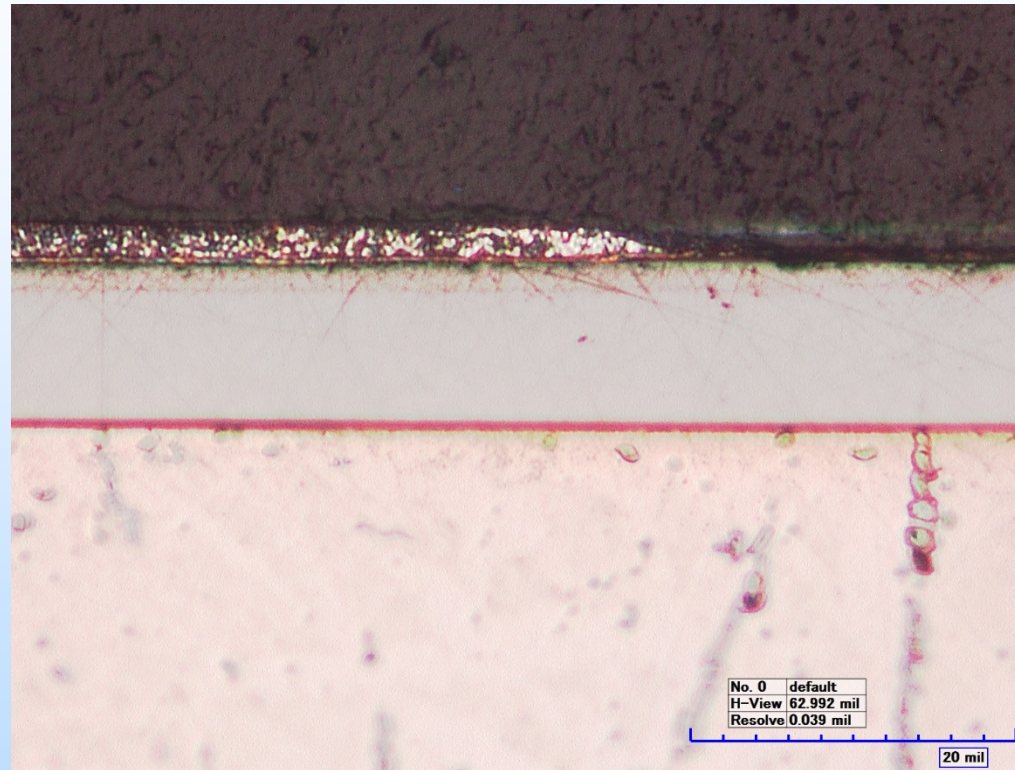
There is no damage structure visible in the damaged diode cross-section

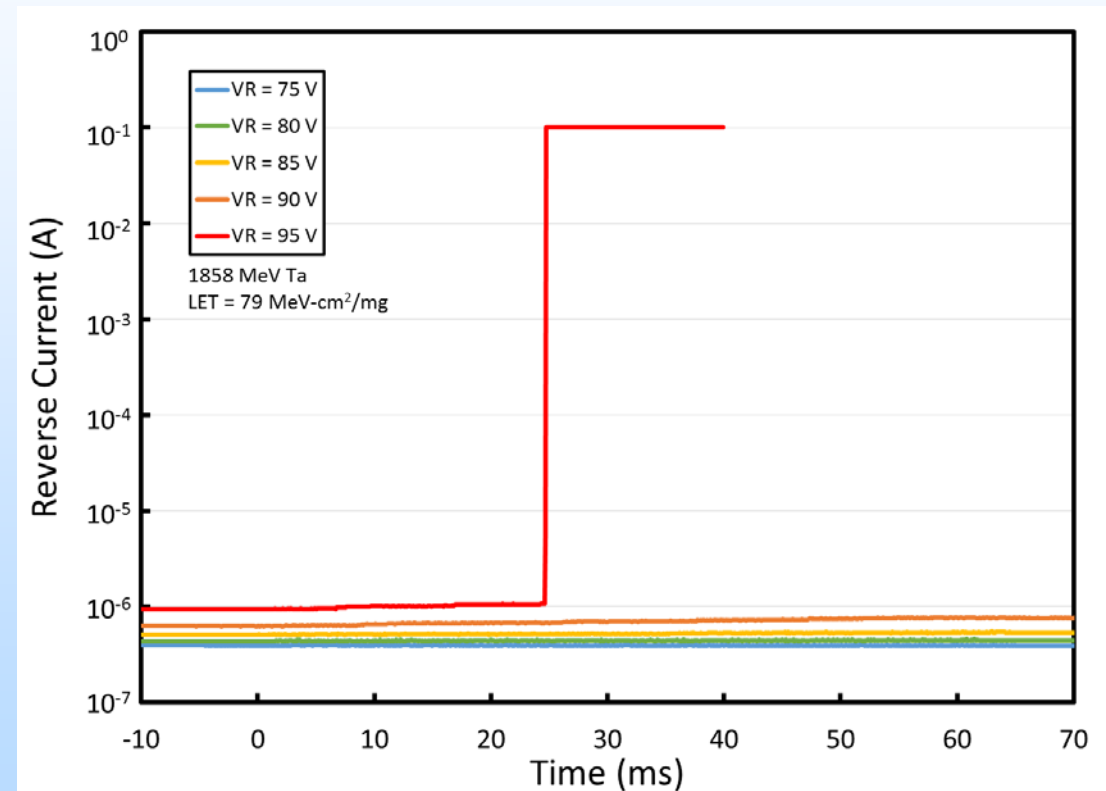
- SN7 was irradiated with 1858 MeV Ta (LET = 79 MeV-cm<sup>2</sup>/mg) in 5 V steps starting at 75 V
- Only charge collection was observed up to the 85-V irradiation
- When biased at 90 V, a ~140 nA increase in  $I_R$  was observed
  - All post-irradiation parameter measurements remained within specification
- At 95 V, the current reached the maximum 100 mA allowed by the power supply, and the anode and cathode were shorted together

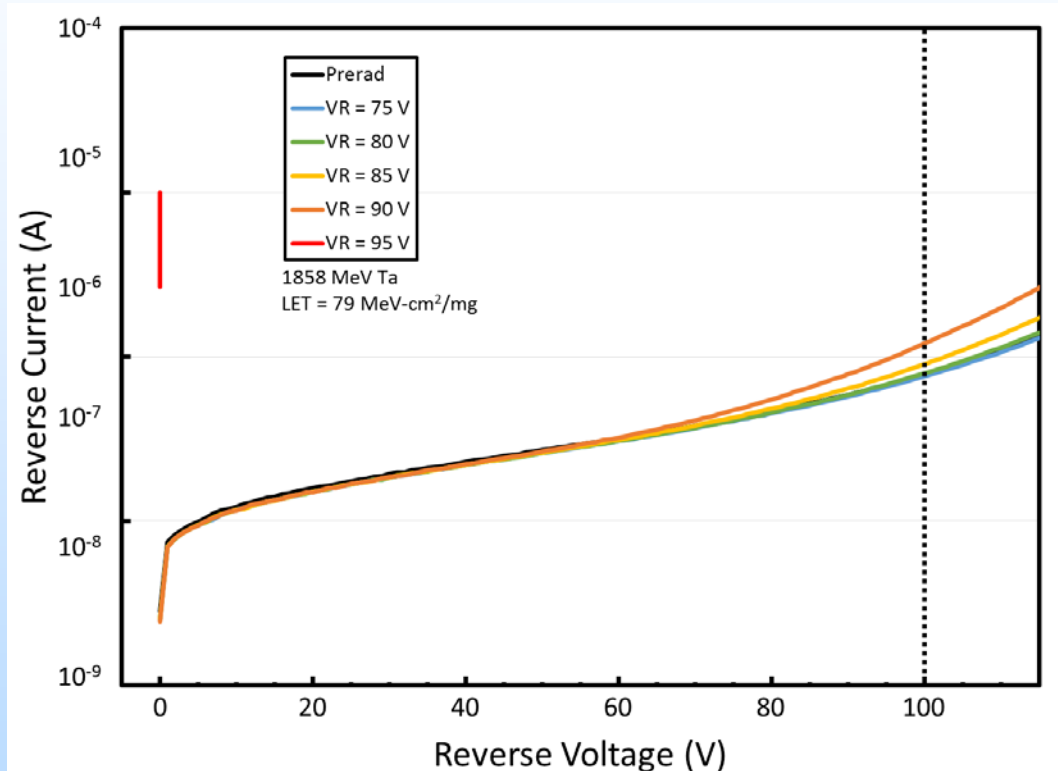
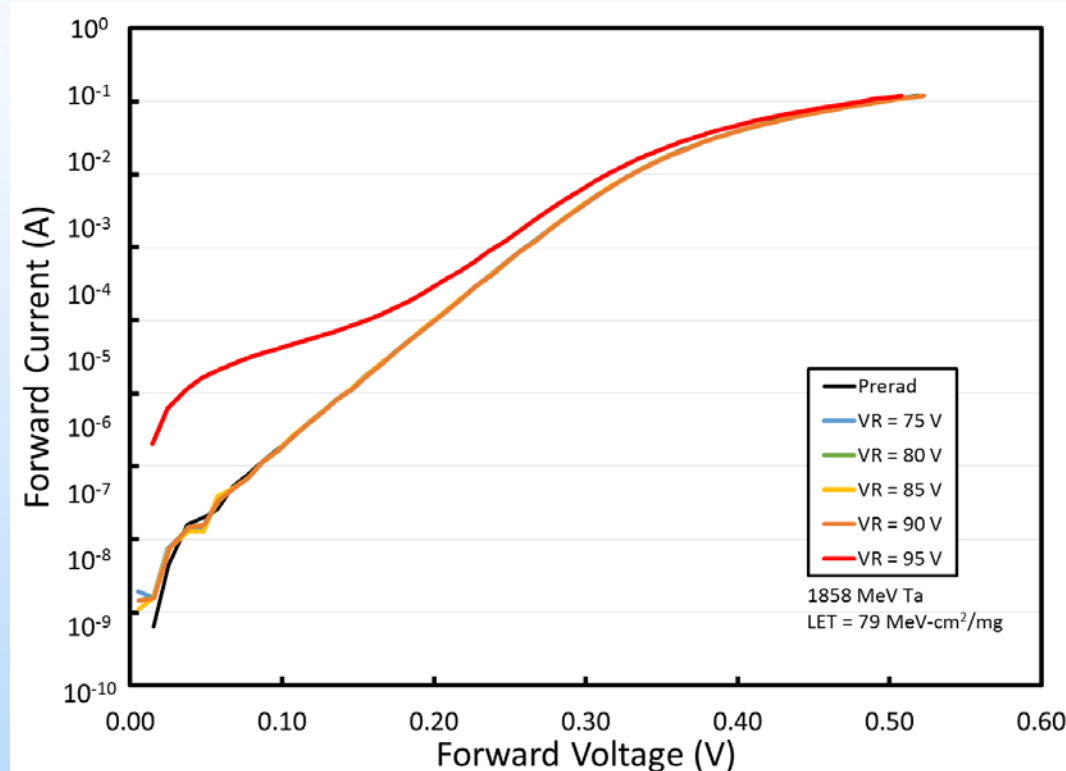
Almost no change was observed in the  $I_R$ - $V_R$  or  $I_F$ - $V_F$  plots until the 95-V irradiation, and then  $I_R$  exceeded 10  $\mu$ A at less than 1 V

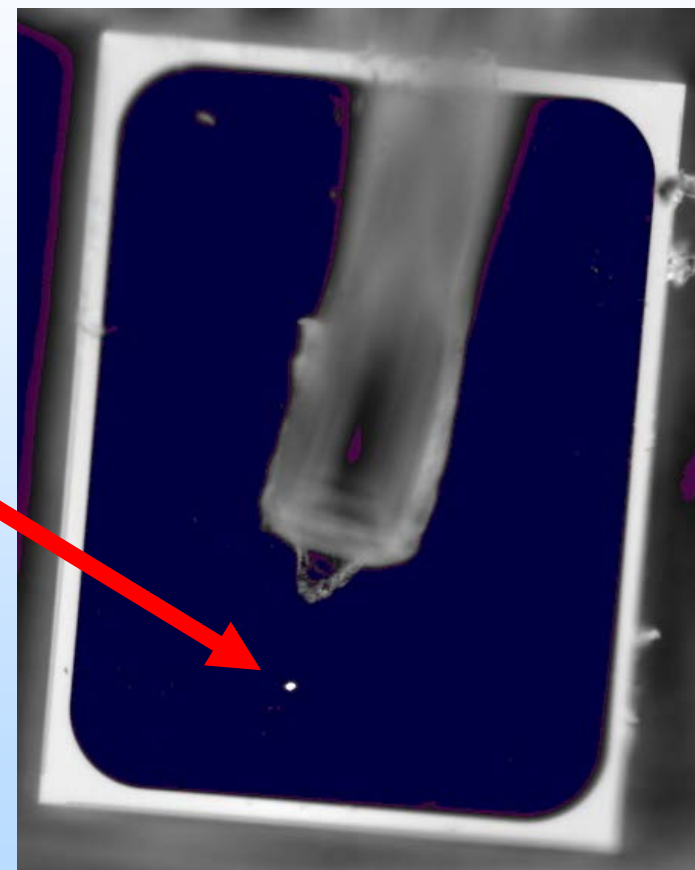
- Diode was examined using an IR camera and pictures were taken with a small voltage applied
  - Bright white spot just below the wirebond contact is the location of the failure
- Low-magnitude and high-magnitude optical images of the surface of the DUT did not show anything unusual at the location identified in the IR image

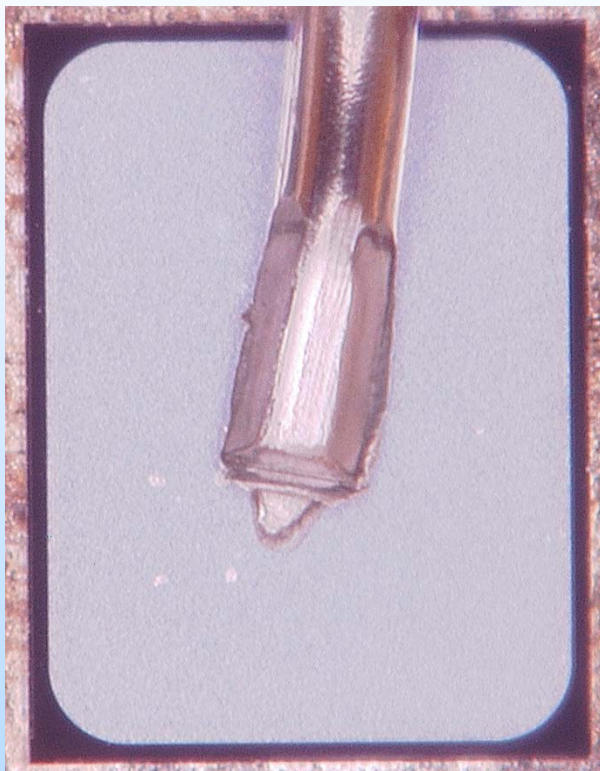
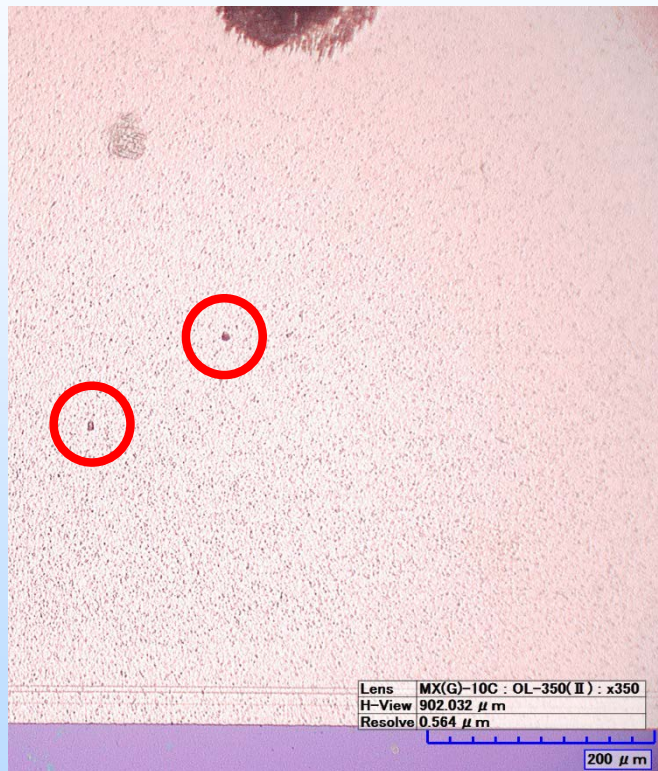
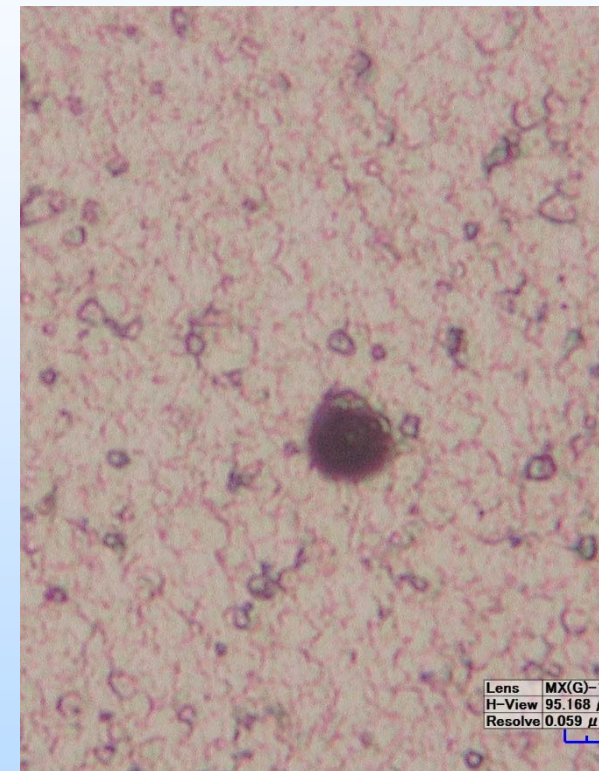
Unlike other part that experienced catastrophic failure, location is visible in high-magnification optical images

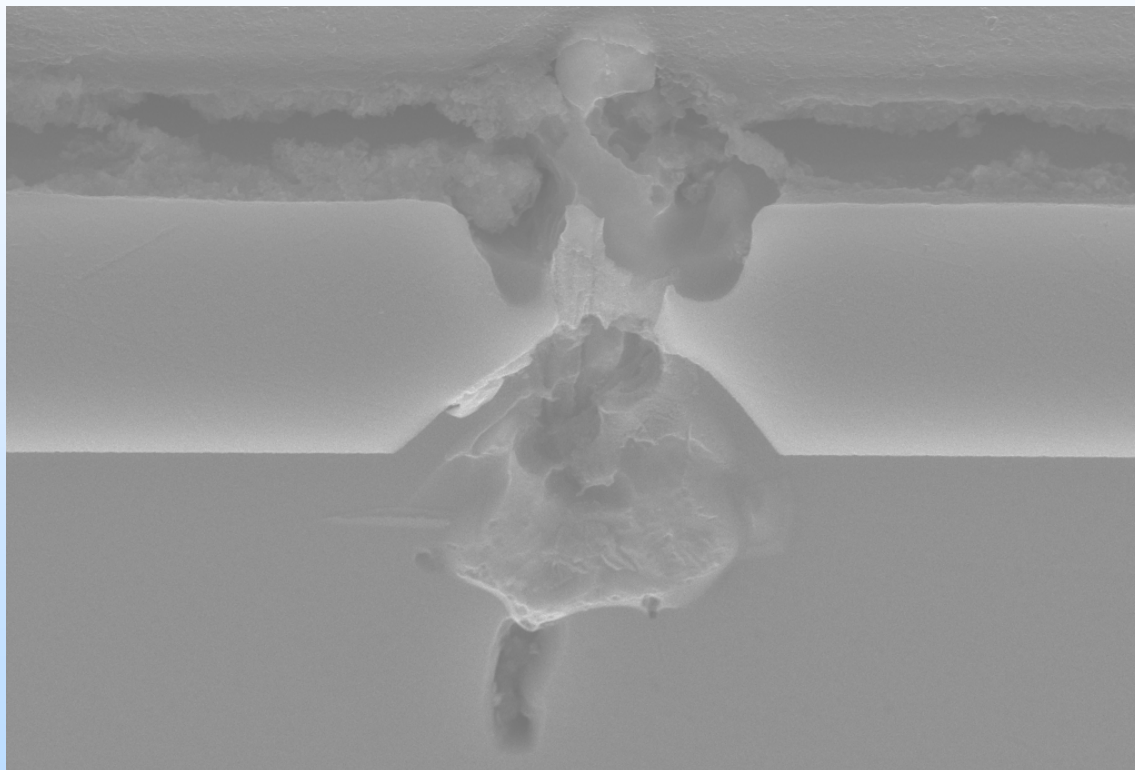
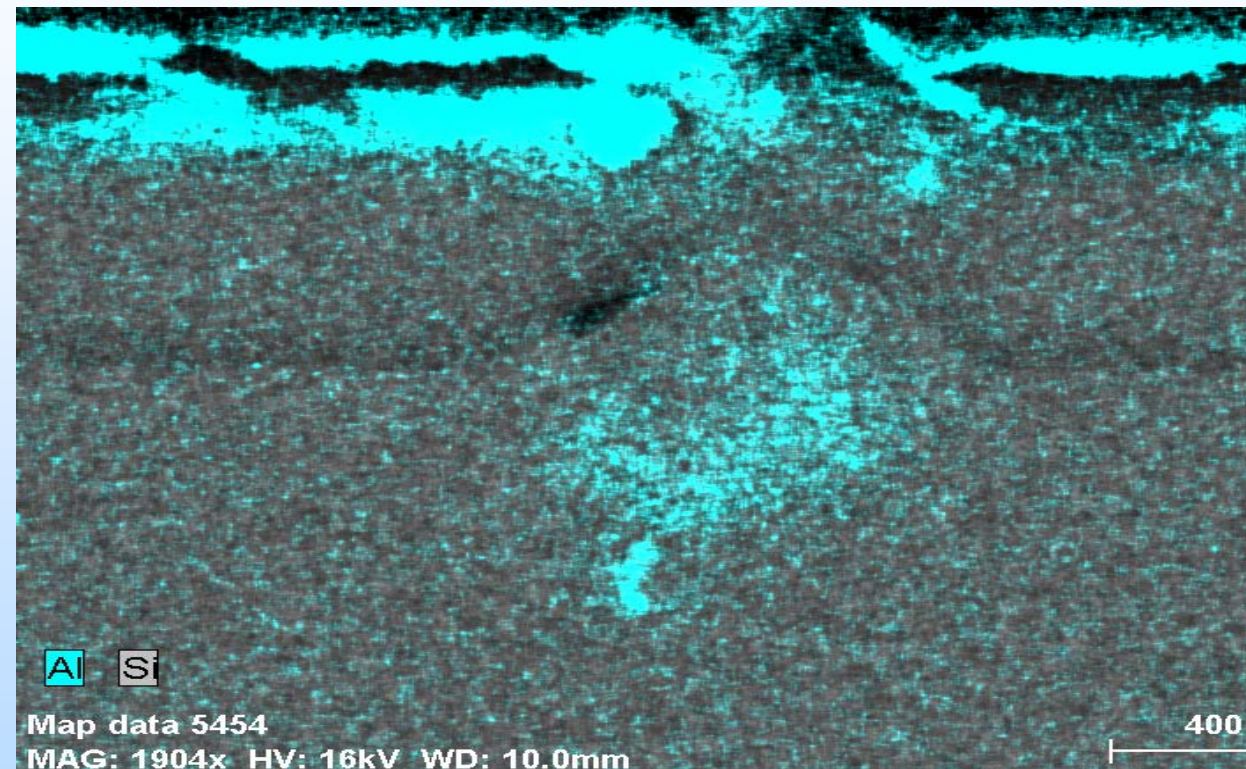
Metal has clearly displaced from Schottky junction into void  
formed from high current

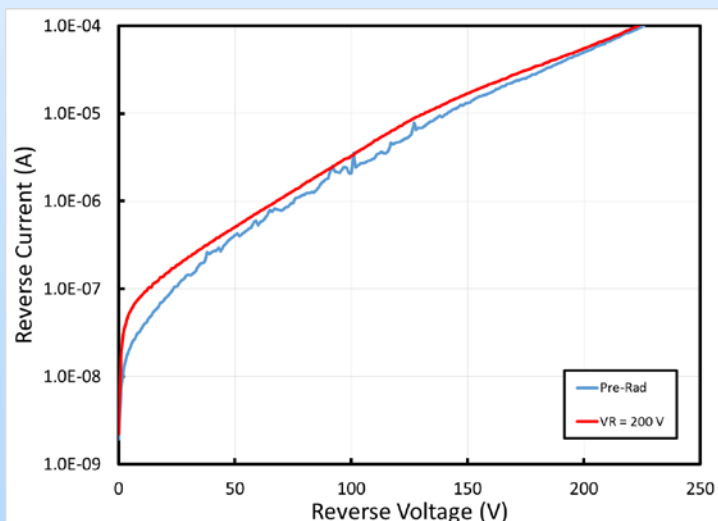
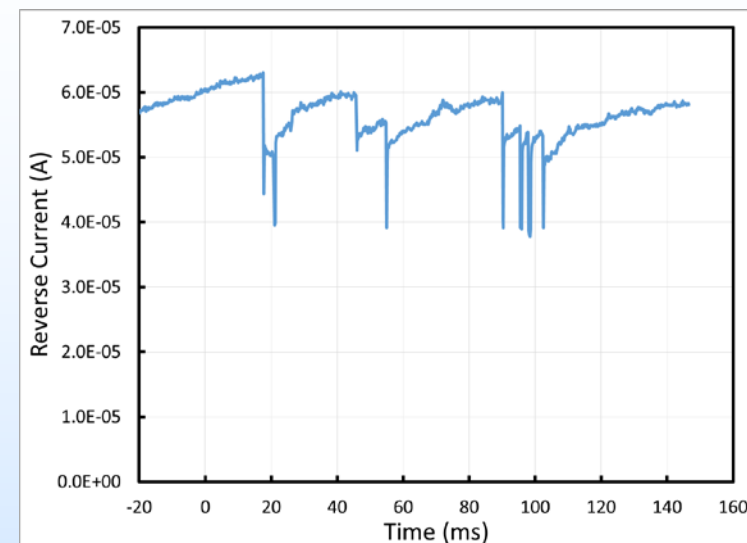
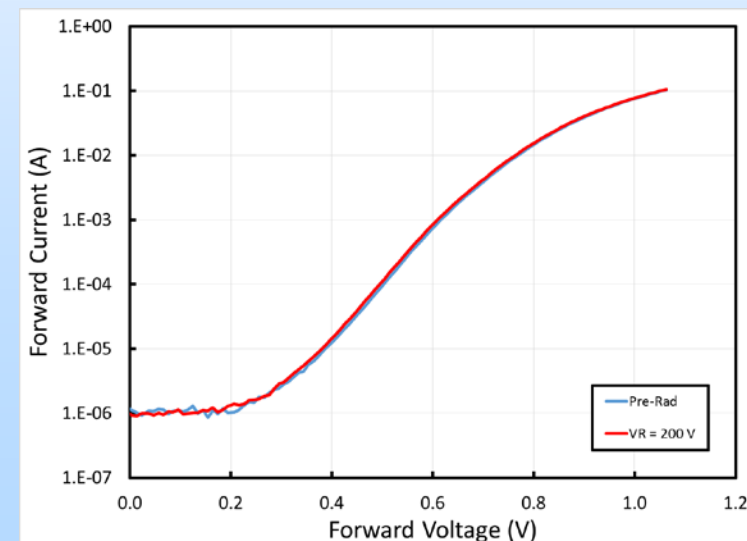
# Diodes, Inc. BAS21-7-F Switching Diode

- Small changes in the reverse current were observed during the runs in which these parts were biased at the full-rated 200-V reverse voltage
- Small changes in the  $I_R$ - $V_R$  and  $I_F$ - $V_F$  plots were observed after the runs
  - How these changes effect the long-term reliability of the parts is unknown
