**Heavy ion Single Event Effects test of
4A Adjustable Switching regulator
MSK5042 from M. S. Kennedy**

Test Report

March 21, 2002

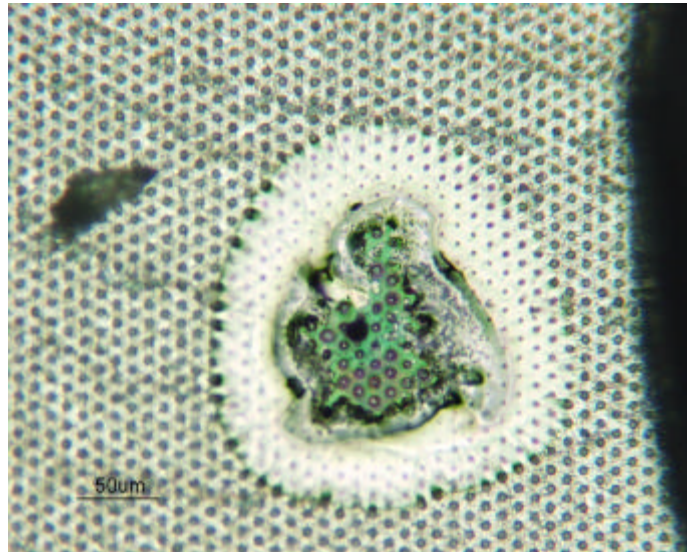
The analysis after irradiation shows that the failure occurred on the power MOSFET. A picture of the burnout of part SN1 power MOSFET is shown in Figure 2 and 3. The reason of this failure could be a heavy ion induced burnout on the IRLC034N power MOSFET, or a transient on the voltage reference or the operational amplifier that causes an overcurrent on the MOSFET.

Figure 1: burnout on Q1

The test results show that the MS5042 has a low sensitivity to transients. Two functional failures have been observed, due to burnout on the power MOSFET. These failures occurred at high LET (>37 MeVcm²/mg), but the sensitivity could be significantly higher for high load conditions. The most probable cause is the heavy ion induced burnout on power MOSFET. The use of higher voltage MOSFET (ie. 100V devices) will give a lower sensitivity. A design analysis is also recommended to study the impact of transients on the voltage reference and the operational amplifier.

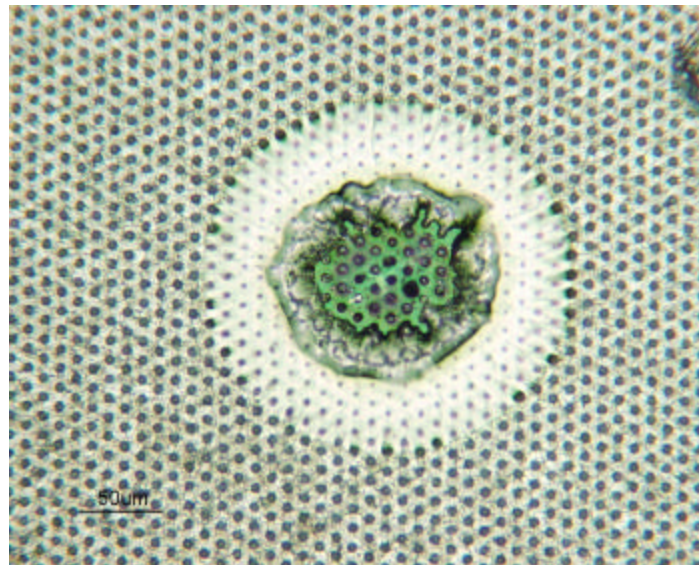
Figure 2: burnout on Q2
