Single-Event Effects Test Report on IEEE 1394

(Testing conducted at Texas A&M on 10/14/01)

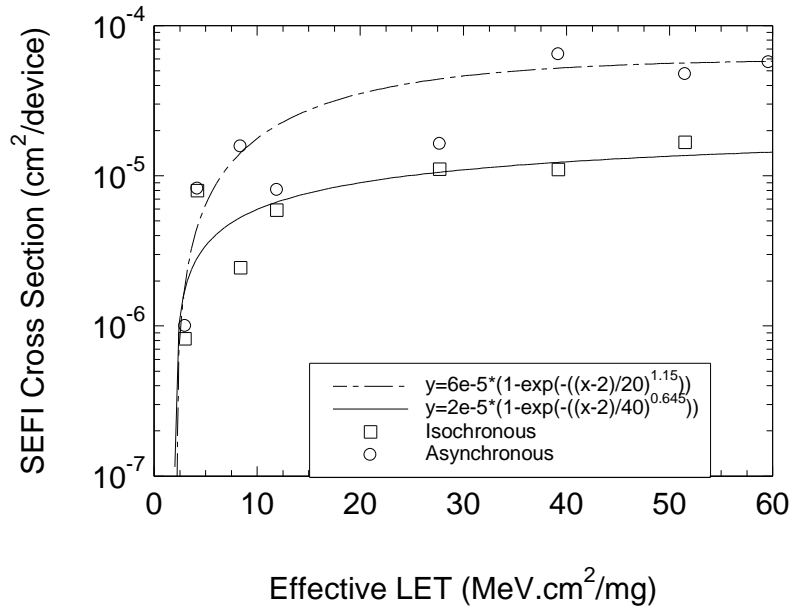
Fig. 2. Cross-section per device for “hard” errors as a function of ion LET for the LLC.

“Hard” and “soft” error cross-sections as a function of ion LET were plotted for the PHY and LLC operating in the isochronous and asynchronous modes. The results are shown in Figs 2, 3 and 4. It appears from figures 2 and 3 that both hard errors and soft error are more prevalent in the LLC for the asynchronous mode than for the isochronous mode. There were no soft errors observable when the PHY was irradiated, and it was assumed that the mode of operation, i.e., asynchronous or isochronous, did not matter as far as SEFI cross-section was concerned. Hence, the data from the two modes were combined into a single plot.

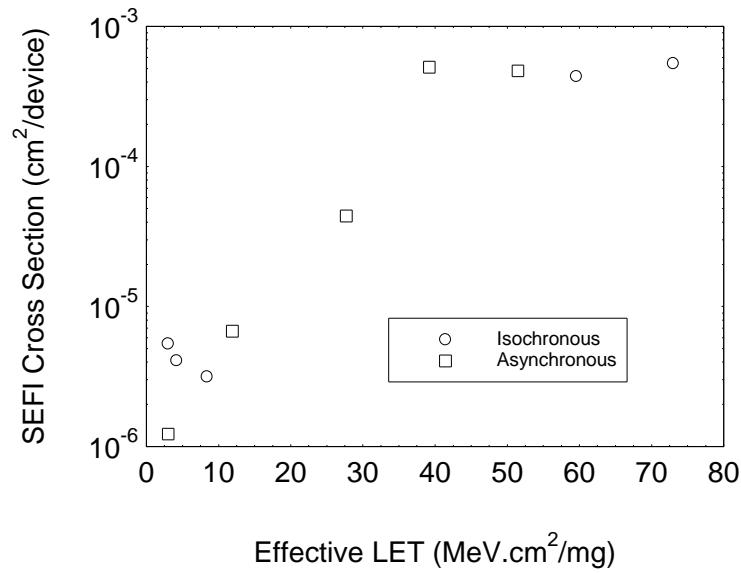
Fig. 4. Cross-section per device for “hard” errors for the PHY. The data for isochronous and asynchronous modes were combined because the mode of operation does not have any effect on the hard errors.
