Effect of Extreme Environmental Thermal Cycling On COTS MEMS Pressure Sensor

Rajeshuni Ramesham, Ph.D.
Jet Propulsion Laboratory

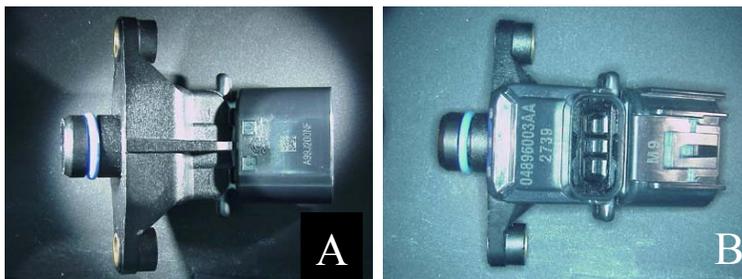
Figure 1: Optical photographs of Motorola's pressure sensor (a) top view and (b) bottom view.

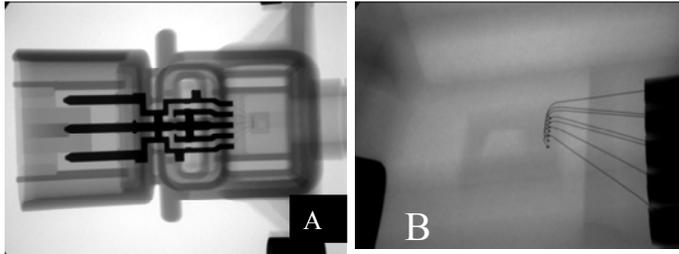
Figure2: X-ray imaging of Motorola's (a) complete pressure sensor and (b) wirebonds in the sensor region where there is a bulk micromachined silicon membrane (sensor 2). This is before thermal cycling.

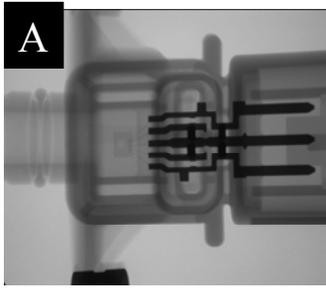
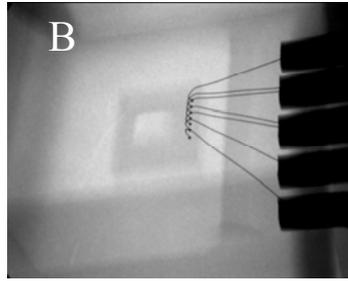
Figure 4 shows the x-ray imaging of the sensor after 15 thermal cycles. There were no failures observed in the sensor or wirebond integrity. We then performed 8 more thermal cycles. As a result of the additional cycling, several of the wirebonds in pressure sensor number 2 were open. This can be seen vividly in the x-ray image of Figure 5. This indicates that the pressure sensors do fail after 15 thermal cycles, however, we do not know where between the 15th and 23rd cycles the failure took place. We have also confirmed similar failures with sensors 3, 4, and 6 as shown in the x-ray image of Figure 6.

Figure 4: X-ray imaging of Motorola's (a) complete pressure sensor and (b) wirebonds in the sensor region where there is a bulk micromachined silicon membrane, after 15 extreme thermal cycles were performed between -125°C to $+90^{\circ}\text{C}$ (sensor 2). The dwell time is 10 minutes and the ramp rate is $7^{\circ}\text{C}/\text{minutes}$.

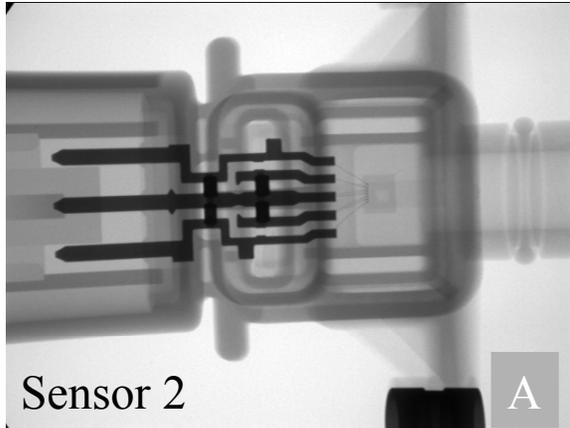
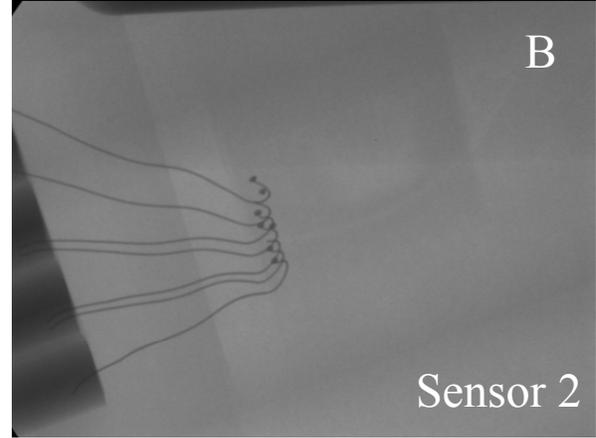
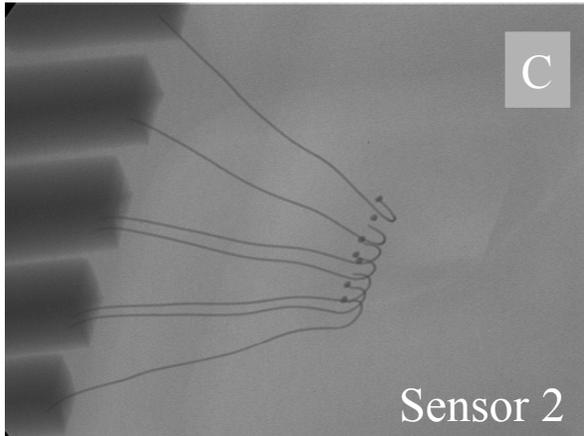
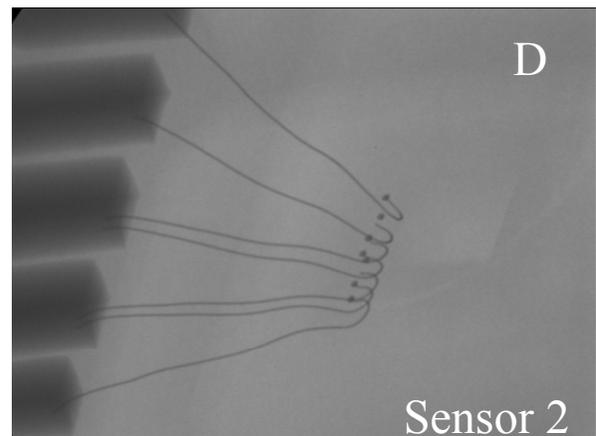
Figure 5: X-ray imaging of the Motorola's (a) complete pressure sensor and (b) wirebonds in the sensor region where there is a bulk micromachined silicon membrane, after 23 extreme thermal cycles performed between -125°C to $+90^{\circ}\text{C}$ (sensor 2). The dwell time is 10 minutes and the ramp rate is $7^{\circ}\text{C}/\text{minute}$.

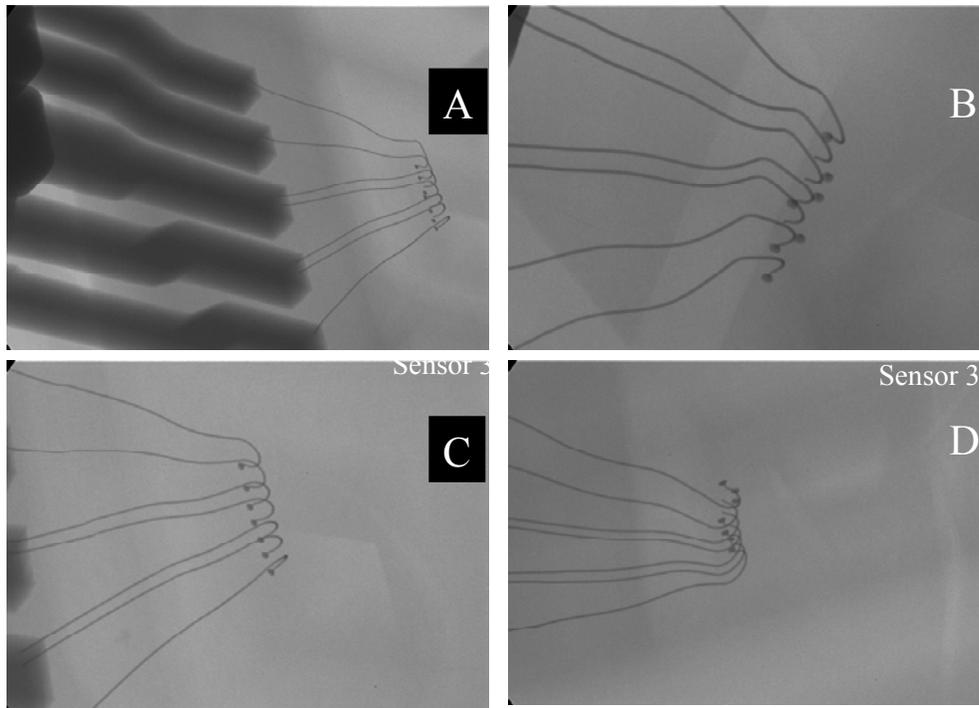
Figure 6: X-ray imaging of the Motorola's (a) complete pressure sensor and (b) wirebonds in the sensor region where there is a bulk micromachined silicon membrane, after 23 extreme thermal cycles performed between -125°C to $+90^{\circ}\text{C}$ (sensor 3, 4 and 6). The dwell time is 10 minutes and the ramp rate is $7^{\circ}\text{C}/\text{minutes}$.

Summary: Motorola's manifold pressure sensors were subjected to extreme temperature thermal cycling -125°C to $+90^{\circ}\text{C}$. X-ray images of the pressure sensors were taken before and after 15 and 23 thermal cycles. There was no opening of the wirebonds or failures observed after 15 thermal cycles, however, several wirebonds were open after 23 thermal cycles. Therefore, these COTS pressure sensors were not reliable in the extreme temperature range employed in this test.
