## Corrosion of Silver-Plated Copper Conductors

**Abstract** Silver-plated conductors, insulated, with fluorocarbon plastics or aromatic polyimide resin and used in aerospace applications, in both Europe and the United States, have been examined for evidence of red-plague corrosion. Extensive metallurgical investigations have shown that, in the worst cases, 3% of the strands making up the braid cross-section can have some degree of corrosion. Metallography revealed that it had initiated at isolated defects in the silver-plating.

The purpose of this paper is to detail the findings of the metallurgical examinations performed by ESA on cables discovered to have degraded by red plague corrosion. In addition, an extensive laboratory test programme was undertaken in an attempt to gain a more comprehensive understanding of the red plague phenomenon. The aims of this programme will be discussed, as will the results achieved to date. A test method based on the laboratory procedures of Anthony & Brown<sup>1</sup> has been developed into a draft ESA specification, which is thought suitable for the acceptance-testing of fabricated wires and cables.

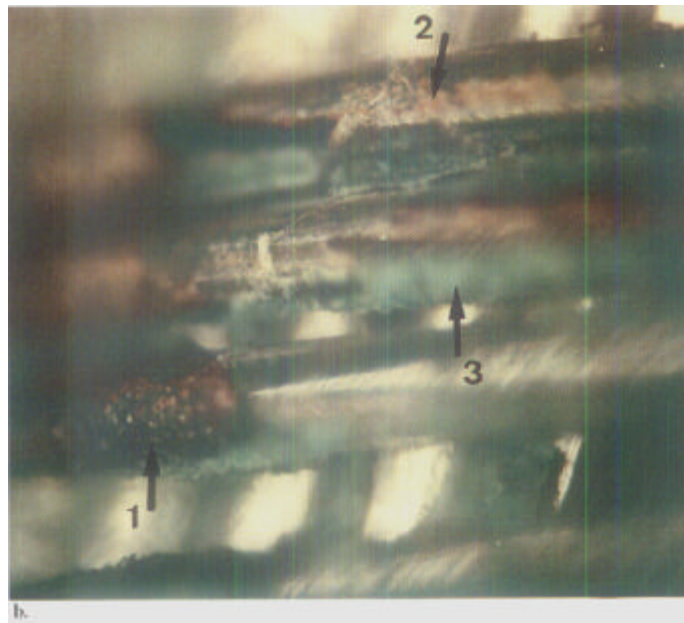
**Figure 2. Colour photomicrographs of typical 'red-plague' corrosion areas on braiding, as circled in Figure 1.**

- a. Red and green corrosion products associated with two strands that have completely broken; the brittle fracture surfaces are arrowed (x 100);
- b. Corrosion products are black (1), red (2) and green-blue (3)

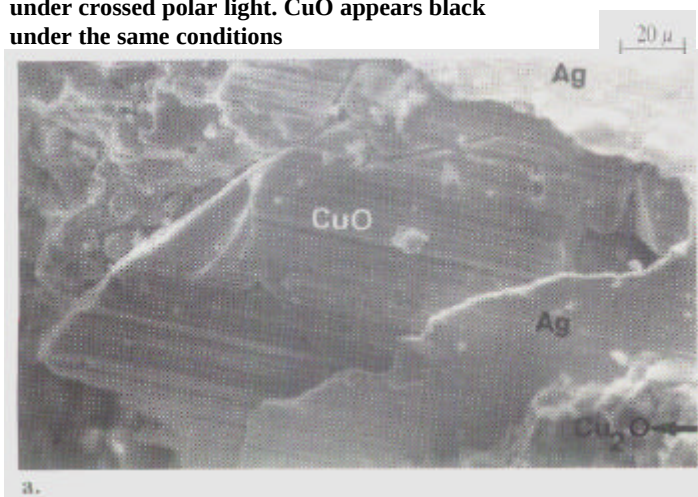
Examination of the corroded strands in the SEM showed them to consist entirely of brittle oxidised copper crystals. Adjacent strands supported crystals of cuprous oxide which were adherent to the silver platings (Fig. 3). Only the presence of copper, silver and a trace of chlorine were detected by EDAX analysis of the strand surfaces.

**Figure 3. Scanning electron photomicrographs of fractured ends of strands from braid shown in Figure 2a. The  $\text{Cu}_2\text{O}$  phases are characteristically seen as ruby-red crystals under crossed polar light.  $\text{CuO}$  appears black under the same conditions**

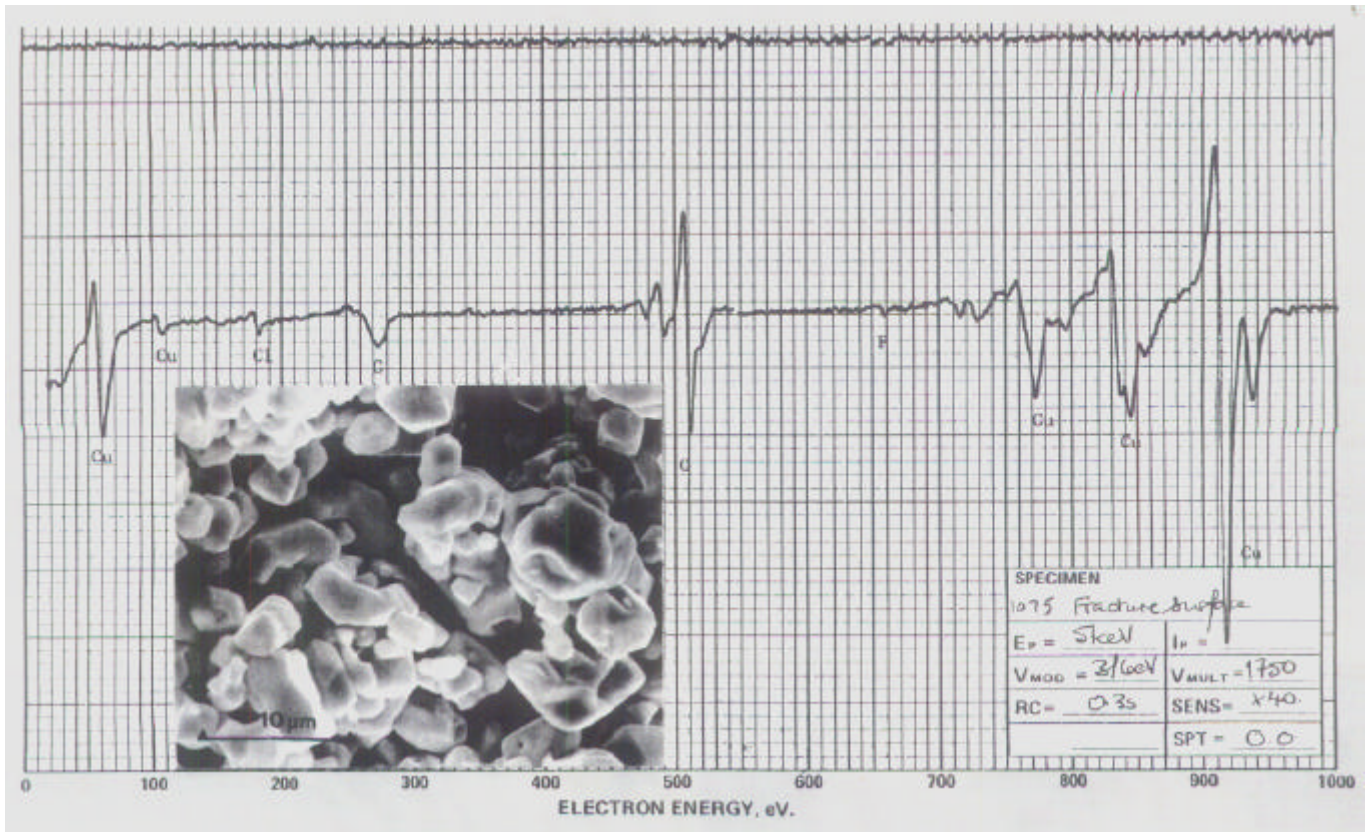
Auger examination revealed that both the silver surfaces, and the copper-oxide films were contaminated by chlorine and fluorine to a maximum of 5 at%. Depth profiles revealed fluorine in the silver plating to a depth of 40 Å. Further Auger analyses also detected the presence of chlorine and fluorine at the central area of the strand fracture surface. This area was composed entirely of copper-oxide crystals (Fig.4). Both chlorine and fluorine, when present as free ions, would tend to be an accelerating factor in any galvanic corrosion mechanism.

**Figure 4. Secondary electron image of the copper-oxide crystals seen at the centre of a corroded and fractured strand. The SEM image is superimposed on the Auger analysis of this area (showing traces of chlorine and fluorine associated with copper oxides)**

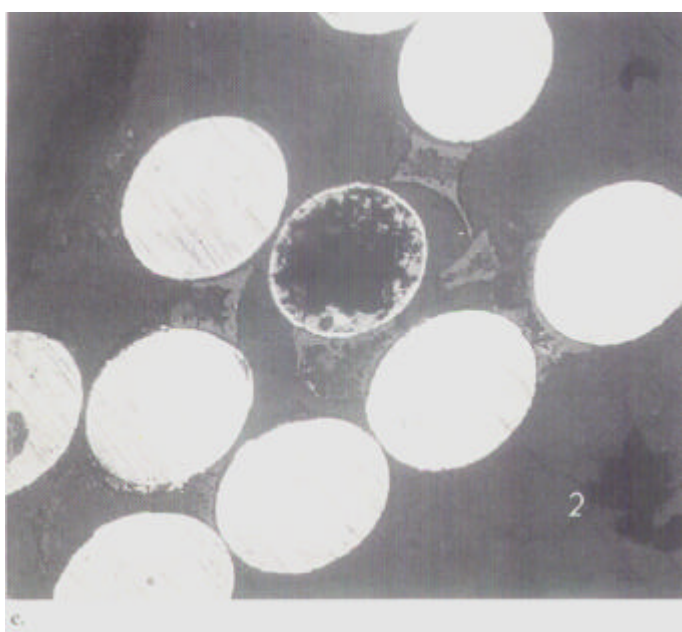
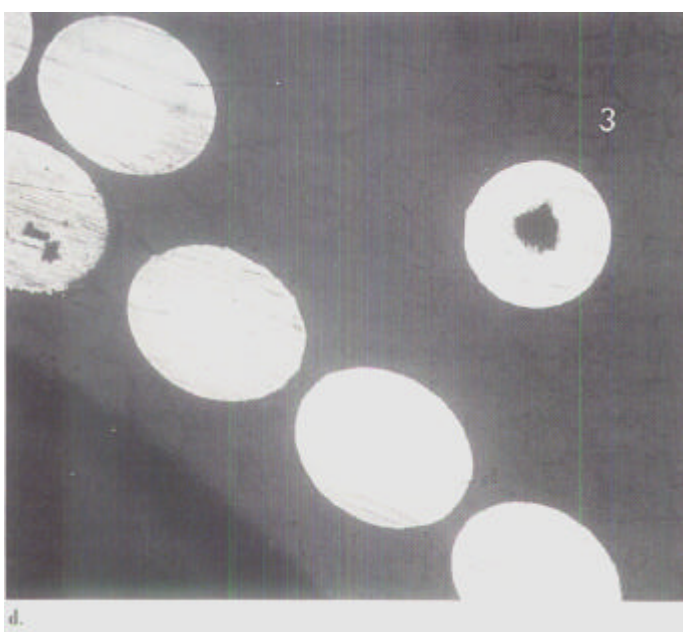
**Figure 6a.** Section through X -X (see Fig. 5), the superimposed numbers referring to corroded strands. Three of the 143 strands are corroded to some extent (2.1%)

**Figure 6b.** Detail of strand no. 1 from Figure 6a. Adjacent strands are uncorroded, but support crystals of cuprous oxide (x150)

**Figure 6d.** Tunnelling corrosion along strand no. 3 (x 150)

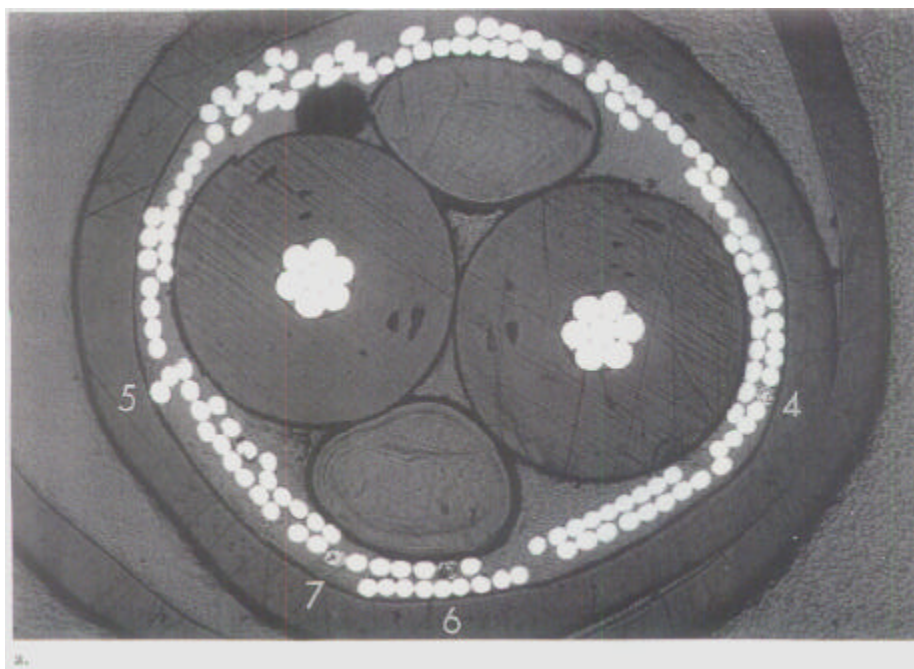
Figure 7a. Section made through Y-Y (see Fig. 5). Superimposed are numbers referring to corroded strands. Four of the 143 strands are to some extent corroded (2.8%) (outer FEP jacket has been peeled back and appears as two rings)

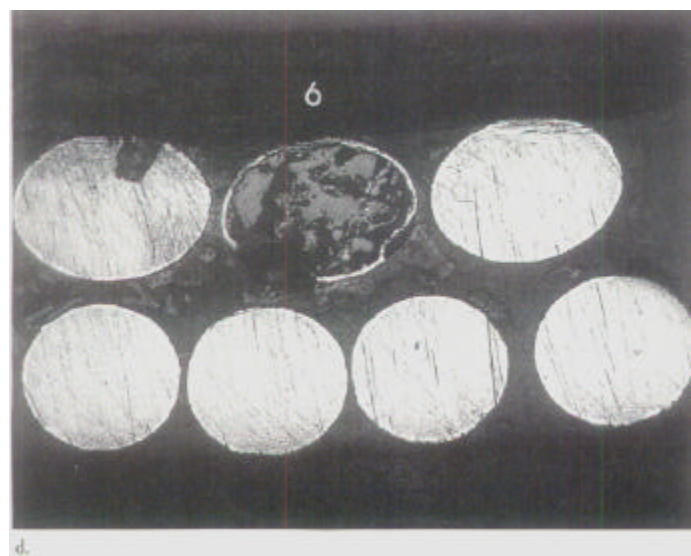
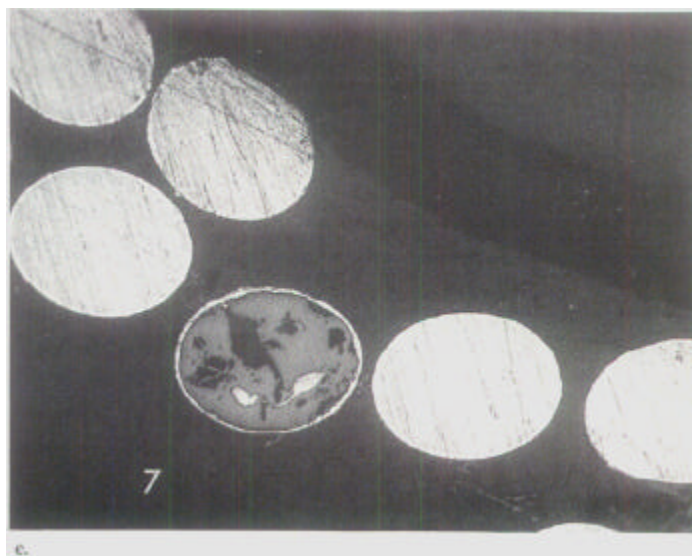
Figure 7b. One corroded strand is surrounded by non-corroded adjacent strands covered by cuprous-oxide crystals. Note large air gaps between outer FEP jacket and inner wire insulants (x 150)

Figures 7c-e. Remaining corroded strands in section Y-Y (x 150)

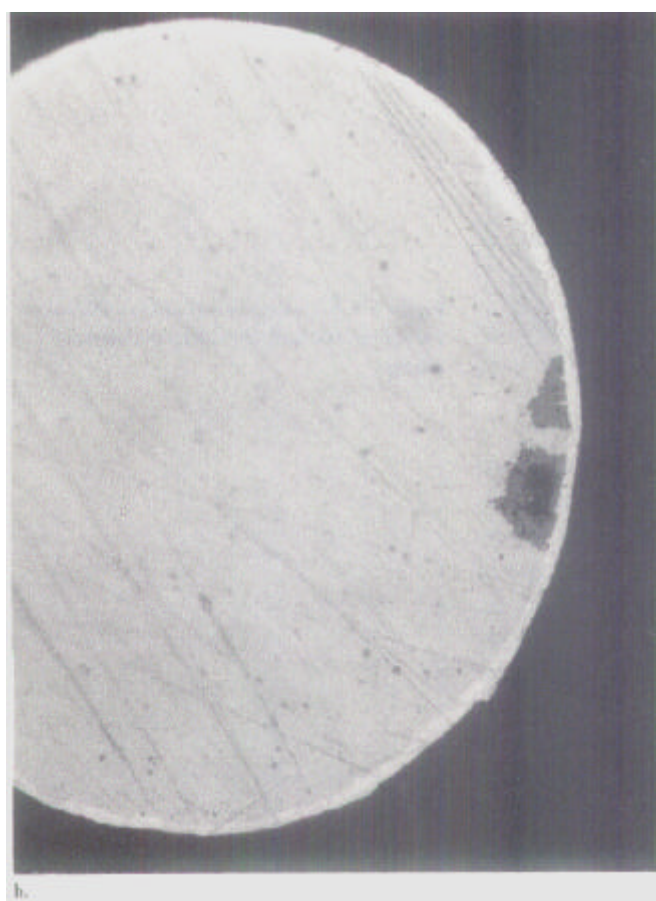
Figure 18. Transverse and longitudinal sections through red-plague corrosion site on sample no. 16. The braid consists of 144 strands, of which only two-support copper corrosion. All strands are of 2 mm silver-plated copper. The insulation materials are black FEP for the outer jacket and natural PTFE on the inner conductors. The longitudinal sections show that galvanic corrosion has initiated at local breaks in the silver plate (after 10d of accelerated corrosion testing).

- a. Outer braid sectioned across site of worst corrosion. Note braid has 144 strands, two of which show signs of internal corrosion
- b. Transverse section through worst corrosion site (x 800)
- c. Longitudinal section through worst corrosion site (x 600)

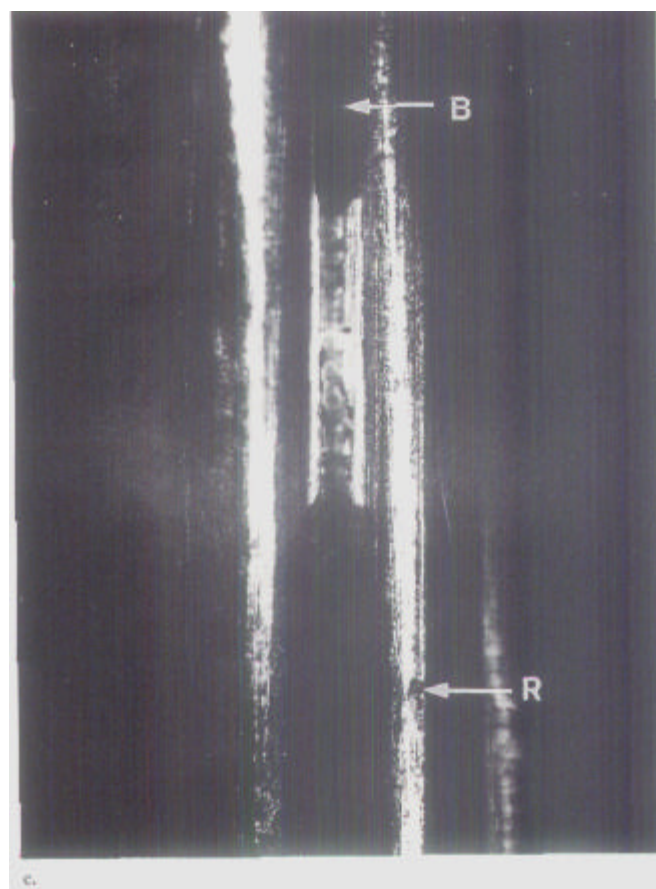
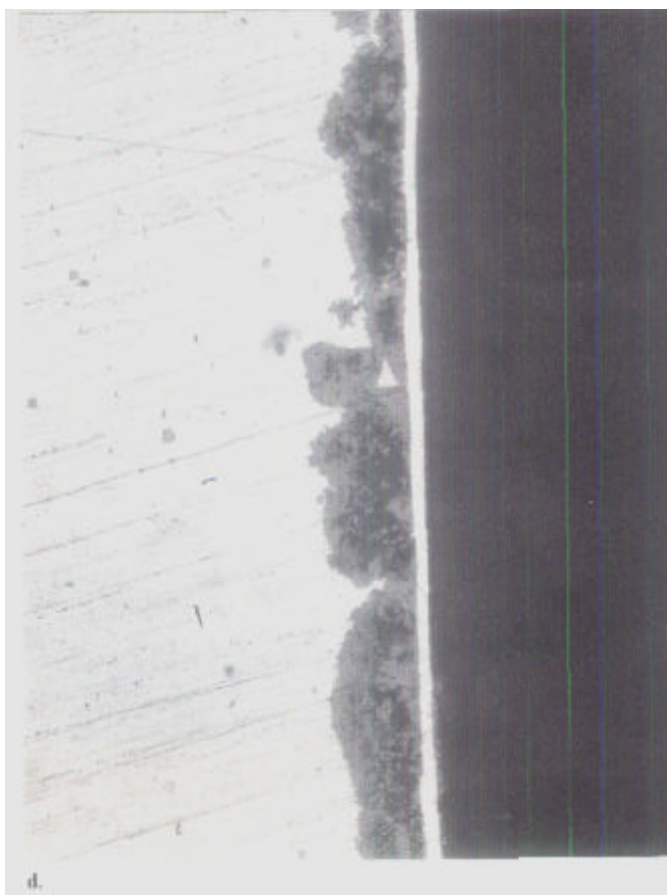
Figure 20. Longitudinal sections showing the most severely corroded strands (some oxidised throughout their section) from sample no. 9. Slight subsurface exists oil on one strand of the inner conductor, after 10d of accelerated corrosion testing. All strands are of 1 mm silver-plated

copper. The insulation materials are natural FEP for the outer jacket and natural PTFE on the inner conductors.

- a. Extensive red corrosion on adjacent strands (x 100);
- b. Corrosion and fracturing occurred through many strands (x 600);
- c. Inner conductor shows some red (R) and black (B) spots (x 100);
- d. internal corrosion (x 600)

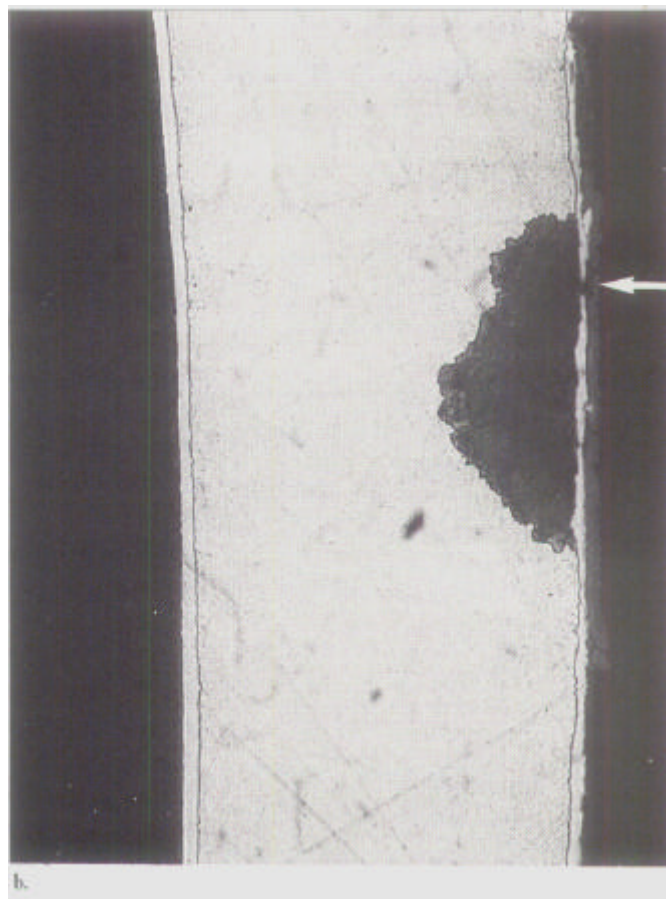
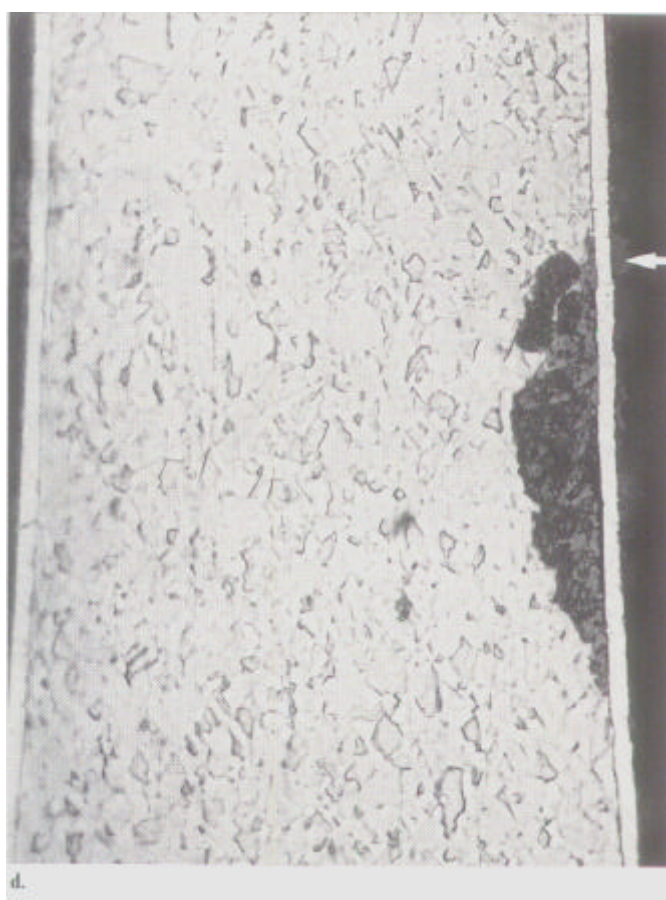
Figure 21. Longitudinal sections through the most severely corroded strand selected from sample no. 8, with Nickel-Plus braiding and 2  $\mu\text{m}$  silver-plated stranded inner conductors after 10 d of accelerated corrosion testing. The insulation materials are natural FFP with kapton hinder for

the outer jacket and natural PTFE on the inner conductors. Subsurface cavities are formed at occasional breaks in the nickel plating, enabling localised corrosion couples to be set up. Corrosion of the inner conductor is extremely limited.
