GODDARD SPACE FLIGHT CENTER

Evaluation Report

Microcircuit (24)
Mfr.: Hitachi
P/N: 58V1001T25
D/C: 9538

Project
PEM
System

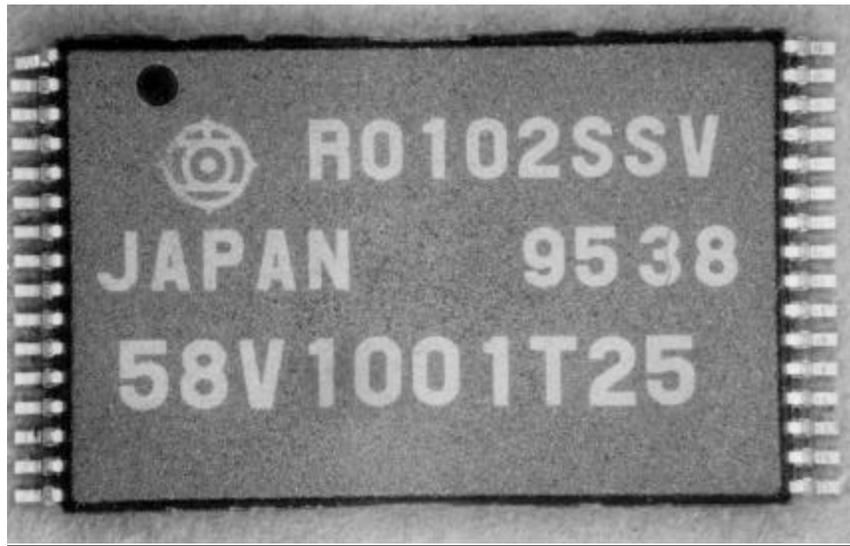
All samples were subjected to external microscopic examinations (e.g. see Figure 1). No package warping, cracks, voids, or foreign inclusions in the plastic encapsulant were found. Practically all parts had gaps between the lead frame support bar and the molding compound on the side of the package (see Figure 2). Cross sectional examinations showed that these gaps were shallow and did not extend into packages more than 150-250 μ . Radiographic examination showed adequate wire bond dressing. Typical top and side X-ray views are shown in Figure 3. The die-paddle had holes which were probably designed to reduce voiding in die attach material, to enhance adhesion between the molding compound and lead frame, and to provide stress relief for the large die.

Figure 1. An overall view of the Hitachi EEPROM. (7.5X)

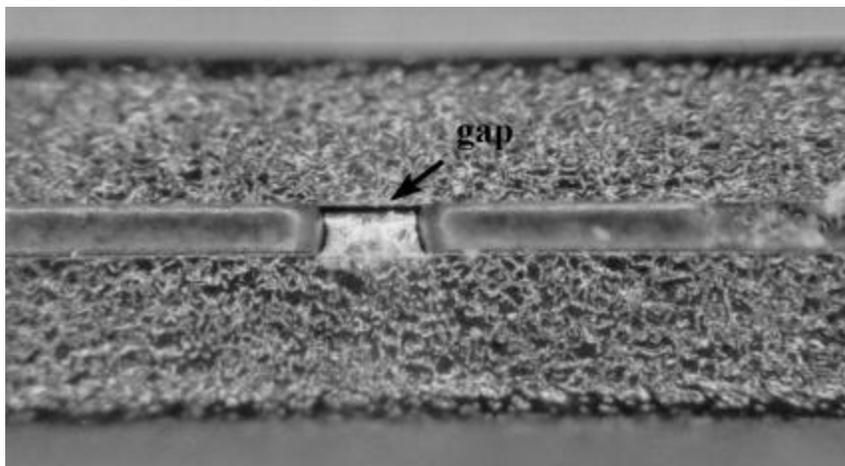
Figure 2. Side view of the package. (50X)

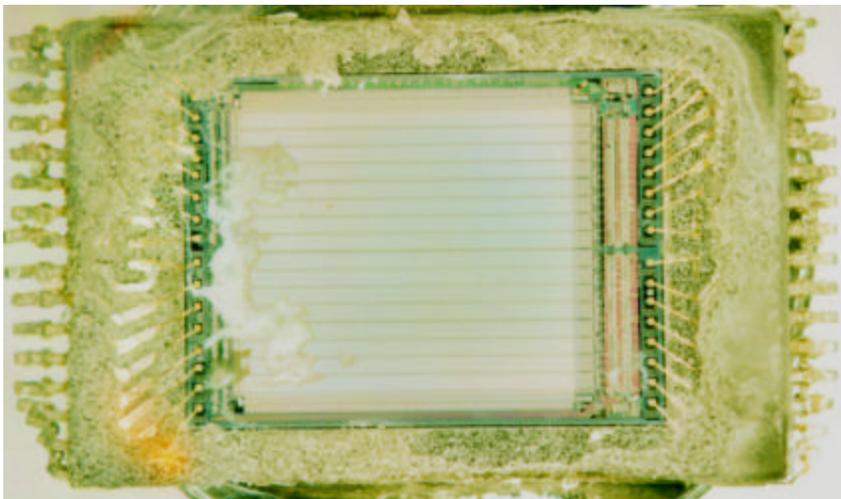
Four samples (SNs 38, 39, 40, and 41) were decapsulated in the red fuming nitric acid and examined microscopically. Figure 4 shows an overall view after decapsulation. Some bonding wires were exposed completely (both to die and lead frame). Bonds to the lead frame fingertips had evidence of acid attack from the decapsulation process. Aluminum discoloration was found at two contact pads in SN 40 (see Figure 5). No other defects were observed.

Figure 4. Overall view of the microcircuit after decapsulation, SN 39. (7.5X)

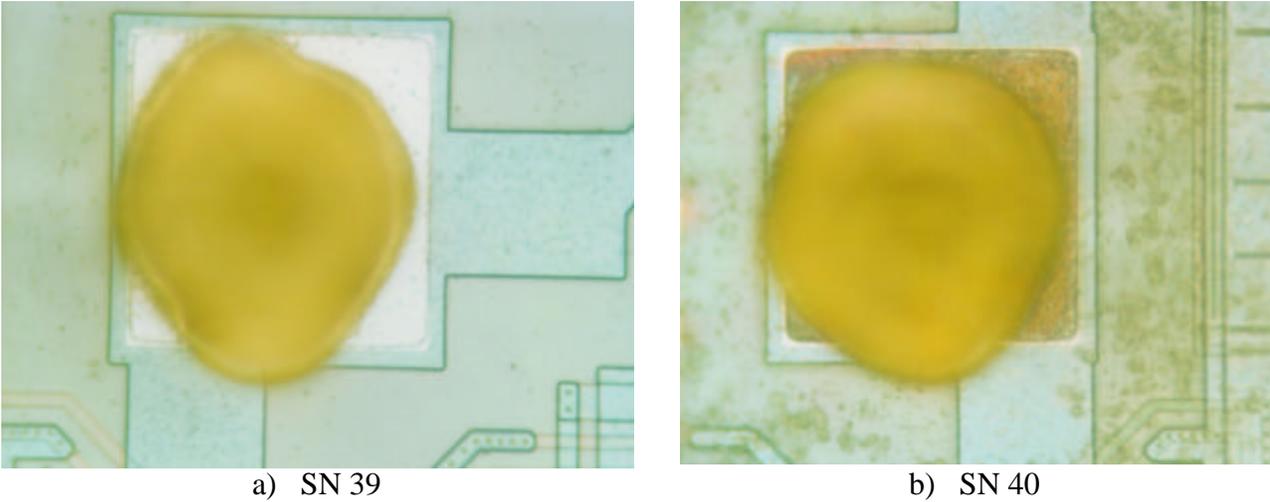
Figure 5. A normal contact pad (a) and a contact pad with aluminum discoloration. (500X)

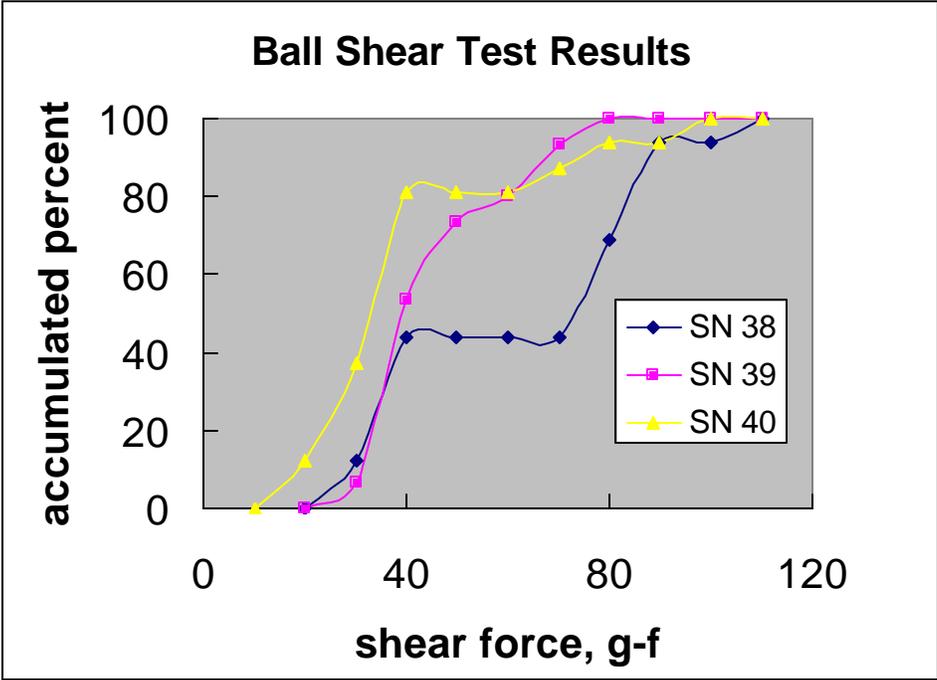
Figure 6. Shear force distributions.

The rest (those not wire-pulled) of the wires in SN 38 and SN 39 and half of the wires in SN 40 were subjected to ball shear testing per ASTM F1269. Results of this test are shown in Tables 3. No failures (cratering, ball/bonding pad lift, or fracture along the intermetallic) occurred during this test. Distributions of the ball shear forces (see Figure 6) were distinctly bimodal. This was found to be due to the positioning of the shearing ram at the ball bond. Figure 7 shows views of two ball bonds which were sheared at a high and normal (approximately at the middle of the ball) positions of the shearing ram. Bonds which sheared at the top of the balls averaged 30 – 38 g-f (see Table 4) whereas bonds which sheared in the balls averaged at 66 – 81 g-f. A typical average shear force for 1 mil wires is 32 g-f with a coefficient of variance less than 25%. For wires of 1.2 mil diameter this value would be approximately 46 g-f. Although there is no official criteria for ball shear testing, ASTM F1269 regards a shear force of less than 15 g-f for 1 mil wires as rejectable. For 1.2 mil wires this limit would be 21 g-f. Table 3 shows that all properly sheared bonds (BC 2) had much larger shear forces. Several bonds which had been sheared with a high position of the ram (BC 1) had a “rejectable” force, but this most likely was caused by the test technique rather than indicating any bond problems.

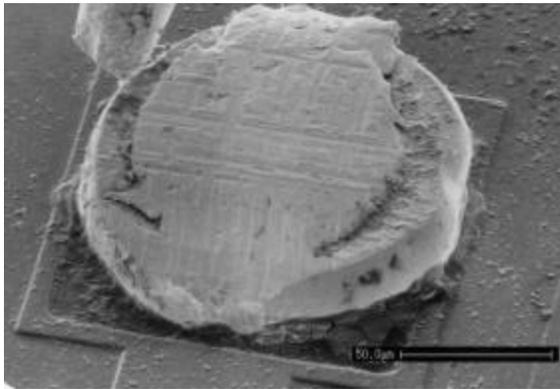
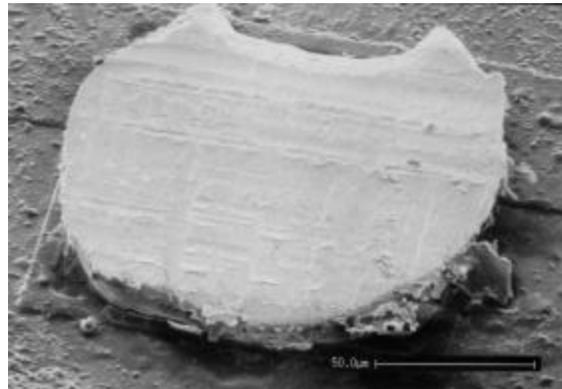
a) high position of the shearing ram

b) normal position of the shearing ram

Figure 7. SEM views of two bonds after ball shear test

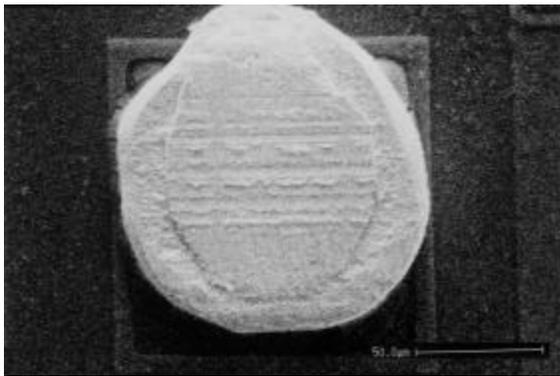
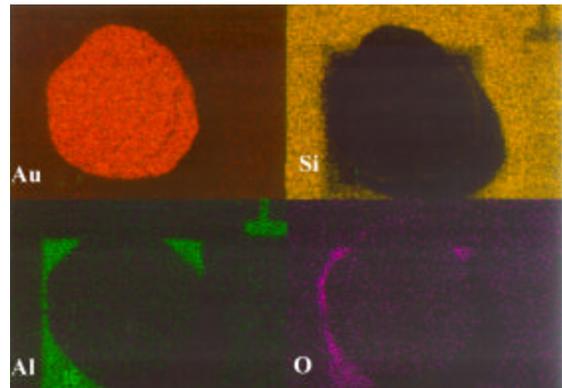
Bond pad examination revealed that the contact pads which appeared discolored actually had no aluminum around the ball bonds. Figures 8 and 9 give SEM views and X-ray mapping of a "normal" contact pad (Figure 8) and a contact pad with apparent discoloration (Figure 9). Metallization at these pads was attacked by chemicals during deprocessing (decapsulation in red fuming nitric acid and rinsing in acetone and isopropanol). As all these chemicals do not normally react with aluminum, the reason for the etching at some of the contact pads is not clear.

Figure 8. SEM view (a) and X-ray mapping of a normal contact pad showing Al around the gold wire ball, SN 40.

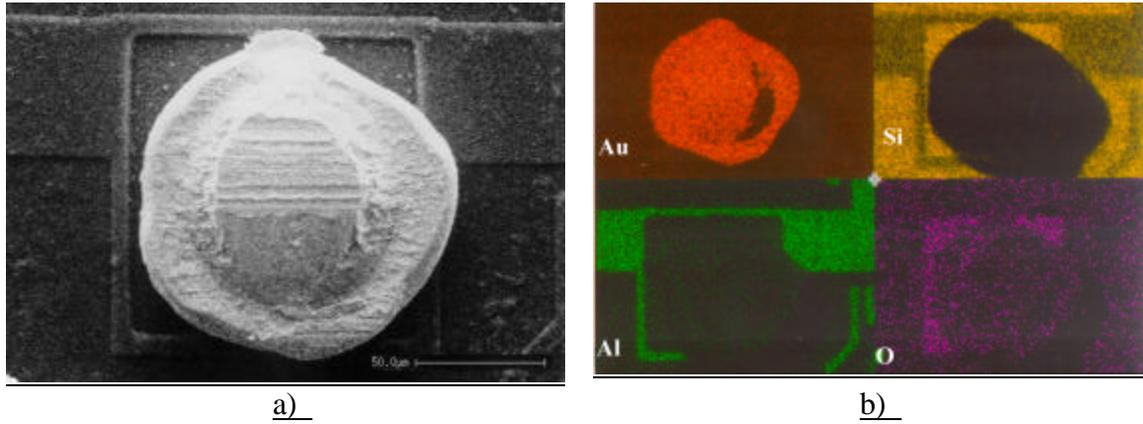
Figure 9. SEM view (a) and X-ray mapping of a “discolored” contact pad. No aluminum was detected around the gold wire ball, SN 40.

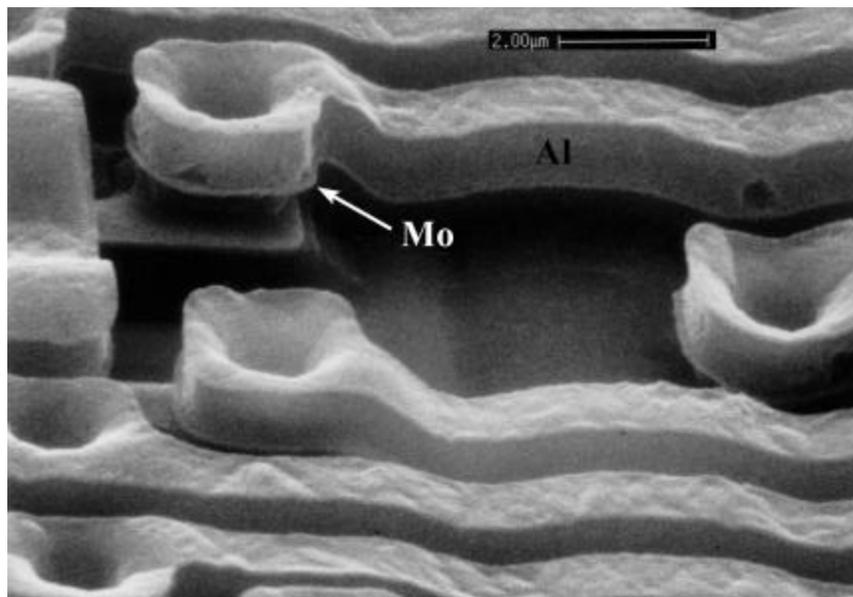
The metallization was inspected in SNs 38 and 39 per MIL-STD-883D, Method 2018 after glassivation removal. No rejectable defects were found. The planarization technique used in the microcircuit design eliminated possible step coverage problems. Figure 10 gives a view of the metallization. EDX analysis showed that molybdenum (approximately 0.1 μ) was used as a metallization barrier layer. Metal notches (mousebites) in the aluminum metallization were observed. These were probably due to galvanic corrosion of Si-Al precipitates during glassivation etching and/or rinsing and most likely are artifacts caused by deprocessing.

Figure 10. Typical SEM view of aluminum metallization, SN 39. (9890X)

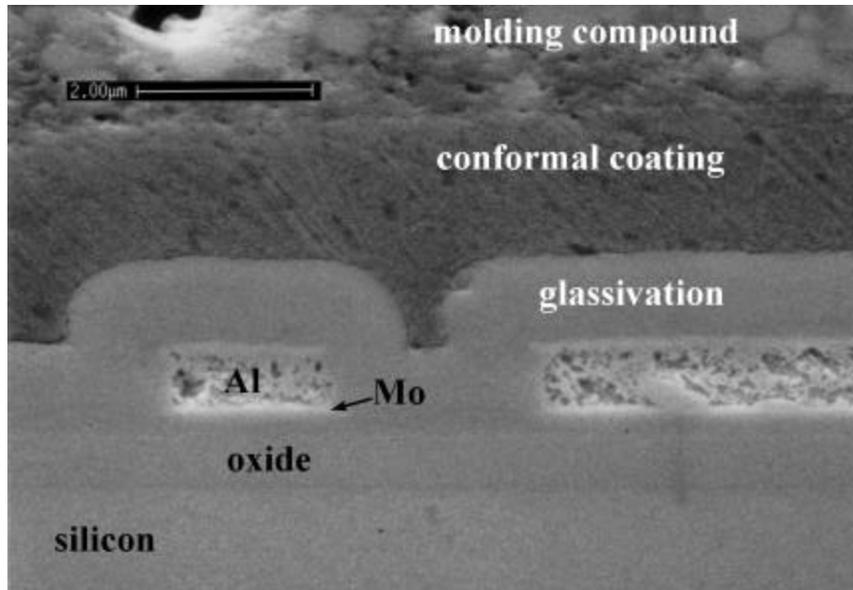
The die was coated above the glassivation with a conformal coating (probably polyimide) approximately 2 μ thick (see Figure 13). No delaminations or gaps between the glassivation and the coating or between the coating and the molding compound were observed.

Figure 13. SEM view of the molding compound-to-die interface. (11,600X)

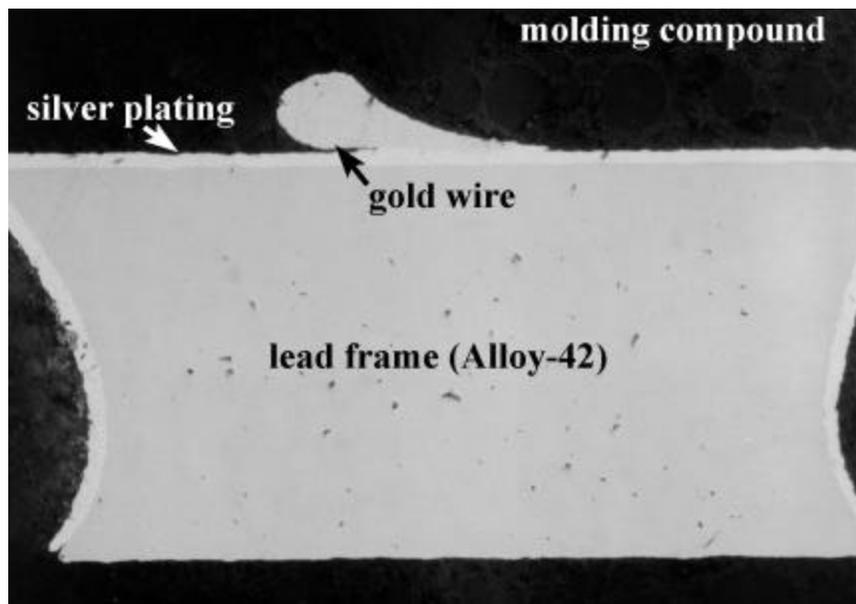
The inner lead tips were spot-plated with silver (approximately 3-4 μ thick). Figures 14 and 15 are views of the wire-to-lead frame cross section. Gold wires formed adequate metallurgical contacts with silver plating at all examined wire-to-lead frame bonds.

Figure 14. Optical view of the wire-to-lead frame cross section, SN 34, plane 4. (400X).

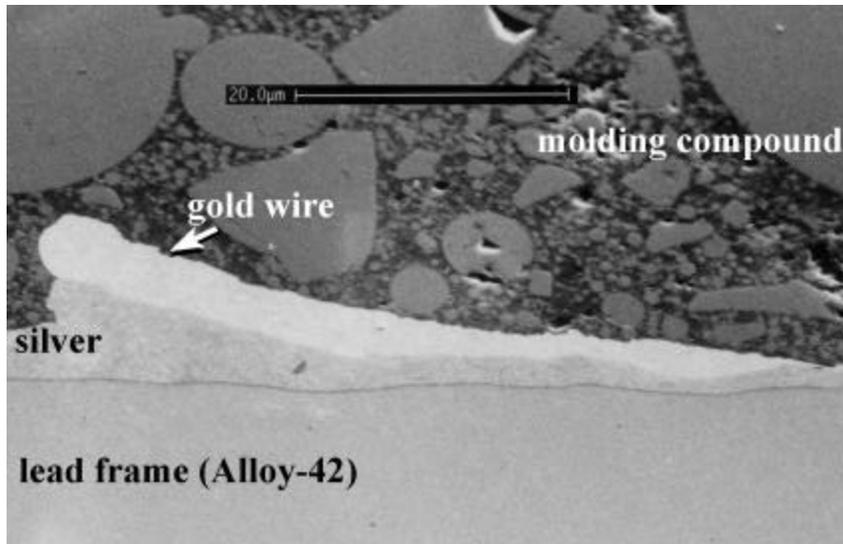
Figure 15. SEM view of the wire-to-lead frame cross section, SN 34, plane 4A. (1810X).

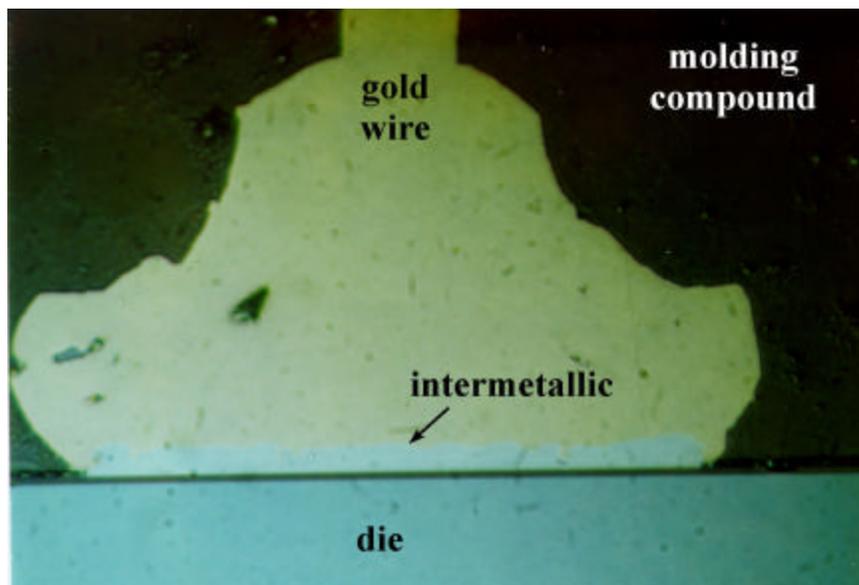
Figure 16 gives an optical view and Figures 17 and 18 give SEM views of typical ball bond cross sections. Aluminum metallization under the contact pads was mostly consumed to form an Au/Al intermetallic layer 2 - 4 μ thick. Voids observed in the aluminum metallization around the contact pads probably were artifacts caused by corrosion during cross sectioning.

Figure 16. Optical view of the wire-to-contact pad cross section, SN 35, plane 3. (1000X).

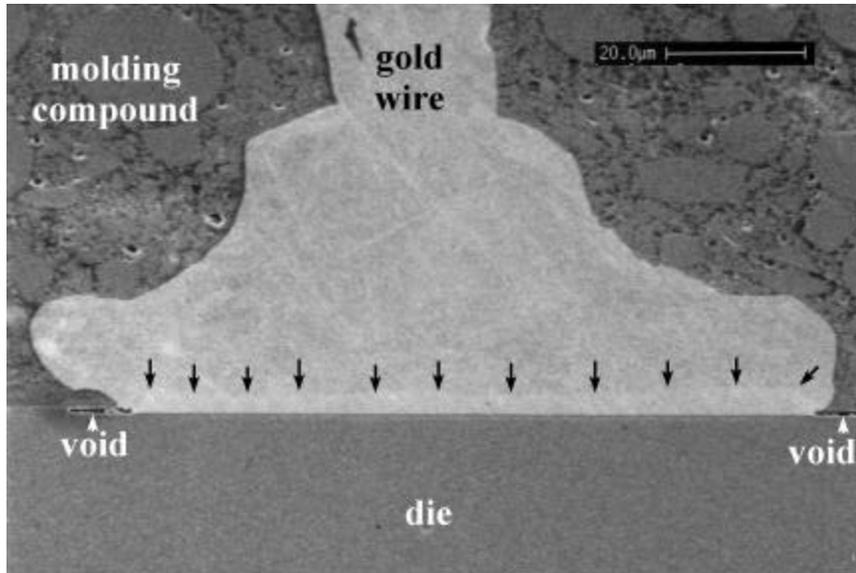
Figure 17. SEM view of the wire-to-contact pad cross section, SN 34, plane 6. (920X).

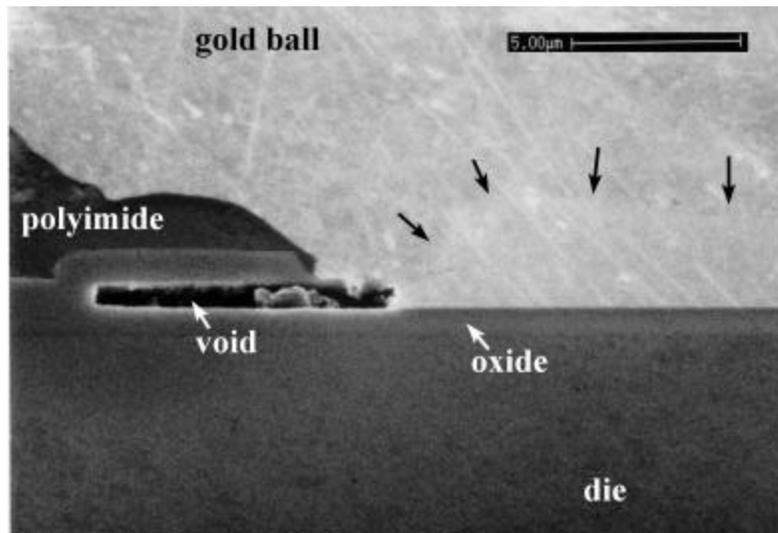
Figure 18. Close-up of the view shown above. (4900X)

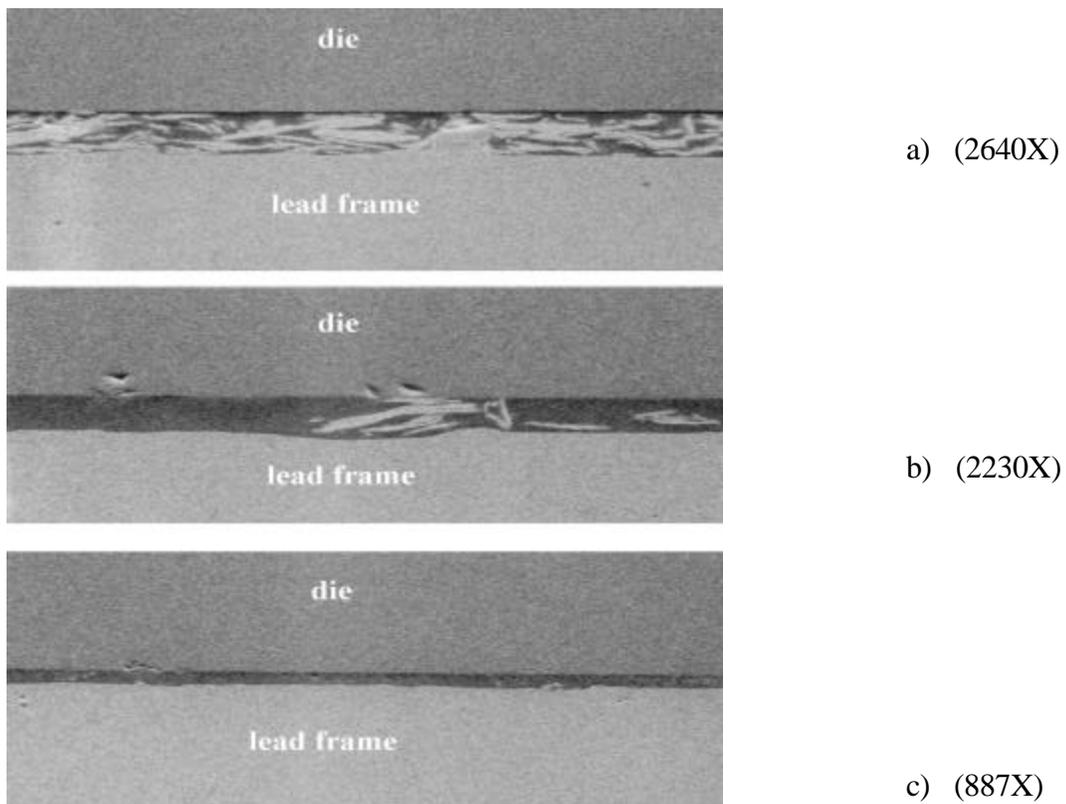
The die was mounted to the lead frame base with a silver epoxy (probably to provide better die-to-paddle thermal conductivity than nonconductive epoxies). The thickness of the silver epoxy layer was approximately 5 μ . The silver filler was nonuniformly distributed along the adhesive layer (see Figure 19). No delaminations or excessive voiding at the die attachment were found. The silver epoxy adhesive did not spread properly near the die edges where the gaps were filled with molding compound (see Figure 11). These defects indicate some problems with the manufacturer's control over the die attachment process, but most likely would not seriously affect performance or reliability of the part.

Figure 19. Three views of sections of the die attachment showing nonuniformity in silver distribution, SN 34, plane 4A.
