**Electromigration Failure in Au and Joule Heating Induced Oxidation in Cu Conductors - Part 3**

**Task Manager: Rosa Leon**

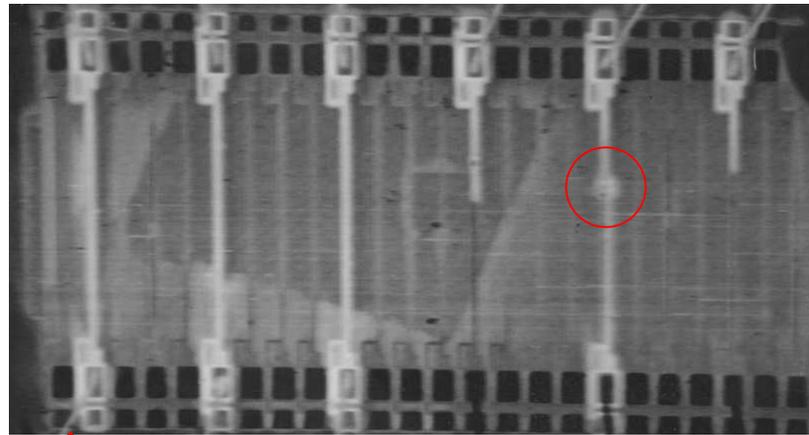
Failure mode 3:

Here current continuity is still obtained, however, the leakage current across the polymer (sandwiched between Au and permalloy) is very large.

**R1 through R6 at 15x, 20 kV, secondary electron mode**

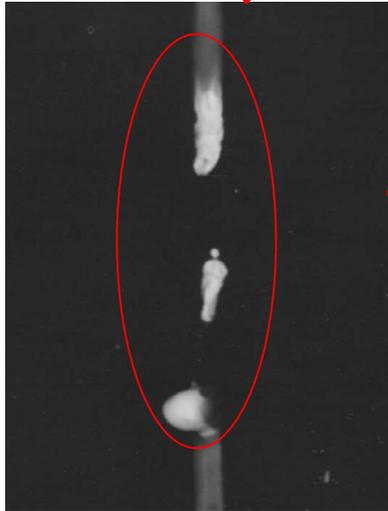
**R2 void at 400x, 20 kV, backscattering mode**

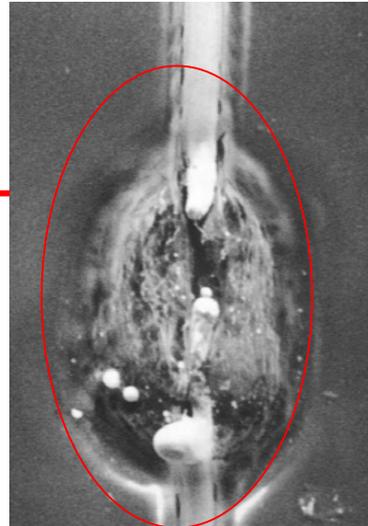
**R2 void at 400x, 20 kV, secondary electron mode**

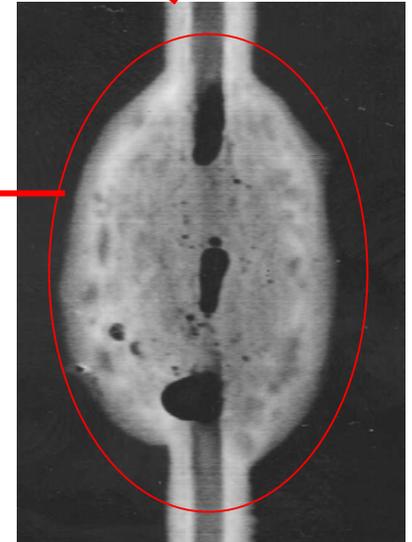
**R2 void at 400x, 20 kV, EBIC mode**

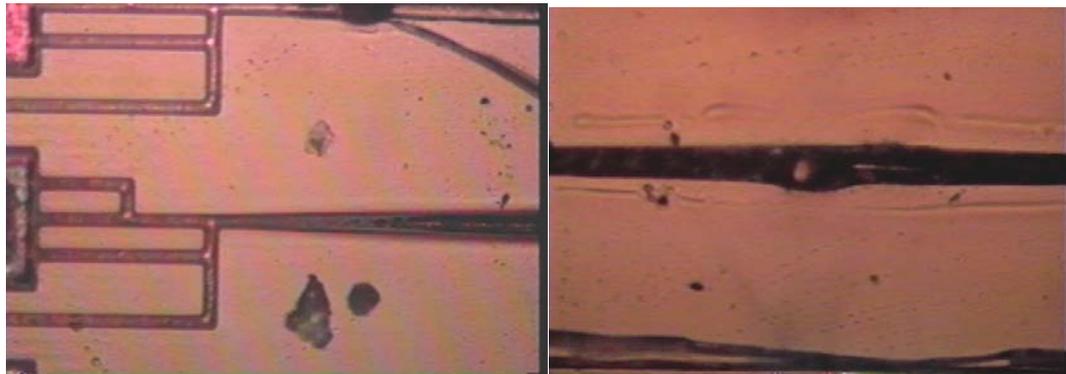
Using two probes at 60°C, our experiments show that Cu conductors failed in less than 7 hours at the following current densities:  $2.13 \times 10^6$ ,  $2.07 \times 10^6$ ,  $2.03 \times 10^6$ ,  $1.9 \times 10^6$  and  $1.85 \times 10^6$  Amp/cm<sup>2</sup>. Joule heating occurred for all these values of current density. This can be clearly observed in the middle of the line, which deteriorated the polymer and exposed the lines to atmosphere. Since the Cu lines were exposed, they turned rapidly dark due to fast oxidation of Cu in air.

Joule heating and Oxidation of Cu at  $2.1 \times 10^6$  A/cm<sup>2</sup>

Central portion of the line.

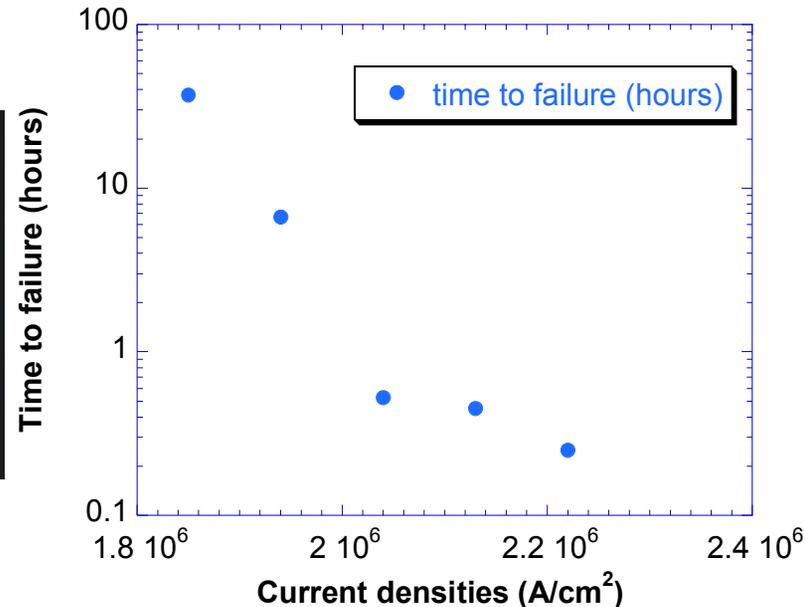
Current density vs. Time to failure of Cu test structures measured at 60C and in air.

- Measurements of lifetimes at different current densities in air and at 60°C show that failure of unprotected Cu lines are mainly due to oxidation failure.

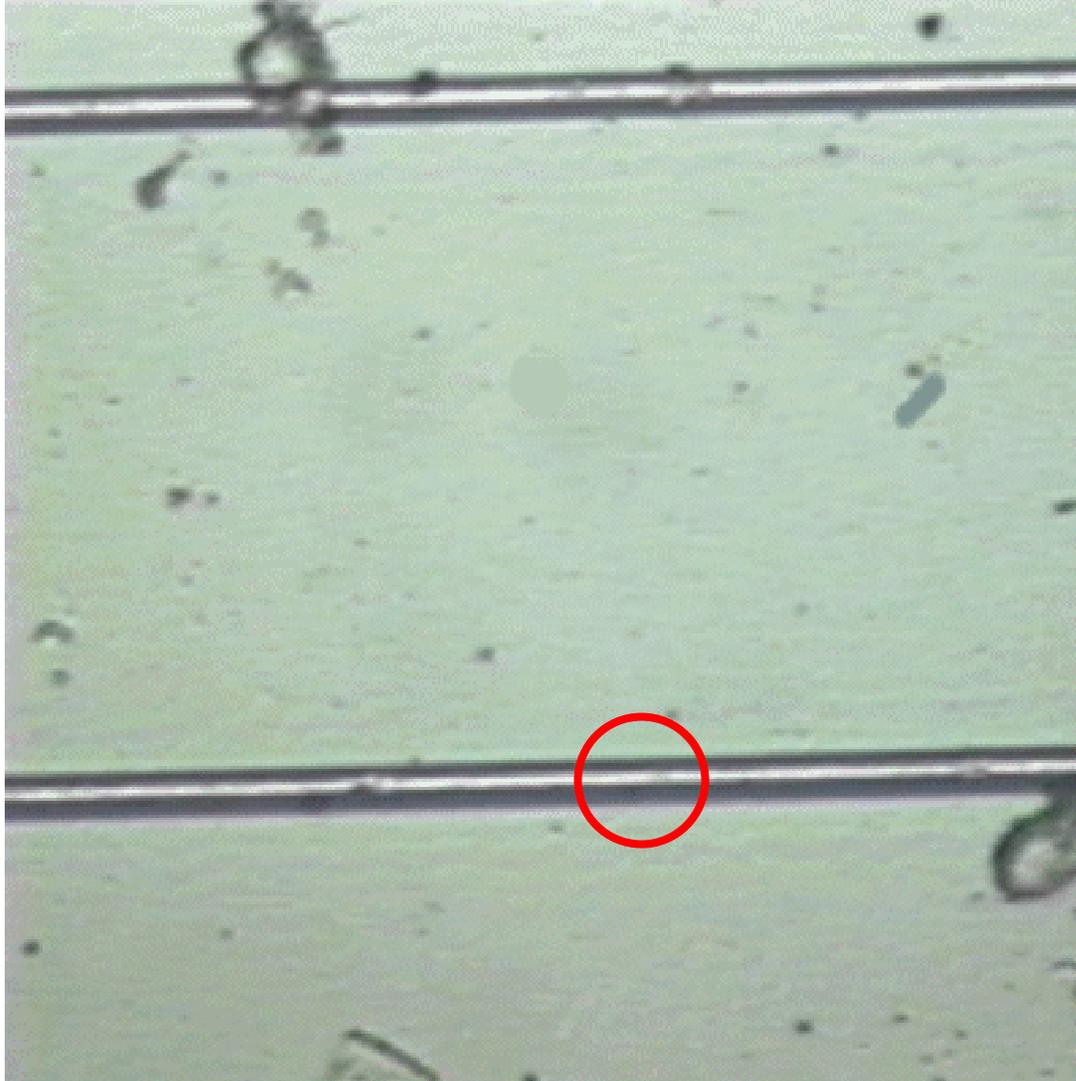
**Film sequence showing rapid oxidation of Copper Interconnect under a current density of  $14.8 \times 10^4$  mA/cm<sup>2</sup>**
