# Reliability Evaluation of PEMs Rejected During C-SAM Examination

**Alexander Teverovsky**

Parts, Packaging, and Assembly Technologies  
Office, Code 562, GSFC/ QSS Group, Inc.

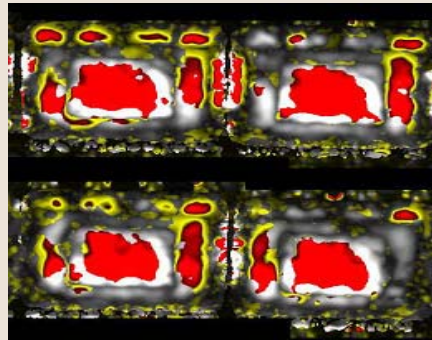
PEM2 had 2 WBs to the paddle, which might cause failures if broken.

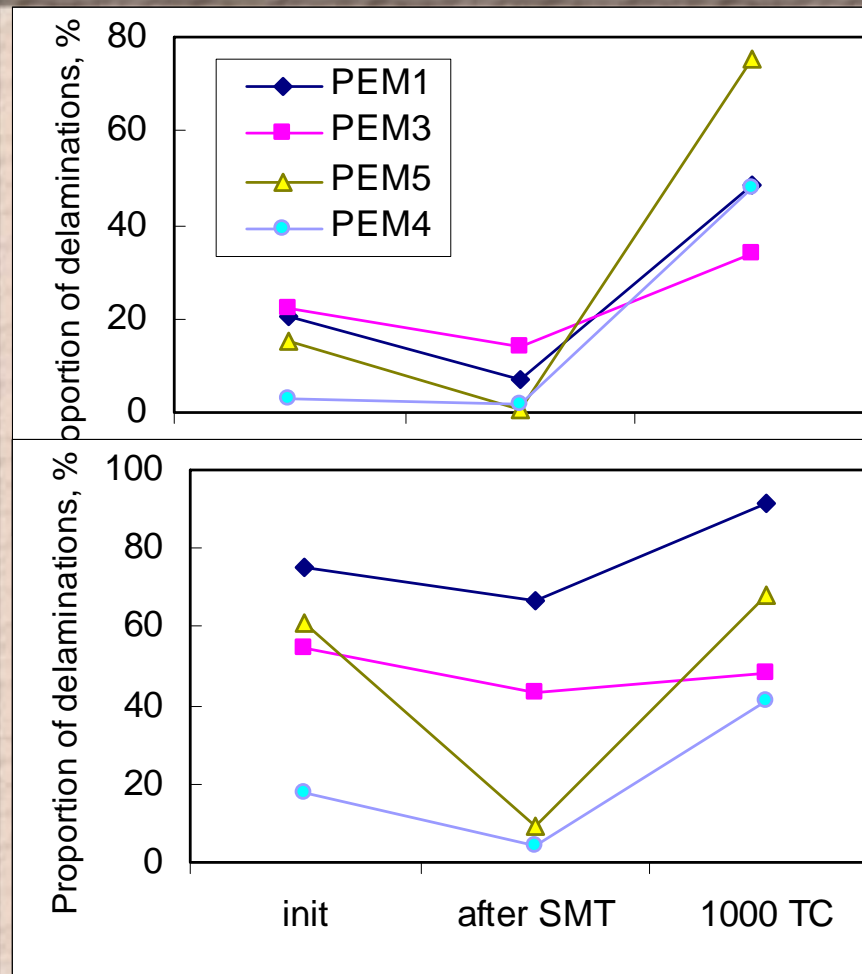
The proportion of delaminated area decreased after SMT and increased after temperature cycling.

Lead-to-MC delaminations

Paddle-to-MC delaminations

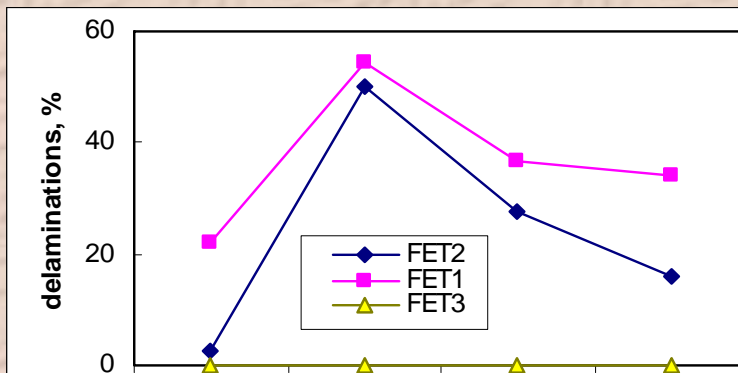
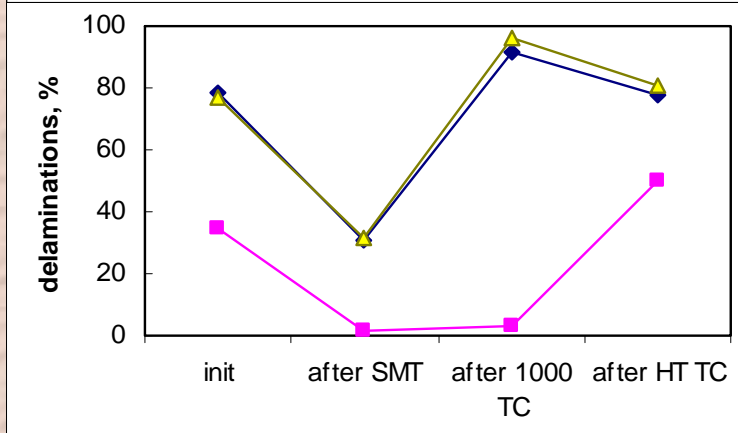
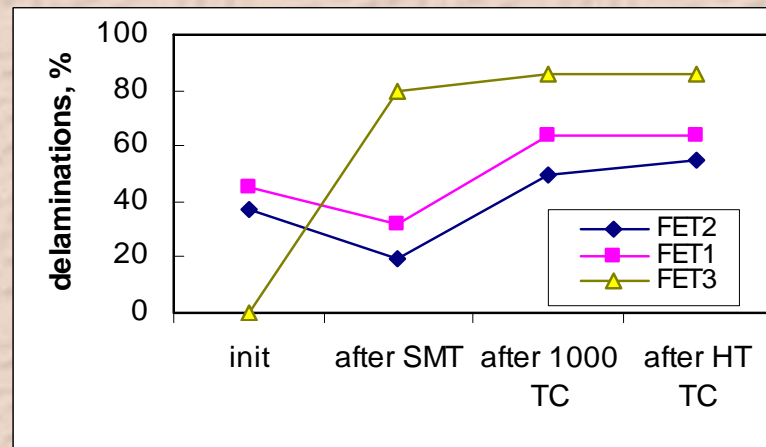
Die surface

Top paddle

Leads

- No top-of-die delaminations (TODD) in FET3.
- In FETs 1 and 2 TODD increased and paddle delaminations decreased after SMT.

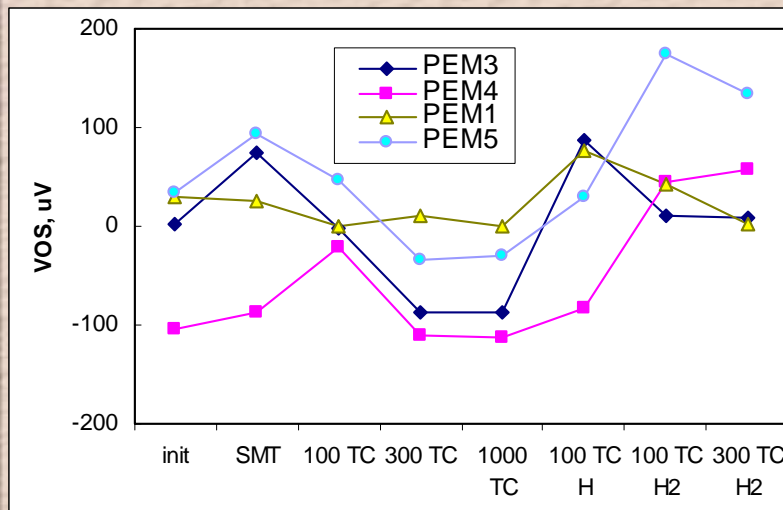
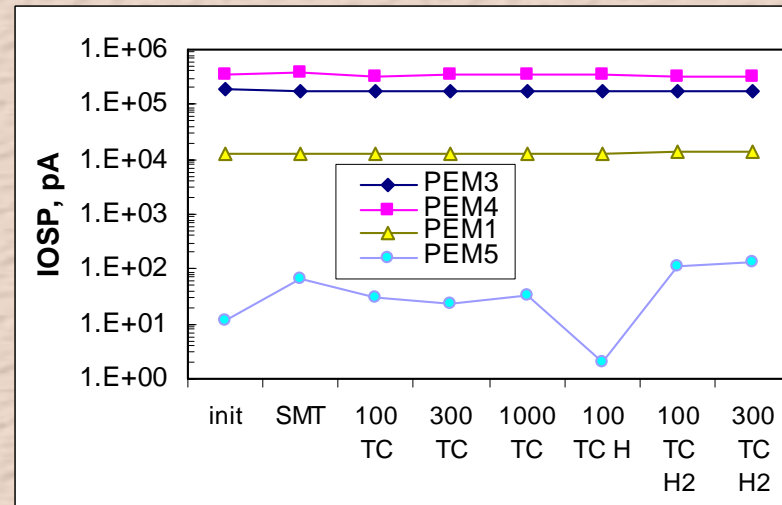
## Offset voltage variation during temperature cycling

## Input bias current variation during temperature cycling

The parts had no failures and manifested only minor parametric variations.

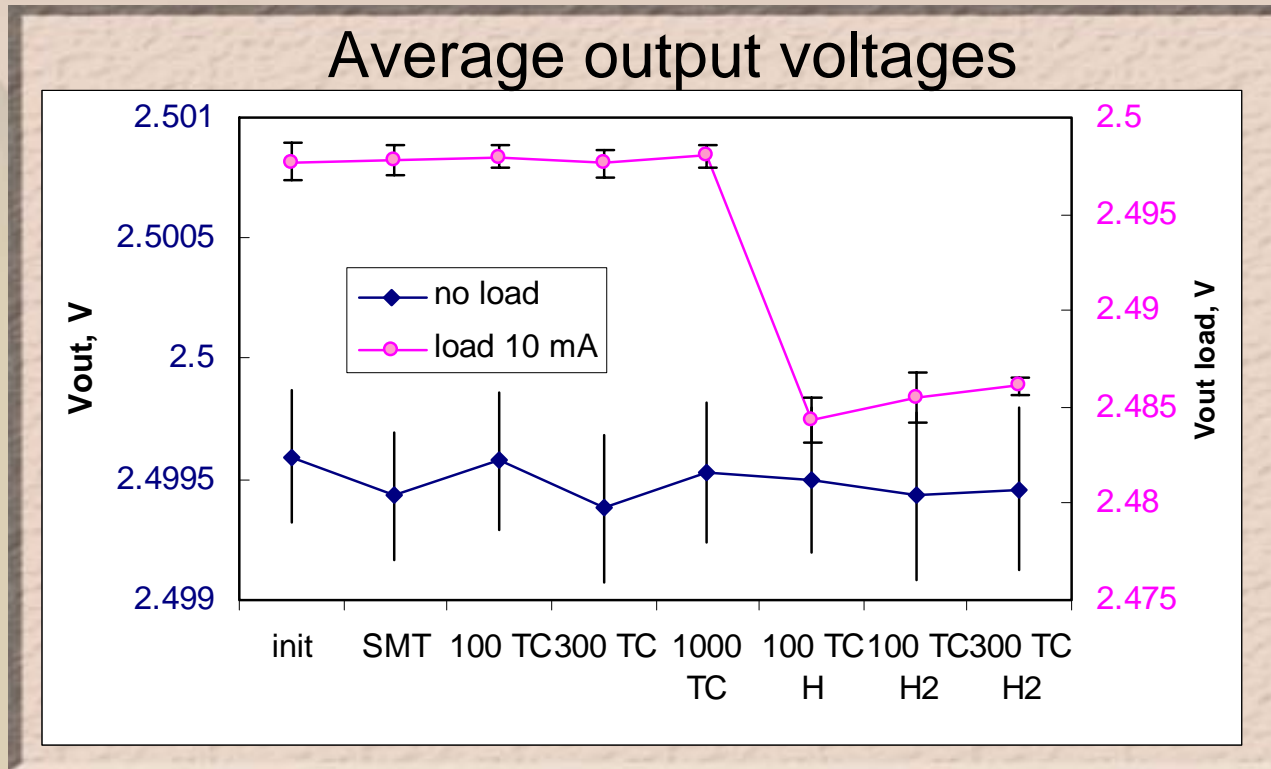
- Devices had minor parametric variations.
- One part failed at load conditions after 100 HT TC.

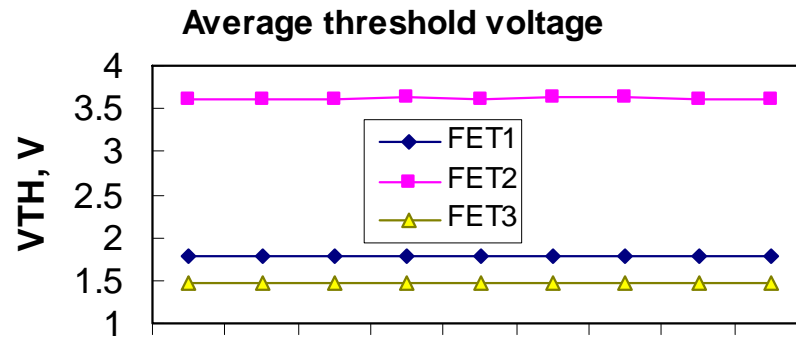
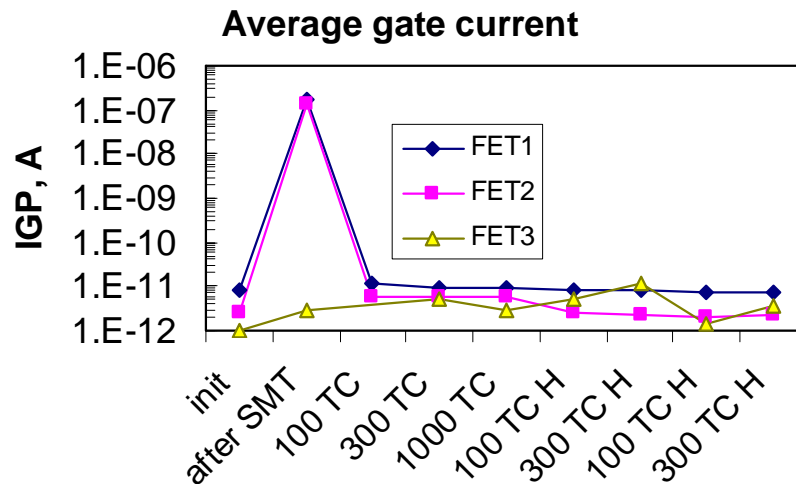
- No failures after TC.
- No VTH variations.
- Significant increase in leakage currents after SMT simulation.
- All failed parts recovered after TC.
- Some failed parts had corrosion of Al metallization after HAST.

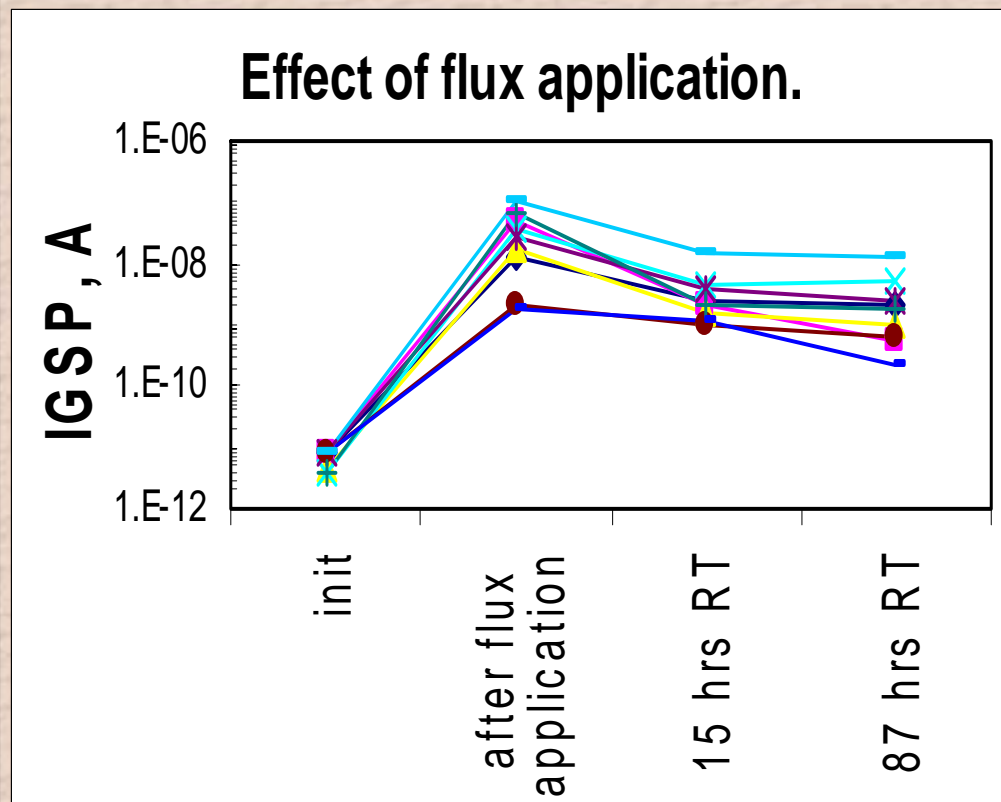
Test conditions:  
Immersion into KESTER 2331-ZX water-soluble flux for 10 seconds, rinsing, and blowing with dry air.

Excessive leakage currents remained after a few days of storing in laboratory conditions.

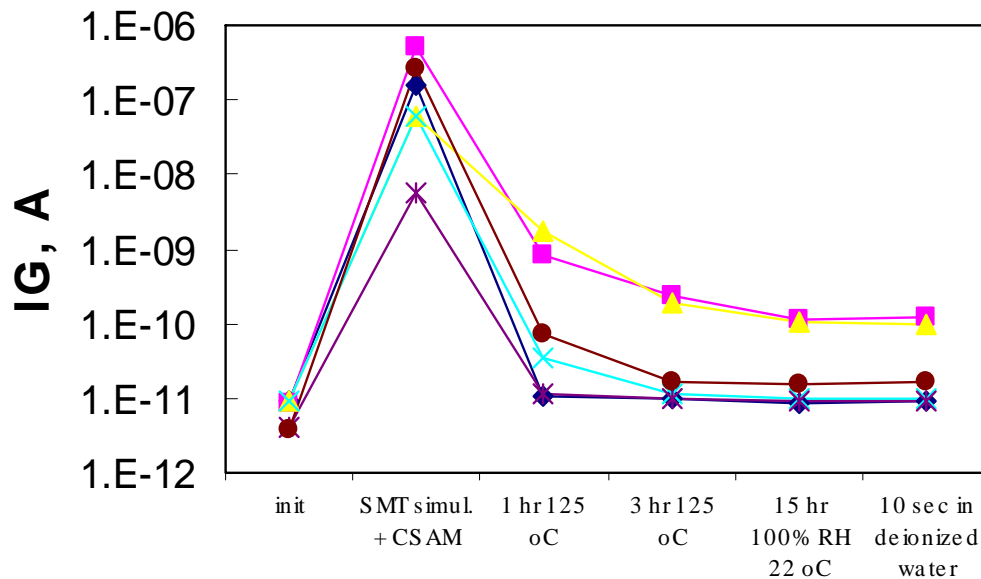
Failed samples.

- Baking for a few hours at 125 °C mostly restored leakage currents.
- Immersion in water and storing at 100%RH did not increase IG.
- Effect of SMT simulation is likely due to good wettability of flux.

- The type of flux used for SMT simulation might affect results of qualification testing. JESD22-A113 might need a review.
- Flux used for soldering might be different from the one used for the simulation, thus making results of qualification questionable.
