ISS Fiber Optic Failure Investigation

Root Cause Report

August 1, 2000

**ISS Fiber Root Cause Investigation Team
Lead organization NASA GSFC
Sponsored by: NASA JSC and the Boeing Company**

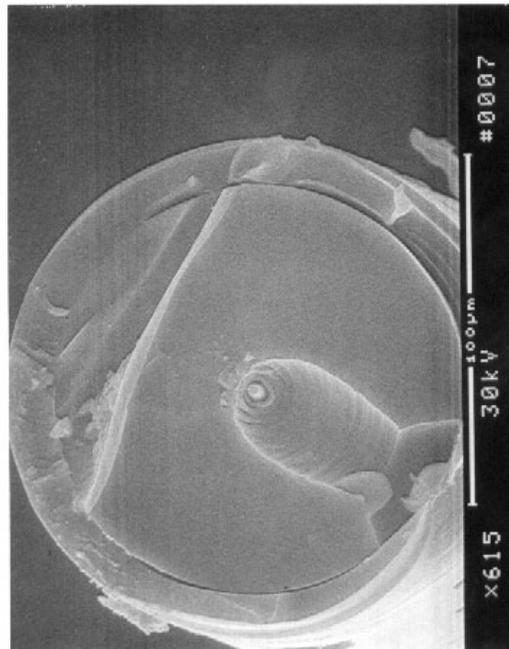
In mid-1999 Boeing engineers were finding multiple failures of 1999 vintage NFOC-2FFF-1GRP-1 optical cable being used to fabricate harnesses for the International Space Station (ISS) program. This cable was used in U.S. Laboratory module, an element of the International Space Station, a deliverable under contract NAS15 10000. Not only were fiber breaks being detected during handling, but breaks were found over time with no handling (sitting on the shelf). This was believed to be a much different experience than was encountered during population of the U.S. Lab module with 6982 feet [ref-1] of 1996 vintage cable of the same part number. The Boeing materials and processes engineers performed destructive physical analysis (DPA) on the fiber at the break locations. Figure 1 shows one of the first images resulting from the DPA. The cone and bulb shape of the defect earned it the name “rocket engine”. This description replaced the term “bubble” which according to the fiber manufacturer, is associated with a topology that is unique and not represented by Figure 1.

Figure 1 “Rocket Engine” Defect

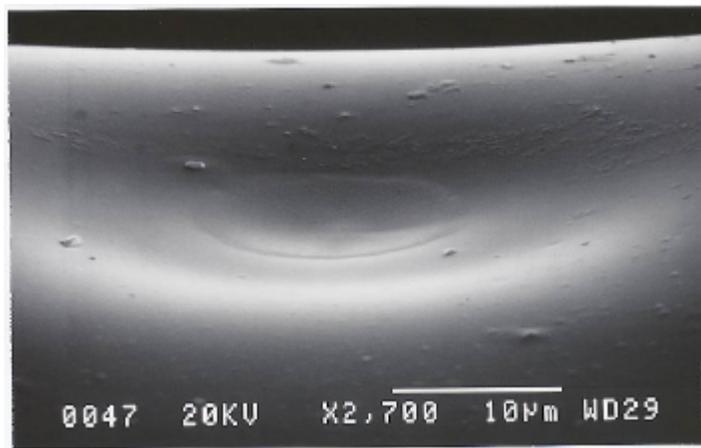
Figure 5 Sink in the Polyimide Coating

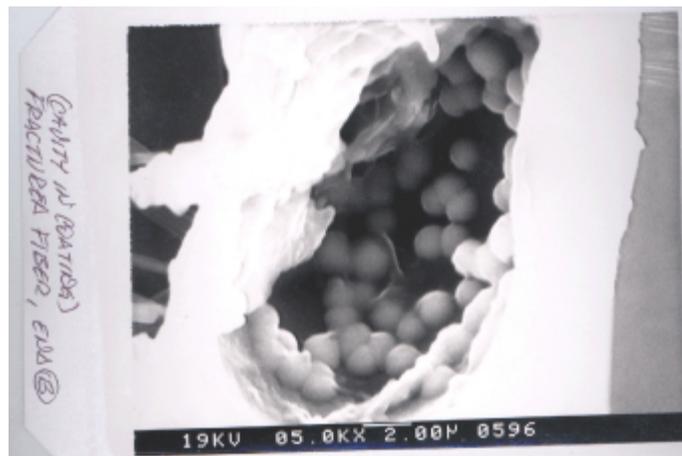
Figure 6 SiO₂ Balls in Polyimide Void

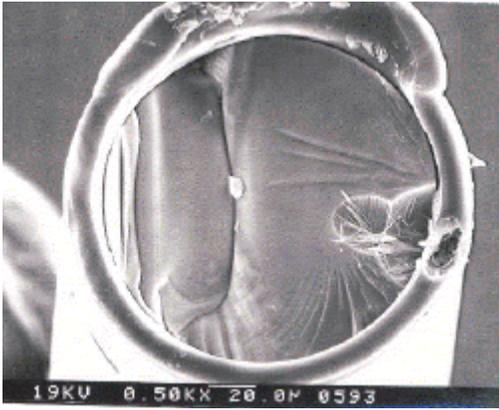
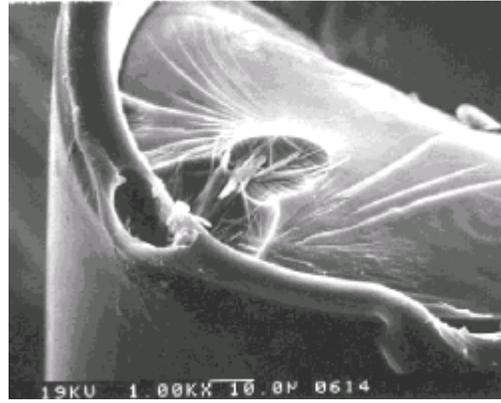
Figure 7 GeO₂ Crystals in Etch Pit

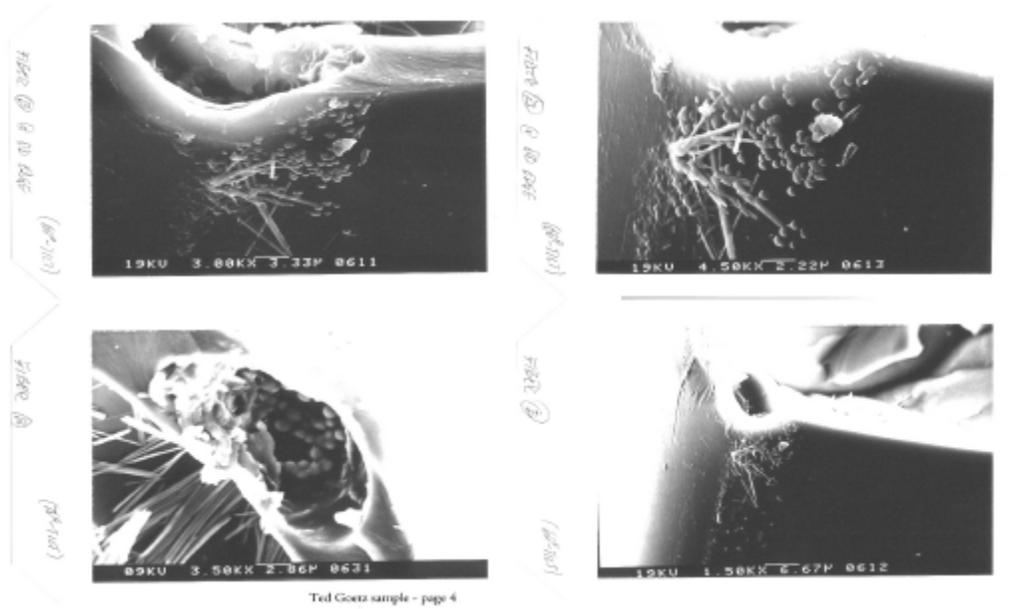
Ted Goetz sample - page 4

Figure 8 GeO₂ and SiO₂ Debris on Outside of Coating

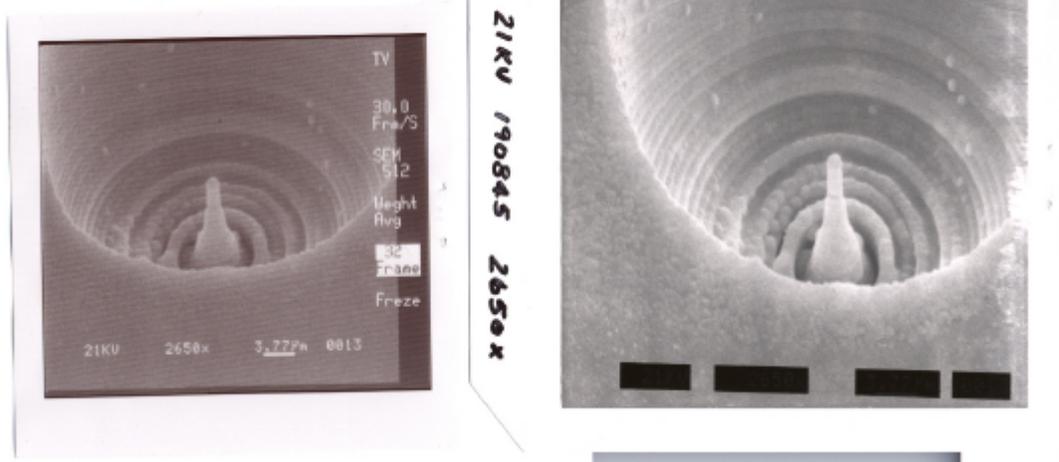
Figure 9 Si-spire in Deep Etch Pit

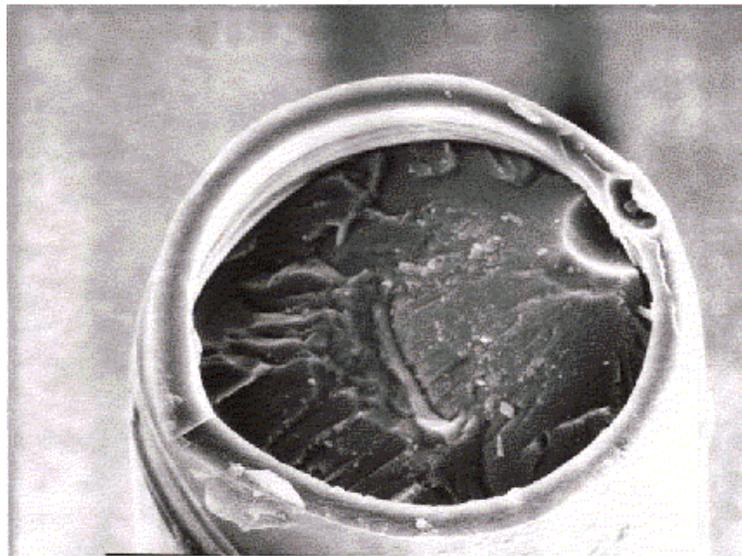
Figure 10 Characteristic Void in Polyimide Above Shallow Etch Pit

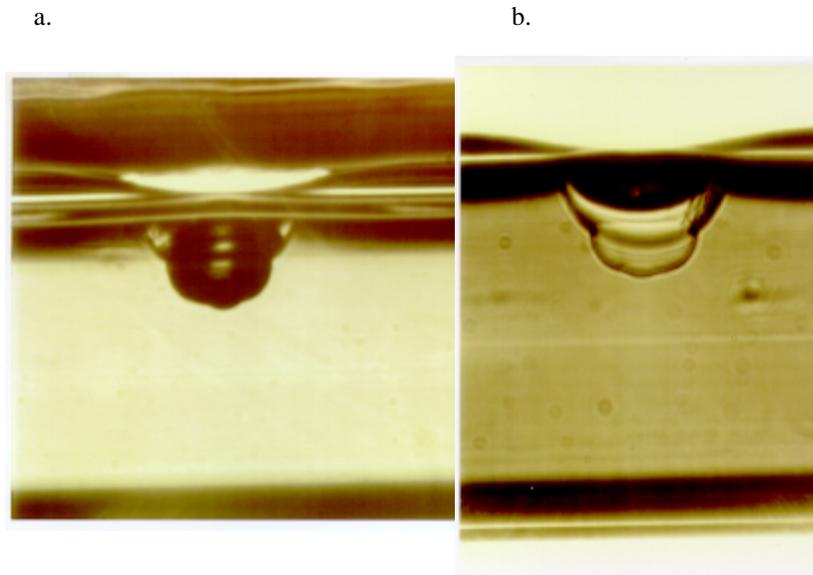
The use of index matching oil and backlighting during imaging was found to greatly enhance the optical microscope images. After submersion of an intact piece of fiber in index matching oil and having left the sample overnight, the oil was found to have filled the “rocket engine” void (Figure 11a and 11b). This indicated that the surface of the “rocket engine” defect was exposed to ambient atmosphere.

Figure 11 Defect Inspection Using Index Matching Oil

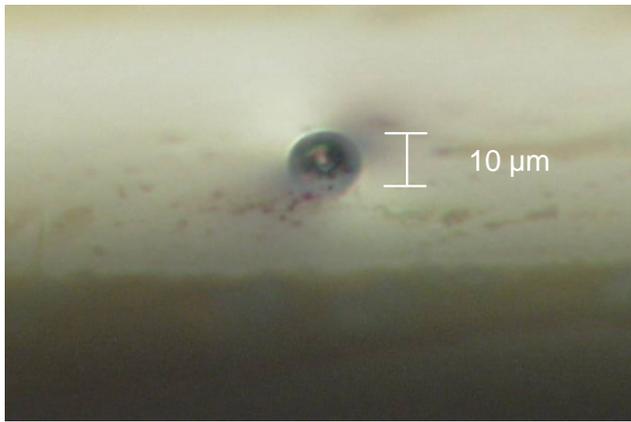
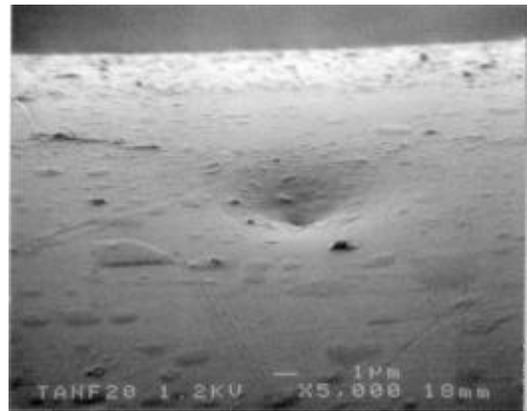
Optical inspection was used to examine the polyimide surface of fiber containing “glows”. Features were found resembling depressions and buried bubbles (Figures 5-8, 10, and 12). Field emission scanning electron microscope (FE-SEM) inspections were also performed on 6” samples from two lots of fiber which had never been cabled by BICC (Figure 13) [ref 8]. The samples were from reels CD0588XD and CD0384XB. Though both lots were found to weaken due to the cabling processes, the CD0588XD fiber was found to be more dramatically weakened than the CD0384XB (see Section 7.0). Sixteen features were found in the polyimide in the “588” sample and one was found in the polyimide in the “384” sample (four more features were found in an additional sample of “588” fiber). An hour glass-like shape was found to be very common among the bubbles observed, as is shown in Figure 13.

Figure 12 Depressions and Bubble in Polyimide Coating in Fiber CD0588XD

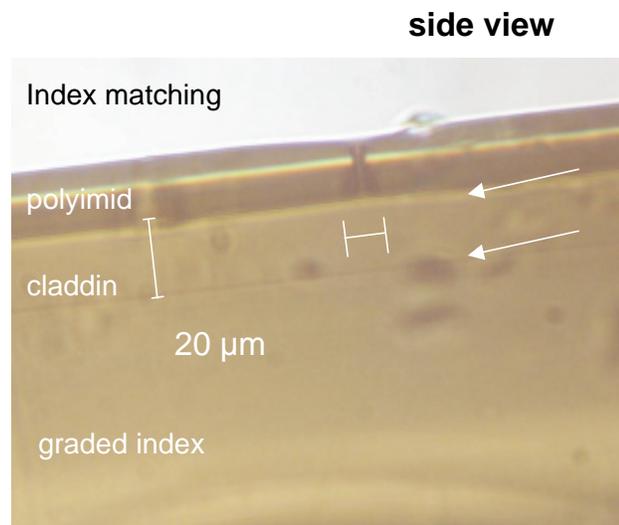
Figure 13 Hourglass Shape of Bubble and Polyimide

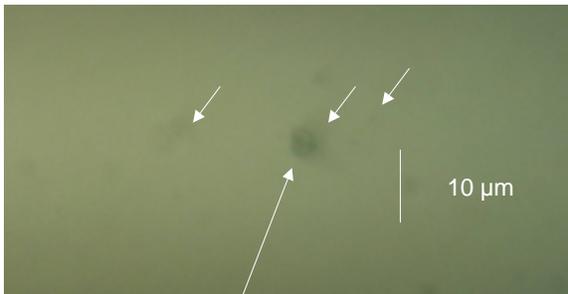
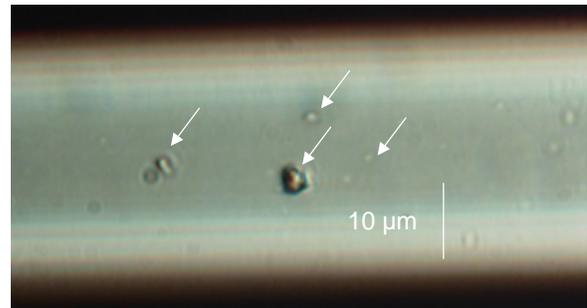
Additional work with these samples was done to catalogue their relationship to breaches in the carbon coating below them. Not only were breaches found below some of the bubbles, but others were found in the vicinity of the bubbles but with no bubble on top of them as seen in Figure 15a and b.

a. Features Below Polyimide Bubble, Reflection Mode 100x, 0.3 μm Resolution

b. Polyimide Etched off with Sulfuric Acid, Multiple Bright Spots at Carbon Coating Surface, Transmission Mode

Figure 15 Carbon Defects Seen Below Polyimide on Sample of CD0588XD Fiber

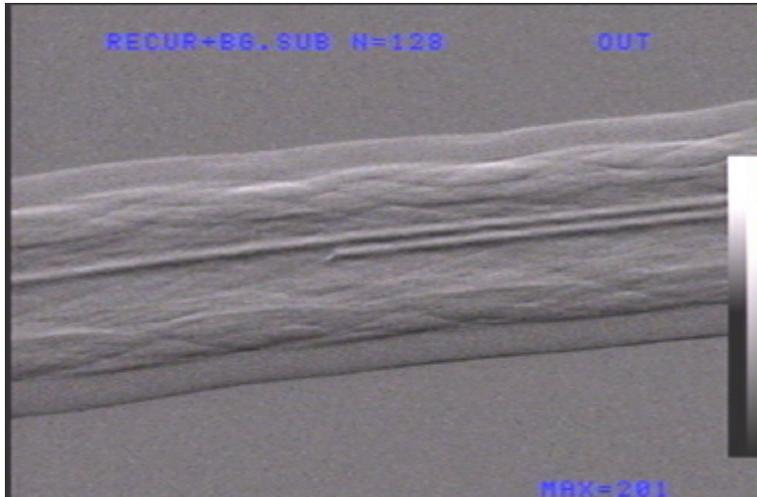
X-ray was used to see if defects on the surface of the coated fiber could be detected. Figure 16 shows that X-ray can be used to look at the fiber without removing the cable elements which is useful for inspecting for fiber which may be too long for the jacketing (in cases where the jacket and/or buffer has shrunken).

Figure 16 E. Banks' Sample With a Broken Fiber Whose Ends Overlap

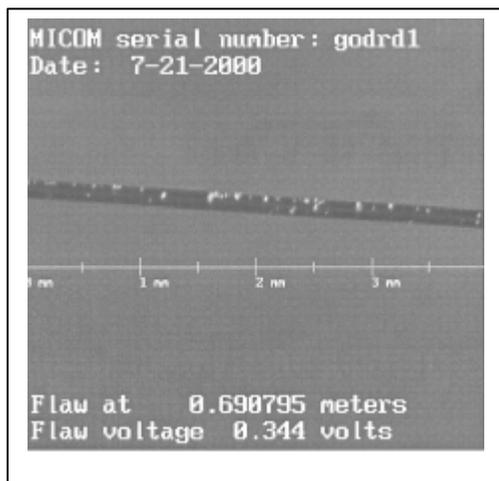
Figure 17 Debris-Laden Fiber

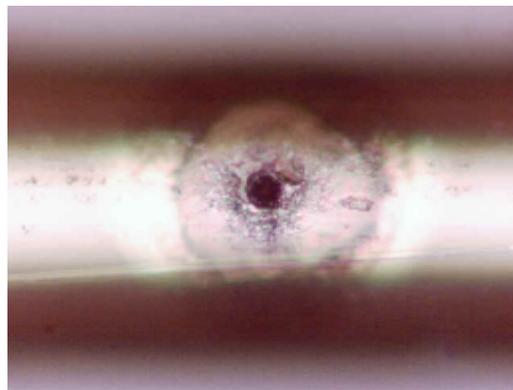
The final thickness of the polyimide on the BF04515 is 15 μm (0.60 mils). The cure schedule used may make its mechanical and electrical characteristics differ from DuPont's published values [ref-12]. The polyimide coating on a sample of BF04515 fiber, which had never been cabled, was tested for dielectric strength. Several lots were not tested so we do not know how the value may vary on a lot basis. A value of 6.5 kV/mil in 50% humidity [ref-15] was measured (See Section 6.5 below for the test set-up and more discussion about ESD testing). DuPont's published value for fully cured polyimide is 4.0 kV/mil at 50% RH. Burn marks were found on the sample tested (Figure 22).

Figure 22 Burn Mark From DWV Testing of “Rocket Engine Defect”- Free Fiber

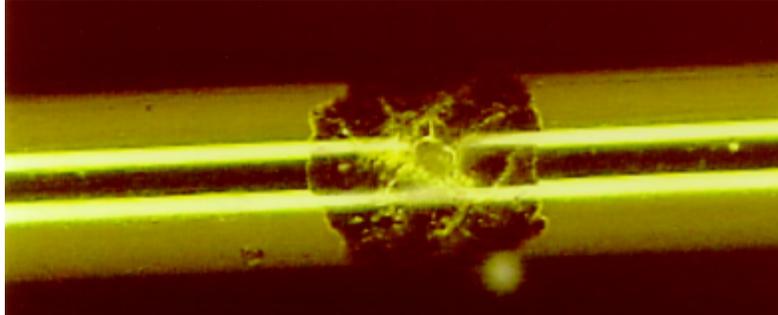
Another test was done on fiber that was removed from NFOC-2FFF-1GRP-1 cable that was known to be defective (several “glows” found along its length, at least one of which was DPA’d and found to be a “rocket engine”). A voltage of 1.5 kV was enough to break through the polyimide between two electrode locations and sustain a current down the carbon coating between them. A burn-mark was created when the voltage was raised to 2.5 kV (Figure 23).

Figure 23 Burn Mark From DWV Testing of Fiber with “Rocket Engine Defects”

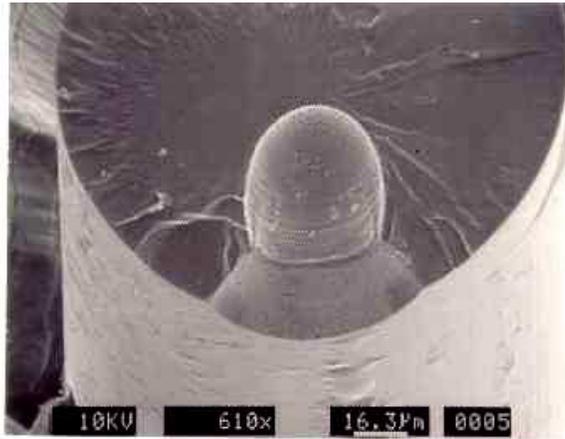
Lucent observed that the Ge-doped core etches considerably faster than the cladding. If the etch time is too long, then the entire core can be removed, leaving a silica tube with a pinhole in it. This indicates that the amount of HF present at the site is the limiting factor in the degree of etching.

Figure 26 Etch Pit Resulting From Experimentation

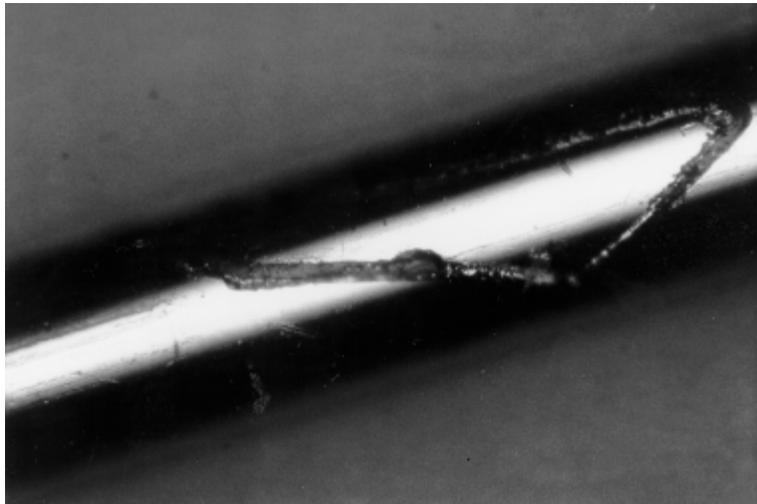
Testing was also done with a 30 kV Tesla coil to demonstrate the conducting behavior of the NFOC-2FFF-1GRP-1 cable. When the Tesla coil tip was placed about a centimeter from the cable, the tip of the coil emitted a spark that was drawn to the cable. This spark was drawn along as the tip of the coil was moved along the cable. Upon removal of the fiber from the cable sample, the trench shown in Figure 28 was observed. Though it is not obvious in the photograph, particles believed to be polyimide surround the blackened edges of the trench suggesting that all of the polyimide did not vaporize and some of it was redeposited around the site near the trench. This demonstrated that high electric fields can cause charge travel all the way through the cable layers and damage the fiber coating.

Figure 28 Electrical Discharge Induced Damage on Fiber Surface

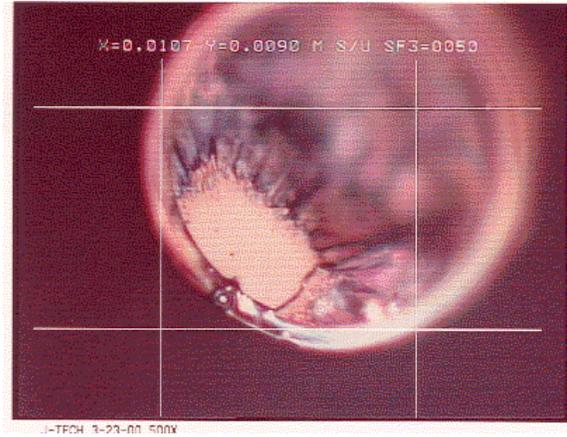
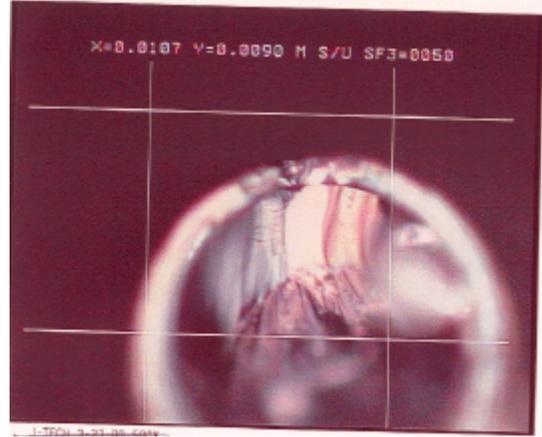
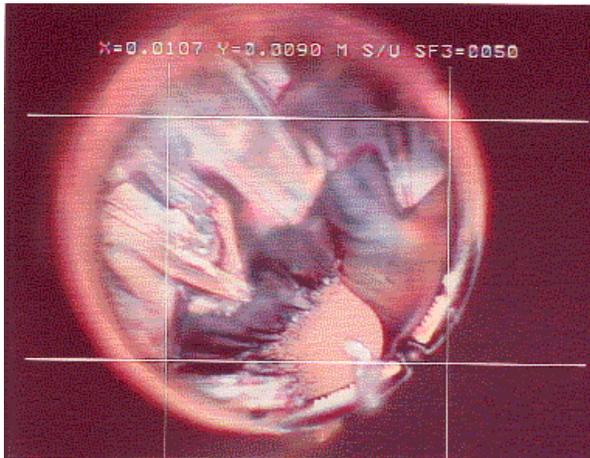
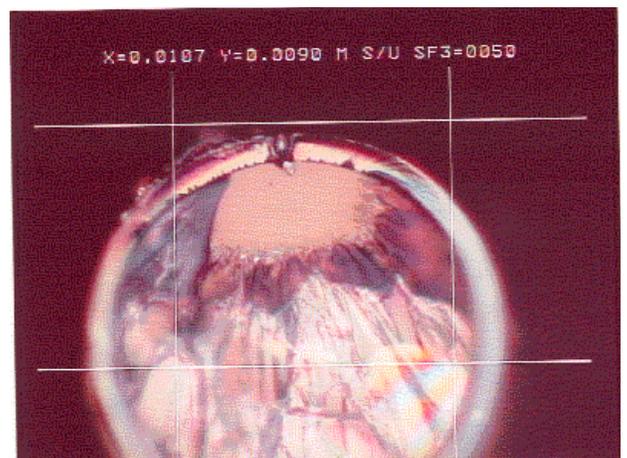
Figure 33 Example of Low Strength Breaks
