Document No: MOD10 SB1-00.03.27

Service Bulletin

THIS SERVICE BULLETIN APPLIES TO ALL MODULAR 10 SERIES RELAYS

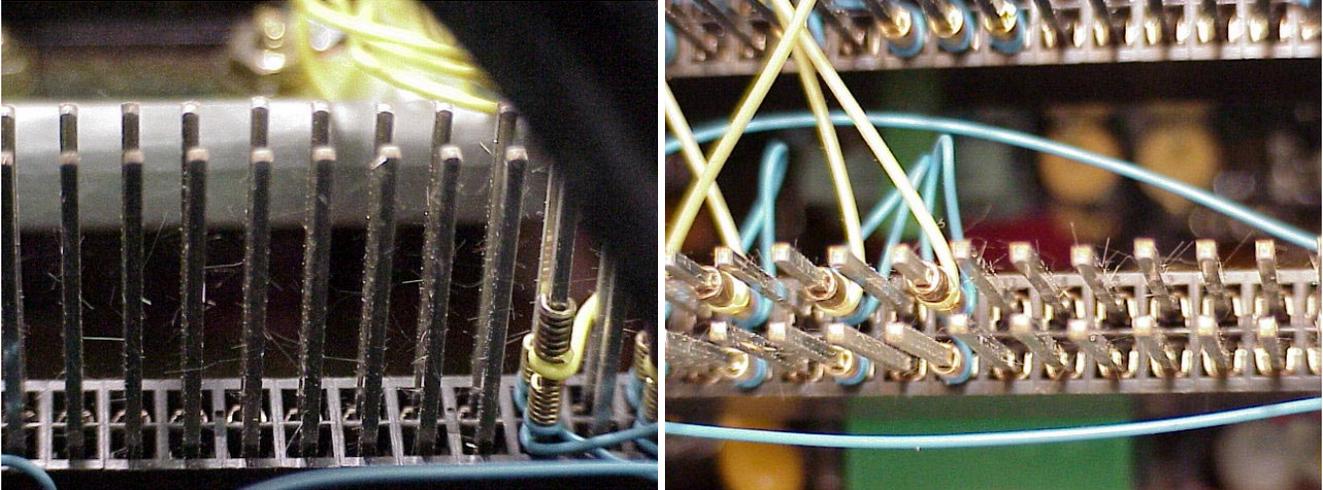
- Issue:** Whisker like components were identified on the PC board edge connectors of GE relays of the Modular 10 series. These whiskers were identified as Tin Whiskers, which crystallize on the PC board edge connectors, and can grow long enough to bridge the pins of the PC board edge connectors. These Tin Whiskers can thus cause relay misoperations. This was found on older MOD10 relays, in the excess of 10 years.

- Units affected:** All Modular 10 relays are affected, specially those 10 years or more in service.
- Symptoms:** Unexplainable relay misoperations due to tin whiskers bridging pins of PC board edge connectors. Tin Whiskers can be observed on the PC board edge connectors using a strong light source and a magnifying glass.

The Tin Whiskers can typically look as follows:

- Unscrew the rear cover of a GE Relay rack and remove slowly, only as far as internal wiring allows. Using a nonconductive bristled brush, nylon for example, agitate and sever the whisker from the connectors. All tin whisker residues should be removed from the entire unit by vacuum. This should be done in a separate lab, if possible, to ensure no contamination of the existing equipment due to the tin whiskers. Inspect cleaned connectors, using a flashlight and magnifying glass, to ensure all whiskers have been removed.

- Actions:** Inspect the back plane of all Modular 10 relays, for the presence of Tin Whiskers, as per instructions below. The age of the relay can also be determined as per instructions below. Re-inspect the relays six months to a year after cleaning, and repeat cleaning if necessary, as per recommendation by Amp Canada Inc.
