Jay Brusse and Michael Sampson

Zinc Whiskers: Hidden Cause of Equipment Failure

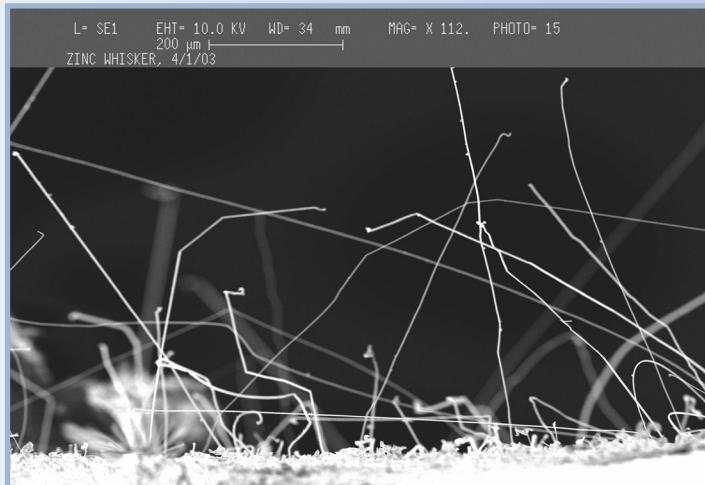
Figure 1. Zinc whiskers (here, magnified 100×) growing on the underside of a raised-access floor tile.

Many of these whiskers are 1 mm or more in length.

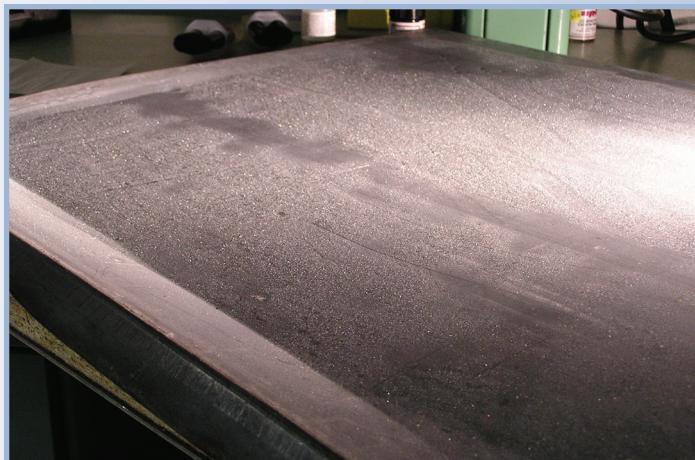
Figure 3. Underside of the zinc-electroplated-steel floor tile in Figure 2b.

The sparkling dust-like surface is actually millions of zinc whiskers shown magnified in Figure 1.

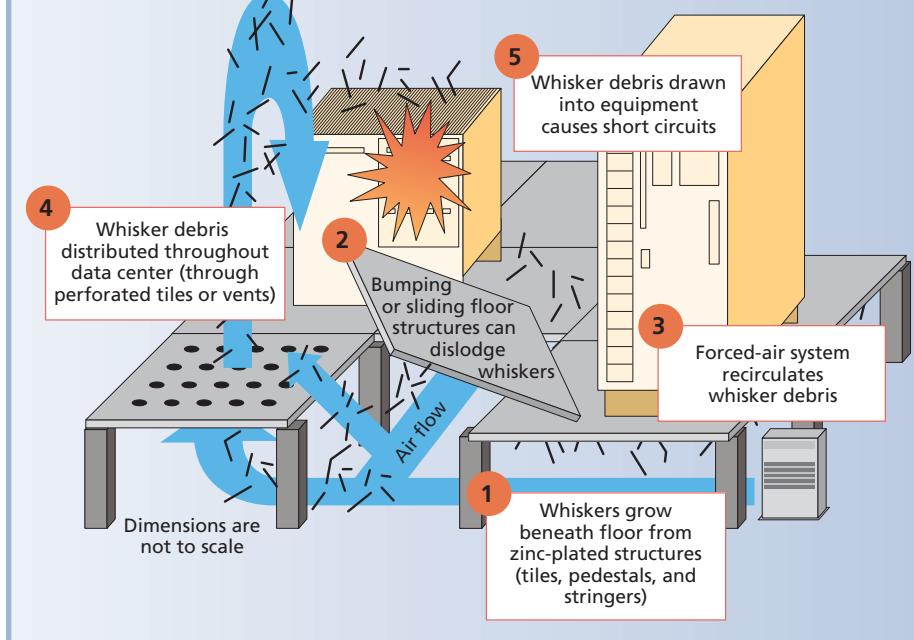
For efficient cooling, the forced-air system typically pressurizes the subfloor space with chilled air. Perforated floor tiles and air vents provide channels through which the cool air—and along with it, zinc whiskers—can pass into the above-floor space. Ultimately, many whiskers can pass into the electronic hardware through vents and fans on the equipment. Once inside the equipment, zinc whiskers can cause various electrical failures, ranging from intermittent to permanent short circuits.

Whisker debris can also become a physical impediment to moving parts or obscure optical surfaces and sensors within some equipment (such as disk or tape drives). Figure 4 shows a graphical representation of this zinc whisker failure mechanism.

Figure 4. Zinc whisker failure mechanism in a raised floor setting.
