Tin Whiskers:

A History of Documented Electrical System Failures

A Briefing Prepared for the Space Shuttle Program Office

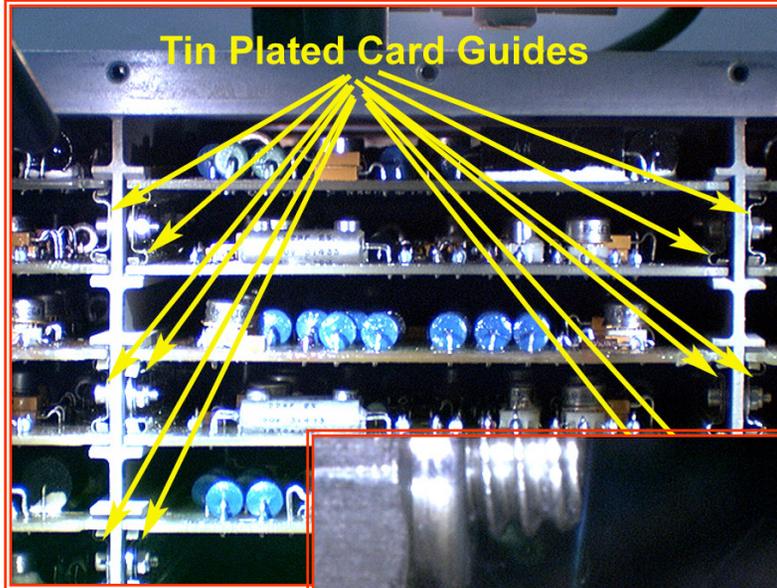
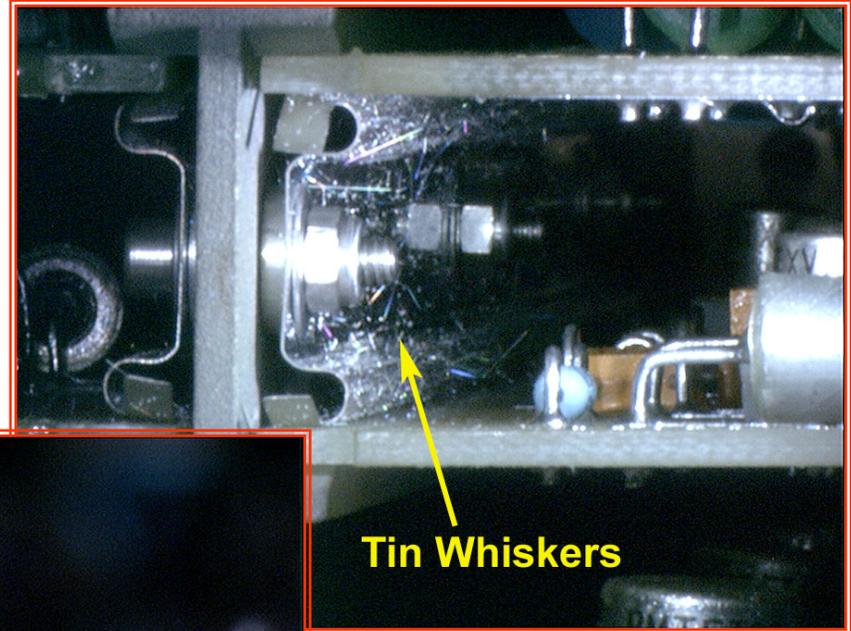
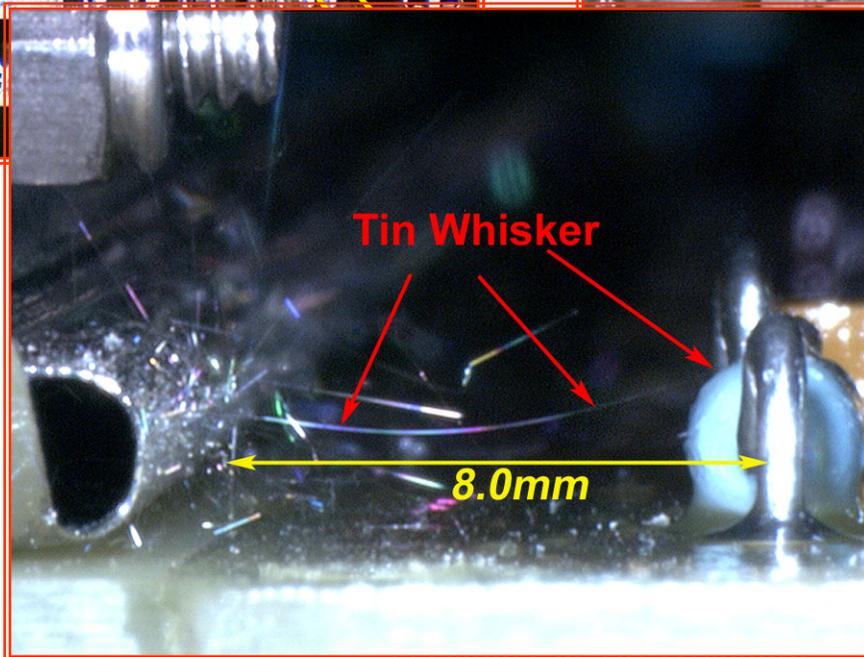
Tin Whiskers on PCB Card Guides

Ref: "Tin Whiskers Found on ATVC S/N 0034", Don McCorvey, March 8, 2006

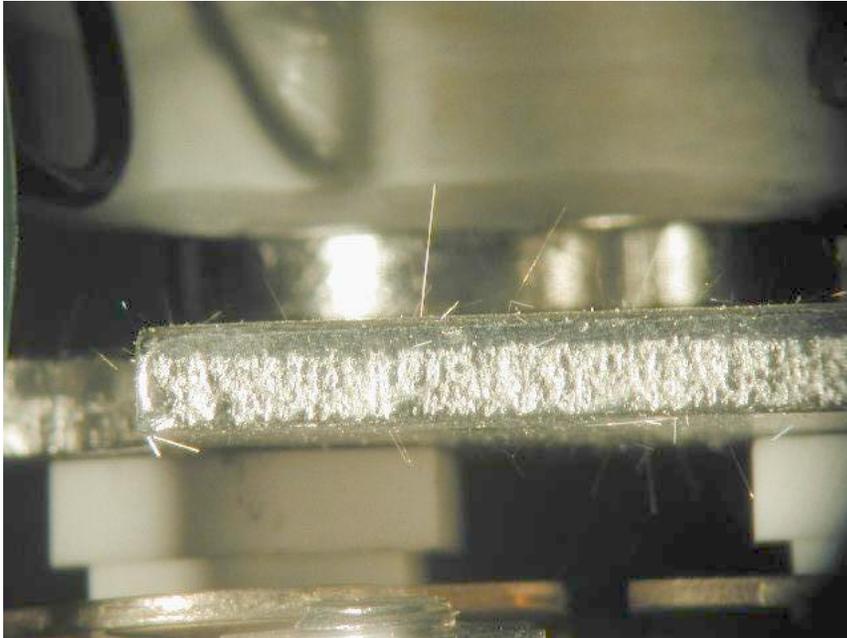
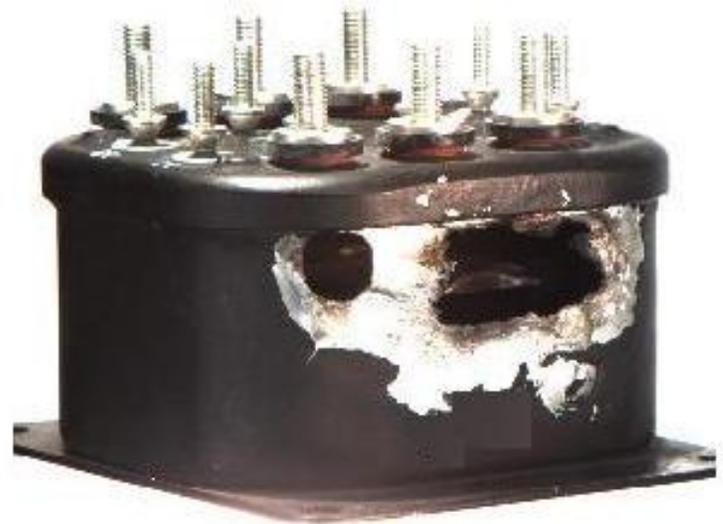
Catastrophic Damage Due to Tin Whisker Induced Metal Vapor Arc (*In Air!!!*)

Is your supplier reliable?
**This Electromagnetic Relay
Was Purchased
To MIL Spec Prohibiting
Pure Tin Finish Inside,
But IT WAS Pure Tin**

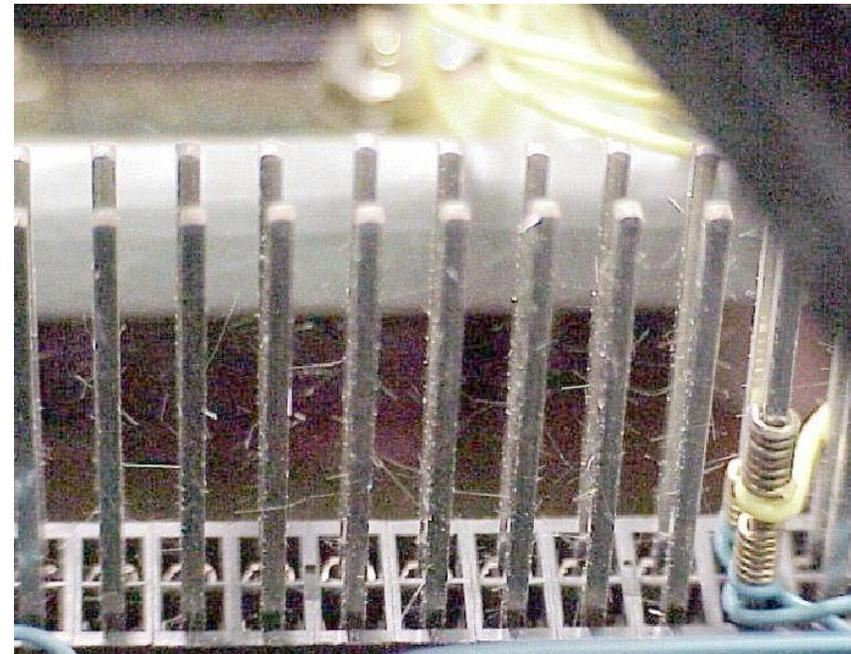
- ***Tin whiskers can occur in pure electroplated tin plating.***
- ***AMP rarely specifies the use of pure tin plating because of the possible whisker growth problem.***

- ***AMP currently specifies (93%-7%) tin-lead alloy whenever possible to retard whisker growth and reduce lead exposure to the environment.***
- From our experience the plating stresses in tin that cause whiskers will relieve over time, and the frequency and magnitude of new whiskers will decrease accordingly.

**Tin-Plated Connector Pins
Displaying Tin Whisker Growths**

- ***We recommend using a nonconductive bristled brush, nylon for example, to agitate and sever the whisker from the contact and use a vacuum or compressed air to remove the whisker from the connector and the relay equipment.***

- ***Although, we believe a one time cleaning to remove the whiskers will be sufficient to solve this problem, an inspection of the connectors six month to one year after the cleaning is recommended.***

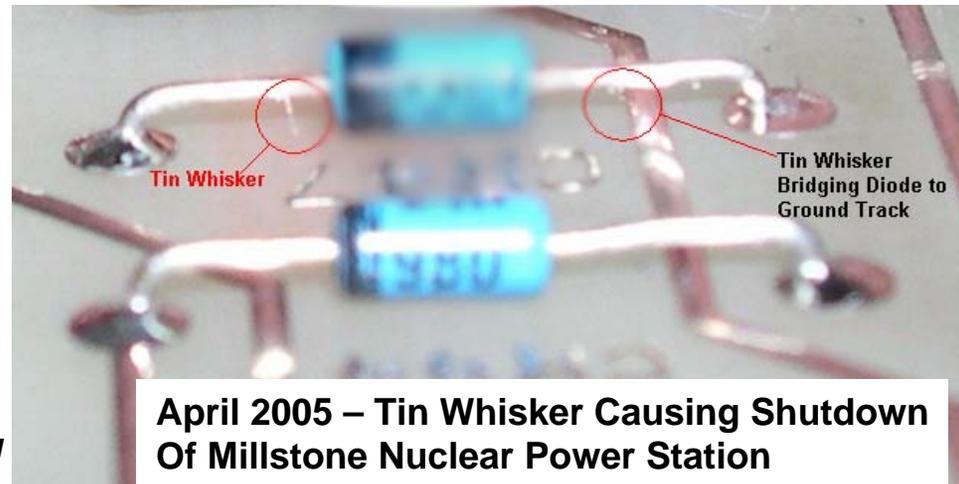
**Tin-Plated Diode Terminals
Displaying Tin Whisker Growths
Which Short From Terminal to Exposed Circuit Trace**
Photo Credit: Dominion – Millstone Power Station

- Westinghouse recommends that utilities conduct periodic inspections for tin whiskers.
- In order to detect the presence of tin whiskers, the **inspections should be done with a minimum of 10x magnification and directed light.** →

- **Upon completion of the inspection, the components should be gently cleaned with a soft bristle, static-free brush and cleaned with either canned air or a static-free vacuum.**

- **Westinghouse recommends that the inspections be performed periodically at least every 5 to 6 years, depending on the operating unit's refueling cycle.**

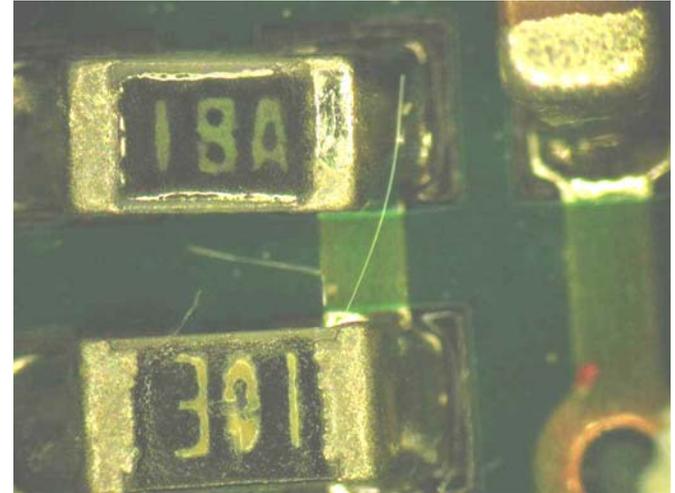
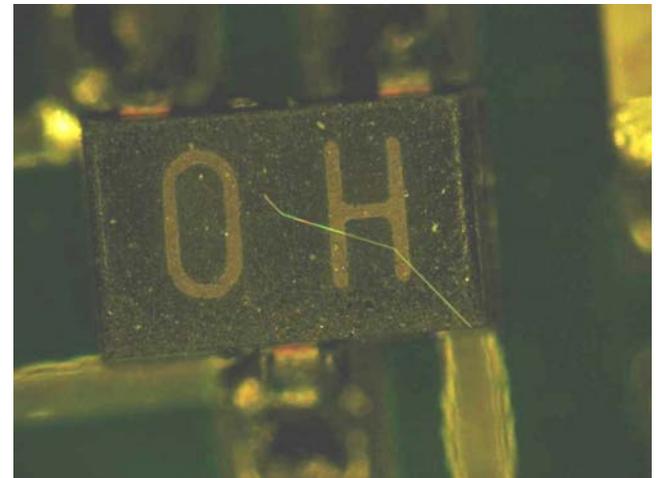
Electrical Failures Due to Tin Whisker Debris

- We ordered fences and covers for a RF assembly, our customer specified **matte tin**, and hoped for the best.
- Our customer brought us failed assemblies after working ~ 1 year.
- ***During FA we found “Whiskers galore!*** Not from the components, not attached to them, but just laying across everything. The lid is attached over the fences by the customer after receiving the assembly from us. ***Whiskers fell from the lid all over the place in the enclosure.***
- Today I checked 2 year-old lids under the microscope. SCHWARZWALD! (“Black Forest”)

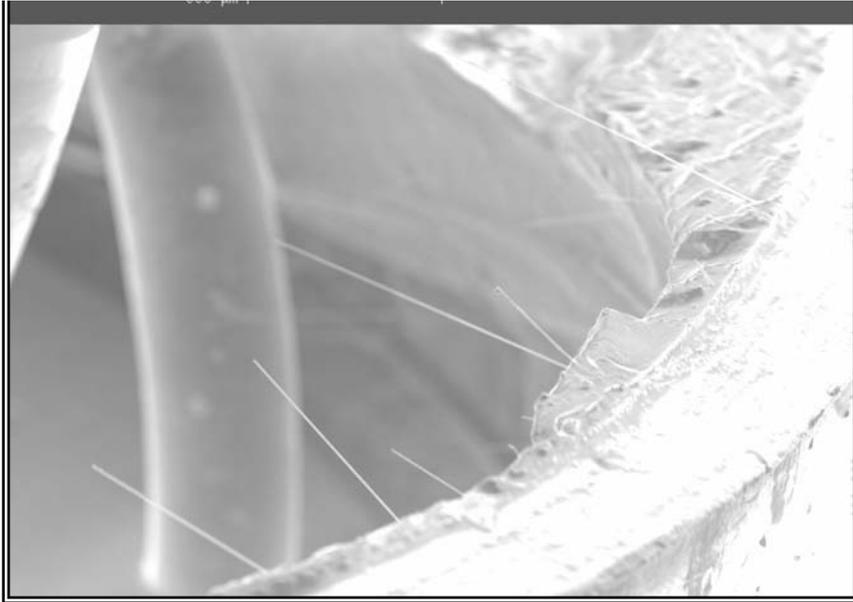
Tin Whiskers grow INSIDE tin-plated transistor package, causing shorting to internal connections.

**AF114 Germanium Transistors
Mfr Date ~1960. Observation Date – 2005**

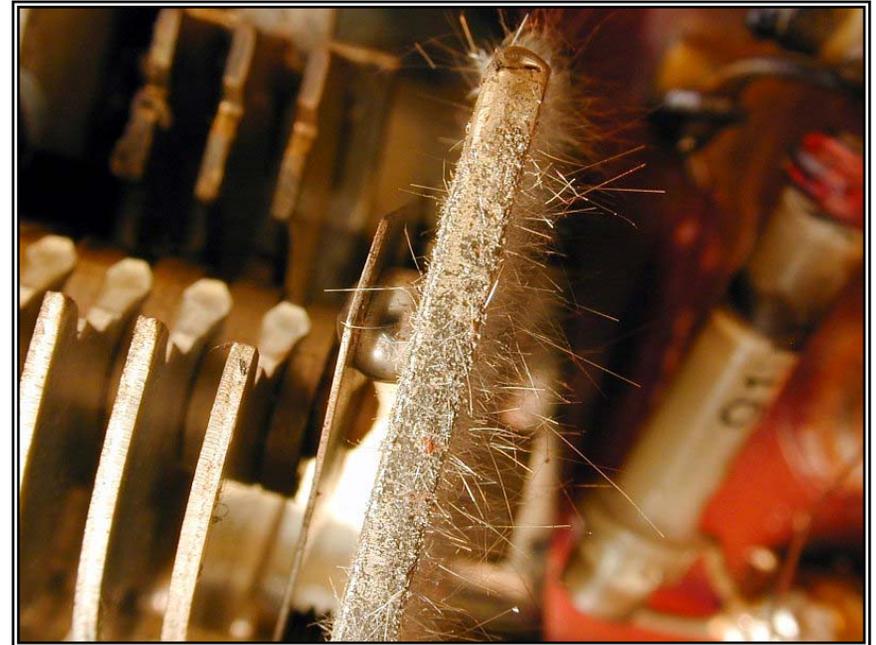
Tin Whiskers grow from tin-plated housing. Some whiskers ~1cm long.

**Variable Air Capacitor
Mfr Date ~1959. Observation Date - 2006**

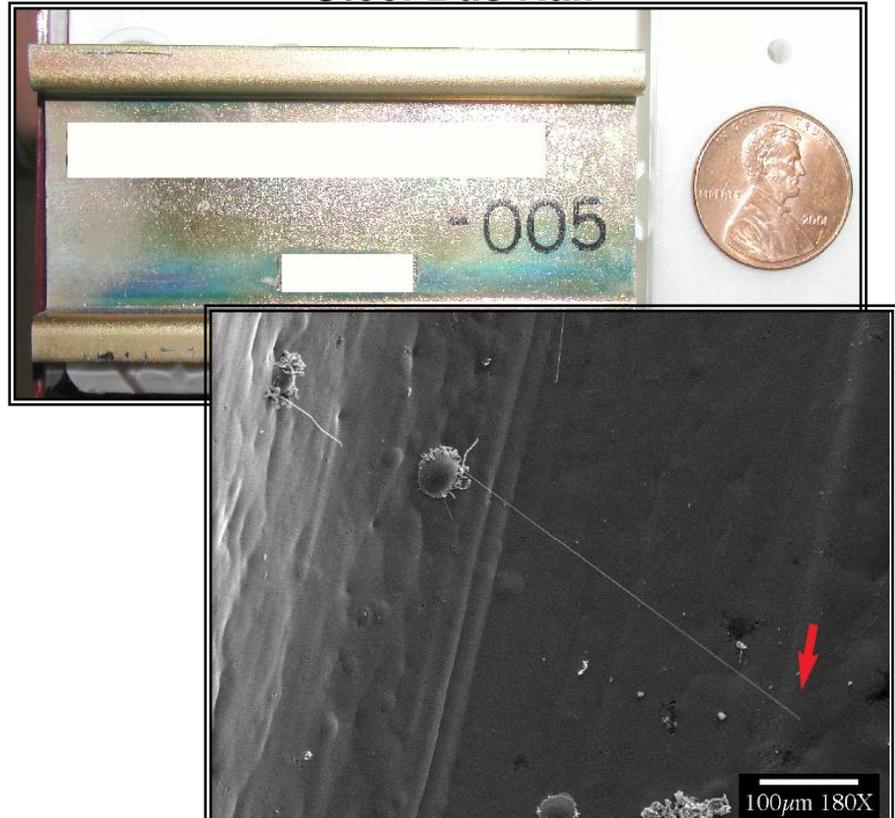
Zinc-Plated Yellow Chromate Steel Bus Rail

- **Circa 2001 Metal Vapor Arcing was induced by zinc whiskers on a twin of this bus rail during system level thermal-vac testing at a space contractor facility:**
 - Whiskers bridged a 45-mil gap from the bus rail to an aluminum chassis
 - The short ignited a metal vapor arc which lasted 4.7 seconds.
 - Extinction of the arc occurred after interruption of 20-Amp fuse pairs on 11 separate boards within the electronics box.
 - **The current was sufficient to melt most of the bus rail, a portion of the aluminum housing under the rail, and some nylon.**
