This paper was originally presented at the SMTA 2008 International Conference on Soldering and Reliability in Toronto, May 14-15 and published in the Conference Proceedings.

WHISKER GROWTH ON SAC SOLDER JOINTS: MICROSTRUCTURE ANALYSIS

Polina Snugovsky, Zohreh Bagheri, Marianne Romansky
Celestica International Inc.
Toronto, Ontario, Canada
Polina@celestica.com

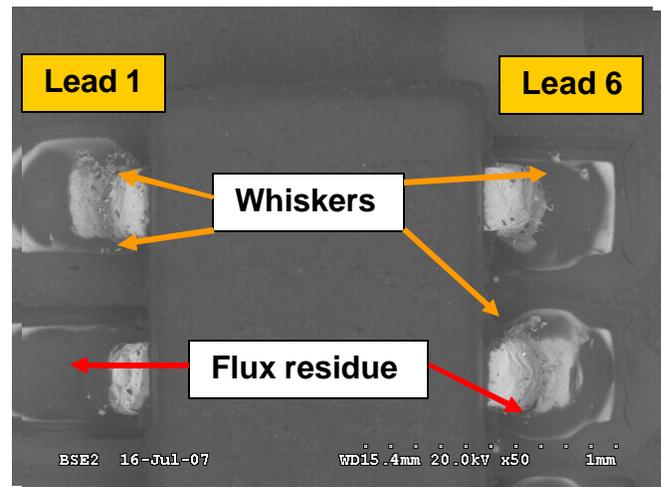
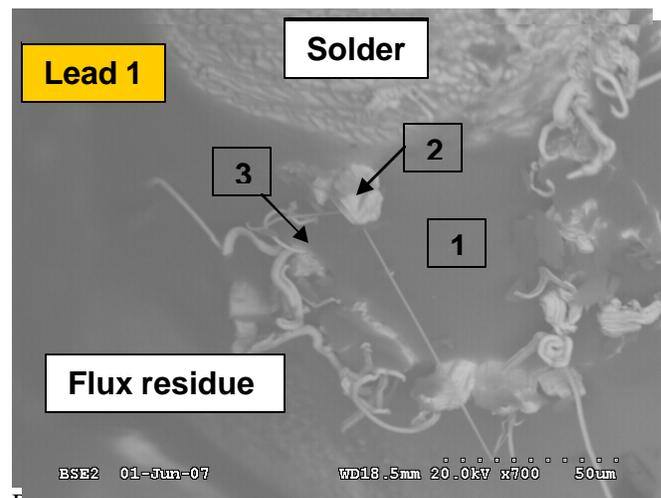
Optical and scanning electron microscopy under low magnification showed many whiskers and hillocks protruding through flux residue, and also growing from solder without flux residue (Fig.1).

Figure 1. Whiskers and hillocks (1 - thin long filaments; 2 - thicker and shorter rods; 3 - hillocks) protruding through flux residue and growing from solder free of the flux residue, SEM: a – 50X; b – 700X.

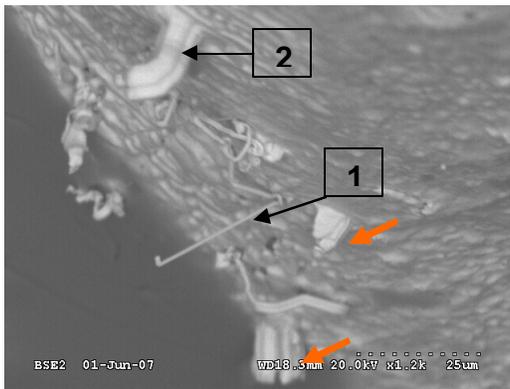
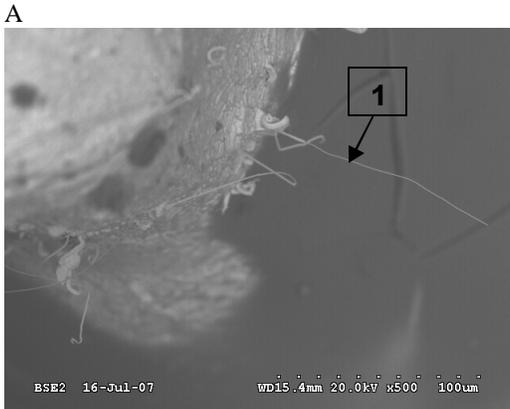
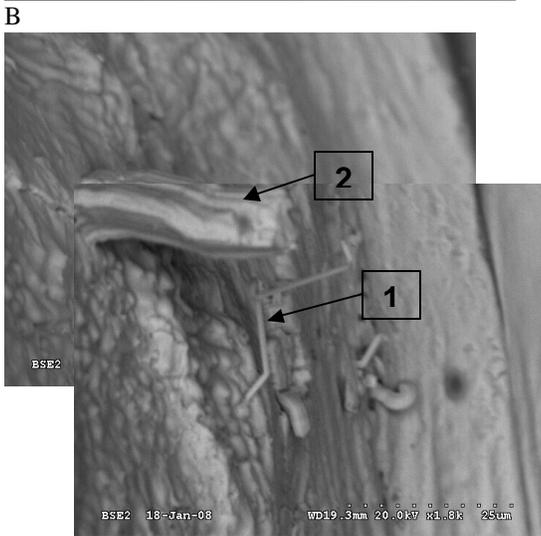
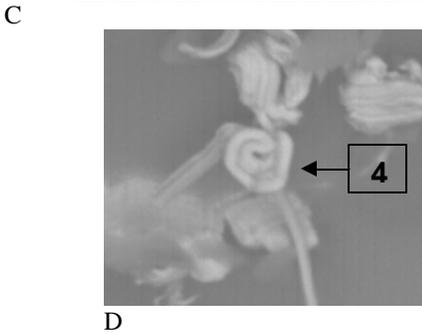
Both thin long filaments and thicker rods were straight, kinked or hooked. Some of the observed whiskers consisted of two connected rods often separated at the top (shown with short thick red arrow on Figure 2a). At least in one case a whisker crystal had a spiral shape (Fig. 2D).

Figure 2. Whiskers with different sizes and shapes: thin long filaments (1) thicker and shorter rods (2), and with spiral shape (4), SEM: a – 1,200X; b – 500X; c – 1,800X, d – spiral, 700X x 3

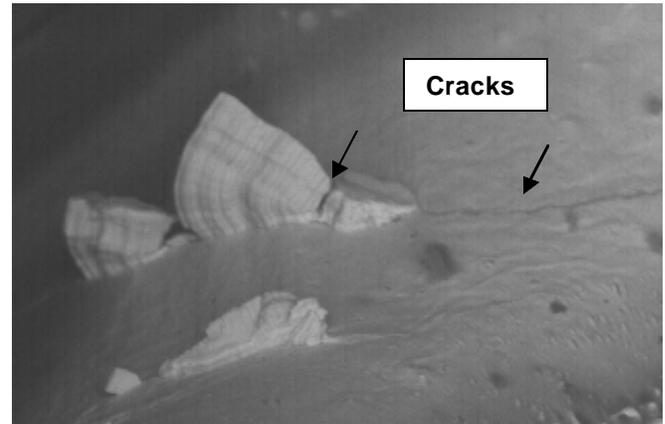
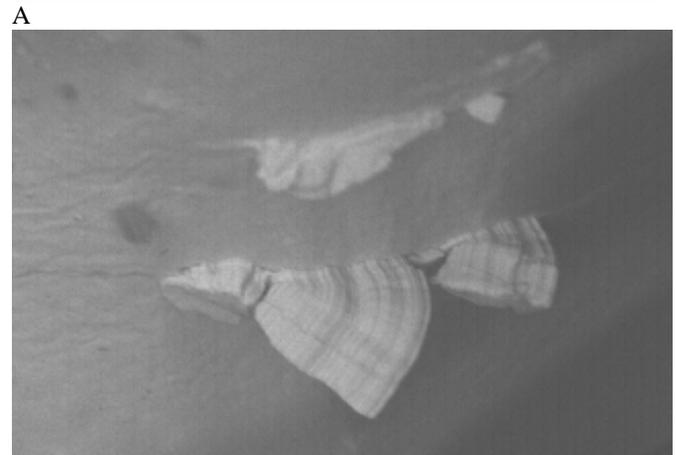
The shell-like protrusions are shown in Figure 3. The photos were taken from two opposite points of view and allow viewing of the length, width, and thickness of the protrusions. It appeared that they grew from a crack in the surface layer that may be an oxide or crystallized flux film. The shells have clearly visible striations in two directions. The stripes were parallel to the edges of the shells. The protrusions were also cracked. The cracks followed the vertical striations.

Figure 3. Shell-like protrusions, SEM, 450X x 2.5

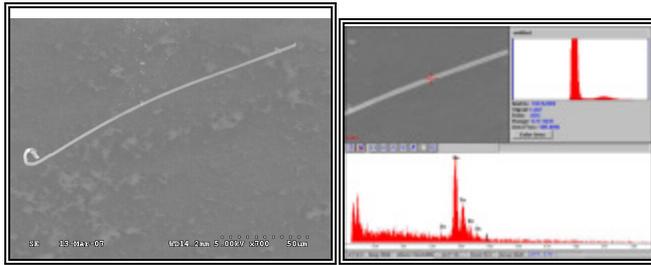
A thin long whisker with the diameter of 1.8μ and length of 172μ was cut out from the joint using a microscalpel and placed on the SEM sample holder is shown in (Fig. 4a). Only Sn was detected by EDX analysis (Fig. 4a). This composition was confirmed on other thin long filaments. Contrarily, EDX analyses on thicker and shorter rods detected not only Sn, but also Ag and sometimes Cu. Because it was difficult to remove short rods from the solder joint surface, these scans were taken without whisker separation. Therefore, the EDX results were ambiguous. The following cross-sections confirmed that Ag and Cu were present in whisker rods. Rod composition is described in the Cross-section Analyses section of this paper.

Figure 4. Thin long whisker appearance (a) and composition (b)

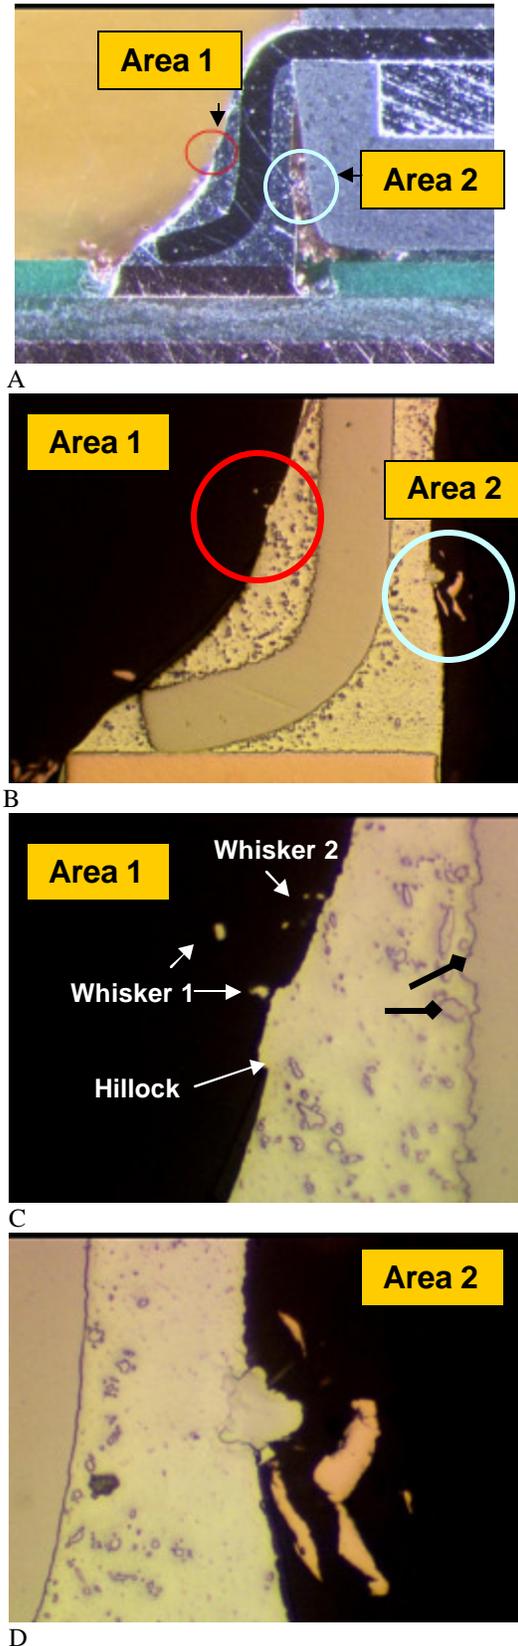
The typical longitudinal cross-section of a sample with whiskers is shown in Figure 5. Figure 5a shows an optical image of lead 1 of a device of interest. The image of the lead before cross-section was shown earlier in Figure 1. The whisker is visible through the potting epoxy on the front part of the lead – area 1 in Figure 5a. In a rear part of the lead, a hillock is situated in the cross-section plane – area 2 in Figure 5a. Each area was analyzed using metallurgical light and scanning electron microscopes. Under the metallurgical microscope, parts of two thin whiskers and a hillock are visible in area 1 (Fig. 5b, c). A big hillock is evident in area 2 (Fig. 5d). It is important to stress that whiskers and hillocks were found at both toe and heel sides of the cross-sectioned lead on different devices.

Figure 5. Longitudinal cross-section of lead 1 from Figure 1: a – optical microscope, 30X; b – 100X, c, d – 400X

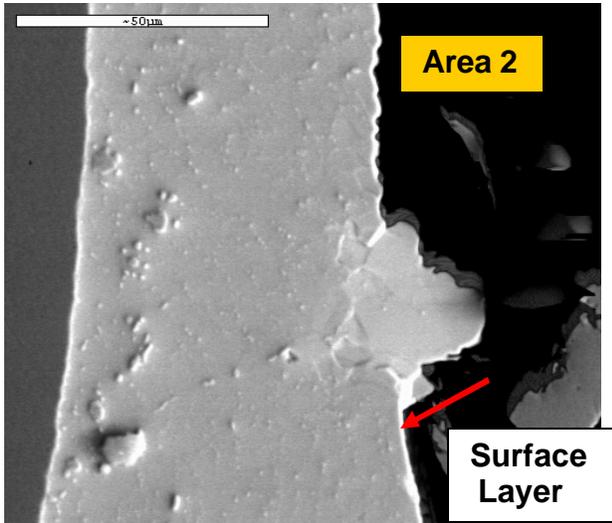
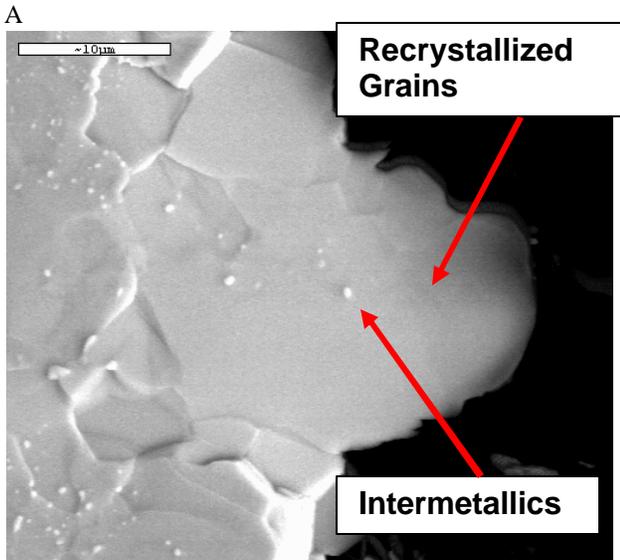
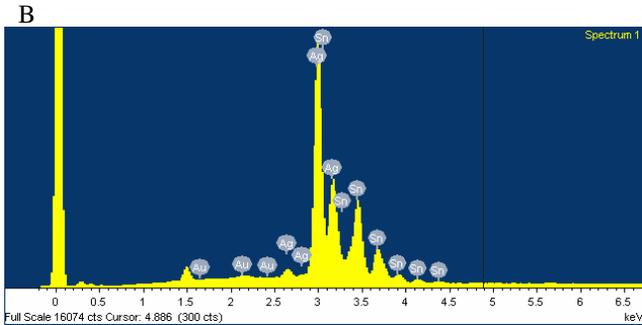
The details of this hillock, examined using SEM, are depicted in Figure 6. It is different from the bulk solder microstructure and contains the recrystallized Sn grains and very few intermetallic particles. It seems that the hillock emerged through the hole in a surface Sn oxide film (white layer) (Fig. 6 a, b).

The intermetallic particles are distributed non-uniformly and located only in the centre of the hillock. They contain either Ag or Cu in addition to Sn (Figure 6c). The particles have similar size and shape as the original eutectic particles Ag_3Sn and Cu_6Sn_5 in the bulk solder. The rest of the protrusion is pure Sn. It is possible that the solder was depleted of Ag and Cu by extensive diffusion caused by oxidation or corrosion.

The recrystallized grain size is smaller at the base of the hillock than in the hillock itself (Fig. 6 a, b). This may explain the mechanism of hillock formation. The depleted solder is under compressive stresses that causes recrystallization and grain growth. It is well known in metallurgy of deformation that under relatively low stresses, abnormal grain coarsening occurs. One or several grains larger in size or with lower surface energy begin to grow, consuming the smaller grains.

Figure 6 Hillock microstructure and composition: a – SEM, 1,000X; b – SEM, 3000X, c- EDX on intermetallic particle inside the hillock, 20 keV

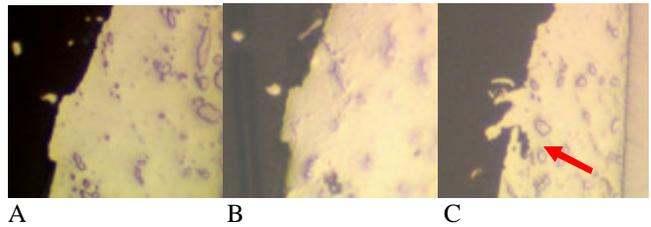
It can be seen how whisker 1 changes its shape and the hillock transforms into two whiskers. Note the void which appeared in Figure 7c (Indicated by the arrow). It is a corrosion mark that will be discussed below.

Figure 7. Polishing in sequence, 400X

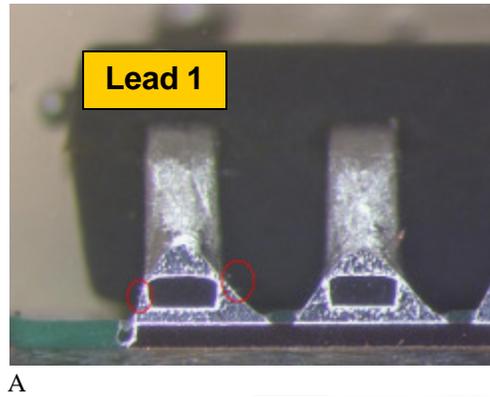
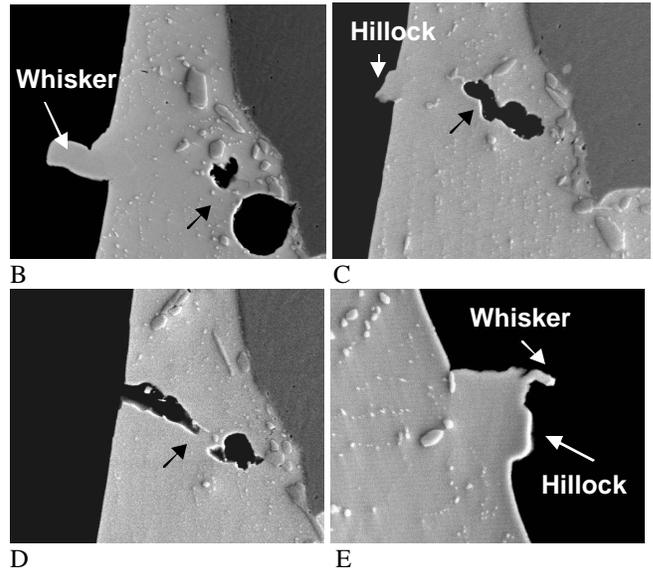
Several more examples are shown in cross-sections perpendicular to the leads (Fig. 8). Whiskers and hillocks were detected from both left and right sides of the several leads.

Figure 8. Perpendicular cross-section of lead 1: a – optical microscope, 30X; b, c, d – cross-sections in sequence, SEM, 1,800X; e – 1,400X

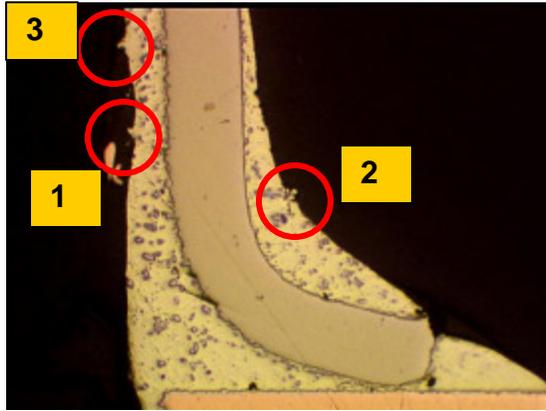
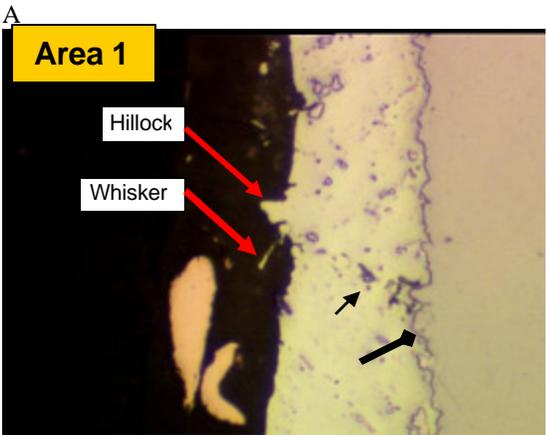
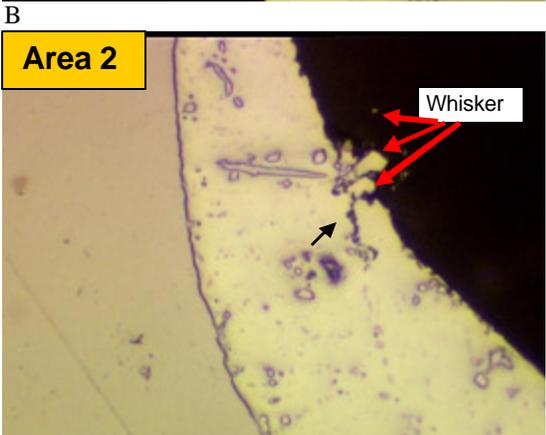
shown in Figure 9a. Whiskers and hillocks formed from both toe and heel sides of the lead. All three locations of this cross-section have visible signs of interdendritic corrosion marked by a black arrow on Figures 9b and 9c.

Figure 9. Longitudinal cross-section of lead 6 from Figure 1: a – 100X, b, c – 400X

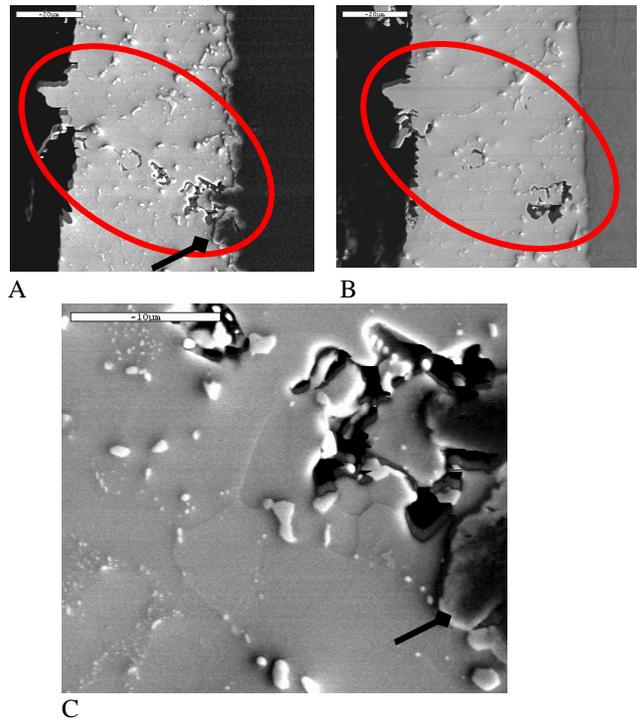
The details of area 1 and area 2 (Figure 9) are depicted in Figure 10 and 11. The corrosion voids propagate through the solder from the solder surface to the component lead/solder interface. The solder around the voids is depleted of Ag and Cu. The number of intermetallic particles is much less than in bulk solder. The particles are also larger in size. The corrosion voids are surrounded with the re-crystallized grains.

Figure 10. Longitudinal cross-section of lead 6, area 1, Fig. 9, SEM: a – 1,300X, b, c – 4,000X

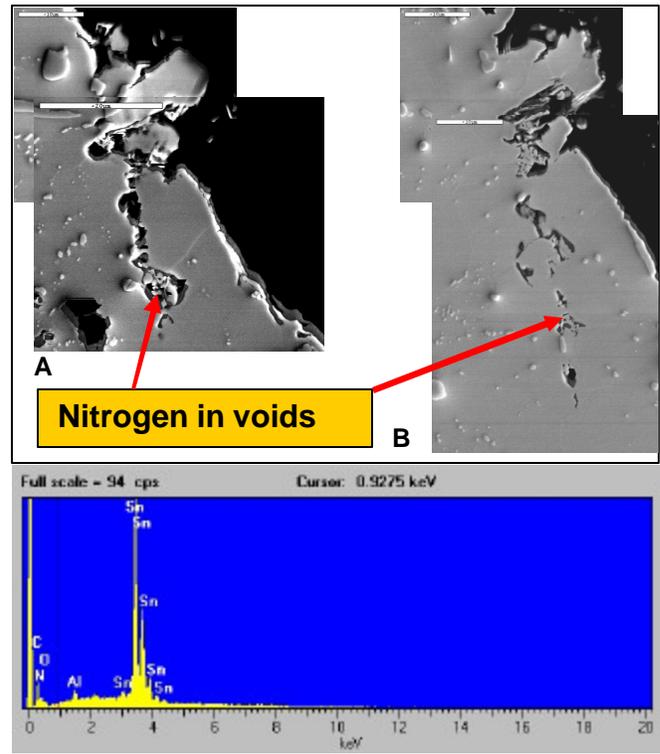
Figure 11. Longitudinal cross-section of lead 6 area 2, Fig.9 and EDX on voids: a – 1,000X, b - 3,000X; c – EDX on voids, 20 keV

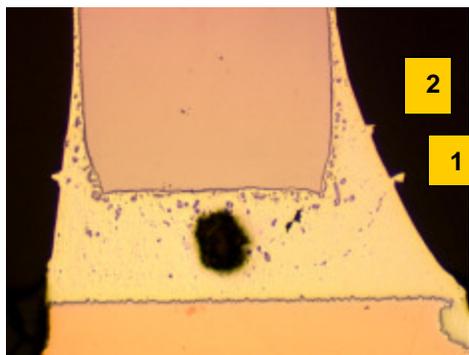
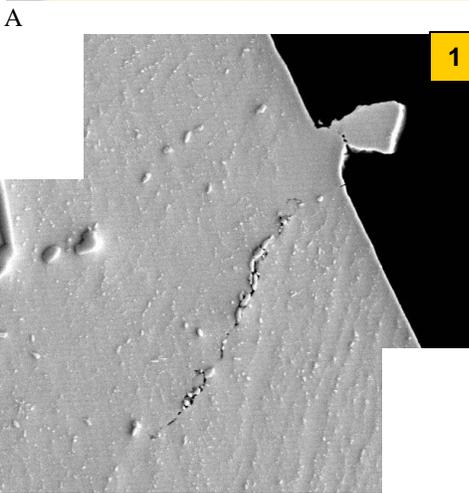
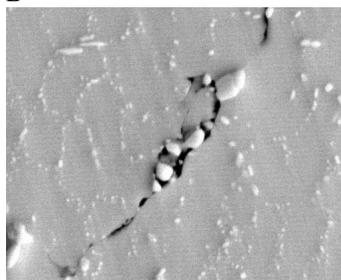
Very often the corrosion channels are traceable to large round voids (Figure 8 b - d) that have their origins from flux or other gas related sources such as surface or plating contaminations. Another example is shown in Figure 12. The cross-section was done perpendicular to the leads. The large outgassing void is located between the lead and the pad. Two protrusions on the right side of the lead have corrosion channels connecting them to the void (Fig. 12 a) (The left side protrusion is shown in Figure 8). The details of the corrosion path to protrusion 1 are shown in Figure 12 b, c. Corrosion propagates through the intermetallic particle/solder interfaces.

Figure 12. Perpendicular cross-section of lead 1 (Fig:9): a – 200X, b – SEM, 1,800X; c – SEM, 6,000X

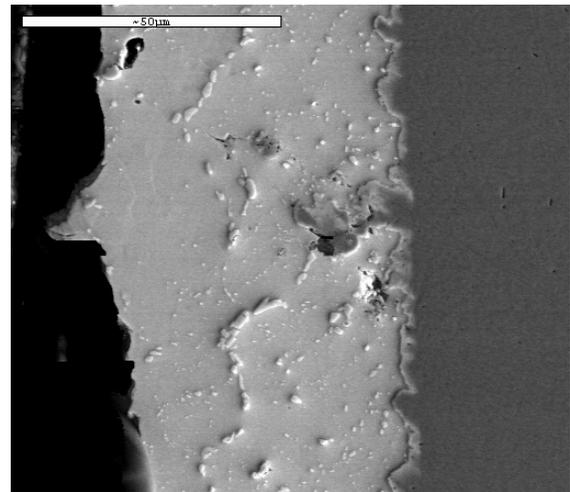
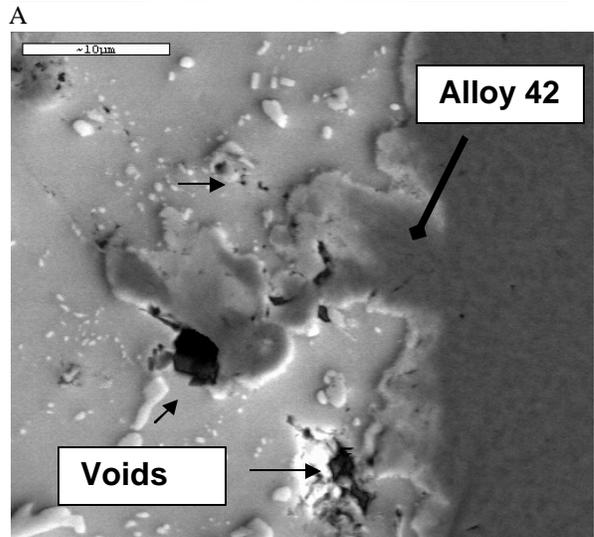
Another microstructural characteristic found in this study that may play a significant role in whiskering is Alloy42 lead/solder interface roughness. The leads with whiskers or hillocks had rough surfaces. Some pieces of the lead-frame material that may be debris or roughness protrusions in the solder joints are visible in cross-sections (Fig. 5c, 9b, 10 a, c – diamond arrows). The voids are often related to the rough interface as it shown in Figure 13.

Figure 13. Area 3 from Figure 9 a, SEM: a – 450X, b – 3,000X

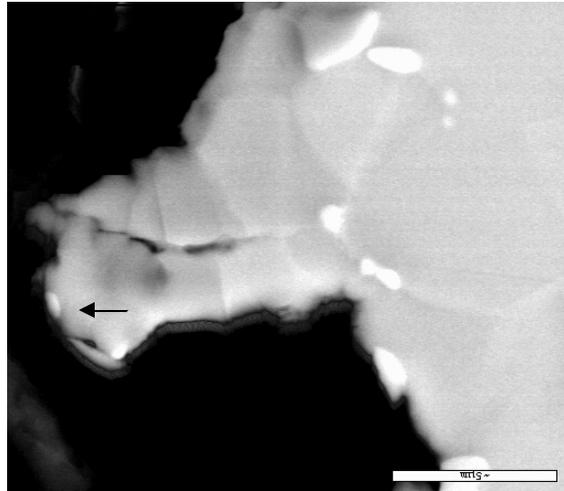
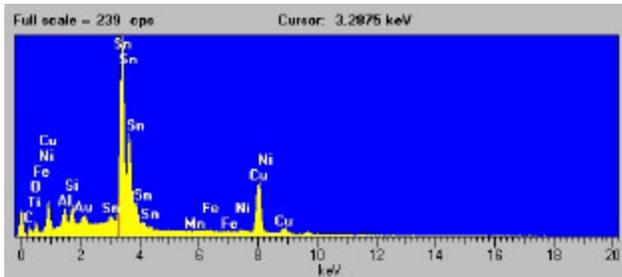
The SEM image at high magnification of this rod whisker is shown in Figure 14a. Two separated parts of the rod whisker have recrystallized pure Sn structure. An intermetallic particle is situated at the top of one of the rod parts. The EDX analysis identified it as Cu_6Sn_5 type (Fig. 14 b). In general, the rod whiskers (shorter and thicker than filament whiskers) have features similar to the hillocks.

Figure 14. Enlarged image of area 3, Fig.9 a and EDX on the intermetallic particle: a – 7,000X; b – EDX on intermetallic particle, shown by arrow, 20 keV

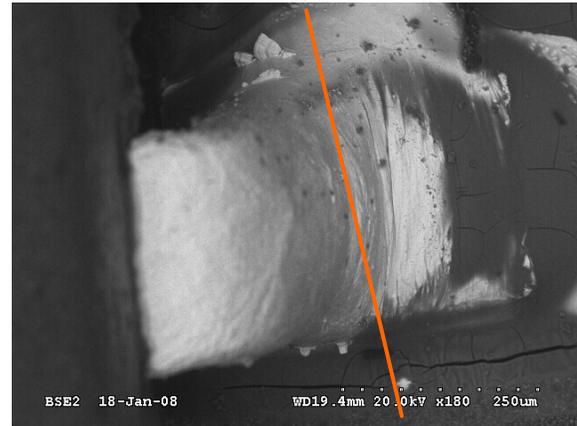
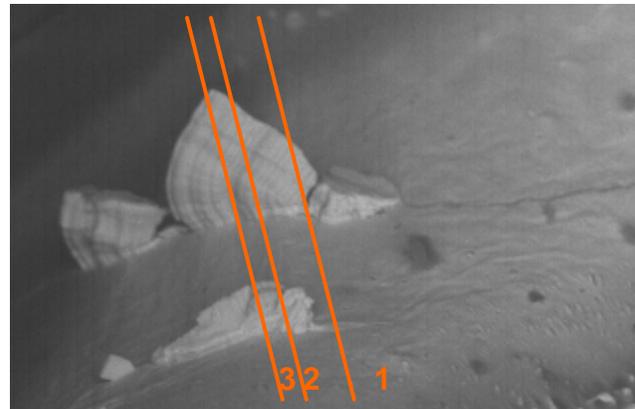
To analyze the shell-like protrusions, perpendicular cross-sectioning with progressive polishing of the lead shown in Figure 15a was done. The sequence of the cross-sectioning and polishing as well as images after polishing are depicted in Figure 15. The details of the microstructure are shown in Figure 16. The shells have a similar microstructure to the rod whiskers and hillocks, that is, a Sn matrix with very few Ag_3Sn and/or Cu_6Sn_5 particles. In cross-section, the two-dimensional striations clearly visible on the surface of the shells, are evident as a surface roughness at the edges of the protrusion and stripes in the parallel direction. In some cross-sections, it they be seen as black lines or wrinkles (Fig.17a, b).

Figure 15. Sequence of cross-sectioning (a) and progressive polishing (b) and images after polishing (c – e) of shell-like protrusions, SEM: a – 180X; b – 450X x 2.5; c, d, and e – 1,800X

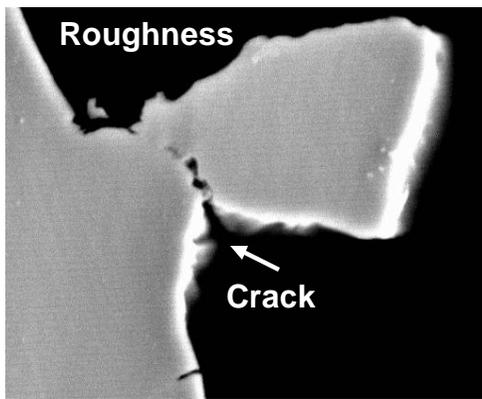
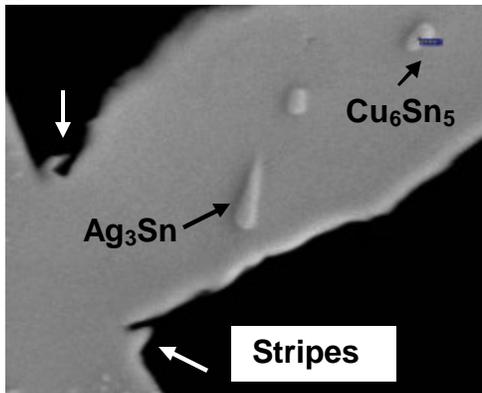
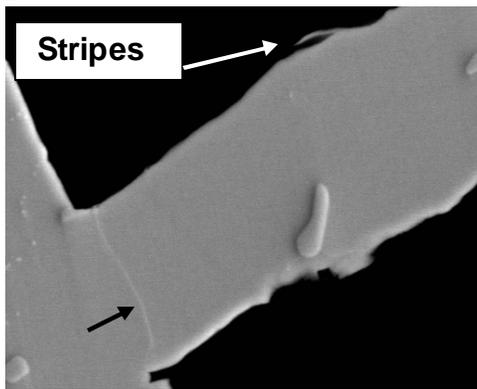
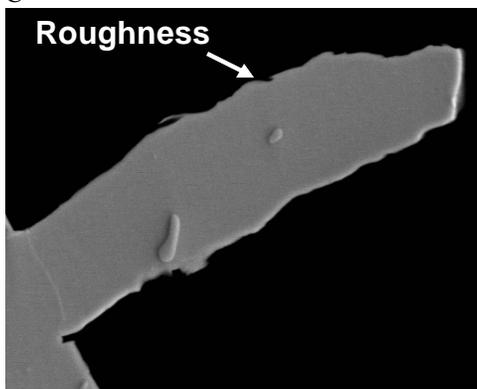
The crack in the first section looks like a separation between the grains (Fig. 16a). It is interesting that in the third polishing, Fig. 16c, a line appeared instead of this crack. This line looks white under the scanning electron microscope. Elemental analysis on this line was attempted but the results were inconclusive because the layer was very

Figure 16. Details of shell-like protrusion microstructure, SEM: a – 1 polishing, 6,000X; b – 2 polishings, 6,000X; c – 3 polishings, 6,000X; d – 3 polishings, 4,000X

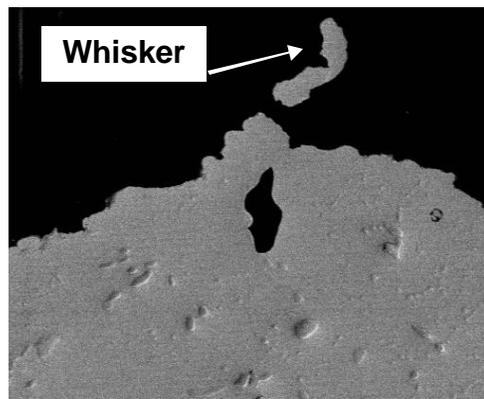
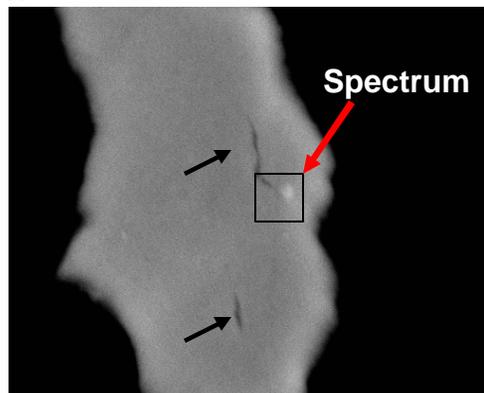
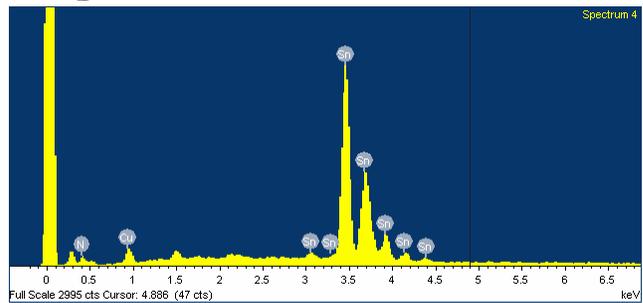
More systematic analyses of solder composition showed that N is present in corroded interdendritic spaces (Fig. 11) and in the Sn matrix as well (Fig. 17c, expand to 200% to view online). N is found in the bulk solder and in hillocks and whiskers. The EDX study using both Hitachi S-3000N and Hitachi S-4500 SEM with three different software packages identified the N peak. It was more pronounced using lower voltage (Fig 19), but still detectable under 20 keV as well (Fig. 17, 18).

Figure 17. a) Whisker in a perpendicular cross-section at 1,800X b) enlarged image with wrinkles at 18,000X c) EDX on the white particle boxed in 17b, 20 keV

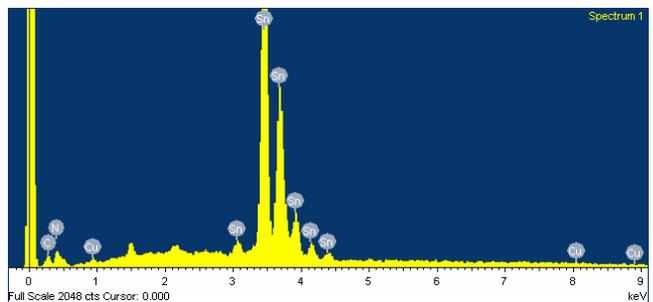
thin, and the main analyzed solder volume was Sn. The EDX scan contained a small peak of Cu. Also, N was detected in this location (Fig. 18)

Figure 18. EDX on white line area of Figures 16c & d, at 20 keV

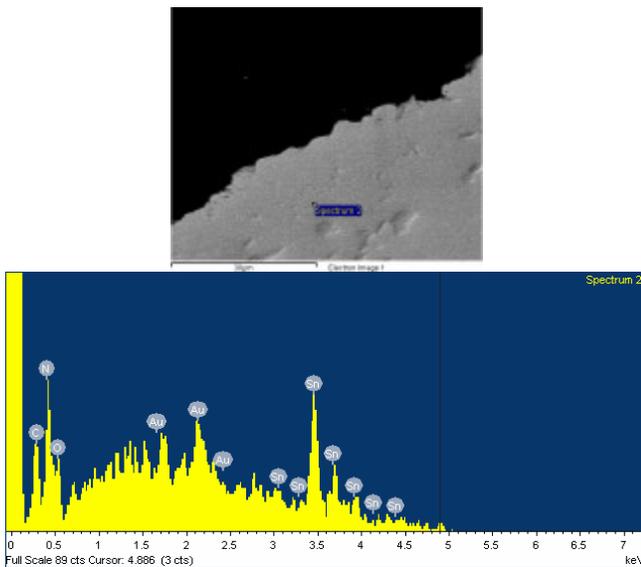
Figure 19. Microstructure and EDX on bulk solder, showing a distinctive N peak, 5 keV

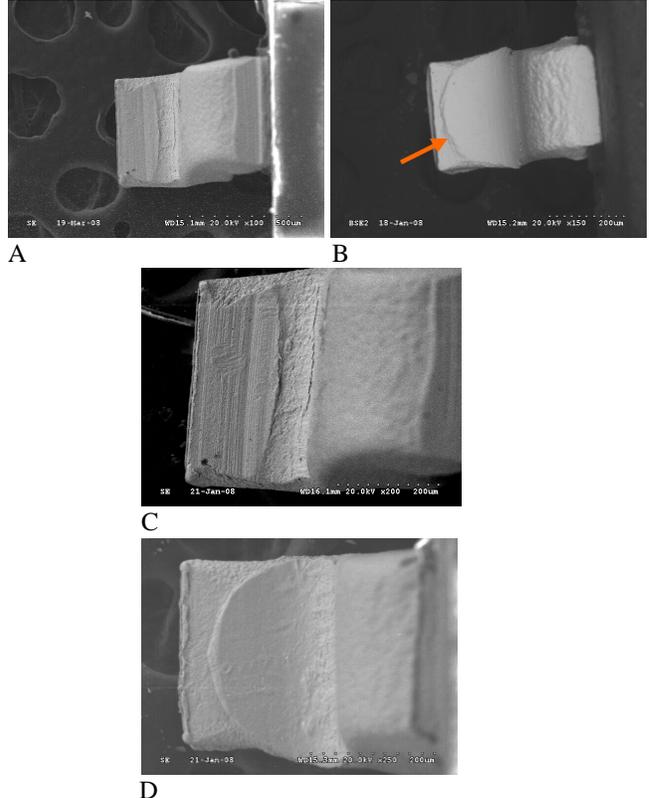
The SEM photos of leads of two types of components with the Alloy 42 lead-frame material are shown in Figure 20. It is easy to see the difference in plating shape. The troubled components have a double layer structure (Fig. 20 b, d). The top layer is shorter than the bottom. It produces a step that is round in shape. A close look at the lead surface allows one to conclude that the cleaning after plating was done differently. The good part has pronounced mechanically produced grooves, but the surface of the bad part is smooth, showing that cleaning was more likely done chemically.

Figure 20. SEM images of two types of components with the Alloy 42 lead-frame material: a – Good, 100X; b – Bad, 150X; c– Good, 200X; d – Bad, 250X

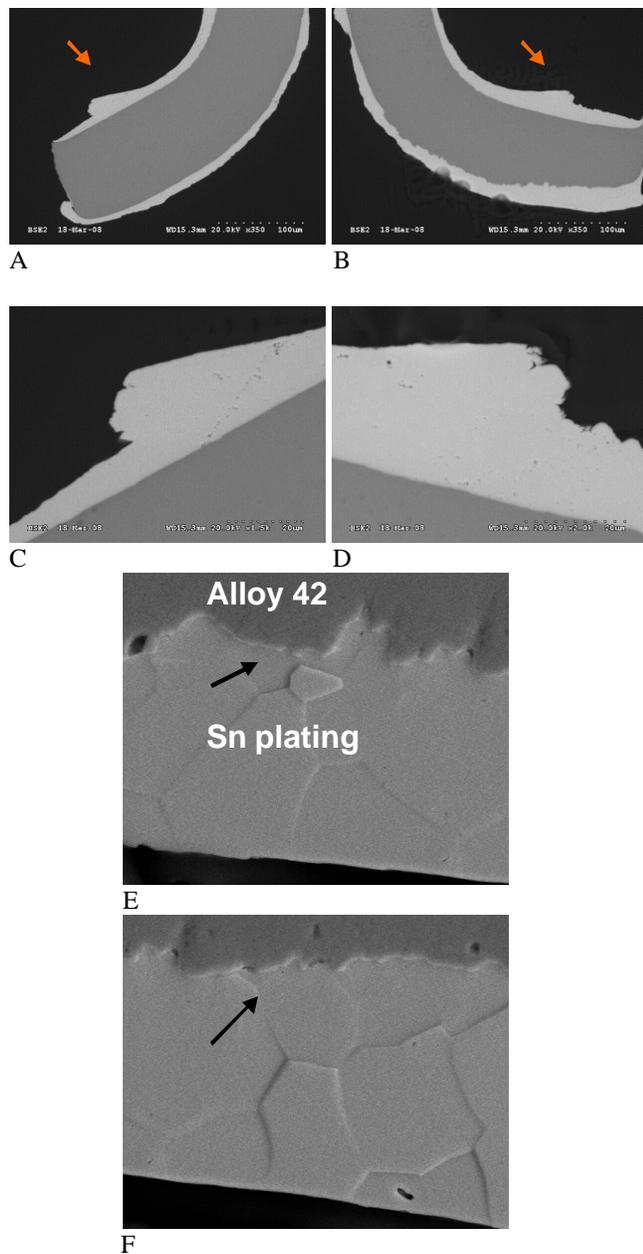
Cross-sectioning confirmed the non-uniform thickness of the leads in the devices used in solder joints that created whiskers and hillocks (Fig. 21). In some of the areas where the step is visible, the thickness of the Sn plating may be greater than 30 μ m. The thickness varied from lead to lead. The average thickness of the Sn layer in lead 1 (Fig. 21 b) is about 24 μ m and in lead 6 (Fig.21 a) is 15 μ m.

The interface between the leads made of Alloy 42 and the bulk solder is rough (Fig 21 b, e, and f) as shown in the solder joint cross-sections. The most severe roughness was found on lead 1.

Figure 21. Cross-section of a virgin component with the Alloy 42 lead-frame material, SEM: a – lead 6, 350X; b – lead 1, 350X; c– lead 6, 2,000X; d – lead 1, 2,000X; e, f – lead 1, 6,000X

Such an interfacial roughness is not normally seen and may be a characteristic of a surface preparation before Sn plating.

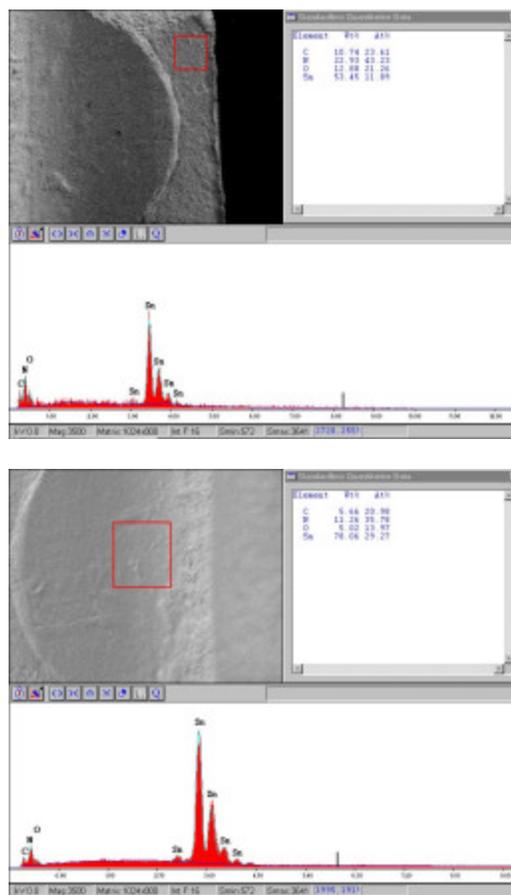
The composition of the Sn plating was analyzed before and after cross-sectioning. N is present in both Bad and Good component plating. There is no significant difference between them in the N content (Fig. 22 and 23). Any area of the leads covered with electrolytic Sn contains N. The lowest detected concentration was 32 At % (10.3 Wt. %) and the highest was 43 At % (22.9 Wt. %).

Figure 22. EDX spectra and semi-quantitative analysis of Bad part

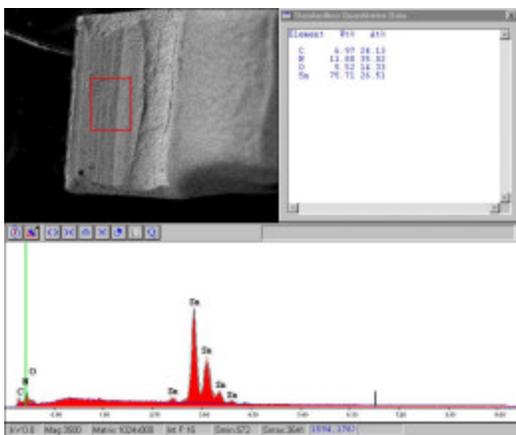
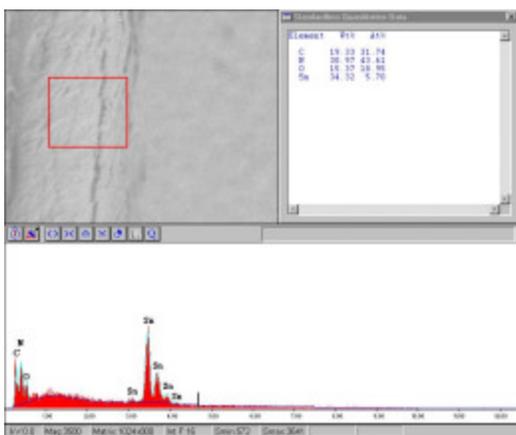
Figure 23. EDX spectra and semi-quantitative analysis of Good part

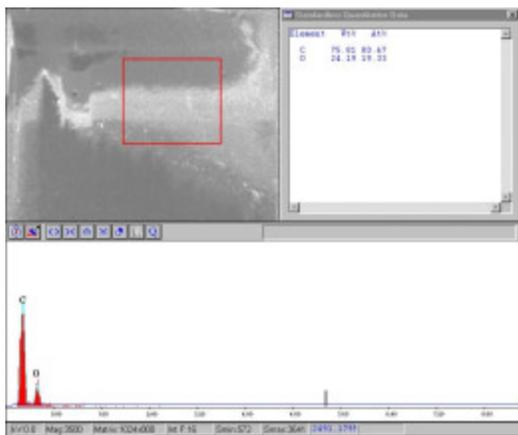
The component bodies do not contain N. The N was not detected in any other materials of the components (Fig. 24).

Figure 24. EDX spectra and semi-quantitative analysis on component bodies

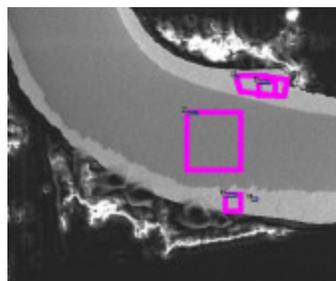
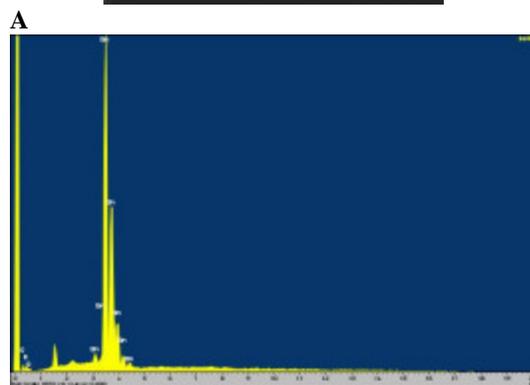
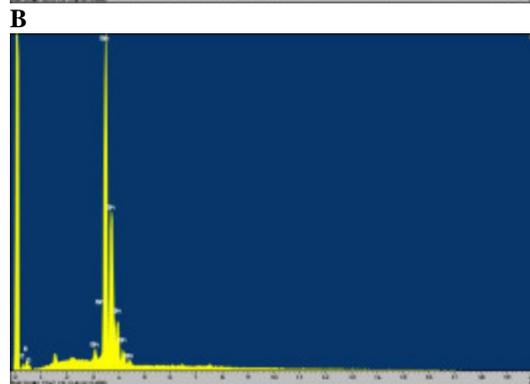
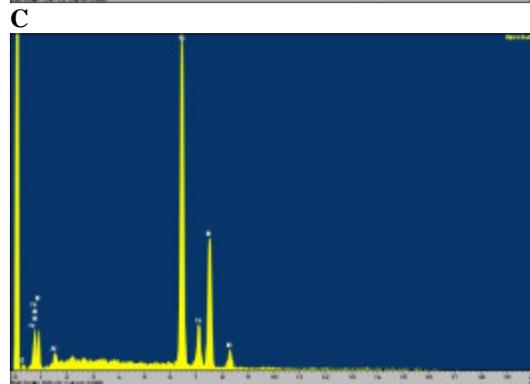
The cross-sections of the virgin components were also examined using EDX. N was found in the Sn plating, and was not detected in the Alloy 42 lead-frame (Fig. 25).

Figure 25. EDX analyses on cross-sectioned sample: a – lead image; b – Sn plating, top box, c – Sn plating, bottom box; d – lead material
