Solder Reflow Failures in Electronic Components during Manual Soldering

Perot Systems/NASA GSFC, code 562,
Parts, Packaging, and Assembly Technologies Office

Purpose and Outline

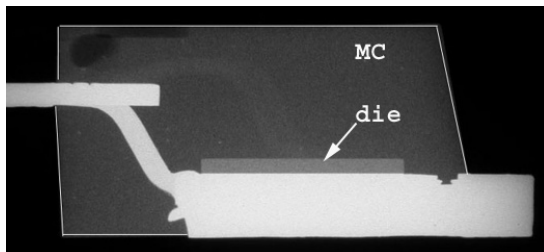
X-ray view

- ❑ Three power FETs in plastic surface mount packages (D2Pak) failed short circuit after manual soldering onto a board.
- ❑ The parts passed screening including 100% C-SAM inspection.
- ❑ Failed parts had top-of-die delaminations.

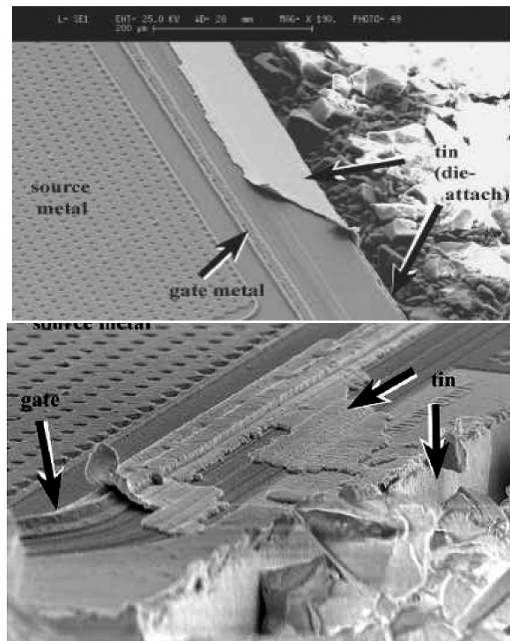
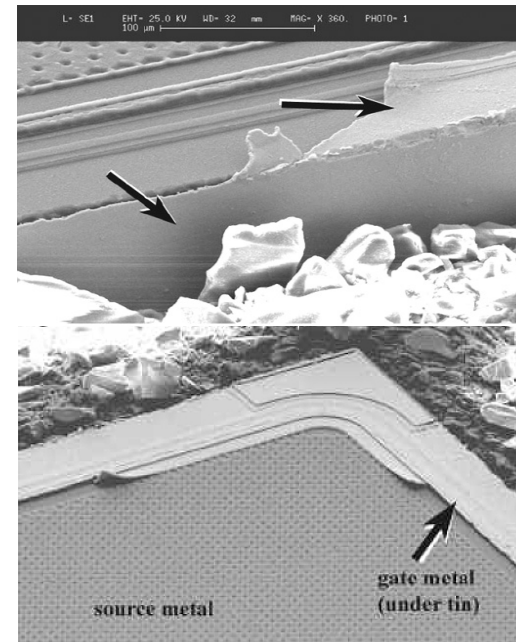
- ❑ Molten solder squeezed up to the die surface along the die-molding compound interface.
- ❑ The dies were not protected with glassivation allowing solder to short gate and source to the drain contact.

Conclusion: the parts failed due to overheating during manual soldering.

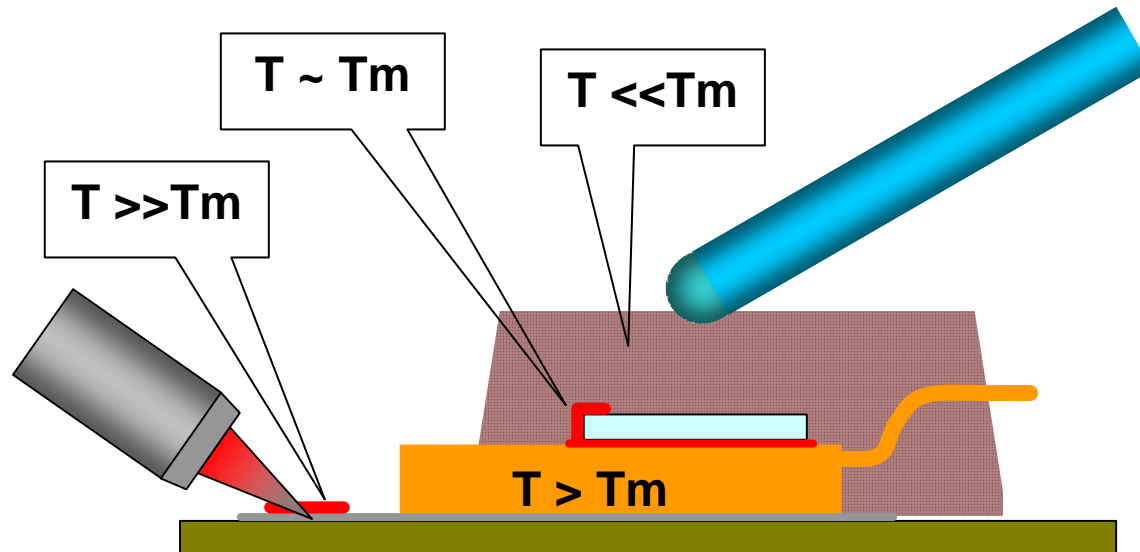
- ❑ Manual soldering caused fast heating of the copper heat sink while MC remained cool thus forcing molten solder to create and fill top-of-die delamination.
- ❑ Fixing a part on a board by applying a force to the package increases the probability of failure.

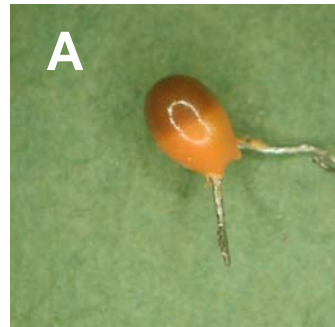
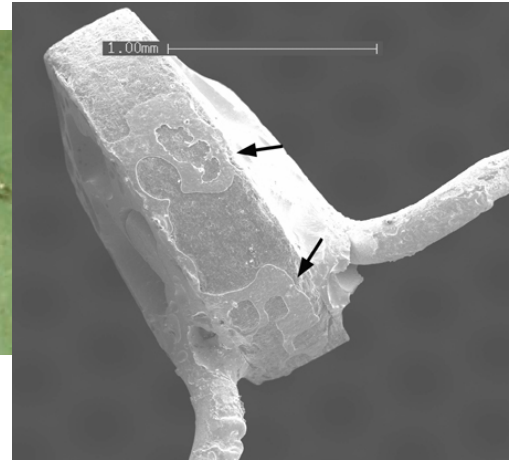
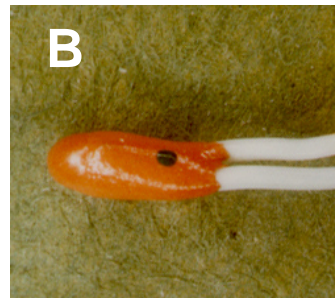
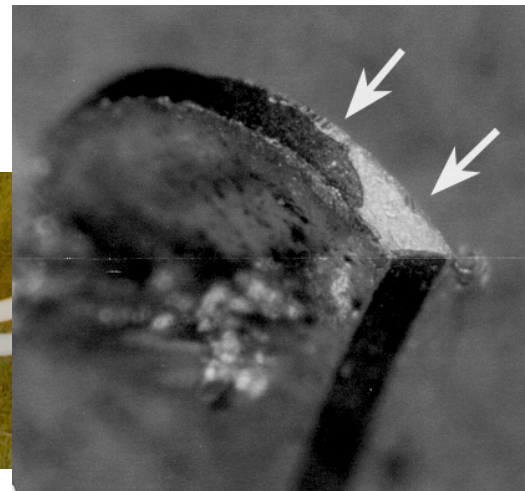
- ❑ Case A: failed during board-level testing.
- ❑ Case B: failed after rework on the adjacent microcircuit.
- ❑ FA: short is due to solder reflow caused by overheating.

Specified length of leads 7.6 cm

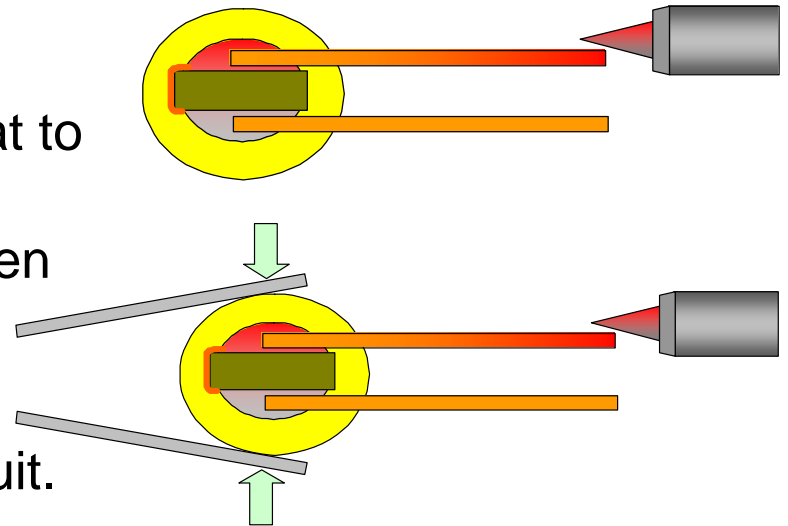
Case A:

Short Cu wire transfer quickly the heat to one side of the sensor forcing melted solder to expand and squeeze between cold MC and die.

Holding a sensor with tweezers increases the probability of short circuit.

- ❑ Reducing the length of wires increases die temperature. Special care (thermal shunts) should be taken to avoid solder reflow failures.
- ❑ Avoid holding or touching plastic packages during soldering.

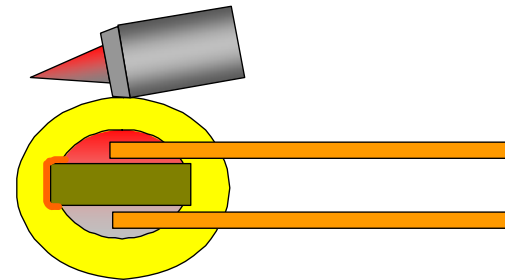
Case B:

A touch with a soldering iron creates temperature gradient allowing solder melting on one side while another side remains cool.

- ❑ Preheating and equalizing temperature across the package might reduce the probability of failures.
- ❑ Temperature of soldering iron holder near the tip might be much higher than melting temperature of solder. Occasional touch to the surface of the package might cause failures.

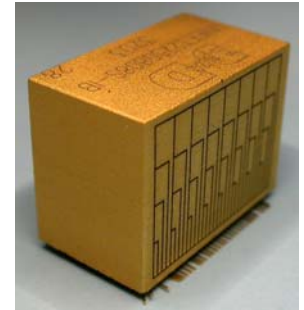
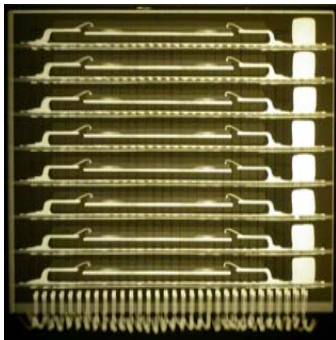
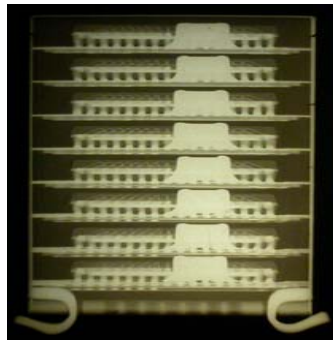
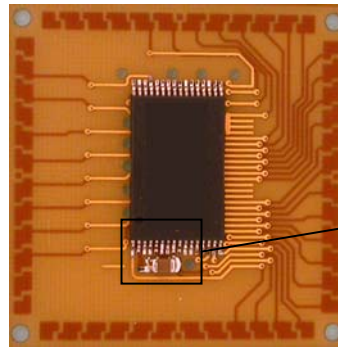
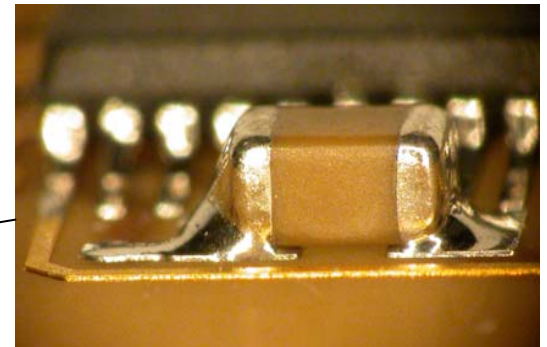
- ❑ The part passed all screening and qualification testing but failed with a short circuit in internal power supply lines after manual soldering onto a board with a soldering iron set to 700 F (371 °C).
- ❑ The part is comprised of 8 micro-boards with a TSOP memory microcircuit and ceramic capacitor in the power supply line. Interconnections are made on the boards and externally, via package metallization (8 μm Au/Cu/Ni).
- ❑ How to pinpoint location of the defect?

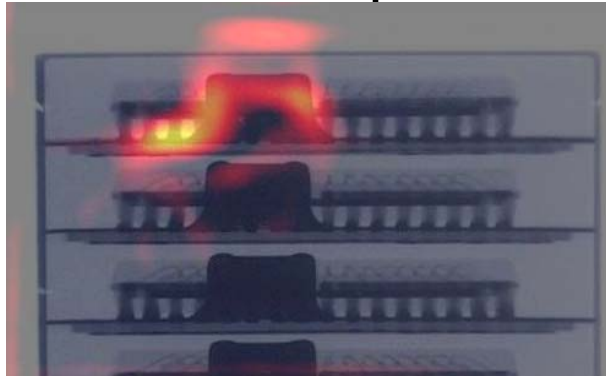
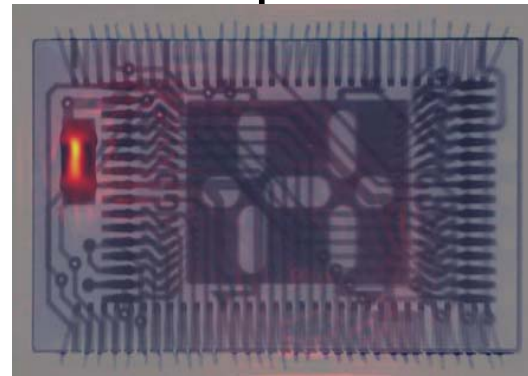
- ❑ Results of MCI indicated the short through a ceramic capacitor on the top board inside 3D-plus cube.

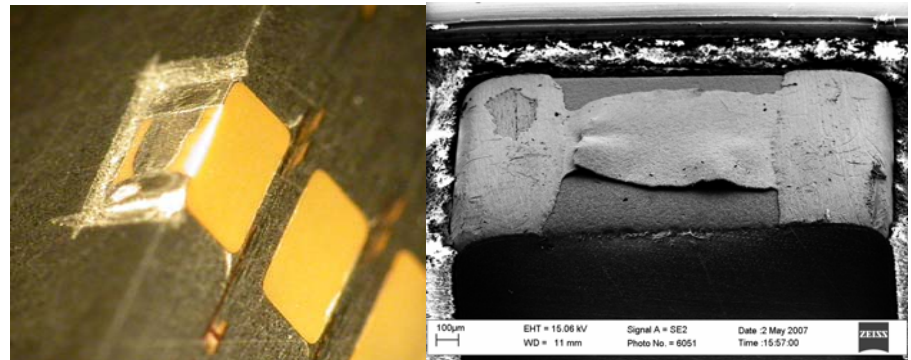
- ❑ Two plane X-section showed that the failure was due to reflowed solder short at the top surface of the capacitor.
