Solder Reflow Failures in Electronic Components during Manual Soldering

Perot Systems/NASA GSFC, code 562,
Parts, Packaging, and Assembly Technologies Office

Purpose and Outline

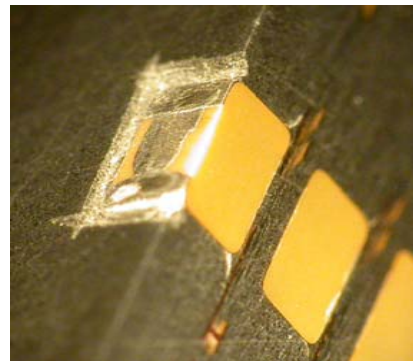
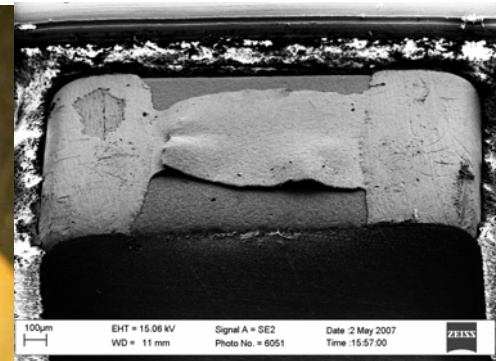
- ❑ Two plane X-section showed that the failure was due to reflowed solder short at the top surface of the capacitor.
