NASA Electronic Parts and Packaging (NEPP) Program

Effect of Preconditioning and Soldering on Failures of Chip Tantalum Capacitors

NEPP task 2014

Alexander Teverovsky
Parts, Packaging, and Assembly Technologies
Office, Code 562, GSFC/ ASRC S&D
Alexander.A.Teverovsky@nasa.gov

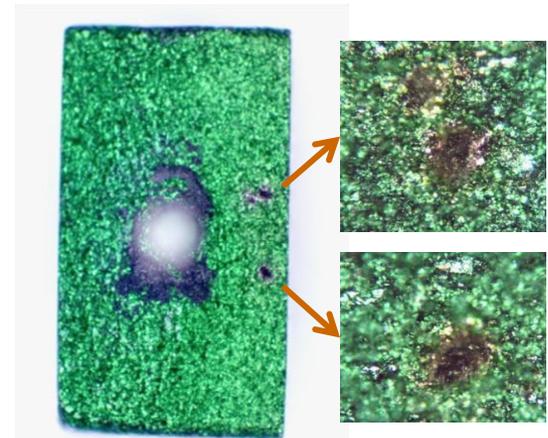
- ❑ Both, an engineering and a flight units failed within a few seconds after powering on for the first time.
- ❑ The failure was due to CWR29 10uF 35V capacitors used in the 15V power line. Maximum current in the line was limited to 1 A.

- ❑ After capacitors were replaced, the unit operated normally.
- ❑ Out of 20 LDC1307 capacitors from Mfr.A used in the unit, 10 failed catastrophically.

Top view (anode shoulder) of a stripped capacitor showing damaged sites

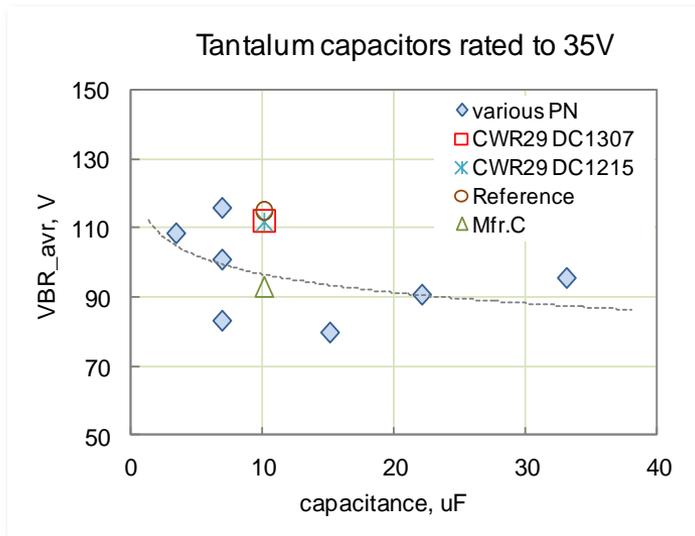
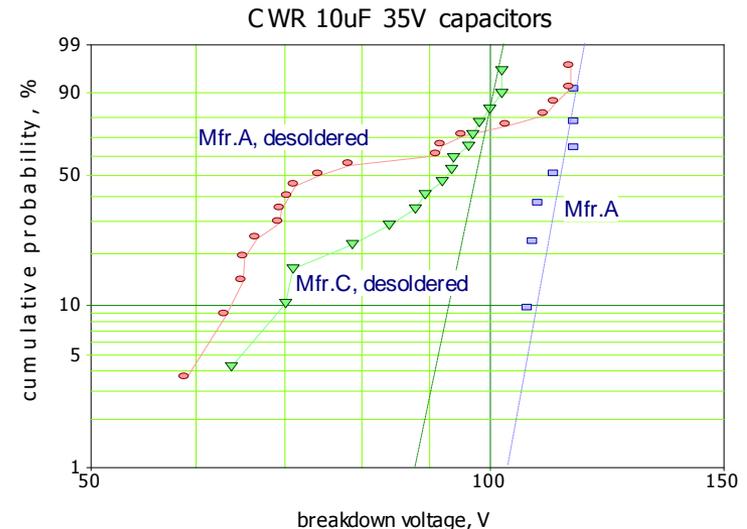
Breakdown Voltages in Capacitors Desoldered from MCE Boards

- ❑ Mfr.A capacitors were removed from the failed engineering board (LDC1215) and both, Mfr.A (LDC1307) and Mfr.C capacitors were removed from the flight board.
- ❑ Breakdown voltages for these parts as well as for LDC1307 and reference capacitors were compared to average values for different types of 35V capacitors.

- ✓ Intrinsic breakdown voltages in 10uF capacitors from Mfr.A exceed $3 \times VR$ and are above average values typical for capacitors rated to 35V.
- ✓ All types of capacitors removed from the units had low-voltage tails of VBR distributions indicating presence of large proportion of defects in the dielectric.

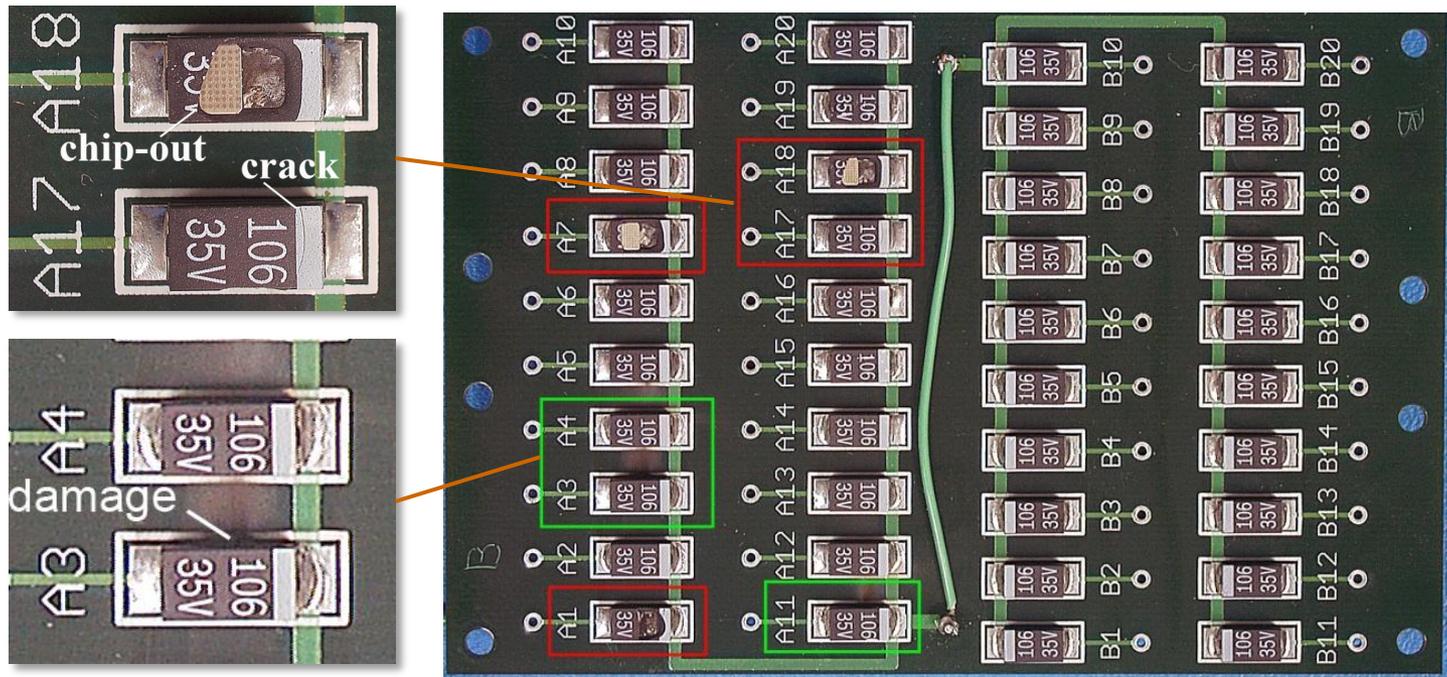
- ❑ Board B was populated with CWR29 capacitors that were preconditioned in humidity chamber (samples A1-A20) and reference parts (samples B1-B20).
- ❑ Cracks were observed on the top and at the bottom of the CWR29 capacitors.

- ✓ No case defects were observed after soldering.
- ✓ Case cracking and damage occur in 50% of CWR29 capacitors after SCT.
- ✓ SCT did not cause damage to CWR09 (reference) parts.

- ❑ Chip-outs and cracks in the case were not observed after soldering, but occurred after surge current testing in CWR29 capacitors preconditioned by moisture soak.

- This might indicate that case cracking is due to moisture remaining in the parts after soldering and overheating of the moisture containing MnO₂ layers by surge currents.

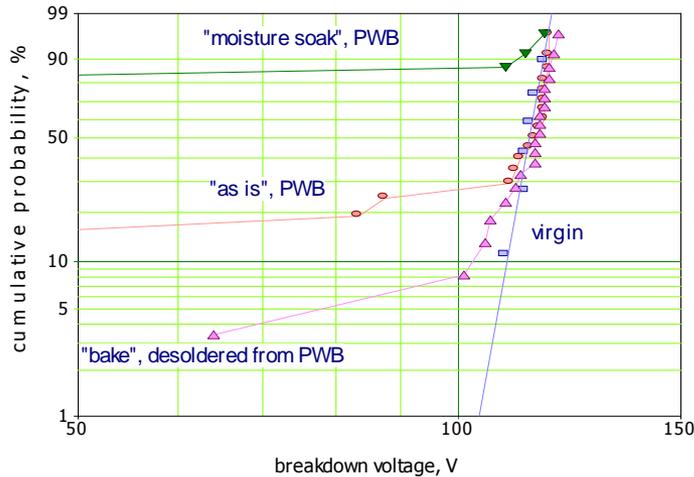
CWR 10uF 35V DC1307

- ✓ Most non-failed parts had intrinsic VBRs.
- ✓ Tails of the distributions indicate defects in Ta₂O₅.
- ✓ There is a trend of increasing the number of defects after soldering capacitors with greater moisture content.
- ✓ Desoldering can cause damage to dielectric.
- ✓ 95% of CWR95 parts failed short circuit, whereas ~50% of the reference parts self-healed after scintillation breakdown.

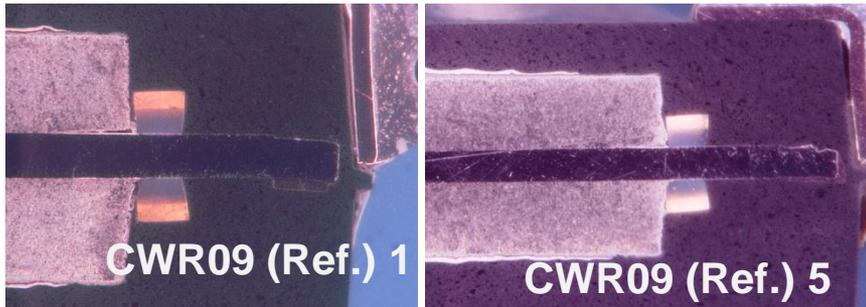
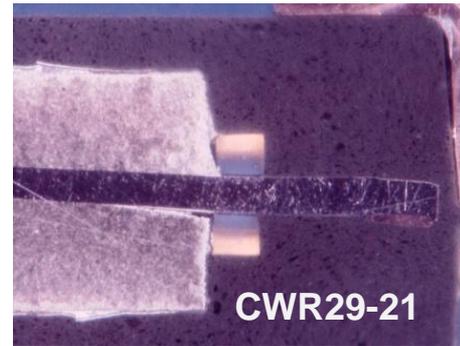
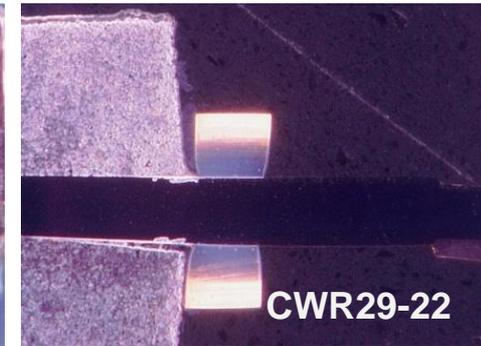
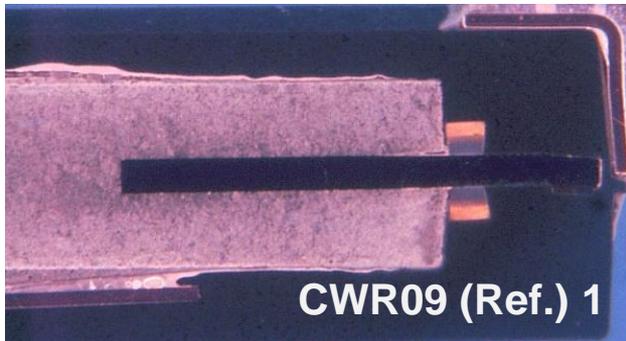
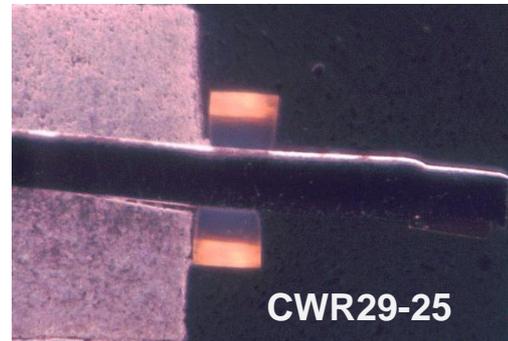
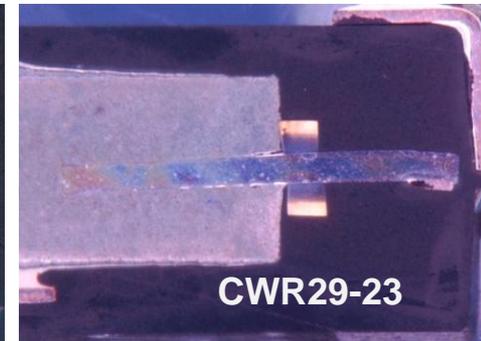
Results of Cross-Sectioning

Parts failed after reflow soldering have been cross-sectioned in small steps in the attempt to reveal damaged area.

- ✓ No substantial difference between CWR29 and reference parts.
- ✓ Delaminations between riser wires the slugs was observed in both part types.
- ✓ No obvious defects that might be associated with failures were detected.

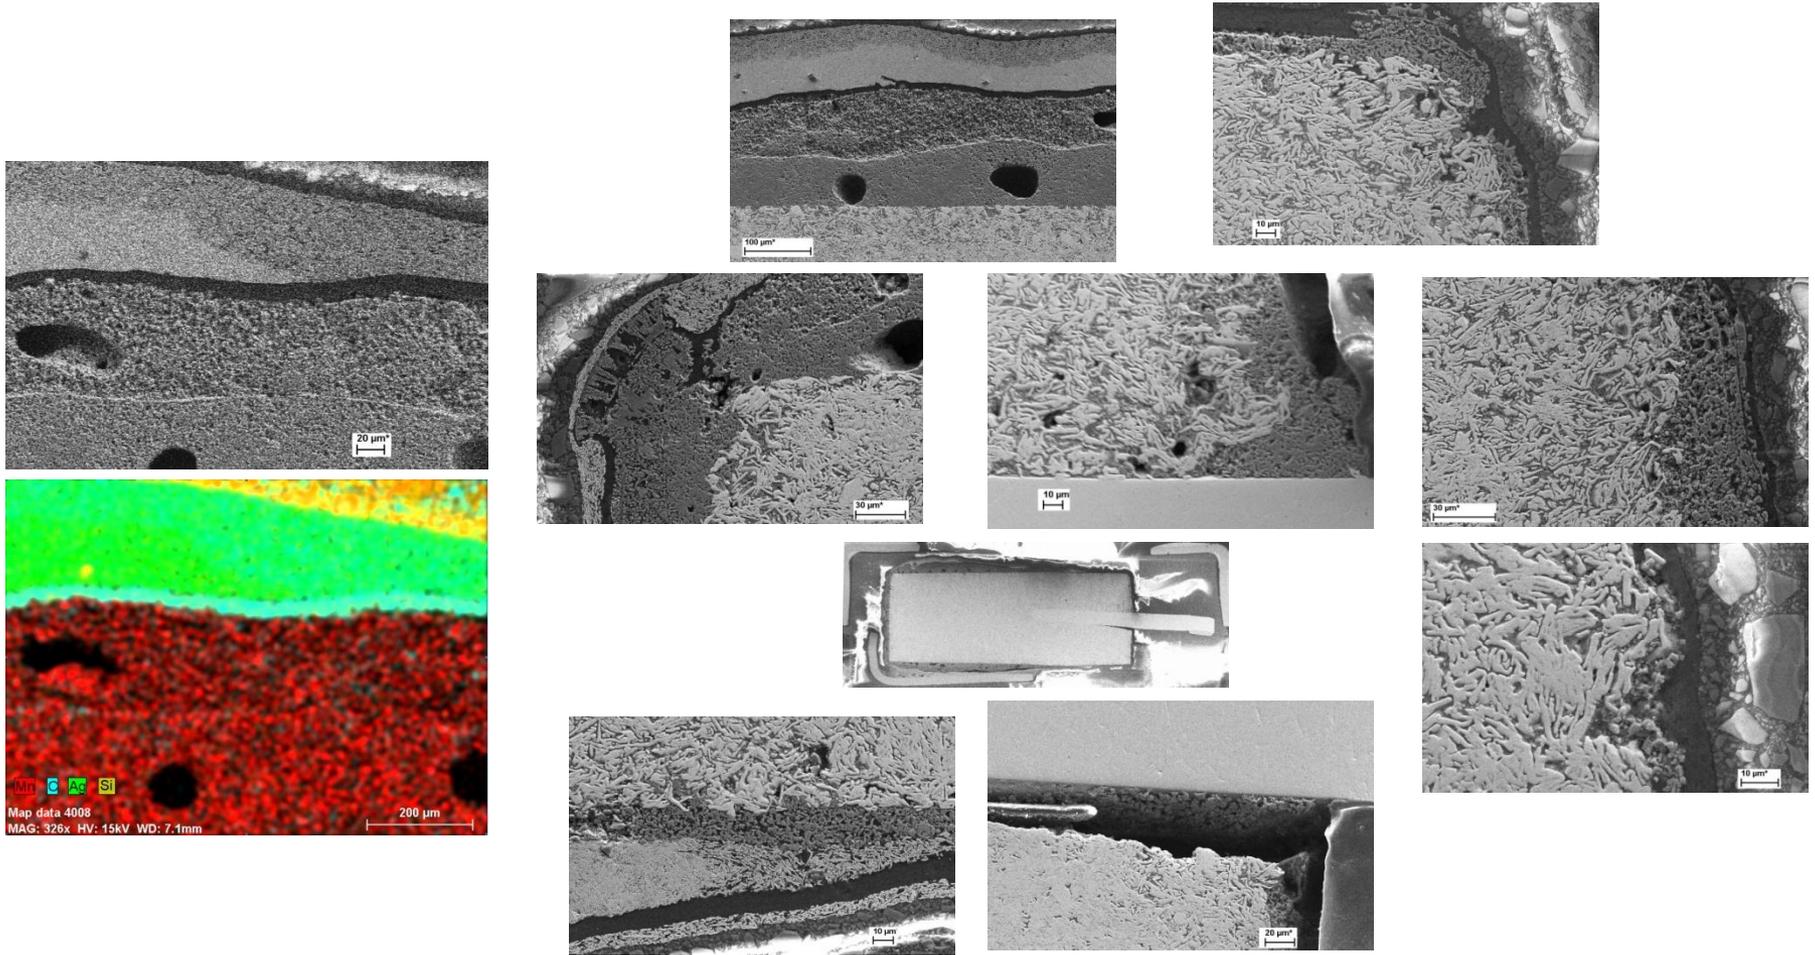
SEM Images and X-ray Mapping CWR29

- ✓ No anomalies observed, good coverage of the slug with MnO₂ and carbon.
- ✓ The riser wire shoulder had a thin layers of MnO₂ and carbon coatings.

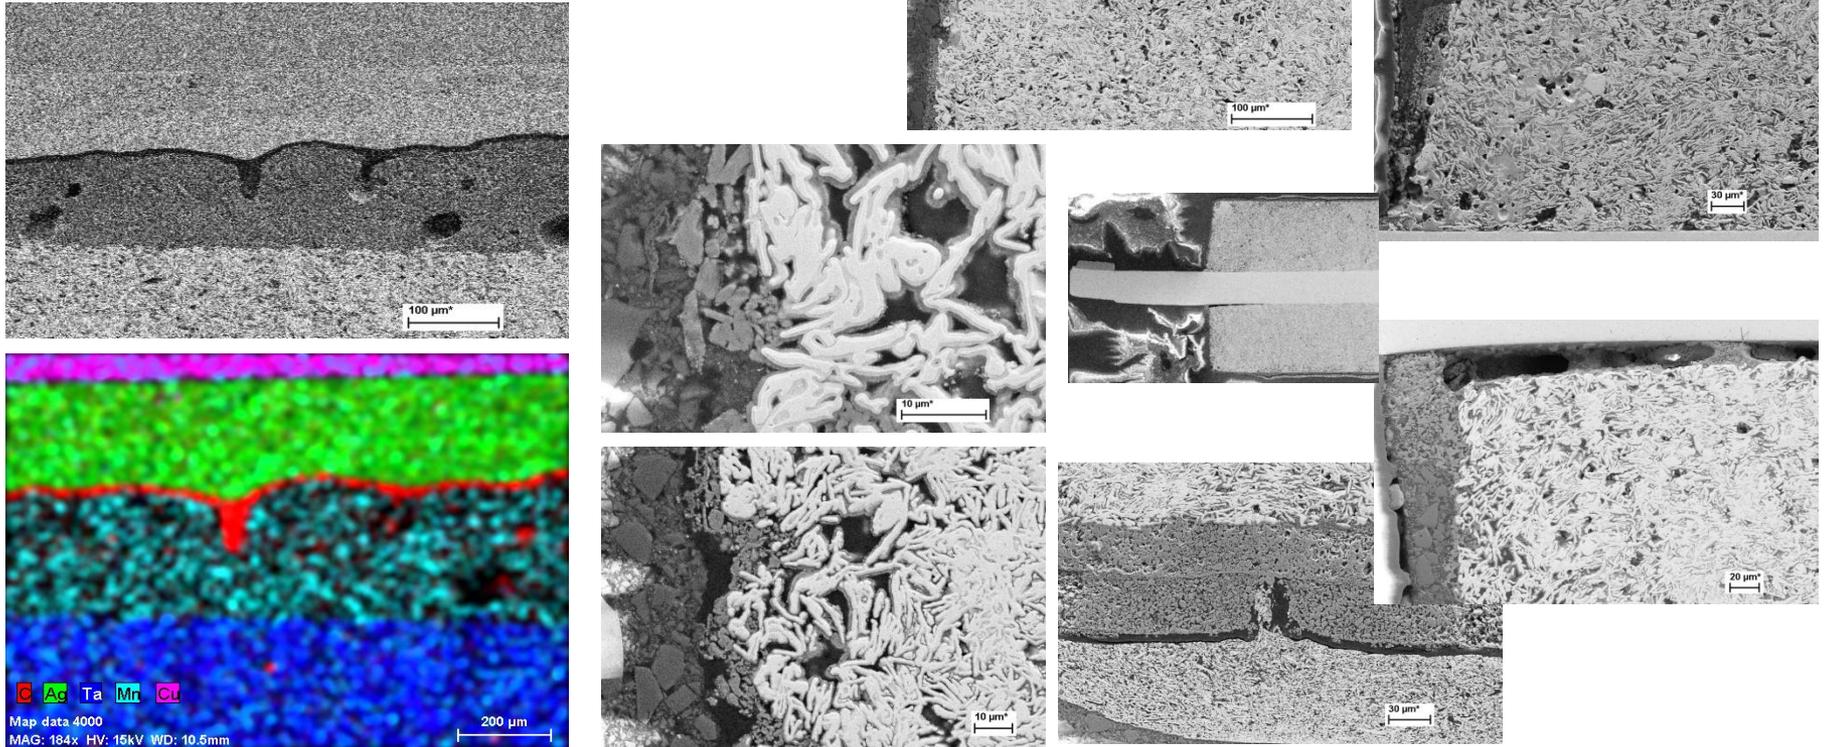
SEM Images and X-ray Mapping for CWR09 (Ref.) Capacitors

- ✓ Results for reference parts were similar to CWR29 capacitors.
- ✓ SEM and EDS analysis of cross-sectioned samples were not successful in revealing defects that might be responsible for the difference in behavior of CWR29 and reference capacitors.

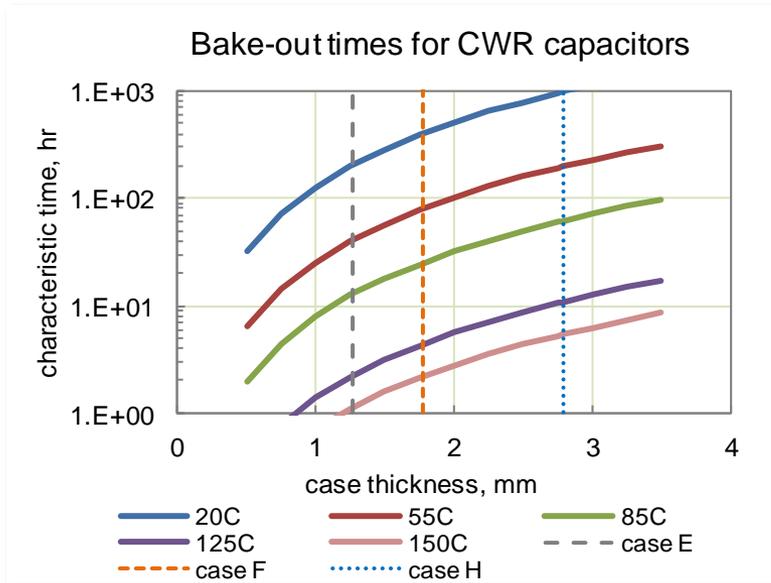
Bake-out Times for Tantalum Capacitors

- ✓ The bake time corresponds to a time that is required to release $\sim 90\%$ of the absorbed moisture.
- ✓ Based on $D(T)$ for molding compounds used in tantalum capacitors, for case H parts ($H = 2.8\text{mm}$), bake-out times are 1000 hr, (~ 1.5 month), 200 hr (1.2 wk), 62 hr, and 11 hr at 20°C , 55°C , 85°C , and 125°C respectively.
- ✓ Note that the bake-out time at 150°C is ~ 5.5 hr, which is far longer than the preheating step during soldering (~ 1 min at 150°C).
- ✓ Overnight baking at 125°C (15 hours) should be sufficient to remove moisture from most types of capacitors.
- ✓ Soldering capacitors within 48 hours after bake or removal from a dry bag should not cause pop-corning related failures.

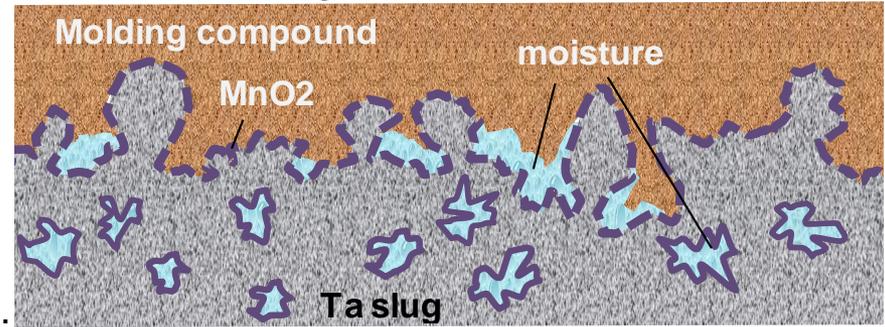
Schematic of local popcorning that can cause cracking in Ta₂O₅ dielectric

- ❑ During soldering, moisture condensed in cracks, pores, or MnO₂ evaporates rapidly creating high local pressure in the sponge-like structure of Ta anode and increasing delamination between MC and slug. When this pressure is applied to a mechanically weak site of the slug, a fracture of Ta₂O₅ dielectric occurs. This effect can be defined as internal popcorning.

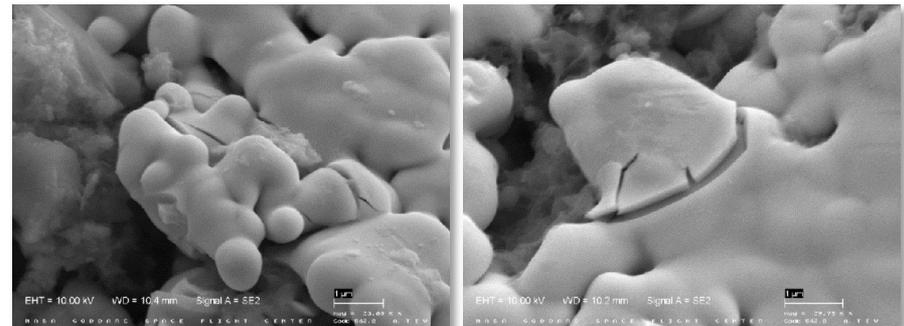
- ❑ In some cases damage can be self-healed (e.g. by oxidation of Ta, or increasing resistance of MnO₂). This might improve temporarily characteristics of the part, but reliability of such a part is compromised.

Examples of cracks in the dielectric of 6.8uF 35V CWR11 capacitors

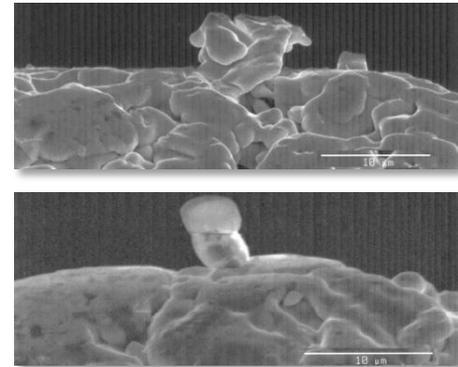
Example of weak sites on the surface of CWR11 capacitors

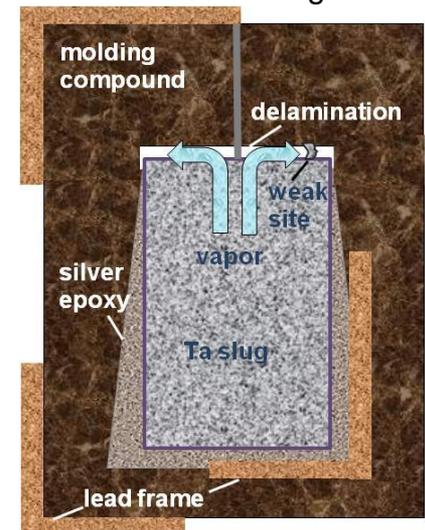
Schematic of popcorning-induced damage
