Failure Analysis of Heavy-Ion-Irradiated Schottky Diodes

Megan C. Casey¹, Jean-Marie Lauenstein¹, Edward P. Wilcox², Alyson D. Topper², Michael J. Campola¹, and Kenneth A. LaBel¹

¹NASA Goddard Space Flight Center, Code 561.4, Greenbelt, MD 20771

In this work, we use high- and low-magnification optical microscope images, infrared camera images, and scanning electron microscope images to identify and describe the failure locations in heavy-ion-irradiated Schottky diodes.

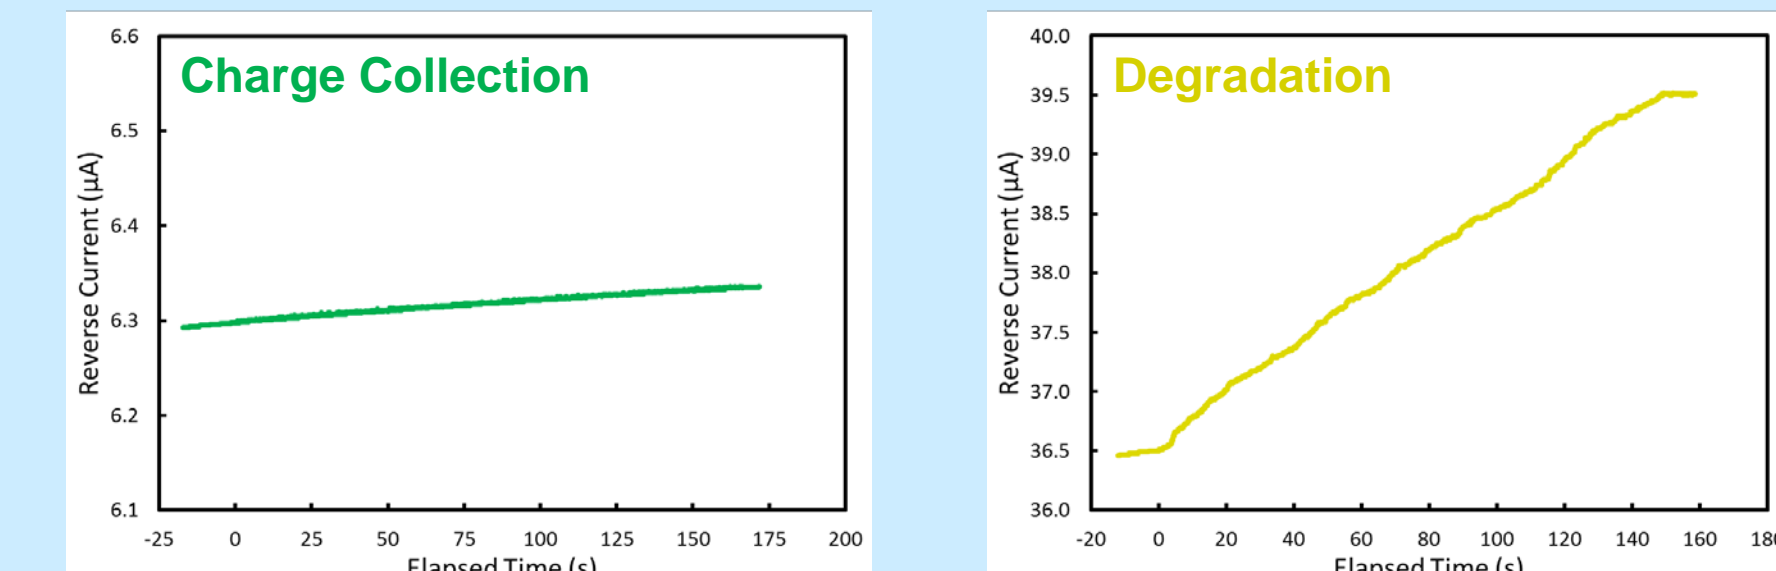
Fig. 1a. Charge collection is observed during the beam run. All post-irradiation parameters were within specification, and this was considered a passing condition. Fig. 1b. Degradation is observed in the reverse current during the beam run. All post-irradiation parameters were within specification, and this was considered a passing condition.

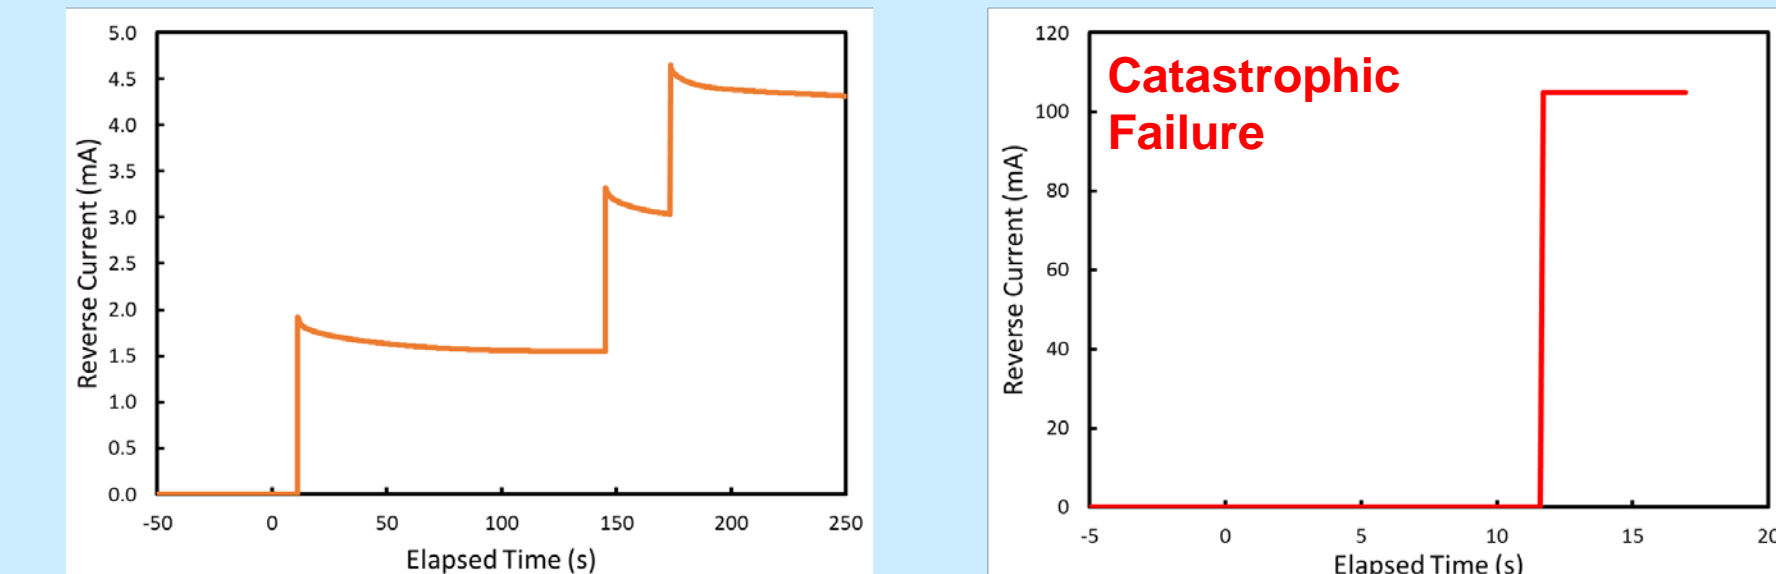
Fig. 1c. Degradation is observed in the reverse current during the beam run. Some or all of the post-irradiation parameters were outside of their specification, and this was considered a failing condition. Fig. 1d. Some time after the beam is turned on, the anode and cathode short causing catastrophic failure. Some or all of the post-irradiation parameters were outside of their specification, and this was considered a failing condition.

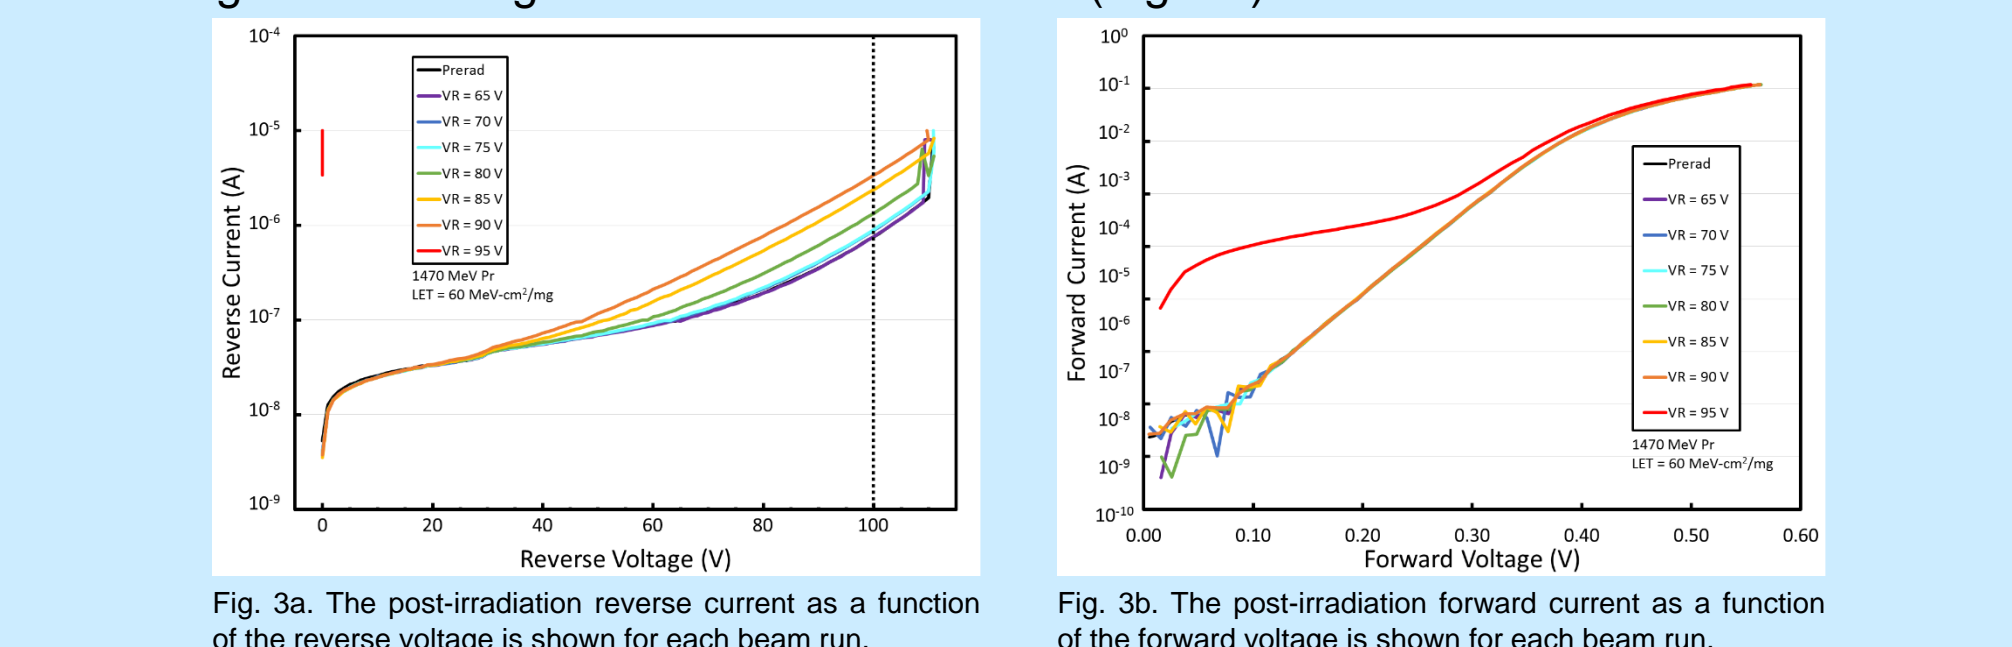
Up to the 65-V irradiation, only charge collection was observed (Fig. 2). When biased at 70 V, small increases in the reverse current (I_R) were observed during the beam run; however, the post-irradiation electrical parameter measurements all remained within specification. During the 95-V irradiation, a small amount of degradation was observed almost immediately, but, within seconds, catastrophic failure was observed, meaning the anode and cathode shorted and the current was limited by the compliance settings on the power supply.

The reverse I-V curve (Fig. 3a) shows that the part was degrading slightly during each run, however, after the 95-V run, I_R exceeded the 10 μ A specification at less than 1 V. There was also a significant change in the forward I-V curve (Fig. 3b) after this run as well.

Fig. 2. Reverse currents from the power supply during each run. The reverse voltage at which the DUT was biased is shown in the legend. Fig. 3a. The post-irradiation reverse current as a function of the reverse voltage is shown for each beam run. Fig. 3b. The post-irradiation forward current as a function of the forward voltage is shown for each beam run.

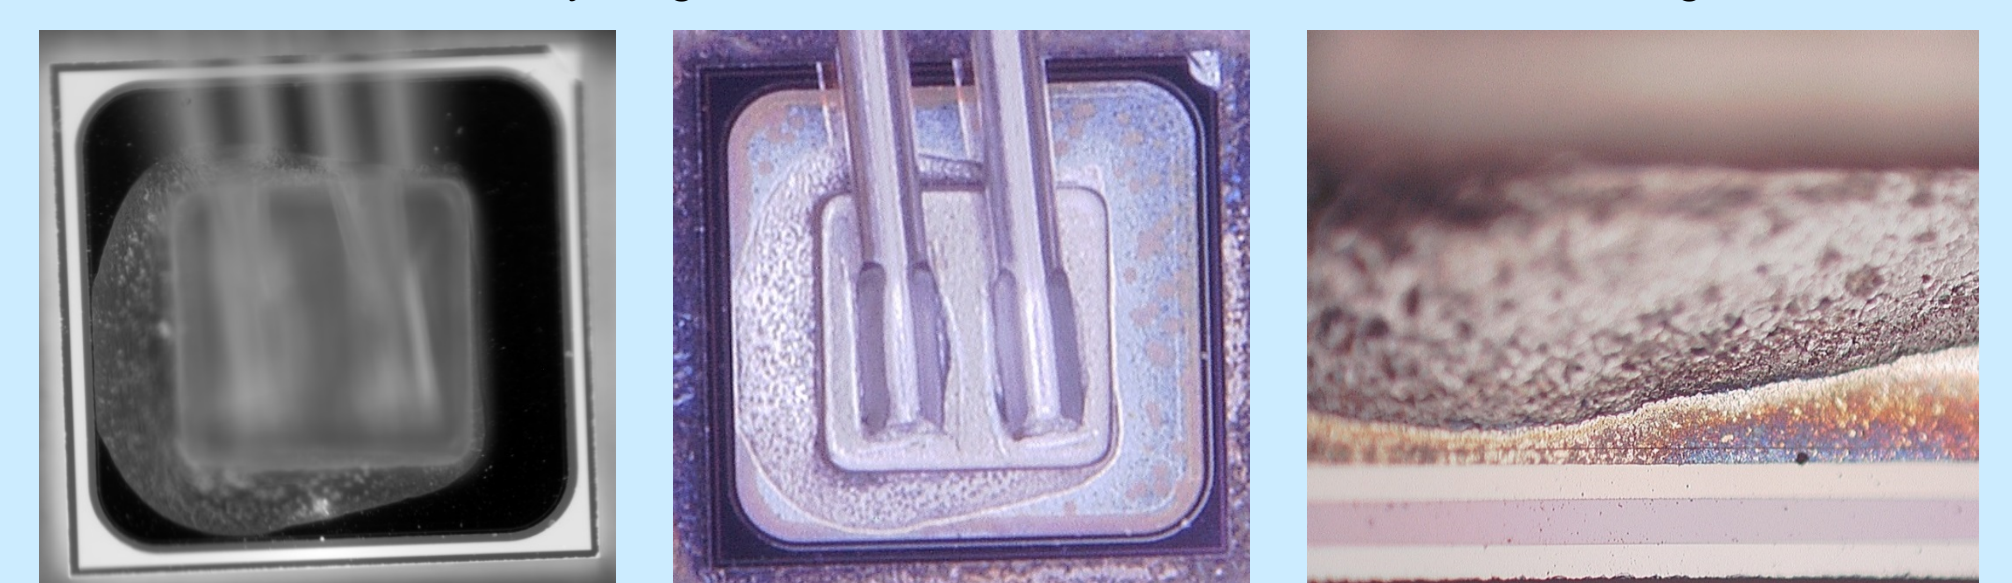
After irradiation, SN5 was examined using an IR camera and pictures were taken with a small voltage applied. Bright white spot (indicating elevated temperature, and shown in Fig. 4a) just below the wirebond contact is the location of the failure. Low-magnification (Fig. 4b) and high-magnification (Fig. 4c) optical images of the surface of the DUT did not show anything unusual at the location identified in the IR image.

Fig. 4a. Thermal image of the irradiated DUT identifies location of failure. Fig. 4b. The failure location is not visible in the low-magnification optical image of SN5. Fig. 4c. The failure location is not visible in the high-magnification optical image of the DUT.

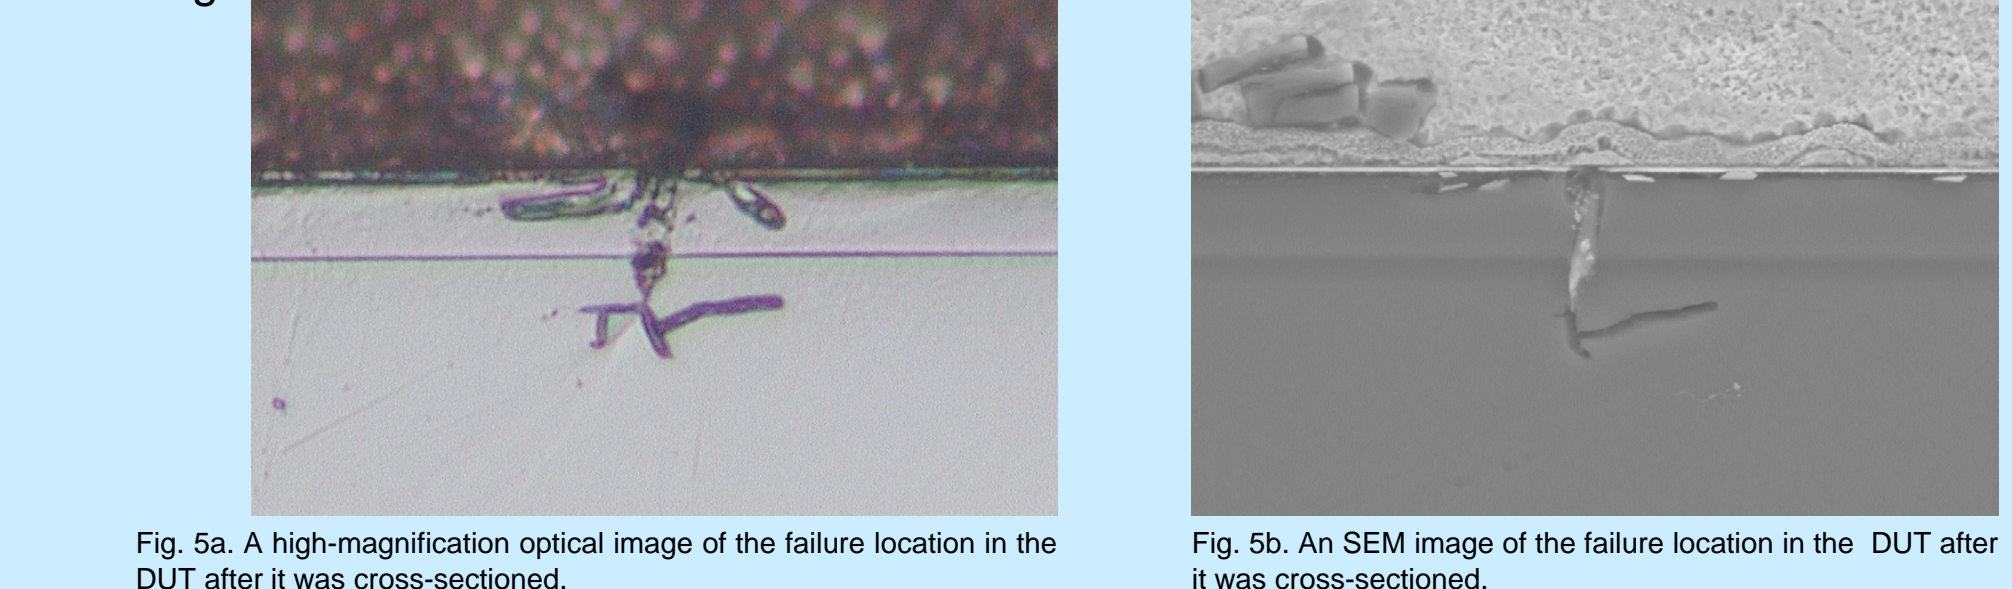
The DUT was then cross-sectioned at the location of the failure identified in the IR image, and then silicon was stained. A high-magnification optical image (Fig. 5a) and a scanning electron microscope (SEM) image (Fig. 5b) of the failure are shown below. The failure location is clearly observed from the Schottky barrier metal down through the epitaxial layer (epilayer), all the way to the bulk silicon. The extreme heat generated by the single-event strike also resulted in mechanical stress on the die and the subsequent cracking.

Fig. 5a. A high-magnification optical image of the failure location in the DUT after it was cross-sectioned. Fig. 5b. An SEM image of the failure location in the DUT after it was cross-sectioned.

The failure created a void that was filled with displaced melted metal from the Schottky contact. The empty column generated during the failure is reminiscent of the filament that develops between the gate and the substrate through the neck region in power MOSFETs [8]. An element map, generated from energy dispersive x-ray spectroscopy (EDS), shows the displaced metal (Fig 6).

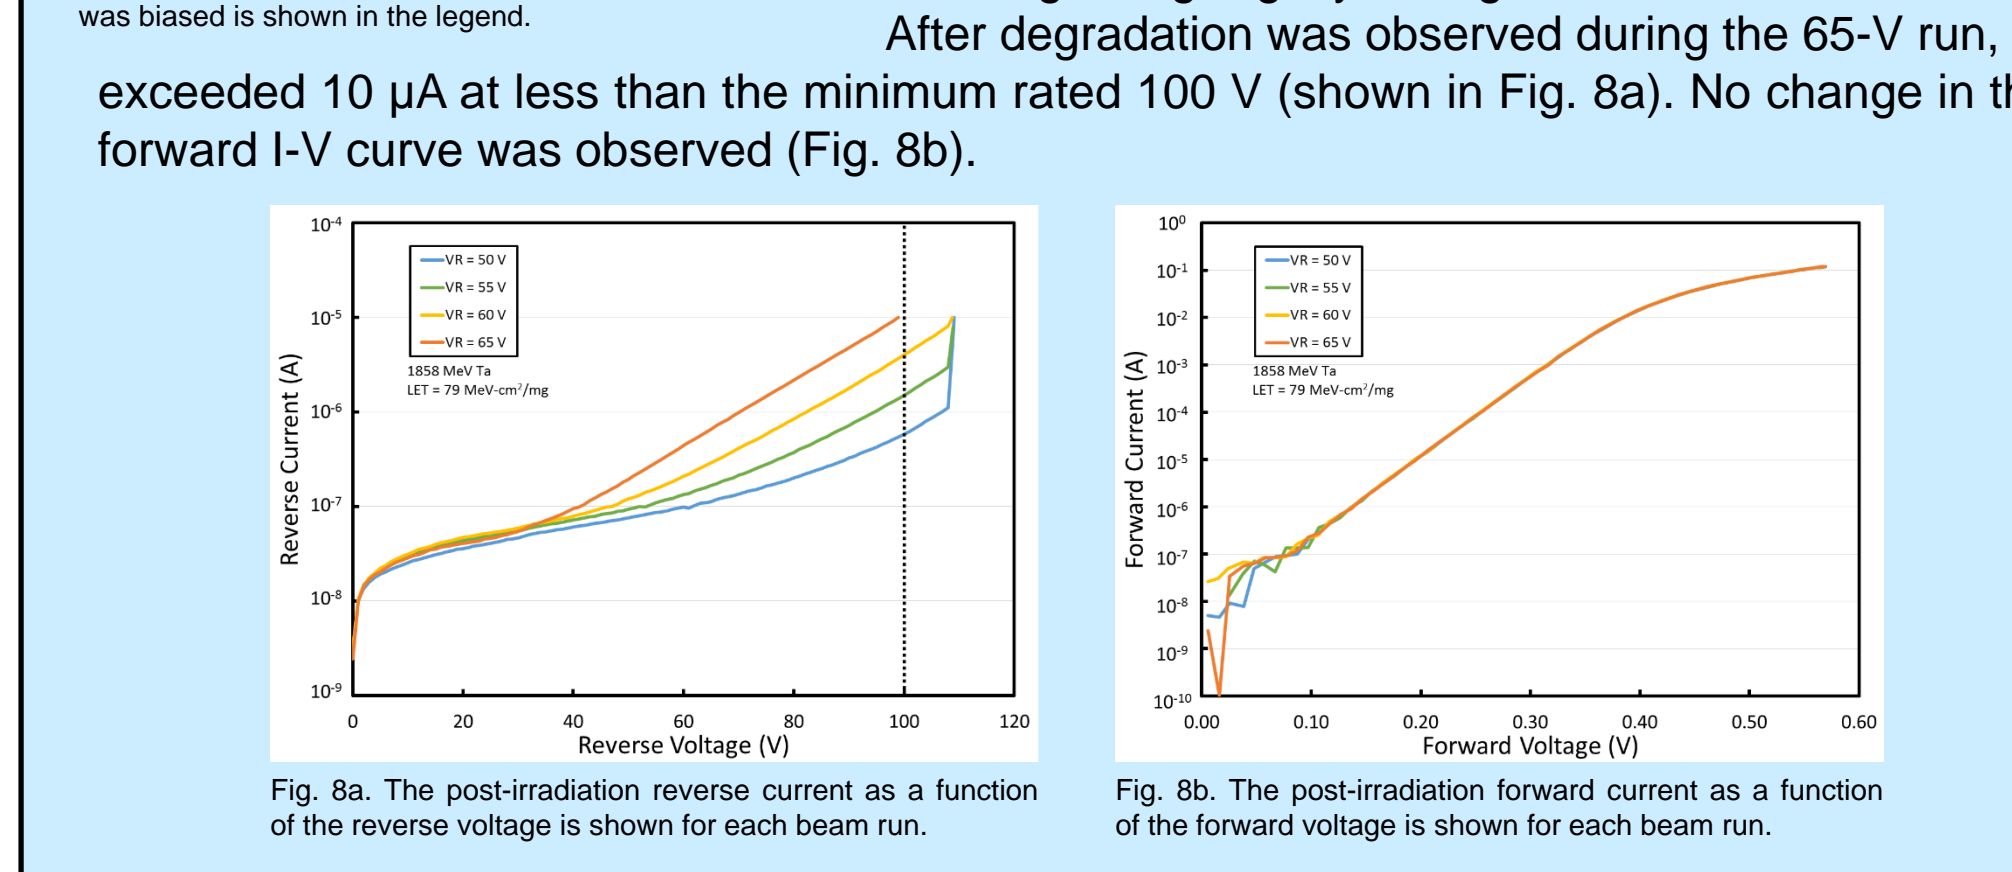
Like SN5, the reverse I-V curve shows that the part was degrading slightly during each run. After degradation was observed during the 65-V run, I_R exceeded 10 μ A at less than the minimum rated 100 V (shown in Fig. 8a). No change in the forward I-V curve was observed (Fig. 8b).

Fig. 7. Reverse currents from the power supply for SN2 during each run. The reverse voltage at which the DUT was biased is shown in the legend. Fig. 8a. The post-irradiation reverse current as a function of the reverse voltage is shown for each beam run. Fig. 8b. The post-irradiation forward current as a function of the forward voltage is shown for each beam run.

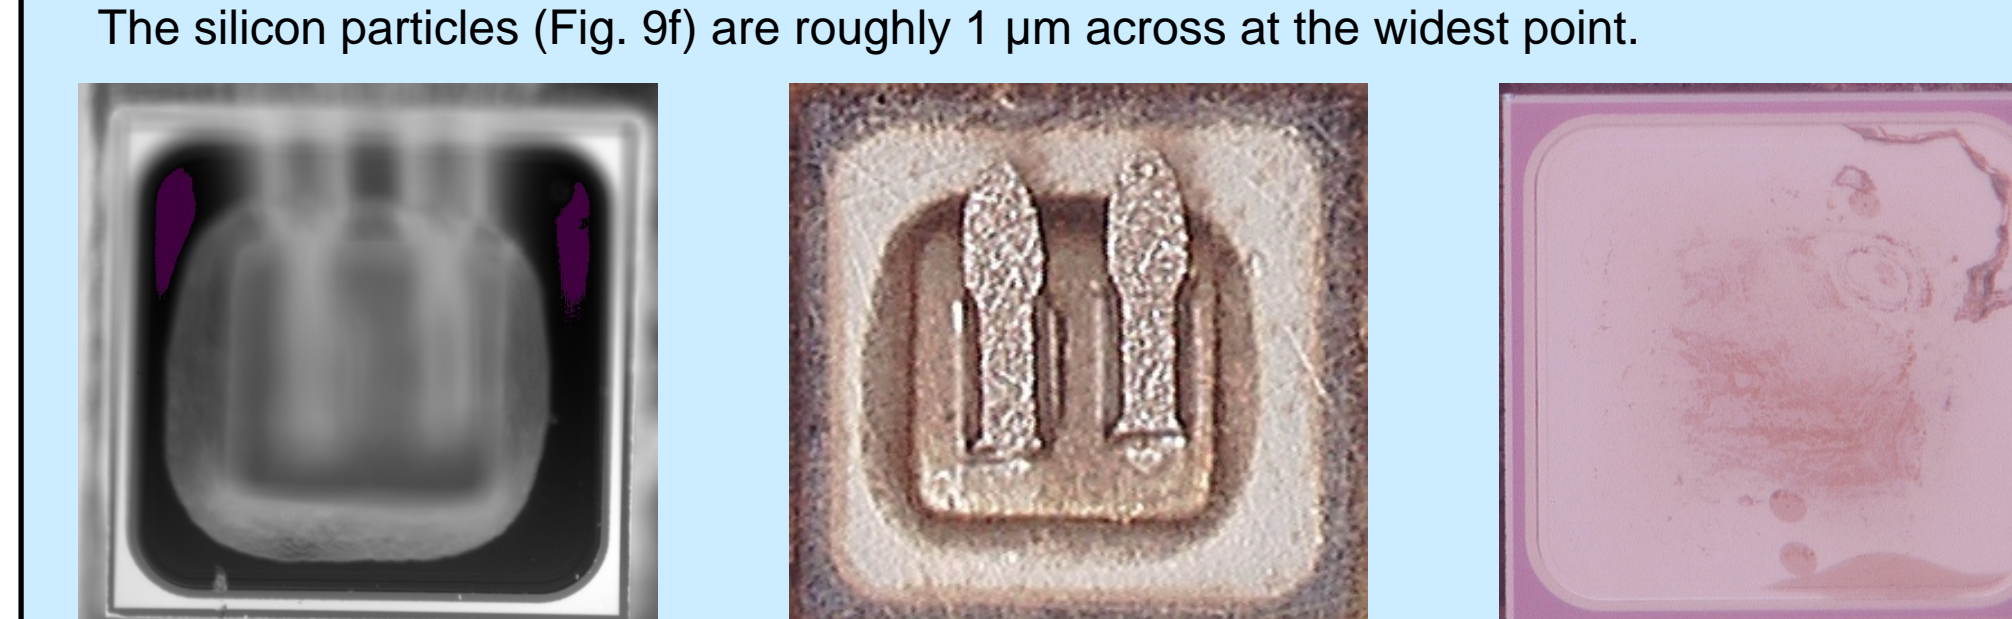
For SN2, even with 100 V applied, no failure locations were observed in the IR images (Fig. 9a), nor were any observed in the low-magnification optical images (Fig. 9b). A different approach was then taken, where the bond wires, bond pad, and Schottky barrier metal were chemically etched and removed (Fig. 9c). On the surface of the silicon, a few discolorations were observed (Fig. 9d) and an SEM image of two of the discolorations, and under high-magnification, a fused particle, which was later determined to be silicon, was observed in the center of the discolorations (Fig. 9e).

Fig. 9a. Thermal image of the irradiated SN2 does not identify any failure locations. Fig. 9b. No failure location is visible in the low-magnification optical image of the DUT. Fig. 9c. These discolorations are observed in the silicon of SN2 after the Schottky barrier metal, bond pad, and bond wires were removed.

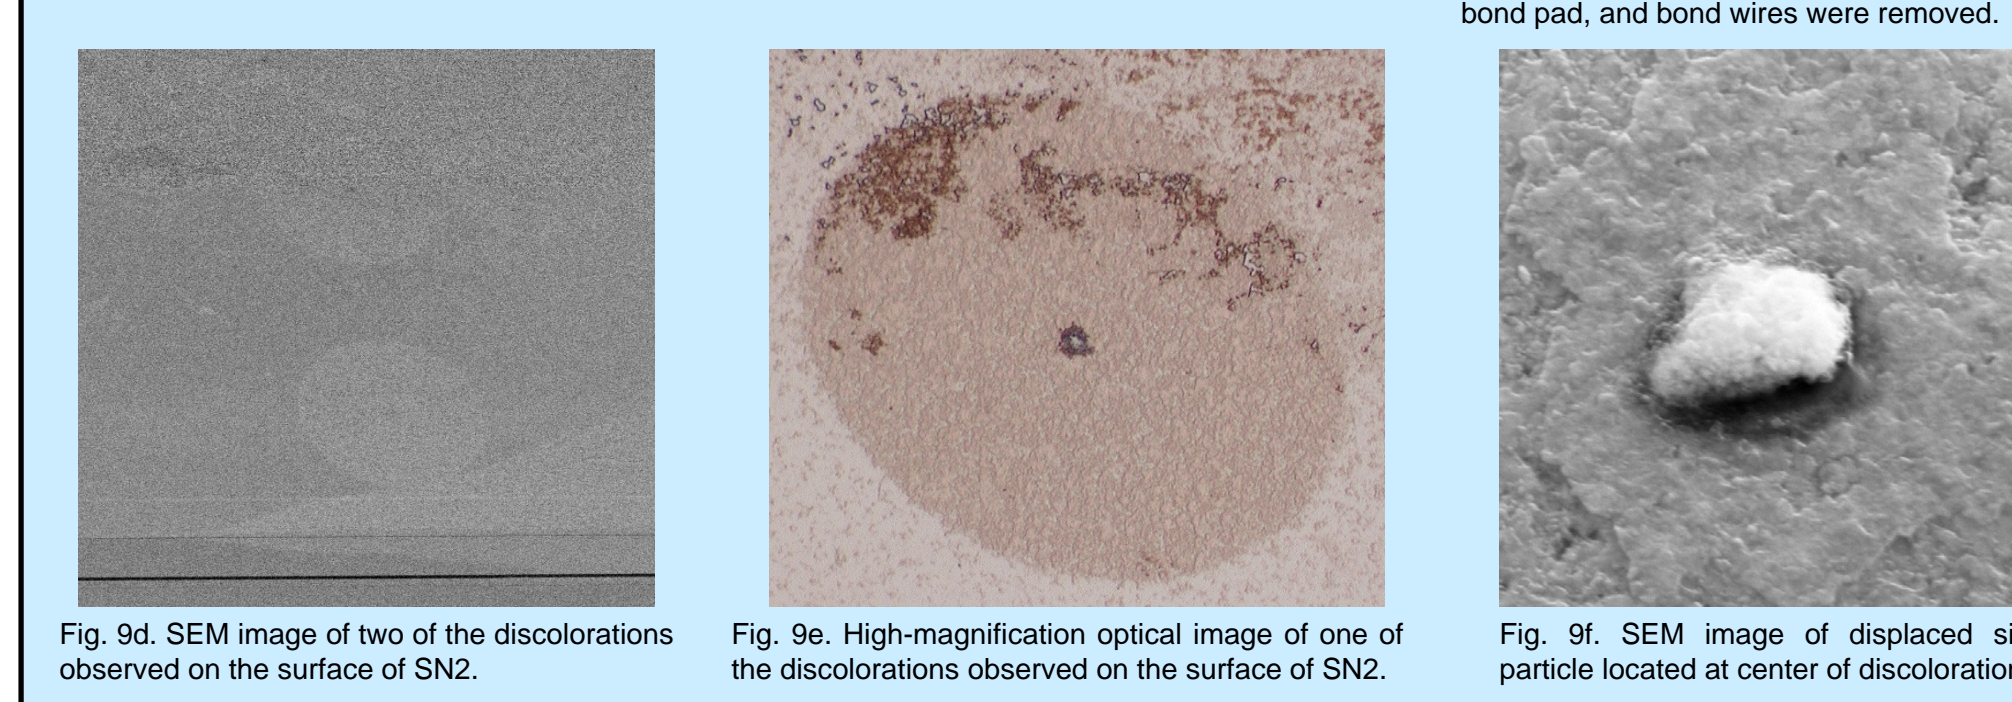
Fig. 9d. SEM image of two of the discolorations observed on the surface of SN2. Fig. 9e. High-magnification optical image of one of the discolorations observed on the surface of SN2. Fig. 9f. SEM image of displaced silicon particle located at center of discoloration.

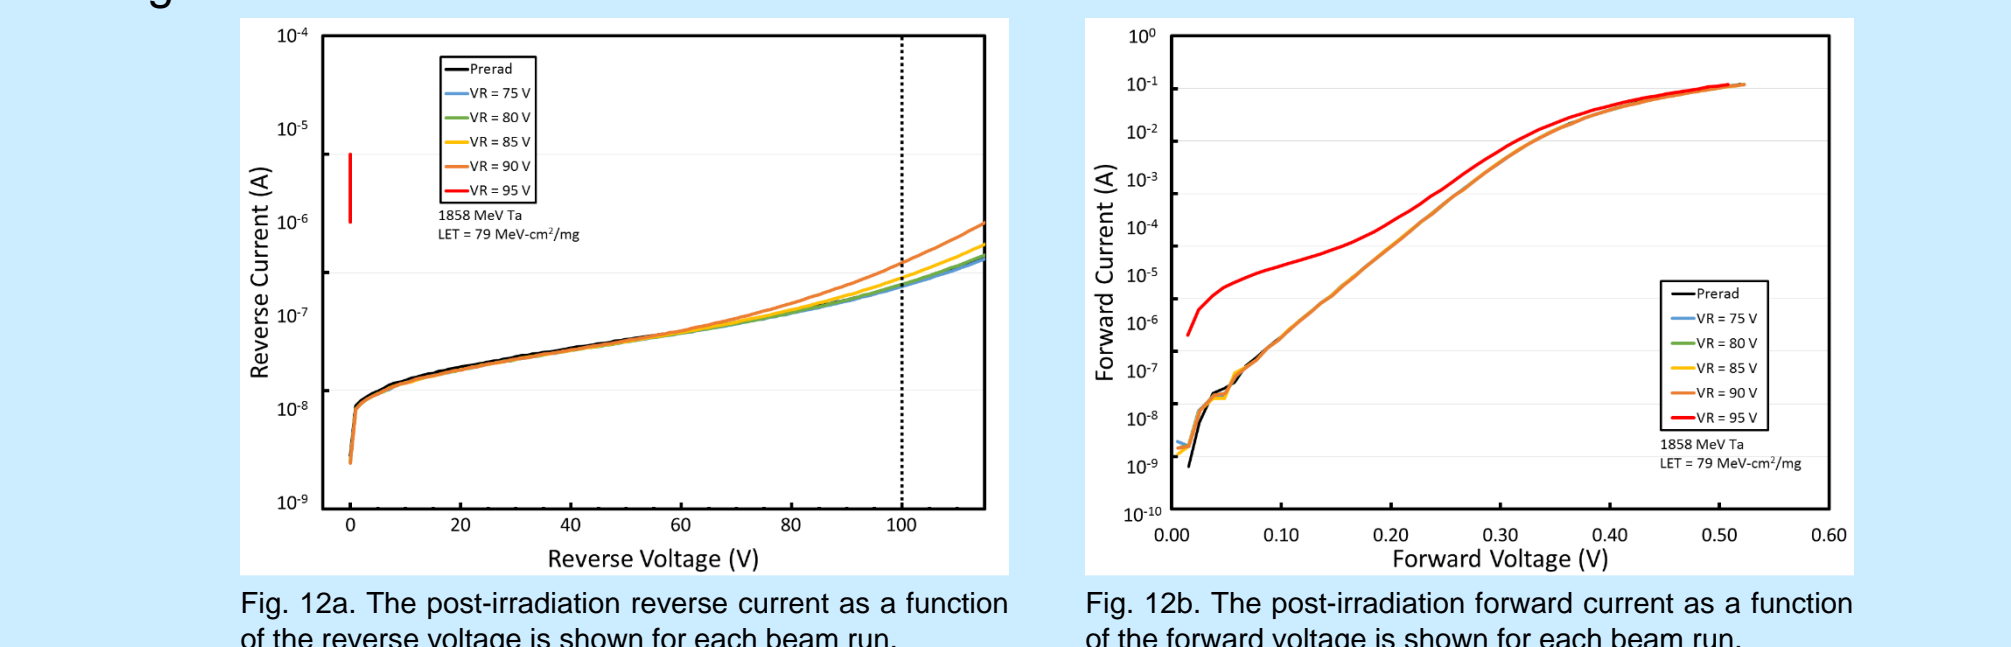
During the 95-V irradiation, a very small increase in I_R was observed immediately after the beam was turned on, and then within seconds, the anode and cathode shorted, and again the current was only limited by the power supply.

Almost no degradation was observed in the reverse I-V curve (Fig. 12a) until the 95-V run when I_R exceeded the 10 μ A specification at less than 1 V. Like with SN5, there was a significant change in the forward I-V curve (Fig. 12b) after the failing run.

Fig. 11. Reverse currents from the power supply for SN7 during each beam run. The reverse voltage at which the DUT was biased is shown in the legend. Fig. 12a. The post-irradiation reverse current as a function of the reverse voltage is shown for each beam run. Fig. 12b. The post-irradiation forward current as a function of the forward voltage is shown for each beam run.

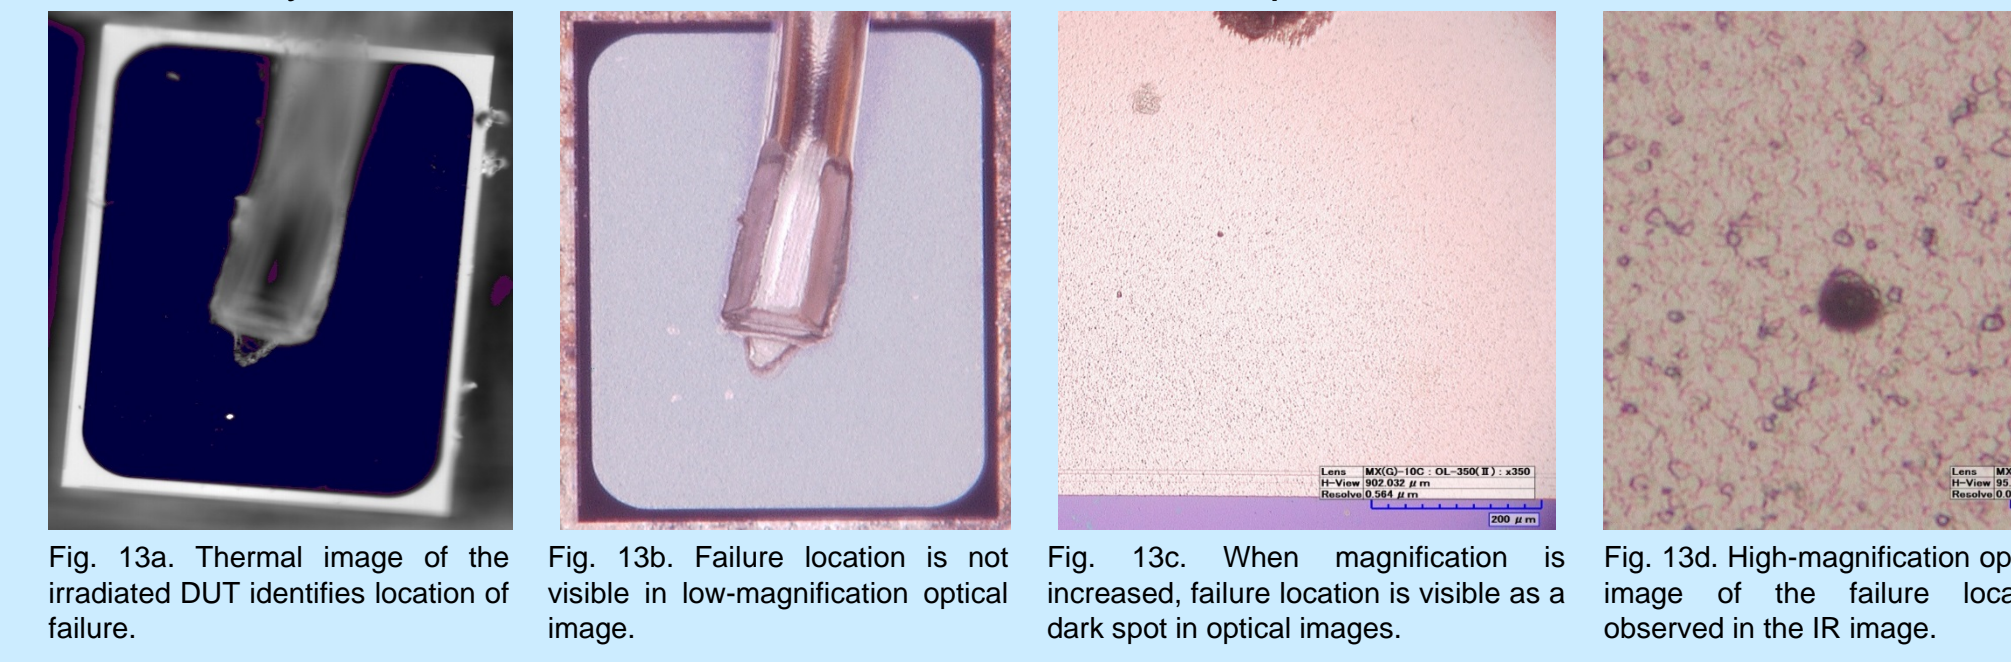
Using the thermal camera and a small applied voltage, the failure location was again visible in this DUT (Fig. 13a). When examined in the low-magnification optical image, the failure was not visible (Fig. 13b); however, when the magnification was increased, a dark spot could be seen (Figs. 13c and 13d). When that spot was investigated further with the SEM (Figs. 13e and 13f), it was clear that the Schottky barrier metal melted. Then, EDS showed (Fig. 13g) that not only had the metal melted, but silicon became displaced to the surface of the diode.

Fig. 13a. Thermal image of the irradiated DUT identifies location of failure. Fig. 13b. Failure location is not visible in low-magnification optical image. Fig. 13c. When magnification is increased, failure location is visible as a dark spot in optical images. Fig. 13d. High-magnification optical image of the failure location observed in the IR image. Fig. 13e. SEM image of the surface of SN7. Failure location is visible below the bondwires. Fig. 13f. High-magnification SEM image of failure location. Fig. 13g. Element map generated from EDS shows the Schottky barrier metal had melted away and silicon ball became displaced to the surface.

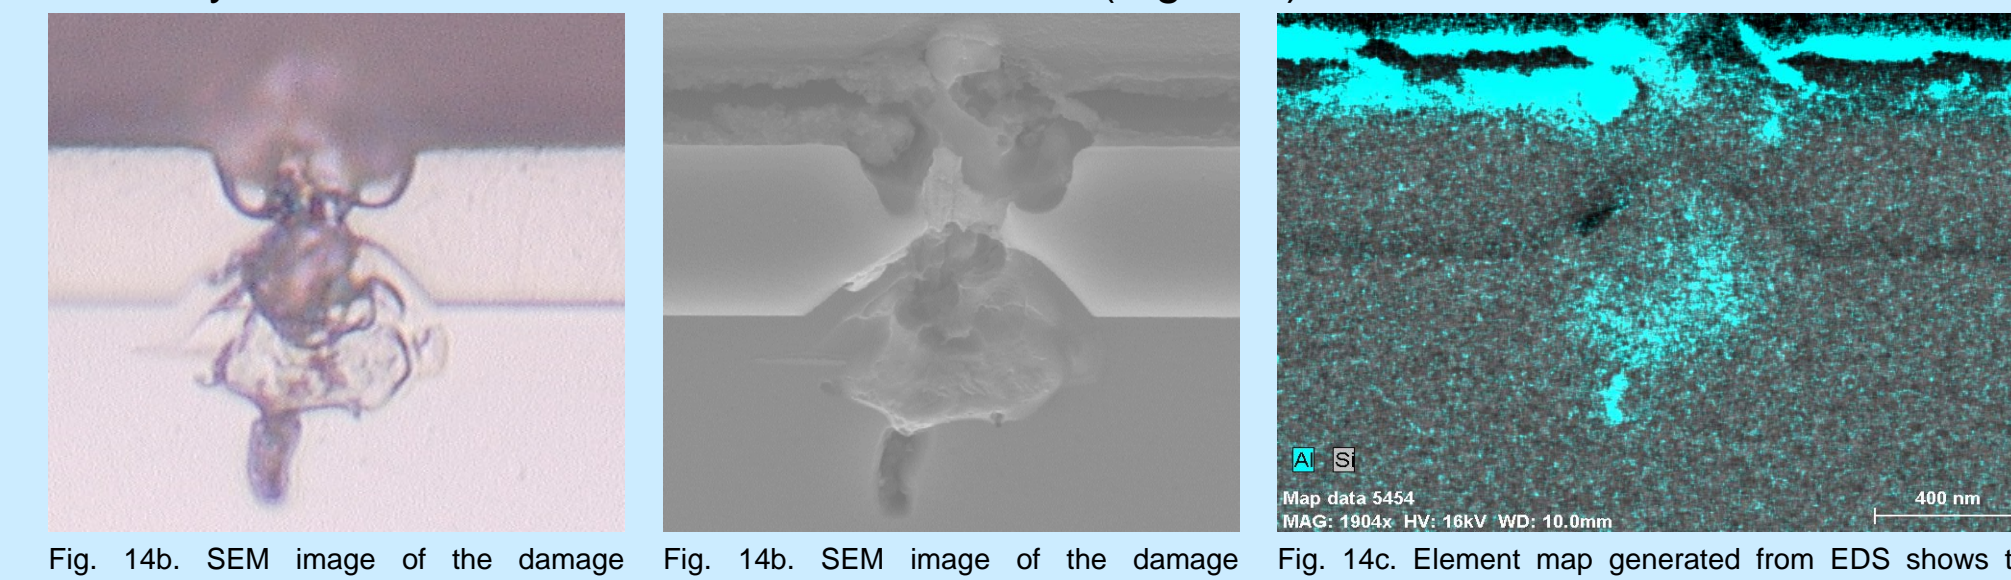
After identifying a failure location, SN7 was cross-sectioned at that location and stained (Fig. 14a). Like SN5, a large void was created through the silicon with most of the event occurring at the epilayer/metal interface as well. When EDS was performed on the cross-section, it was clear that, in addition to the displaced silicon that could be seen on the surface, aluminum from the Schottky barrier metal flowed into the bulk silicon (Fig. 14c).

Fig. 14a. SEM image of the damage structure after the failure location in SN7 was cross-sectioned. Fig. 14b. SEM image of the damage structure after the failure location in SN7 was cross-sectioned. Fig. 14c. Element map generated from EDS shows the Schottky barrier metal migrated into the bulk silicon.

To avoid these radiation responses in which the diode is operating outside of the manufacturer's specifications, a reverse voltage derating of 50% is recommended when testing will not be conducted. If testing will be conducted on the flight diodes under the application-specific bias conditions, then a derating similar to power MOSFETs is recommended, in which the maximum reverse voltage that may be used is 75% of the last passing voltage.
