# Testing the Tester: Lessons Learned During the Testing of a State-of-the-Art Commercial 14nm Processor Under Proton Irradiation

**Abstract**— Testing of an Intel 14nm desktop processor was conducted under proton irradiation. We share lessons learned, demonstrating that complex devices beget further complex challenges requiring practical and theoretical investigative expertise to solve.

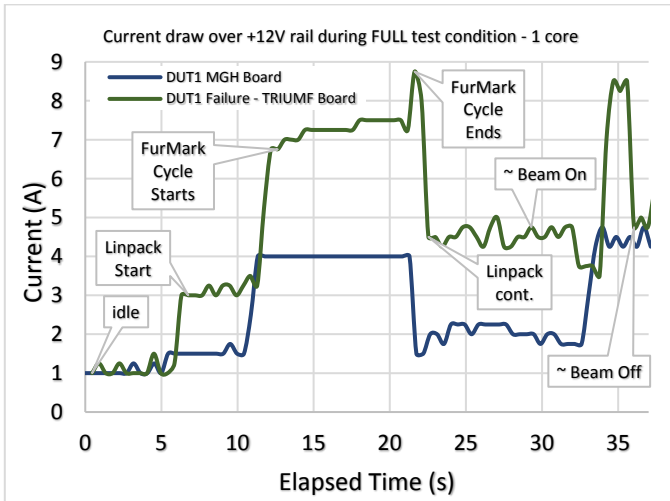
Fig. 7. Comparison of power supply current readings recorded during execution of the “Full” test condition at MGH. Peak current on the TRIUMF Board corresponds to 102 Watt.

While Fig. 7 certainly appears to depict what looks like a single event latch-up (SEL) situation, we were unable to reproduce the failure condition in the absence of proton irradiation. At best, repeat measurements, sans radiation, continue to reproduce the continue to exhibit the same experimentally-observed effects (Fig. 12). During this test, the “Control board” featured the latest available BIOS revision, 3402, available as of this writing, while the “TRIUMF board” remained at revision 0219 and the “MGH board” remained at revision level 2002.

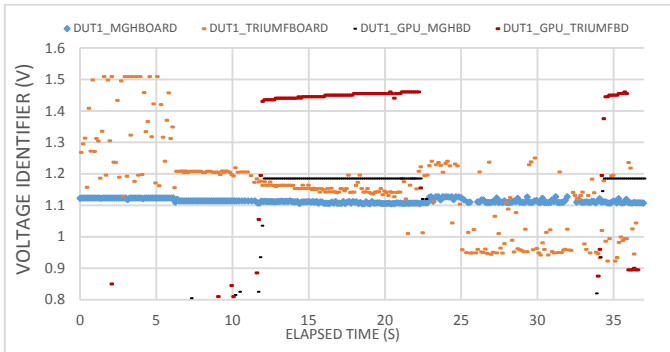
Fig. 8. Voltage Identifier (VID) levels requested by processor and GPU cores during test runs compared in Fig. 7.

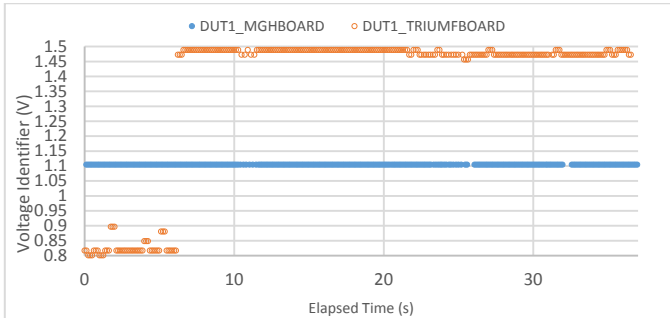
Fig. 9. The actual voltage levels being provided by the motherboard to the DUT, showing widely divergent behavior between data sets.

Finally, despite the Vcore values being nearly 40% above the VID level being requested, these values remained within specification

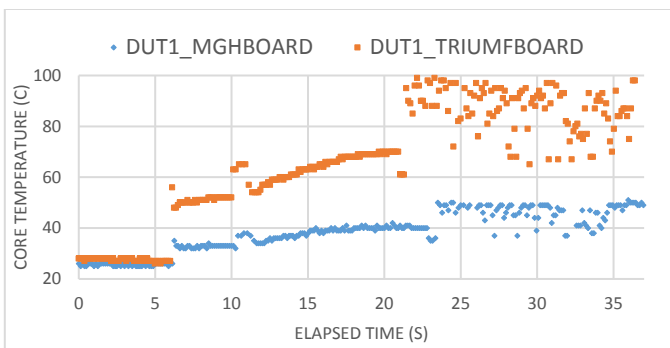
Fig. 10. Processor core digital thermal sensor (DTS) temperature readings during the test runs shown in Fig. 6.

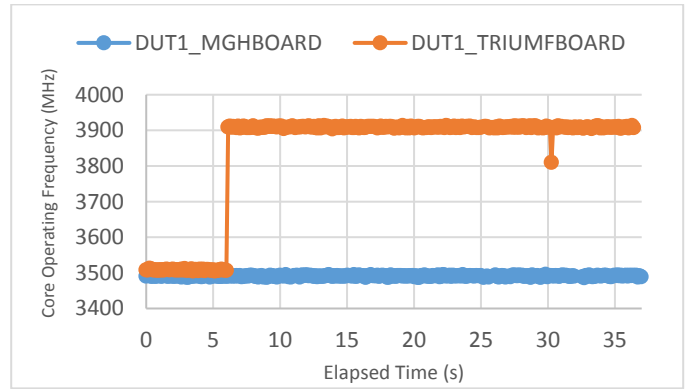
Fig. 11. Operating frequencies observed during “Full” test conditions.

One difference was glaring: the motherboards, having been acquired months apart from one another, featured different BIOS revisions. (Recall, our TRIUMF visit occurred in November of 2015, and the MGH visit did not occur until October of 2016). With the settings normalized between motherboards, the older BIOS on the “TRIUMF Board” appears to have driven the DUT with aggressive parameters, enabling high power consumption, high operating frequency, and elevated thermal emission. The MGH board, by contrast, treated the DUT rather conservatively.

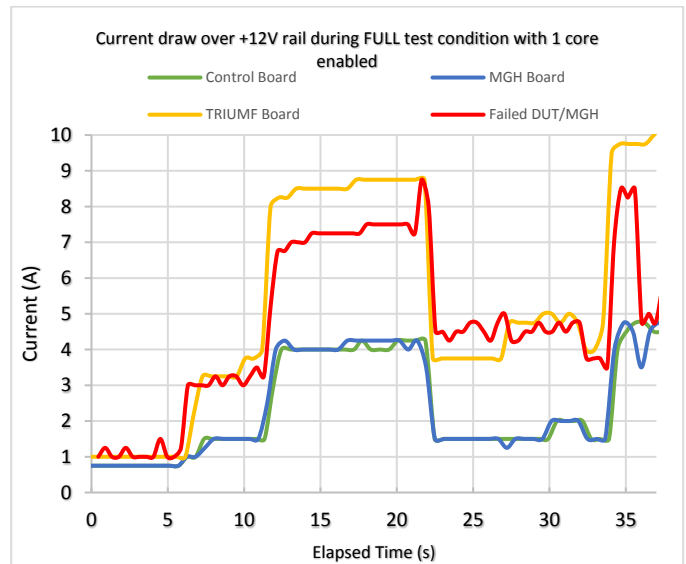
Fig. 12. Revisited in September, 2017: Comparison of power supply current readings recorded during execution of the “Full” test condition. Peak current on the TRIUMF Board corresponds to 120 Watt, further in excess of the device’s 91 Watt TDP. Peak power on the Control board, by contrast, is only 57 Watt.

Thus far, we can surmise that our findings indicate a role in which proton irradiation can contribute device failure, but not without the DUT operating in excess of its rated TDP.

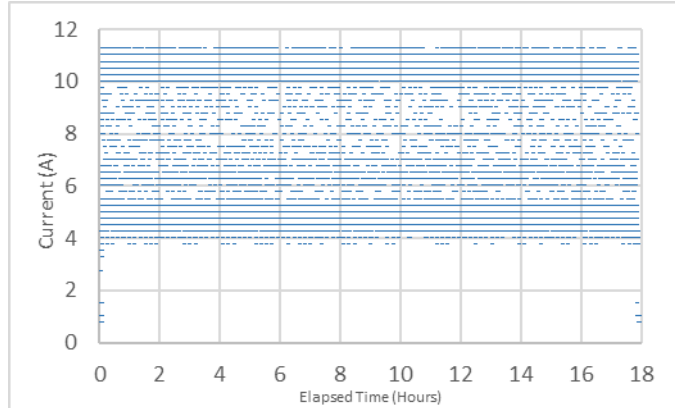
Further stressing at an extreme level – still – could not induce another hard failure while using the TRIUMF motherboard. To emphasize “extreme”, an insufficient (35 Watt) heat sink was affixed to the DUT and the “Full” test condition was modified to run infinitely, for a period of ~18 hours. Figure 13 reveals no surprises in the distribution of current levels. Despite this, no system instability was apparent, given the Linpack result. All runs passed, and the integrated graphics continued to produce output as expected.

Fig. 13. Extreme duration “Full” test condition of TRIUMF Board and fresh DUT showing current levels drawn from +12V rail. Peak power reached 135 Watt.

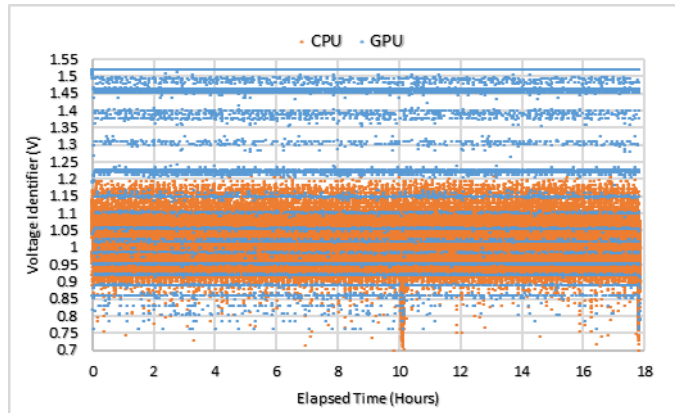
Fig. 14. Voltage Identifier (VID) levels requested by processor and GPU cores during extreme test.

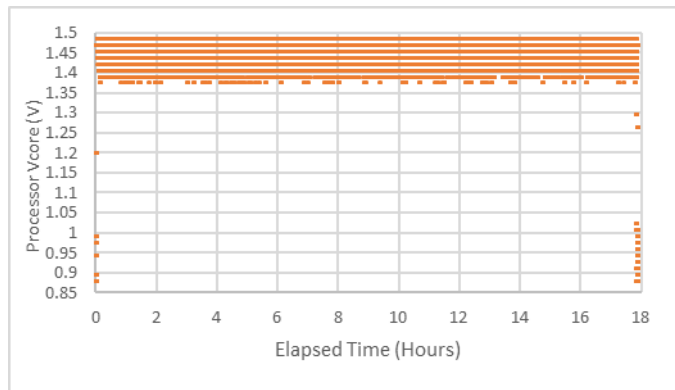
Fig. 15. The actual voltage levels being provided by the motherboard to the DUT.

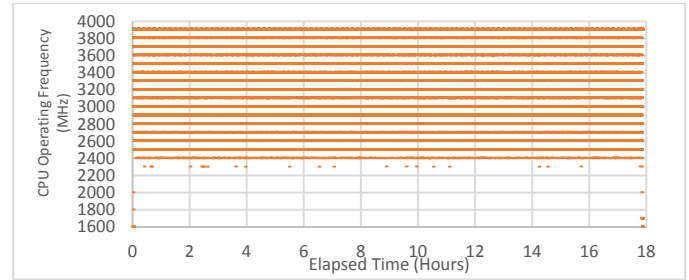
Fig. 17. Operating frequencies during the extreme “Full” test.
