Electrical Failure of an Accelerator Pedal Position Sensor Caused by a Tin Whisker and Discussion of Investigative Techniques Used for Whisker Detection

- Describe the failure of a Accelerator Pedal Position (APP) sensor caused by a **TIN WHISKER***
- Describe the failure analysis methods used to identify **TIN WHISKERS** as the root cause of failure
- Convey guidance to failure analysts/troubleshooters for improved techniques to electrically detect metal whisker-induced short circuits

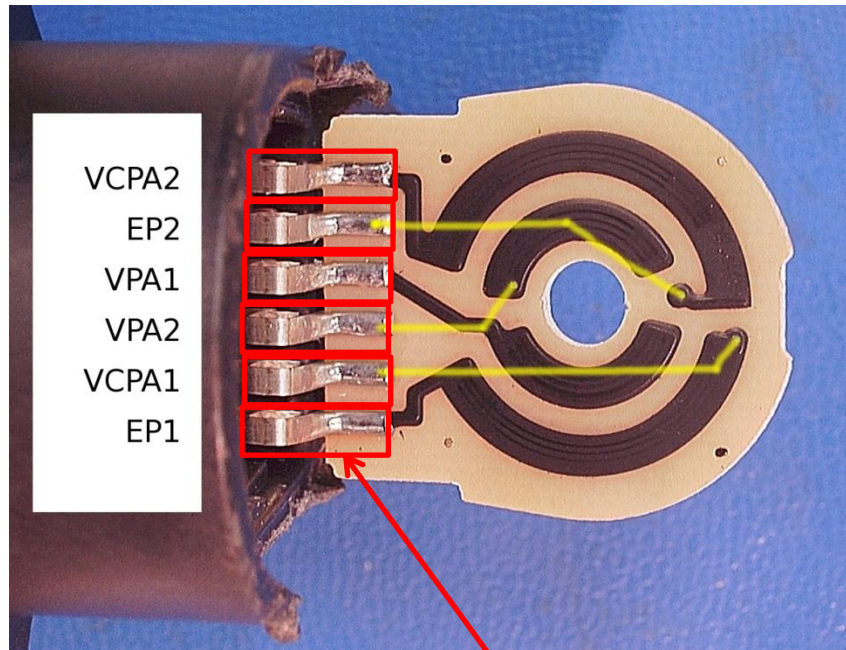
Partially Disassembled Dual Potentiometer-Based APP Sensor

- Ribbon Leads are a Copper Alloy Coated with 2 μm of Pure Tin
 - Confirmed by XRF & EDS
- No other coatings present on Ribbon Leads (i.e., no conformal coating over them, no intermediate plating layers)
- Separation between adjacent terminals varied from 1000 to 1500 μm
- Dual potentiometers produce independent electrical signals based upon pedal depression angle (VPA1 and VPA2)

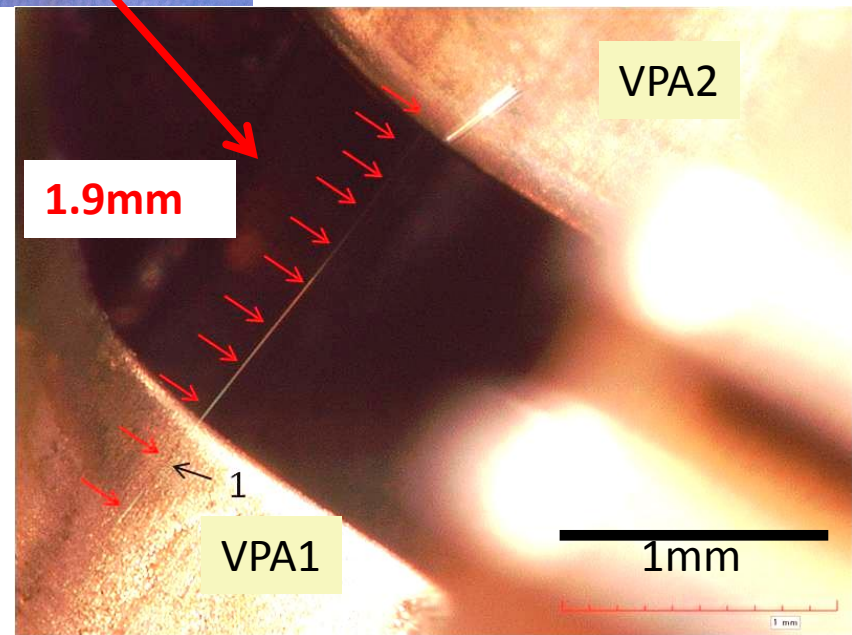
Tin Whisker Shorting Between VPA1 and VPA2

Calculation of Thickness of the Bridging Whisker from Measured Resistance and Length

$$R = \rho \frac{L}{A}$$

- Where ρ = resistivity of Sn $\sim 11.5\mu\Omega$ cm;
 - L = length of whisker;
 - A = cross sectional area of whisker = $\pi \frac{d^2}{4}$
where d = diameter of whisker (approximating thickness of whisker)
- Therefore, since L= 1900 μ m, R = 238 Ω , then
 $d \sim 1.1 \mu$ m
 - This is in line with typical thicknesses of tin whiskers
