Space Shuttle Program Tin Whisker Mitigation

Keith Nishimi - United Space Alliance, LLC

International Symposium on Tin Whiskers

April 24-25, 2007

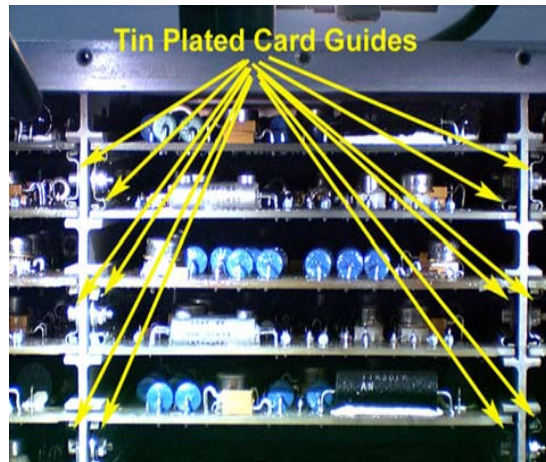
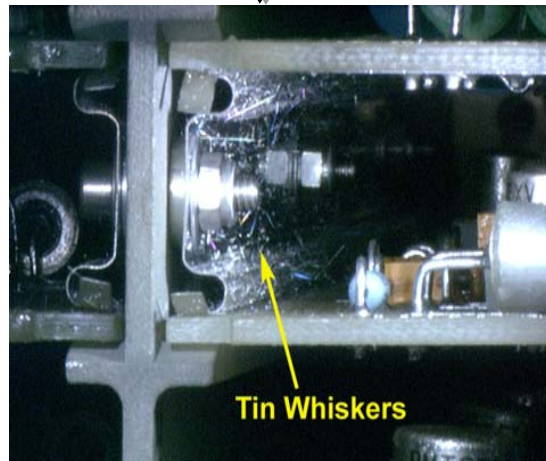
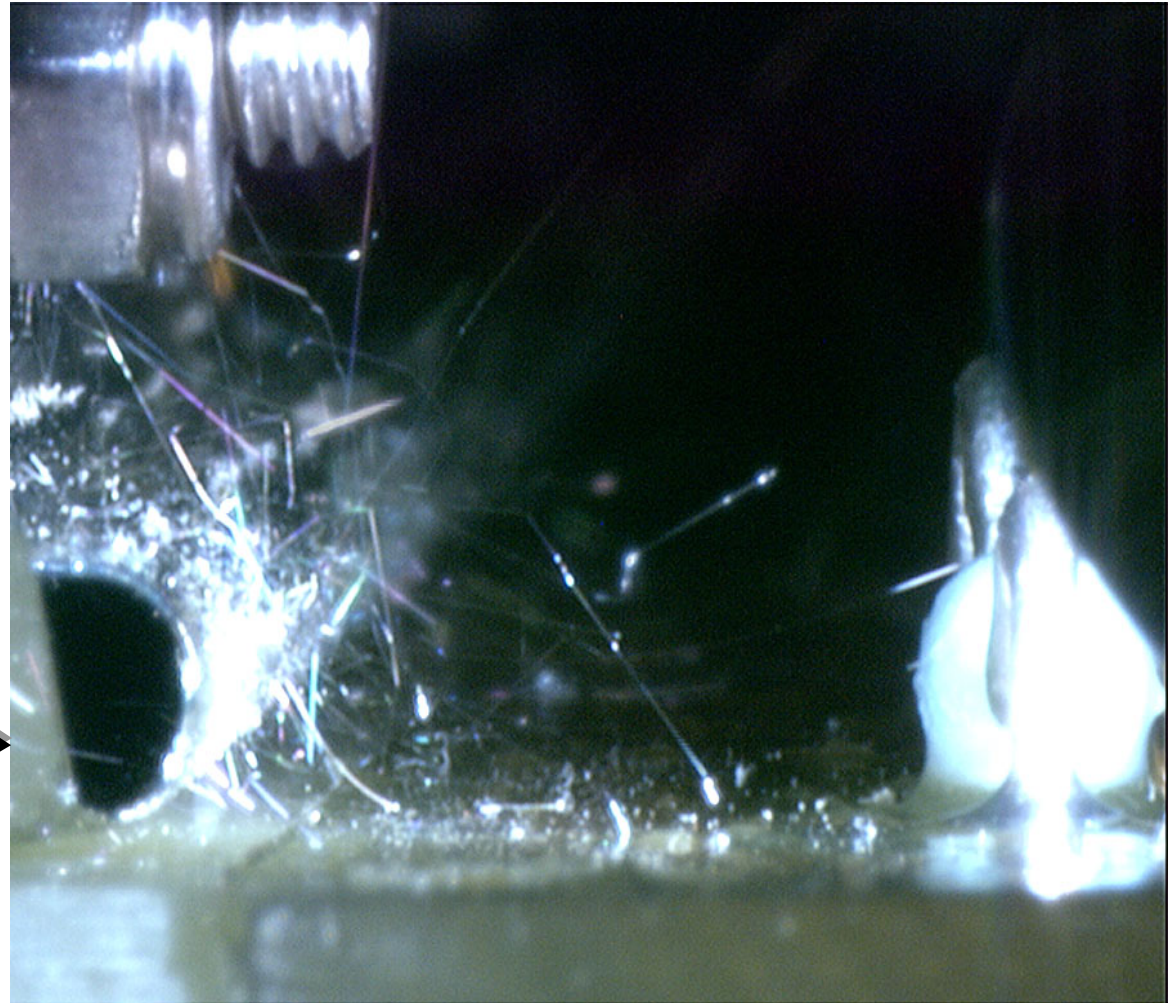
Internal Photos of Tin Whisker Growth

- Whiskers grew from pure tin plated circuit card retainers, not from electrical components
 - Intent of tin plating in original design was for corrosion protection of BeCu retainers
- Immediate Concerns:
 - All FCS avionics boxes in the same family were similarly designed and could fail because of TW
 - Whiskers could either grow into conformal coating, or touch electrical components having inadequate coating
 - Active concern for July 2006 launch; particularly if no clean spares exist to rotate into vehicle
 - How can the Program ensure that other Space Shuttle hardware isn't at high risk for TW failures?

- Box with cover removed illustrates progressively finer detail

- Remediation plan developed:
 - Avionics Lab: Remove tin plating and TW
 - Expedite procurement of non-plated card retainer assemblies from vendor
 - Cycle boxes through Lab
 - Incoming testing, disassembly / card removal
 - Assess gross order-of-magnitude quantity of loose whiskers
 - Clean chassis and circuit cards
 - Cards pass magnified inspection
 - Conformal coating touch-up via brush coating as needed
 - Reassemble with non-plated card retainers
 - Full acceptance testing at box level: vibration, thermal, functional
 - Flight Operations: Prioritize Reaction Control Jet firing to minimize likelihood of critical risks
