Relay failures induced by the growth of tin whiskers. A Case Study.

Craig Stevens
The FOXBORO COMPANY

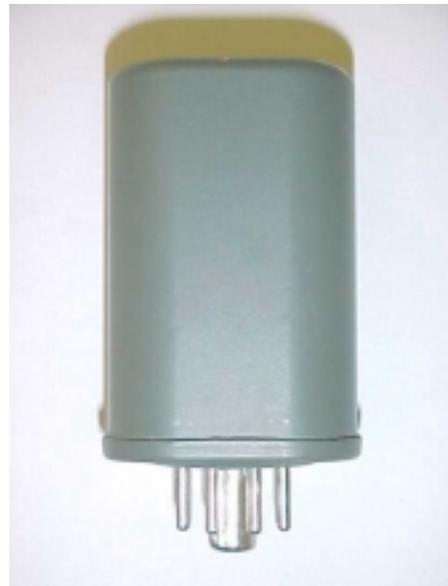
Overall view of relay

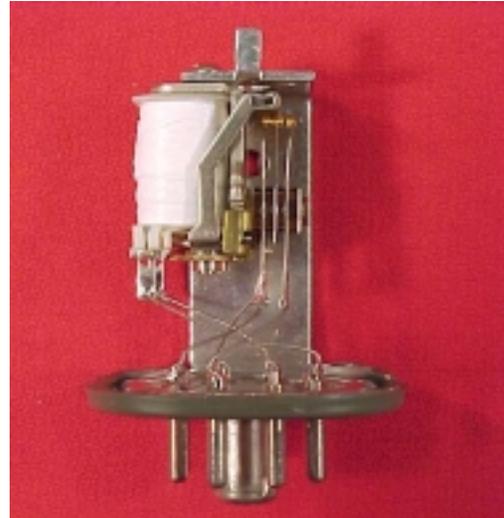
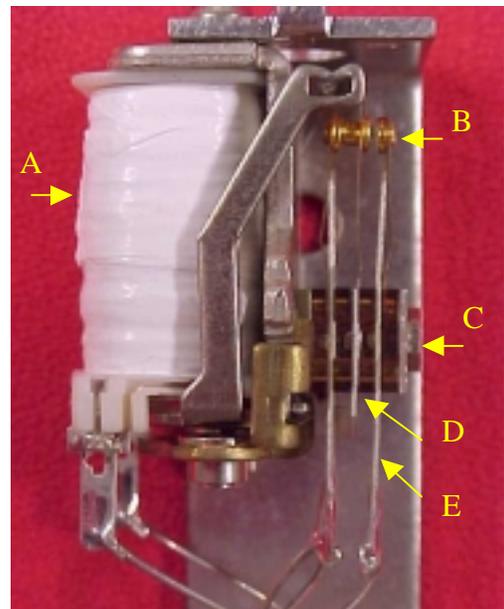
Higher magnification of relay assembly:

Depicted at right are internal components of relay.

A = Coil assembly.

B = Normally Closed & Normally Open Contacts.

C = Contact support arm mounting assembly.

D = Area D – Contact support arm insulator. (Discussed later in report).

E = Contact support arms (3 total).

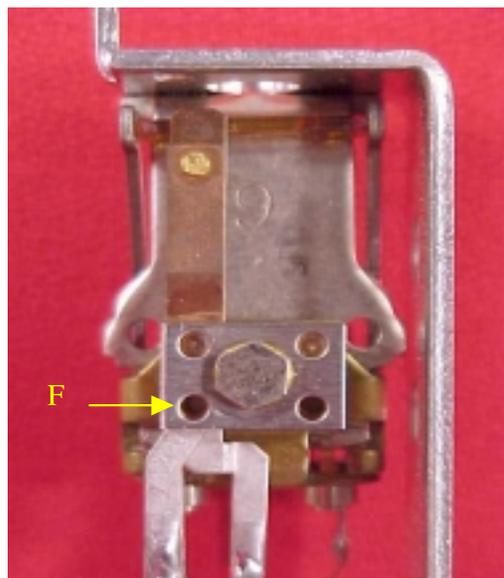
Right angle view:

Illustrated is the contact support arm mounting assembly (C in above photograph). Contact support arms are visible extending from bottom of insulator assembly.

F = Insulator guide hole & keyed insulator assembly. Assembly is held in position by hex bolt. Area detail is discussed later in report.

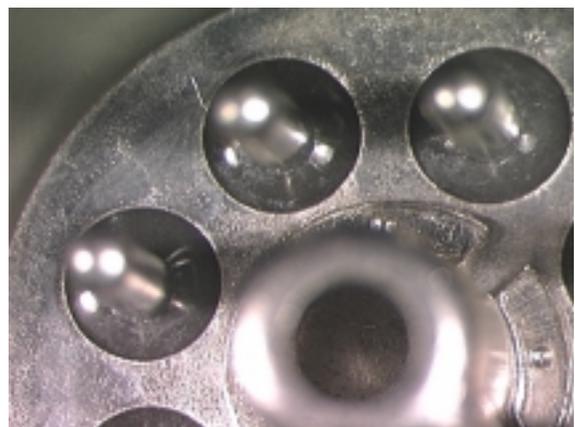
Log# 990 30008

Utilizing high magnification, examination of the internal components revealed the growth of extremely small diameter tin whiskers at the N.C. terminal and on the inside of one insulator guide hole. The following photographs provided by the supplier illustrate the tin whisker growths.

Presence of "Tin Whiskers" inside one of the insulator alignment cavities

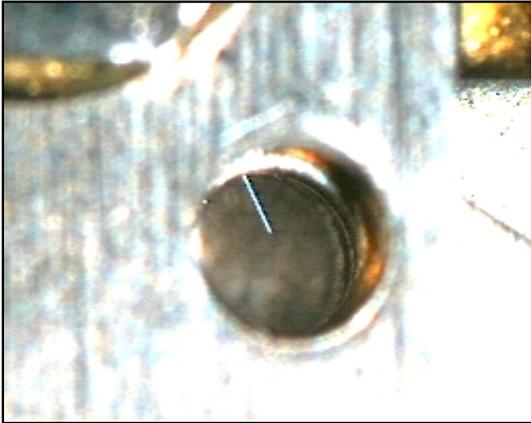
Tin Whiskers

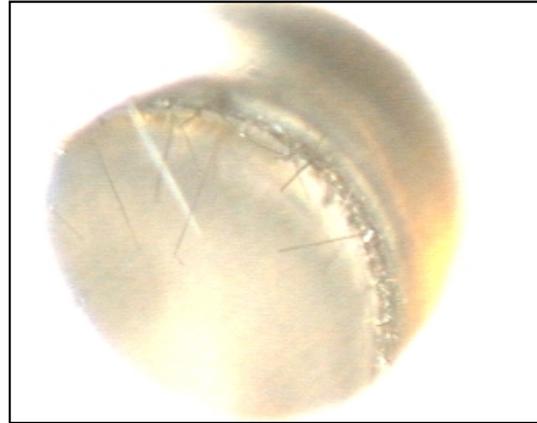
Tin whisker on N.C. terminal
(near insulator)

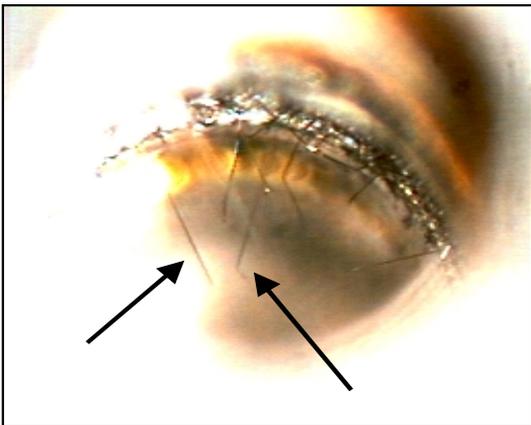
Upper Left, Upper Right & Lower Left Images: High magnification images of tin whiskers detected inside one insulator guide hole (*page #3 'Arrow F'*).

All whiskers were detected in areas where high mechanical stress existed.

The supplier's Staff Chemist confirmed that the plating on the contact support arm is pure tin. The utilization of pure tin plating was enacted as a cost reduction effort in 1981 when the supplier changed manufacturing sites. Production of this particular relay was discontinued in 1993 by the supplier.

Due to the potential safety issues associated with the root-cause and application of the relay by both commercial and Nuclear customers, it was determined that customer notification was warranted. A relay replacement program was established. Such activity covers all relays supplied by this particular relay supplier. It is recommended that all relays utilized in applications where switching potential are not large enough to produce a spark during relay operation, be replaced with a similar relay supplied by another qualified supplier.

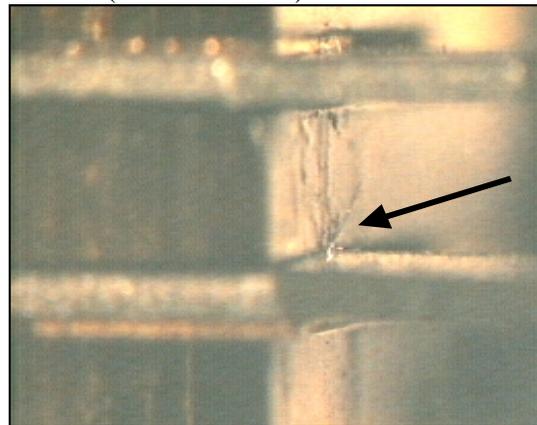
Lower Right Image: Depicted in this image is the area between contact support arms adjacent to the support arm insulator (*page 3 'Area D'*). Arrow in photograph points to tin whisker detected near insulator.
