# GSFC NASA ADVISORY

1. **Advisory Number**  
NA-GSFC-2004-01

2. **Subject**  
Indium Solder Encapsulating Gold Bonding Wire Leads to Fragile Gold-Indium Compounds and an Unreliable Condition that Results in Wire Interconnection Rupture.

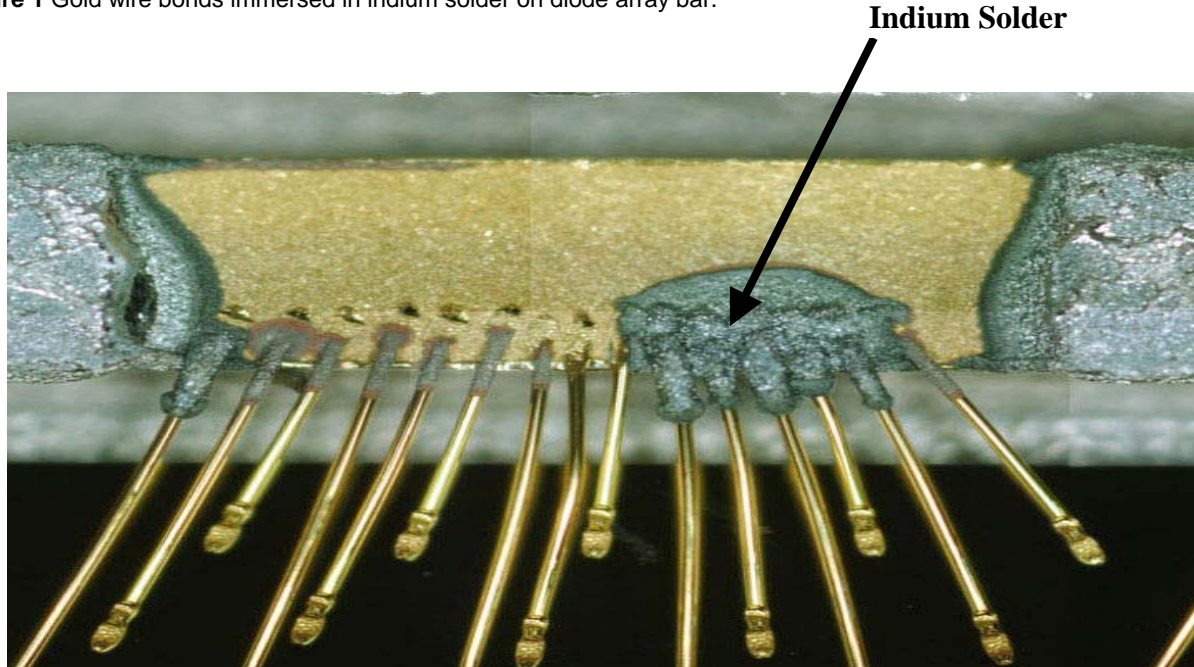
A NASA GSFC satellite recently experienced cessation of laser beam activity for a laser after 36 days of on orbit operation. This was attributable to a laser diode failure. The laser diode root cause failure mechanism was the degradation of the gold bond wires by indium solder. At the interface region of gold and indium, the gold bond wires were transformed to fragile gold-indium intermetallics, which eventually resulted in an electrical open after a number of thermal cycles.

As illustrated in Figure 1, the gold wire bonds of a diode array are immersed in indium solder. This indium solder was used as the attachment material to secure adjacent diode arrays. Apparently, in the assembly process, the indium solder reflowed into the wire bond region and encapsulated these wire bonds in the process. When the molten indium solder encapsulated the gold wire bonds, there was a rapid growth of gold-indium intermetallics. Afterwards, the intermetallic growth continued but at a slower rate. The brittle intermetallics eventually fractured due to fatigue failure after a number of thermal excursions. After fracture of a given wire, the remaining wires conduct more current, thereby accelerating the thermal excursions. When enough wires fracture, the remaining ones melt; the last ones vaporize. During gold wire vaporization, a multi-amp current results which causes the given laser diode array to destruct. Since the laser diode arrays are connected in series, the destruction of one diode array results in an inoperable laser.

Figure 1 Gold wire bonds immersed in indium solder on diode array bar.

- 1) All flight projects should perform a Destructive Physical Analysis (DPA) on a representative sample of laser diodes and detectors to inspect for the presence of indium in contact with gold.
- 2) All flight projects should review their projects to ensure that any gold wire (e.g. gold wire bond) is not in contact with indium or an indium alloy (i.e. indium solder).

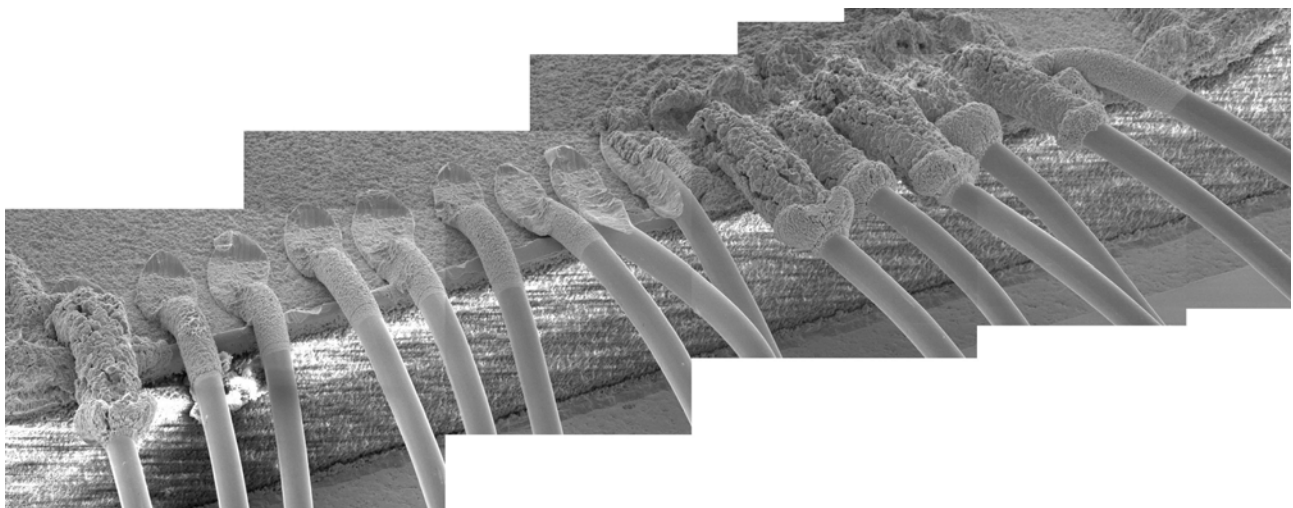
Indium reacts with gold to form a succession of gold-indium intermetallic compounds. Consequently, the original gold mechanical and thermal properties are degraded by this intermetallic reaction. The brittle gold-indium intermetallics cause an unreliable electrical interconnection. An electrical open can occur if there is an interconnection rupture of the fragile intermetallic region. The intermetallic rupture could occur as a result of thermal cycling.

Figure 2 A close up view of the gold wire bonds encrusted with indium on the diode array. The encrusted gold has been transformed into a gold-indium intermetallic that is mechanically brittle.

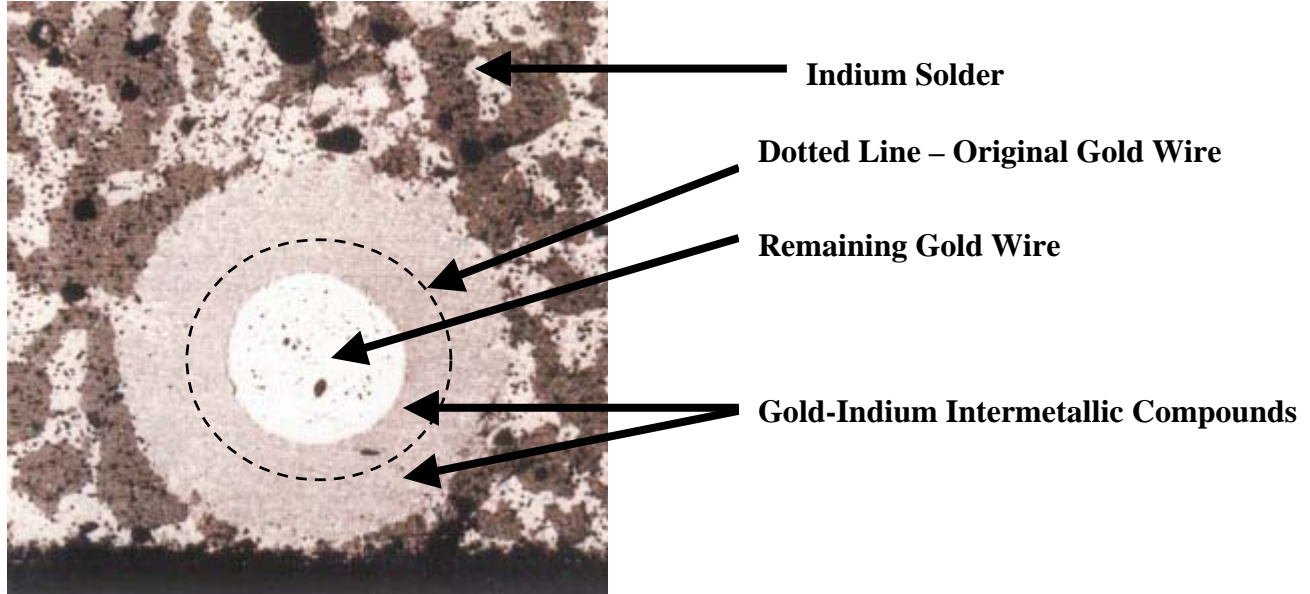
The Goddard Materials Branch has demonstrated that the gold-indium intermetallic formation occurs significantly even at room temperature and at an enhanced level at elevated temperatures. The volume of the gold-indium intermetallic section occupies approximately four times the original volume of the consumed gold. Figure 3 is a cross-section of the gold wire with a formation of gold-indium intermetallics, which shows that a similar volume increase occurred after about 90 months at room temperature.

**Figure 3** Photo (Gold wire cross-section surrounded by indium) is courtesy of the University of California, Lawrence Livermore National Laboratory, and the Department of Energy under whose auspices the work was performed. Arrows and dotted line are added to illustrate how the original gold wire has shrunk in diameter and also shows the development of an intermetallic compound section that has grown after approximately 90 months at room temperature.

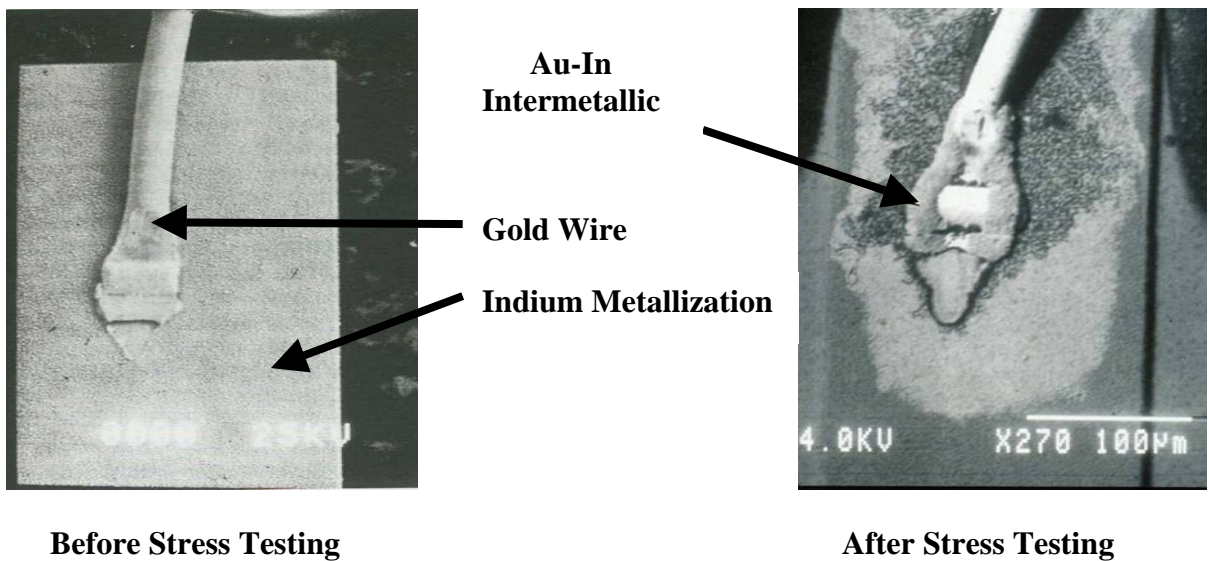
See page 4 for figures 3 and 4. The University of California, Lawrence Livermore National Laboratory, and the Department of Energy under whose auspices the work was performed provided Figure 3 that illustrates the growth of gold-indium intermetallics at room temperature. Dr. George G. Harman of the National Institute of Standards and Technology provided Figure 4, which depicts gold-indium intermetallics that formed after terrestrial stress testing at the gold wire bond to indium metallization interface of a GOES weather satellite IR detector.

**Figure 4** Photos are courtesy of Dr. George G. Harman of the National Institute of Standards and Technology (NIST). GOES HgCdTe, 77K, IR detector (Wire is Gold, Pad is Indium: Intermetallics are Obvious!). Low-Temperature Space Devices may be Damaged during Terrestrial Stress-Testing.
