COTS Trends in DPA Results from 2020

Presented By: Trevor A. Devaney

Presented to: NEPP ETW

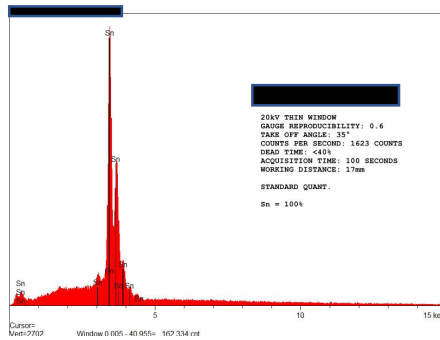
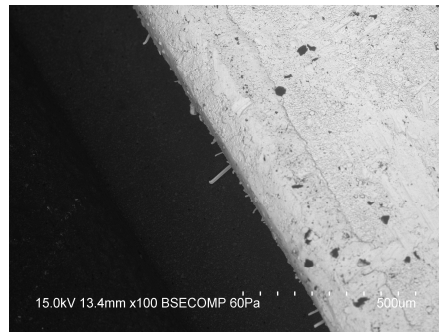
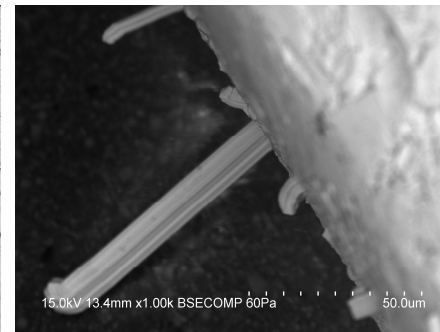
COTS – External PMA Failures

A high tin content surface finish (≥ 97 wt%) was the primary cause of external PMA failures. This surface finish is susceptible to whisker growth.

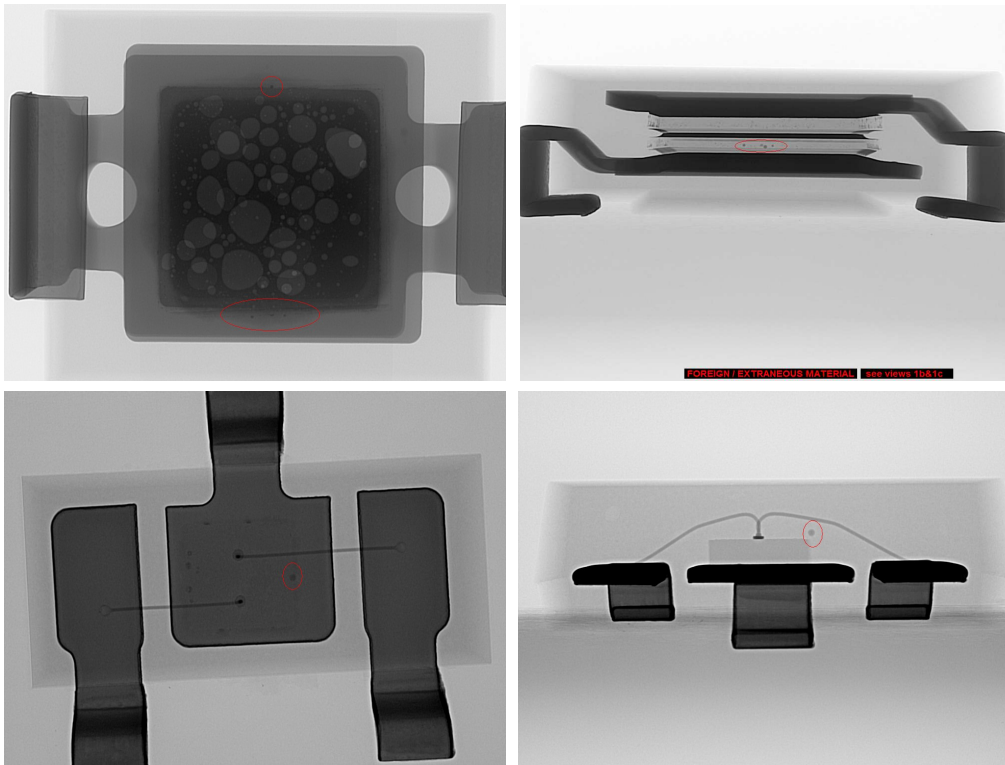
COTS – Radiography Failures

Majority of radiography failures are a result of embedded foreign/extraneous material within the encapsulant. The risk associated with this condition is likely minimal.

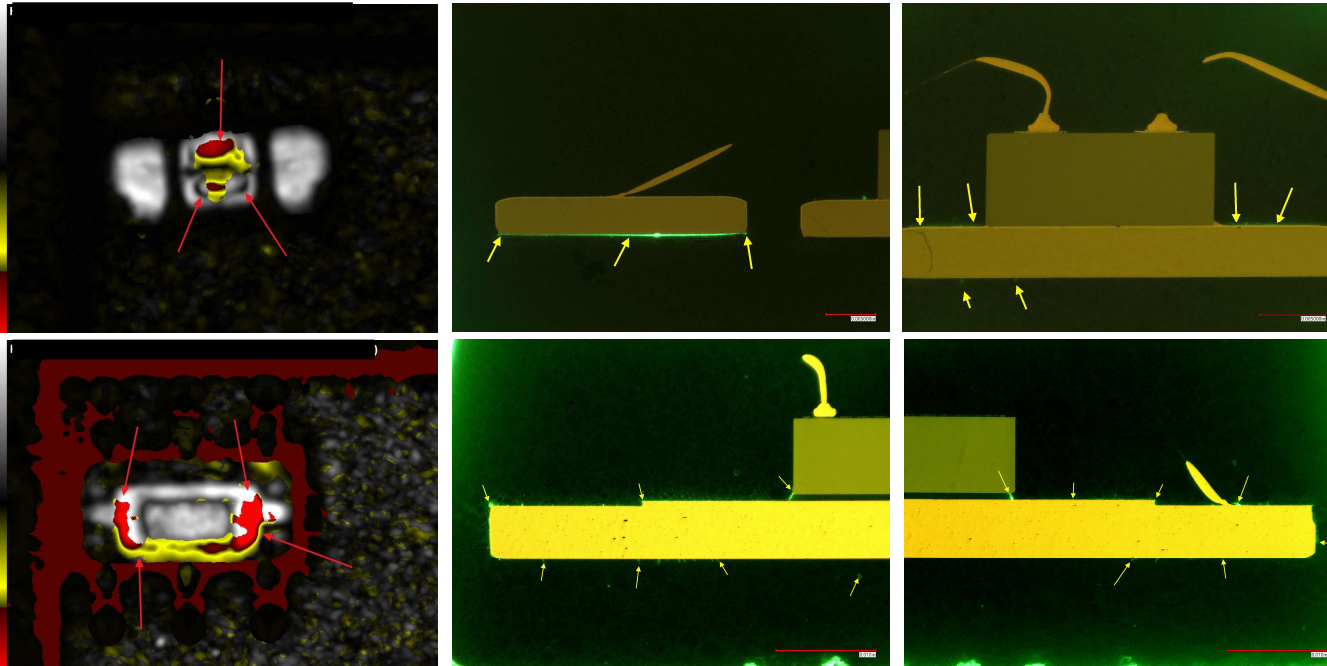
COTS – SAM Failures

Majority of SAM failures have an ingress path from the outside world to the internal construction features. These pathways can potentially allow for manufacturing or end-use environmental elements to contact sensitive features within the device resulting in leakage, corrosion, etc. This is a particular concern with copper wire bonded devices.
