# NASA GSFC EEE Parts: DPA and FA Summary

Lyudmyla Ochs

NASA GSFC Code 562 EEE Parts, Photonics and Assembly Branch

June 16, 2022

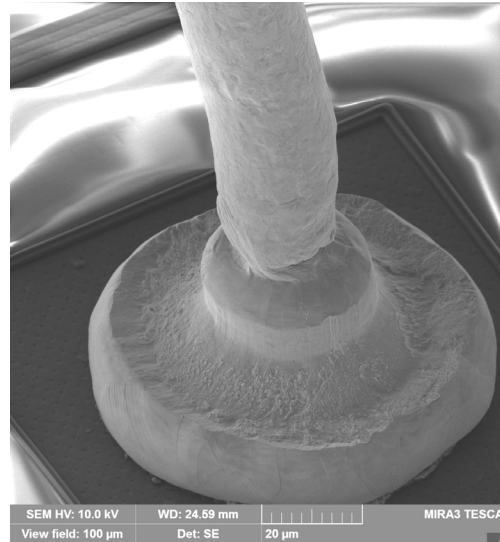
Wire necking above the gold ball bond – reduced wire pull strength

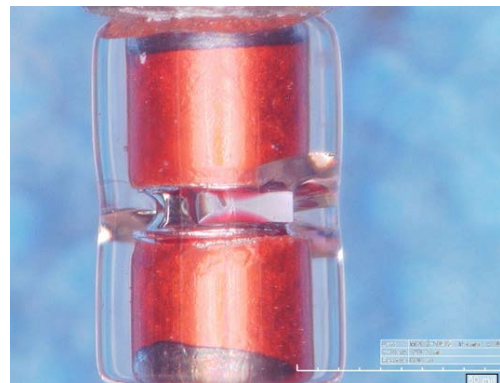
Gross Leak failure of diode – red dye penetrated through a crack to the die

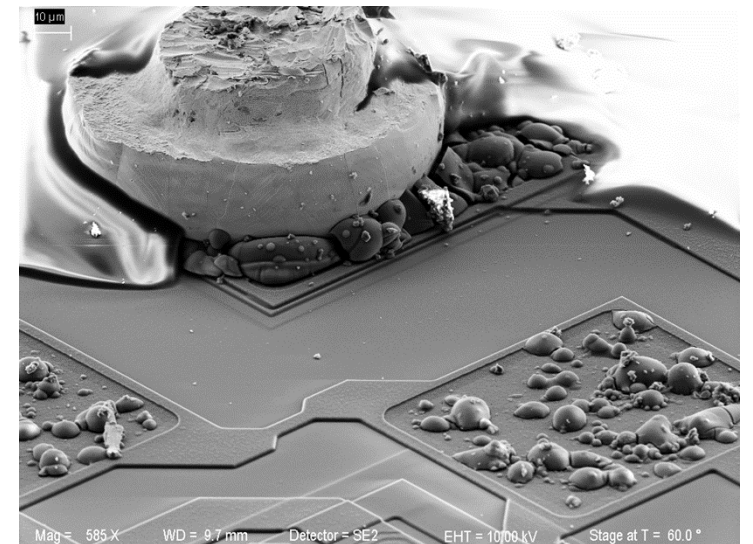
Corrosion of aluminum pad due to moisture ingress and elevated temperature exposure during screening

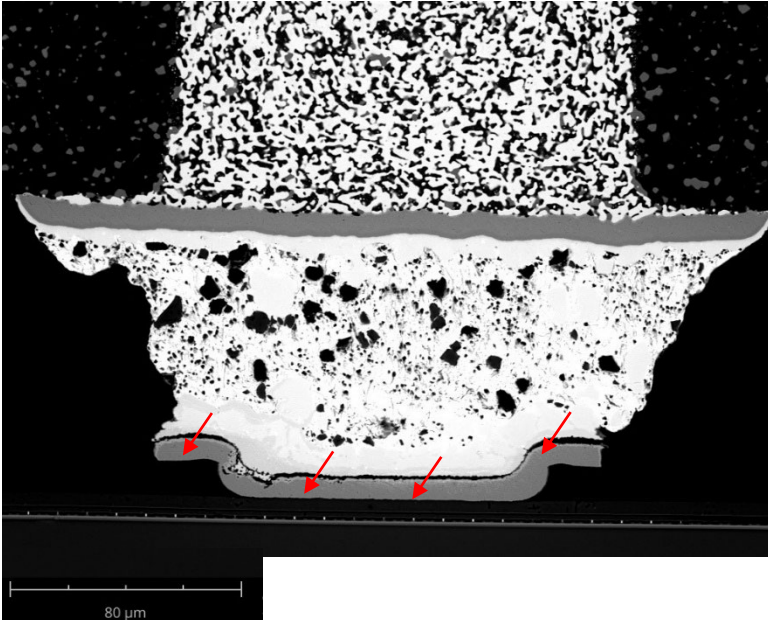
SEM view of underbump with a separation along the Au-Sn intermetallics

- Part:
  - Commercial microcircuit inside a hermetic package
- DPA failure:
  - Observed Au-Sn intermetallics along both sides of the solder bump
  - Some bumps showed a separation of solder bump along the intermetallics
  - Parts were solder dipped in an uncontrolled manner by user, which may have contributed to the separation
- Disposition:
  - Not recommended for flight use
  - Attention should be paid to presence of Au-Sn intermetallics in future lots

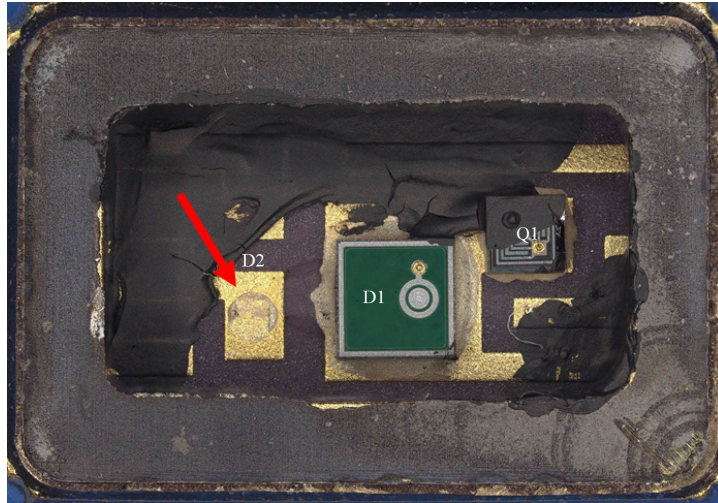
*Optical view of delided device after die shear. Missing D2*

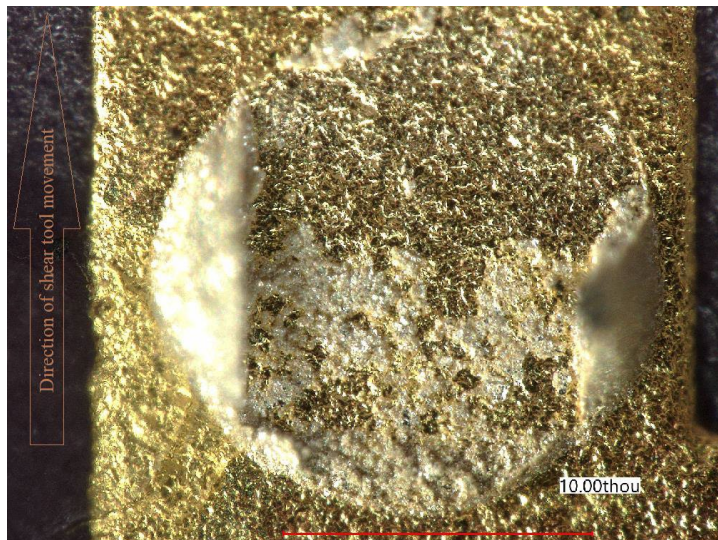
*Close-up view of the epoxy with D2 sheared off at 0g-f*

- Part:
  - Optocouplers in hermetic ceramic package
  - Parts are commercial with JANS-like screening
- DPA failure:
  - 1/5 submitted to die shear exhibited the LED die failing below the 1X limits
  - Tester indicated that die was moving as soon as shear tool made contact and measured result is invalid
  - LED die must be chemically exposed from the light pipe material, which may have resulted in damage to the bonding characteristics. The other four devices exhibited LED shear levels slightly above the 2X limit, and were all in family
- Disposition:
  - Not recommended for flight use
  - Project has designed part out of the system. Lot may be usable in future applications but will require evaluation of the DPA results

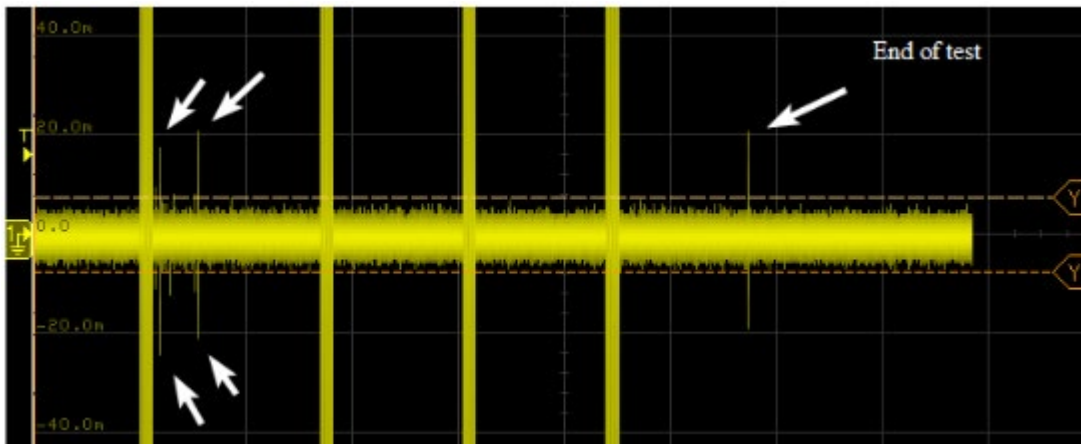
- Part:
  - Transistors in TO-can packages
  - Part is commercial, rad-hard, manufactured on MIL-PRF-38535 Level V (with modification)
- DPA failure:
  - 1/3 failed for Particle Impact Noise Detection (PIND)
  - Particle capture attempted, but unsuccessful
- Disposition:
  - Remainder of the lot subjected to PIND with no failures
  - Recommended use-as-is due successful completion of PIND

*PIND scope recording of failure*

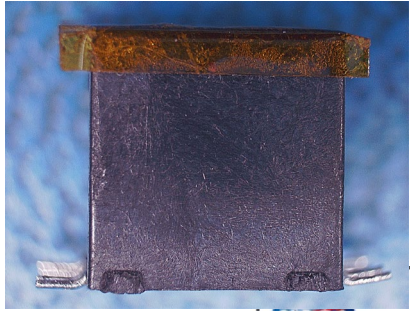
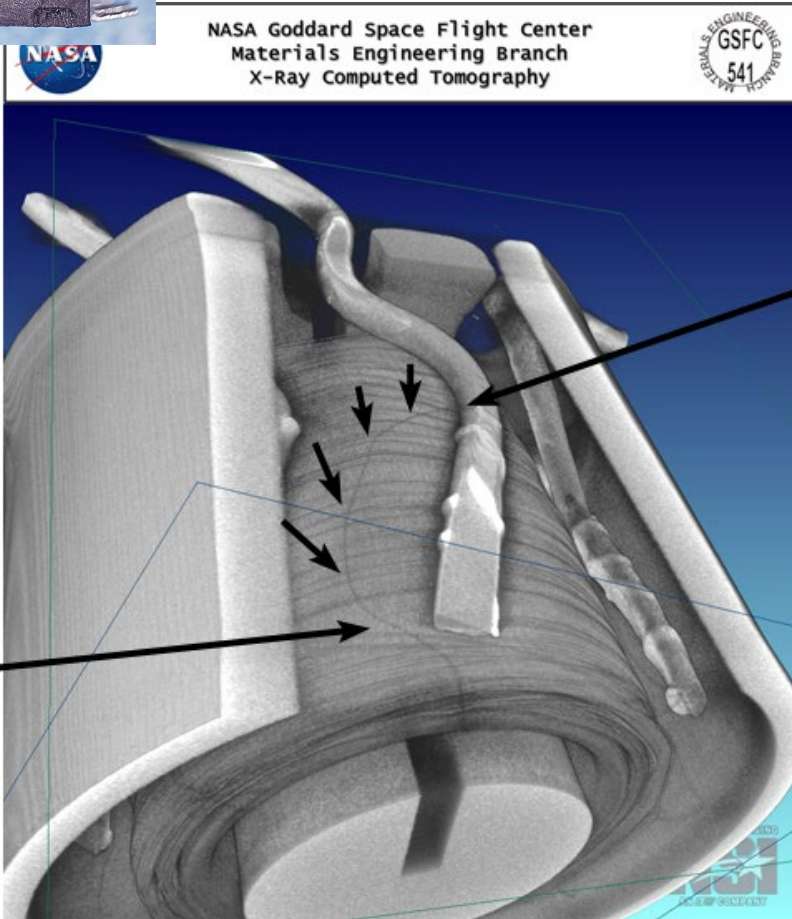
- Part:
  - Commercial transformer used on engineering (non-flight) board failed open circuit
- Failure description:
  - Failure traced to a break in wire
  - Wire is 1mil (~ AWG52), which does not meet MIL-STD-981 requirements
  - There is a separation between the mold compound and the surrounding tape near the break in the wire. It is suspected that the wire traversed the void/separation in the mold compound, and mechanical stress during temperature changes broke the wire at the transition from molding compound to the void
- Disposition:
  - Do not use this lot for flight
  - For flight, project procured a lot of same construction parts with screening that included temperature cycling

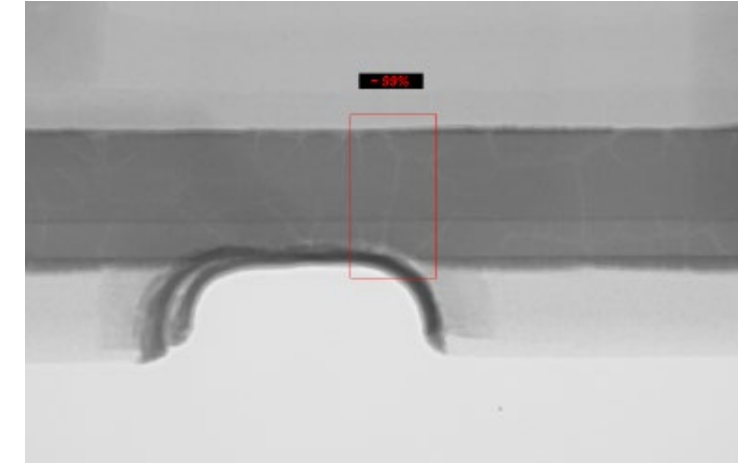
Close-up X-Rays of the package showing void in solder lid seal

IGA results of three packages with lid seals showing voids >99% IGA results show a hermetically sealed device

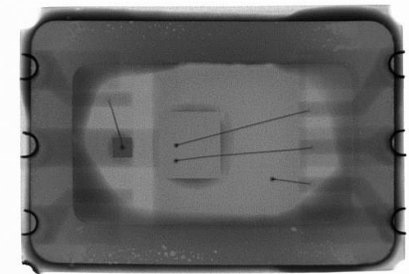
- Background of parts
  - A commercial device screened to MIL-STD-883
  - Package style: UBA
  - Hermeticity test at manufacturer results: fine leak (147 passed/1 failed) and gross leak (147 passed/0 failures) passed.
  - X-Ray of 30 received units showed all units with lid seal voids in excess of 75%, with many units showing lid seal voids spanning 95% of the seal
- Test Plan
  - 30 units with lid seal voids in excess of 75%, and 5 control units with lid seal passing MIL-STD-883 TM2012 criteria

*X-Rays of the package showing void in solder lid seal*

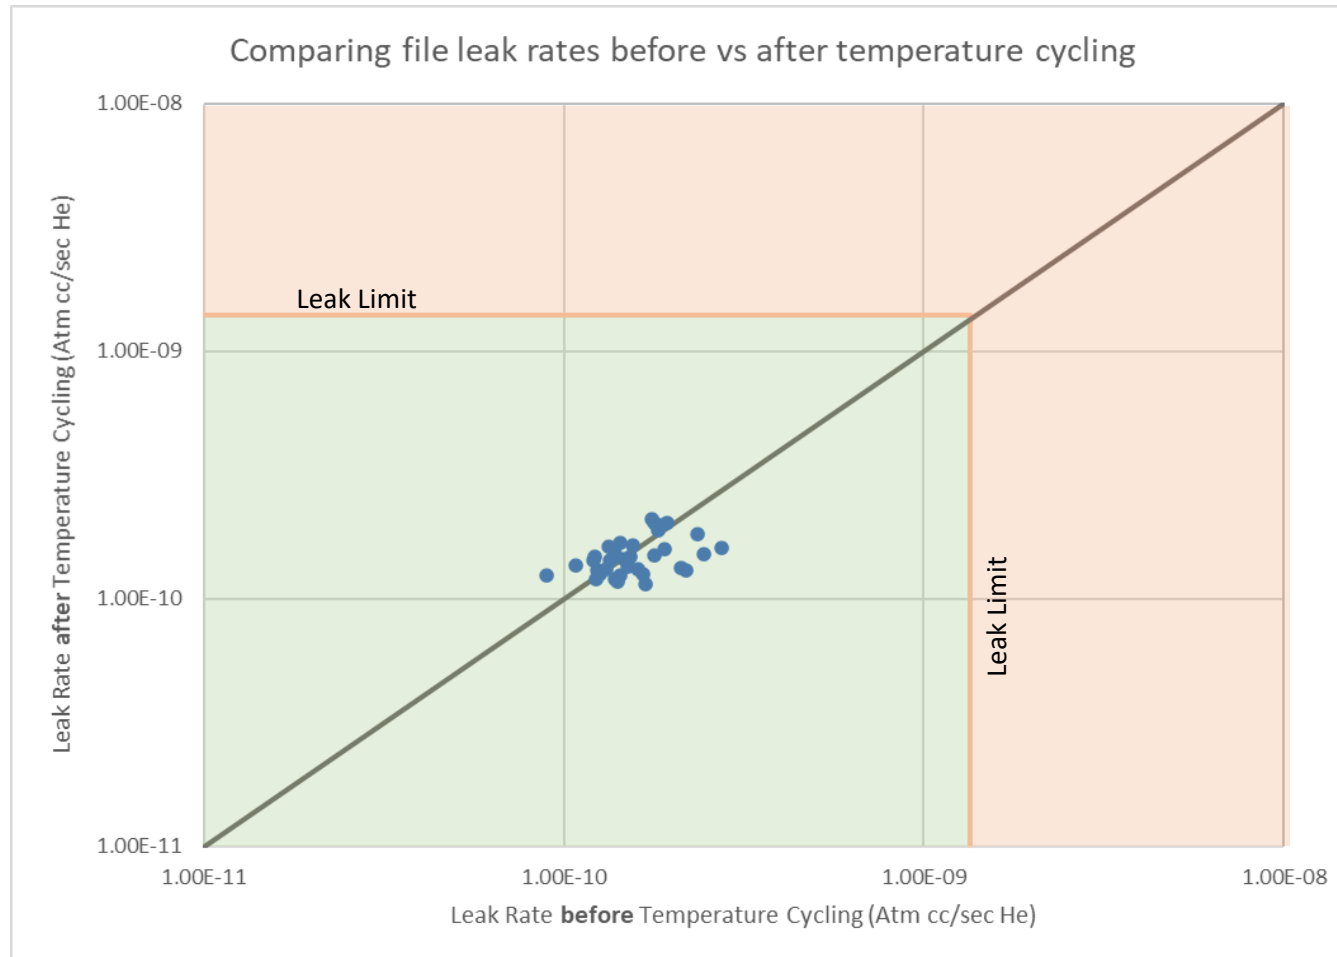
- 35 units tested for fine and gross leak before and after temperature cycling
  - 30 units with lid seal voids >75%
  - 5 units with lid seal voids <75%, as controls
- All units passed fine and gross leak before and after temperature cycling
- Fine leak measurements show consistency before and after temperature cycling
- Notes on graph:
  - Red area on the graph for leak rates failing fine leak limit
  - Green area on the graph for leak rates passing fine leak limit
  - Grey diagonal line – readings on the line mean there was no change before and after temperature cycling

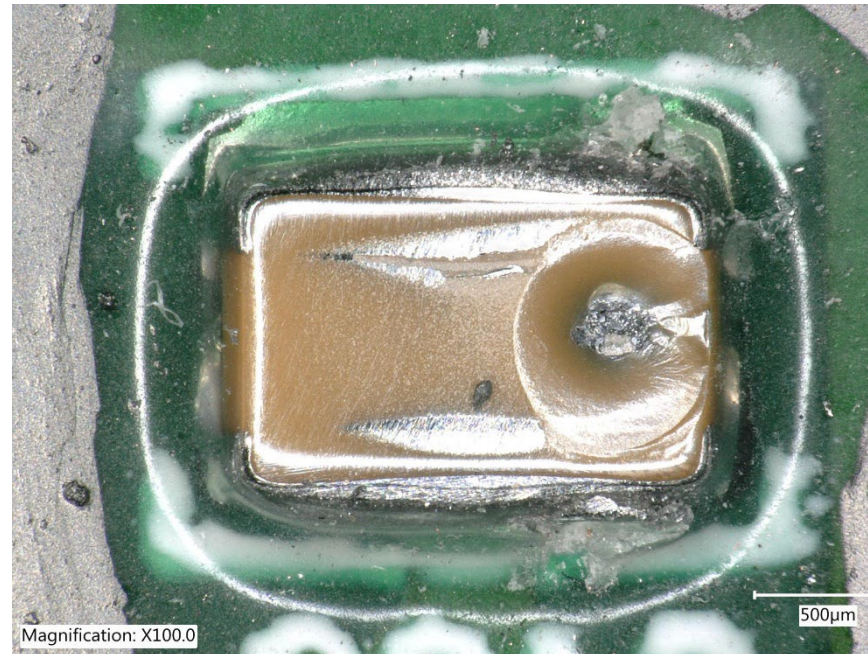
Multilayer ceramic chip capacitor with a cone-shaped piece of top plate separated after internal electrical short
