Heavy Ion SEE Test Report for the Samsung 4Gbit NAND Flash Memory for MMS

Test Date: 8-9 March 2009

Report Date: 2 April 2009

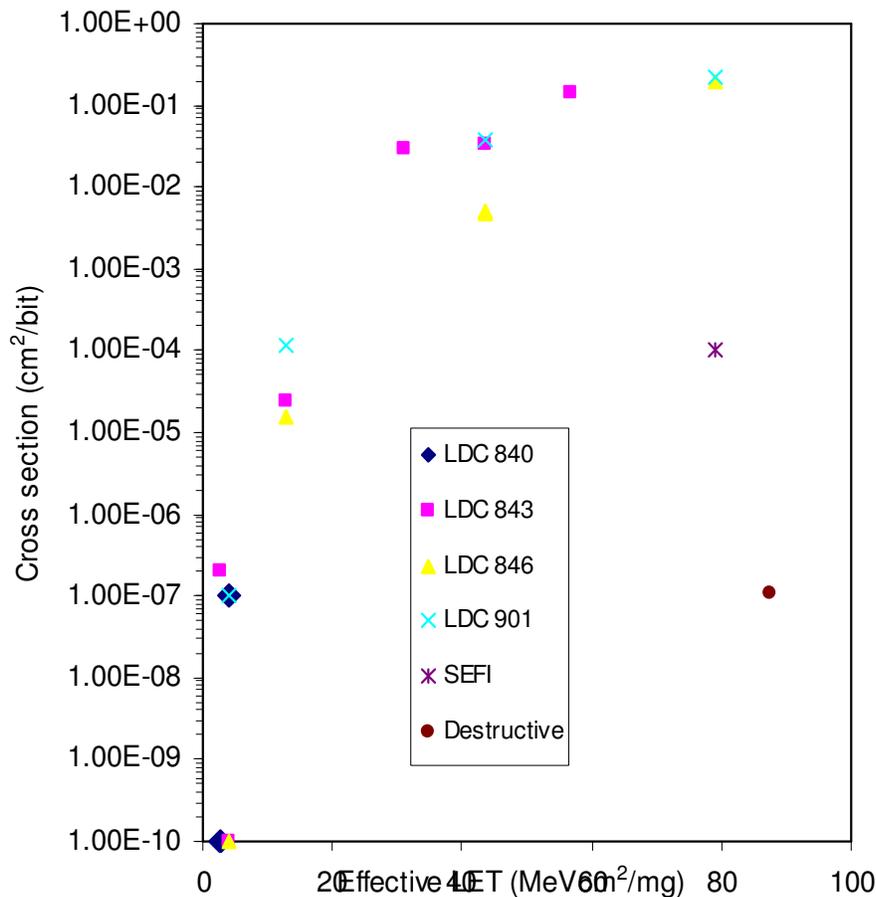
Fig. 4. Results in static, unbiased test mode.

Even for the static unbiased case, bit errors and one SEFI (LDC 0843) and one destructive failure (LDC 0840) were observed. The SEFI, which occurred with Xe ions incident at 45 degrees, was that blocks 0-15 were completely corrupted. The stored pattern (checkerboard, AA) was replaced with all ones (FF). Cycling power did not correct the errors, but the DUT was erased and rewritten successfully before the next shot. The destructive failure, which occurred with Au ions at normal incidence, was the failure of the erase circuit—the part still worked in read mode, but the pattern could not be altered. The failure of the erase function was probably due to damage to the charge pump, which was surprising only because the charge pump was unbiased. There does not appear to be any gross difference between any of the LDCs, in Fig 4. However, we were not able to take multiple shots at any test condition, in general, because of the need to repeat everything for the four different date codes. Therefore, the statistical confidence comes from the fact that the date codes give consistent results, and not from the fact that there is a lot of data for each date code. We believe the probability of errors in the control circuits is increased at high angles because more charge is generated close to the surface and over a wider area, and, therefore, closer to multiple active device regions. That is, charge sharing between multiple sensitive nodes is increased, compared to an exposure at normal incidence. Because the DUT was not actively exercised during the static exposures, we could not determine exactly when a SEFI or destructive failure occurred, so cross sections are approximate for these error modes. Here and in the following discussion, bit errors are taken to be single bits, which are flipped, as a result of the interaction with incident ions, normally from zero to one. We do not have the physical to logical address mapping, which would allow us to look for

multiple bit errors (error clusters) for these parts. However, in the overwhelming majority of cases of bit errors, there is only one error in a page, or one error in an entire block, which makes it extremely unlikely that there will be multiple bit cells upset from a single ion. This result is consistent with previously published results on the upset mechanism in flash memory—an ion passing through a floating gate creates a dense charge column, which creates a conducting path between the gate and substrate, which allows charge to leak off the floating gate. Since the ion only hits one gate at normal incidence, only one bit is affected. This situation is far different from that in volatile memories, where charge generated in the Si substrate can be shared across multiple nodes. Here and in the following sections, the only apparent multiple bit errors are due to errors in the control logic, for example, cases where an entire page or a block (or a large part of one) upsets simultaneously. These page and block errors are attributed to errors in the control logic, rather than to the individual bit cells. These are counted as SEFIs (Single Event Functional Interrupt). In general, a SEFI is any event where the entire DUT, or a large part of it, stops working, presumably from an interaction with a single ion.

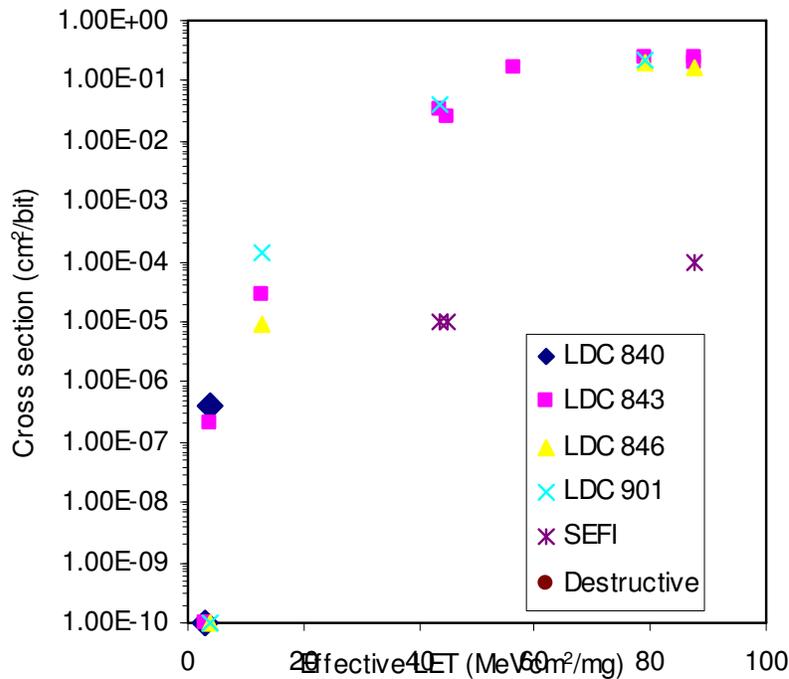
Fig. 5. Results for static mode, with bias applied.

The results for static mode with bias applied are shown in Fig. 5. The main effect is single bit upsets, along with three SEFIs, but no destructive events. The first SEFI, with Au ions at normal incidence (LDC 901) had 2400 five-bit errors after a power cycle. These were reset, and the part was used on the next shot. The other two SEFIs were both with Kr ions at 45 degree incidence (LDCs 0843 and 0846), with virtually the entire memory affected. Both parts largely recovered after a power cycle. The LDC 0843 part had 2559 bit upsets, which reset normally. The LDC 0846 part reported 377 remaining errors, but the error messages themselves appeared to have been corrupted, so the significance of the number is unclear, at best. However, the part reset properly, and was used on the next shot.

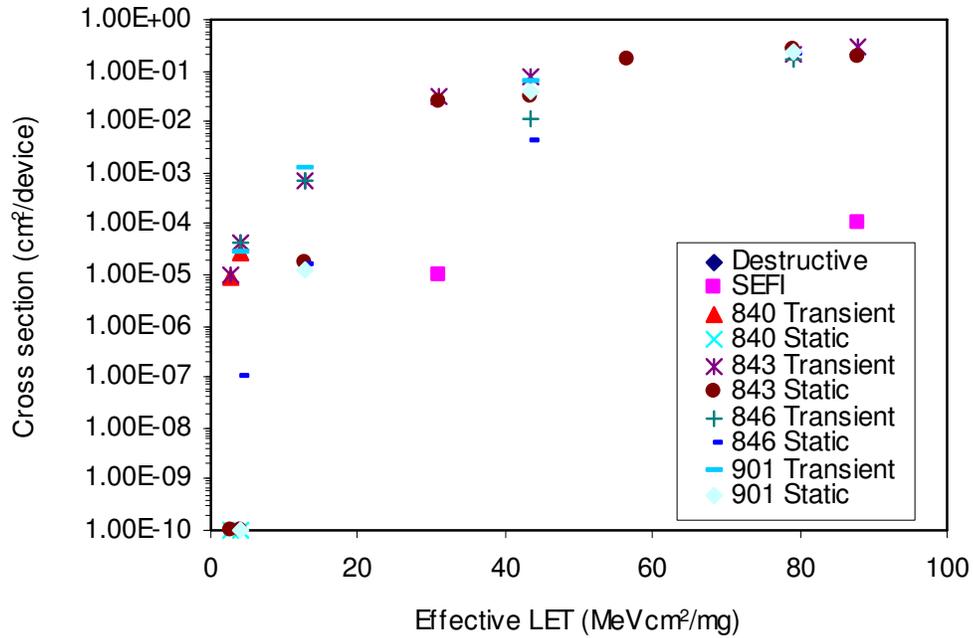
Fig. 6. Results for Dynamic Read mode.

For the Dynamic Read condition, the parts showed exhibited transient read errors in addition to the bit errors, which are plotted in Fig. 6. In this mode, the DUT reads continuously with the beam on. The significance of the transient errors is not always completely clear, because the entire memory is read multiple times, which means static errors will be read multiple times. In addition there are errors due to transient noise in the read circuit or the control logic. The static errors are bit errors read after the beam is turned off. In this test mode, there were two SEFIs and no destructive events. One was with Au ions at normal incidence (LDC 0843), and the other was a page error with Kr ions at 45 degree incidence (LDC 0843). In both cases, the part reset properly, and was used on the next shot.

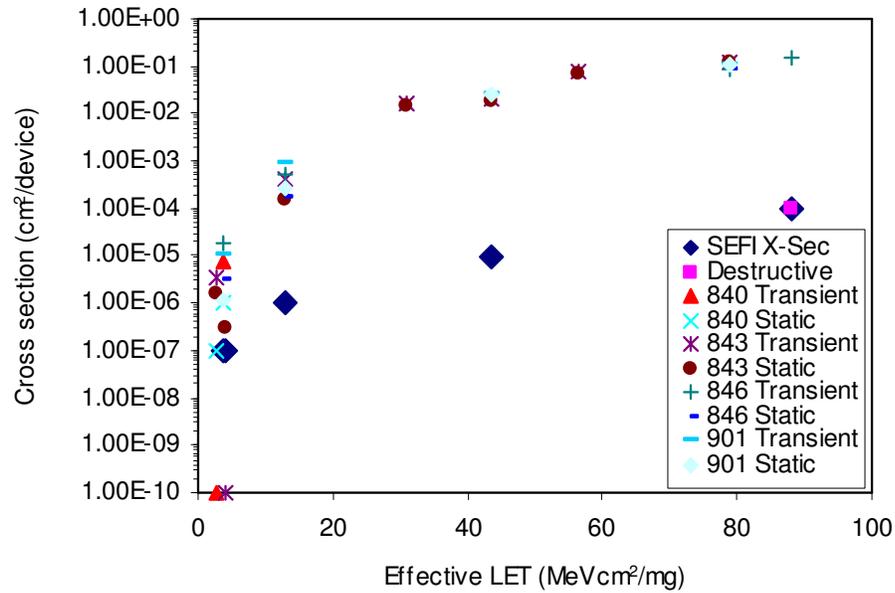
Fig. 7. Results in the dynamic R/W mode.

Results of the dynamic R/W tests are shown in Fig. 7. Generally these results are unremarkable, because the usual zero-to-one errors are rewritten as they occur. For this reason, there are fewer errors indicated than in Fig. 6, although the difference is not large. The main reason for including this test was the expectation that the high voltage write operation would contribute to more errors in the control circuits, which appears to have happened, but not on a large scale. Probably, this is because the write operation is performed only when a zero-to-one error is detected. For this circuit, there are relatively few such errors, so the write circuit duty cycle is a very small number. Where a static cross section is given, it is based on the number of errors detected after the exposure and resetting of the DUT, as before. The transient cross section is based on errors detected during the exposure. But some of the transient errors are probably really static bit errors that were rewritten during the test. In this mode, there were five SEFIs and one destructive event. The destructive failure was with Au ions at normal incidence (LDC 0846), when the erase operation could not be performed after the beam was turned off. This shot was also counted as a SEFI, because the DUT did not respond to commands until power was cycled. Two of the SEFIs were with Ne ions incident at 45 degrees (LDC 0840 and 0843). In both cases, the DUT would not respond to commands until power was cycled. There was one SEFI with Ar ions incident at 45 degrees (LDC 901). There were two page errors on that shot, which persisted after cycling power, but which were erased and rewritten successfully. There was also one SEFI with Kr ions at 45 degrees (LDC 0846), which was 65000 non-random errors. The DUT reset successfully.

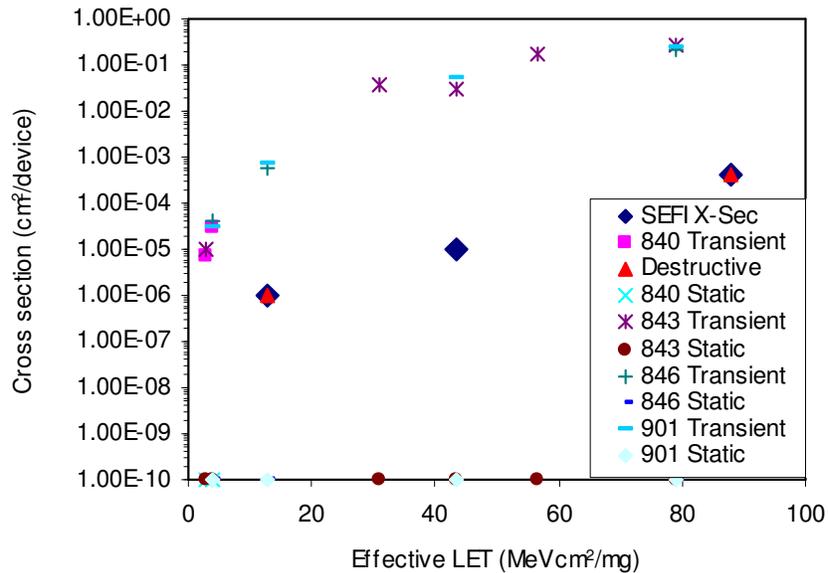
Fig. 8. Dynamic Read/Erase/Write results.

Results for the room temperature dynamic R/E/W tests are shown in Fig 8. In this mode, errors are counted as they are read, but then they are erased and rewritten. Therefore, there are no static errors read after the beam is turned off, and bits in error for a time are counted as transient errors. Because the high voltage erase and program operations are performed constantly, it is expected there will be errors in the control logic in this mode. In fact, there were three SEFIs and two destructive failures in this mode, in addition to the high temperature results which will be discussed later. One SEFI and one destructive event occurred with Ar ions

incident at 45 degrees (LDC 0843). Immediately after the shot, the DUT did not respond to commands. After power was cycled, the part responded to commands, except that the write circuit had failed. With Au ions at normal incidence, there was also a SEFI with a destructive failure (LDC 901). This shot was counted as a SEFI because of multiple block errors, but the erase circuit also failed.

In addition to the room temperature results shown in Fig. 8, there were four shots at elevated temperature (70° C) and increased voltage (3.6 V) to test for SEL. All were using the R/E/W test mode, with Xe ions incident. In one shot, the ions were at normal incidence, and the DUT survived at a fluence of 10^5 particles/cm². A SEFI was recorded, but after power cycling, the DUT was successfully reprogrammed. In this case, the DUT was from LDC 901. In three other shots at 45 degree incidence, the DUTs all suffered write circuit failures at lower fluences (LDC 0901 and two parts from 0840). For every shot, the power supply current was monitored continuously, and it is clear from the current traces when these failures occurred. The current traces typically show a read current of about 10-11 mA, with pulses up to 15-16 mA when errors are being rewritten. When the write circuit starts to degrade, the write current will increase, but parts with current in the range of 22-23 mA have still functioned properly. On these shots, the current suddenly increased from 22-23 mA to 30 mA, then 40, then 50 mA, or more, which meant the part had failed. This high current was not the result of SEL, because current returned to normal when the DUT was told to stop writing—no power cycle was necessary. The DUTs all worked properly in read mode, and they could be erased, but not rewritten. Our best estimate of the fluence when failure occurred on these three parts is that the first two parts (LDC 901 and 840) both failed at about 25,000 particles/cm², and the third (LDC 840) failed at about 7,000 particles/cm². The reason there is some uncertainty in these numbers is that, although it is clear when the failure occurred, it is not clear from the current traces exactly when the beam was turned on. Additional analysis may clarify this point. In summary, there were three failures in about 57,000 incident particles at 45 degree incidence, or three failures in 157,000 total incident particles at high temperature. The flux at and above the LET of Xe in geosynchronous orbit is
