Electromigration Failure in Au and Joule Heating Induced Oxidation in Cu Conductors - Part 1

Task Manager: Rosa Leon

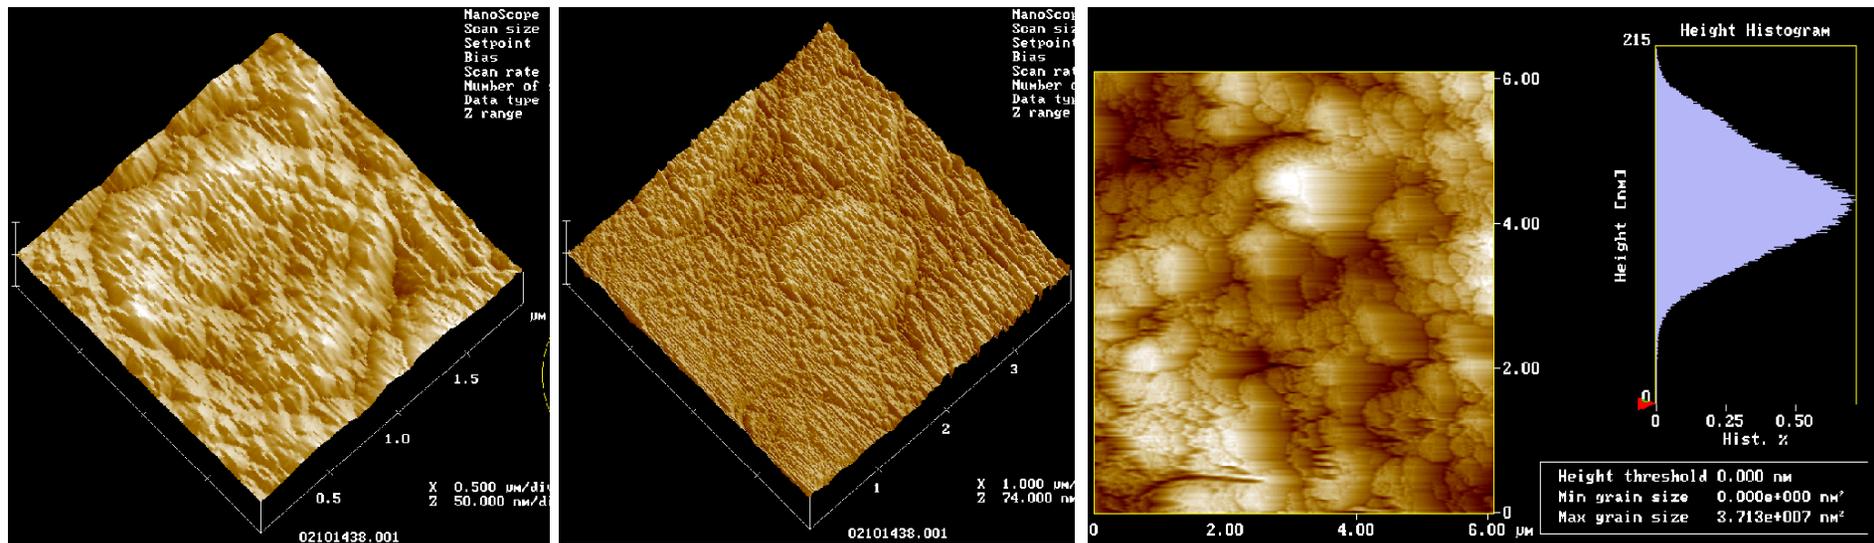
(a) And (b) Deflection AFM image in contact mode. (c) shows a lower magnification AFM height image of a larger area which depicts a typical bond pad microstructure in the SoC microinductor metallization structures.

The electromigration structures were analyzed under an Atomic force microscope, where the maximum Cu grain size in the interconnects (bond pads) was found to be about 6-7 μm , the average grain diameter is roughly 1 μm , and the surface roughness ~ 32.5 nm.
