# **Failures in Hybrid Microcircuits during Environmental Testing. History cases.**

Alexander Teverovsky

Perot Systems/NASA GSFC, code 562, Parts, Packaging,  
and Assembly Technologies Office

To discuss failures in hermetic hybrids observed at the GSFC PA Lab. during environmental stress testing.

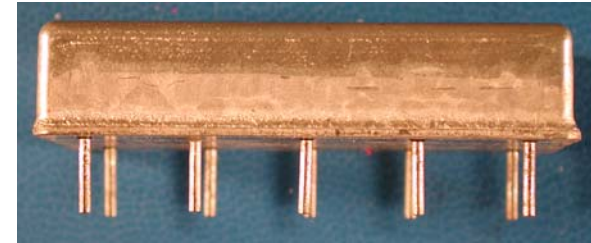
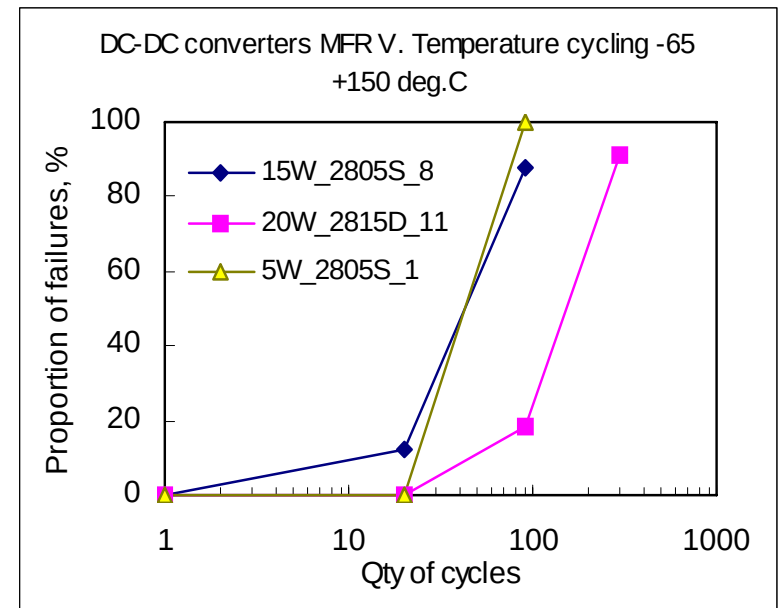
- Hybrid DC-DC converters (5W to 20W) manufactured by different vendors were tested at -55, +25, and +125 °C after 20, 100, 300, and 1000 TC from -65 °C to +150 °C.
- Failures in parts manufactured by one vendor were observed starting 20 TC.
- Out of 20 tested parts 17 parts failed after 300 TC.
- Most parts failed at RT and 23% failed at -55 °C.

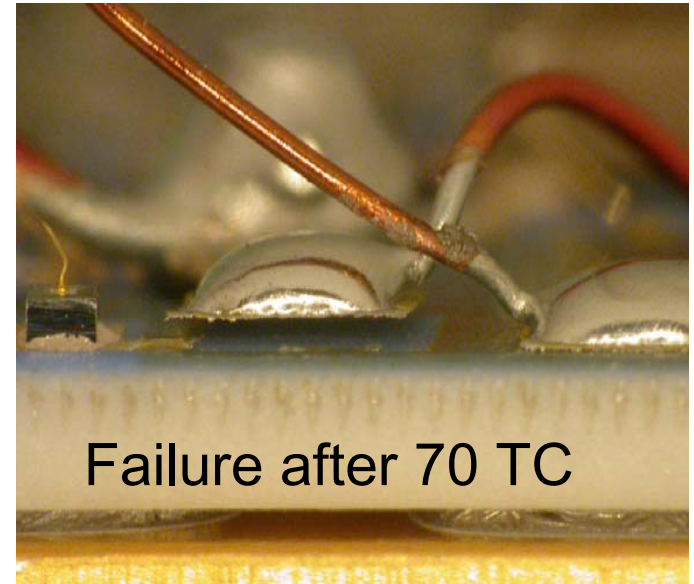
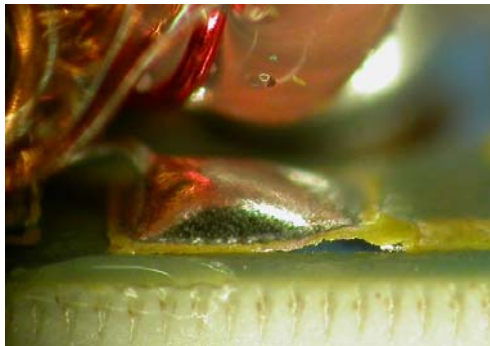
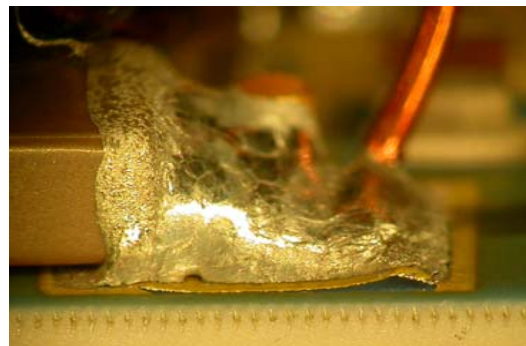
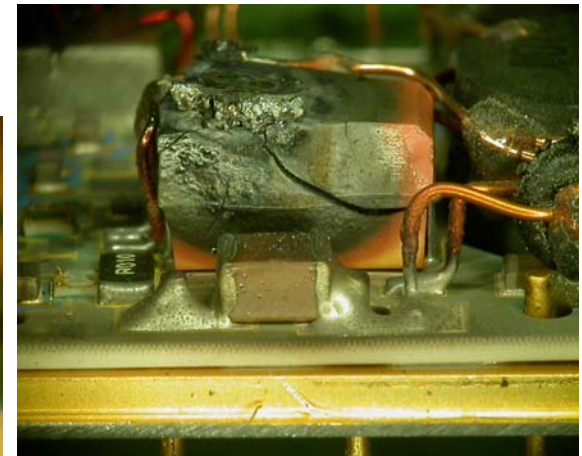
# Case I. Results of Failure Analysis.

- Most failures were due to fractured metallization traces on the substrate near solder joints.
- Element and components are evaluated per MIL-PRF-38534.
- Failed Ta capacitor was observed in two cases.
- Capacitor failures might be caused by intermittent contacts.

- ❑ TC might induce substrate metallization failures. MIL-PRF-38534, substrate evaluation, needs a revision.
- ❑ Lid flexibility might cause low-cycling fatigue failures in attached elements and lost of hermeticity.

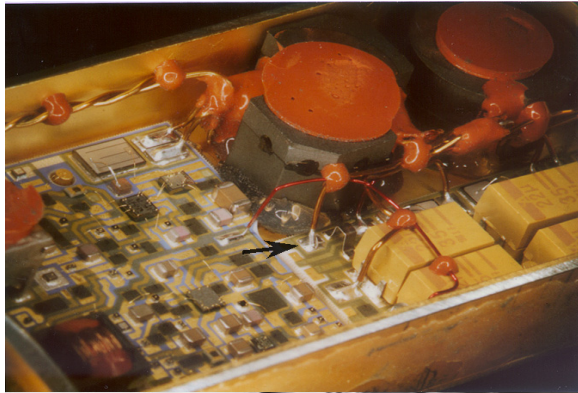
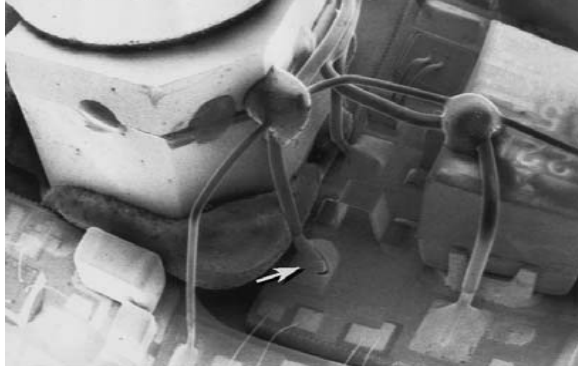
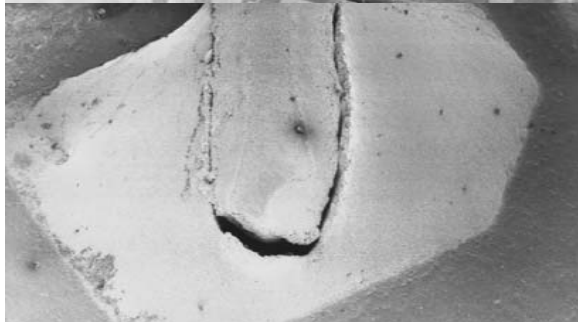
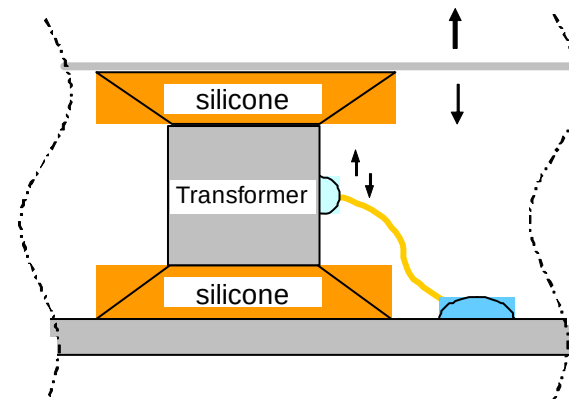
# Case II. Flex-Lid-Induced Failures.

- A DC-DC converter failed during box-level testing in a thermo-vacuum chamber.
- The failure was due to a soldered joint fracture.
- Failed wire was secured to the transformer fixed to the lid with silicone.
- Mechanism of failure: low-cycling fatigue caused by deformation of the lid and shifts of the transformer and wire.

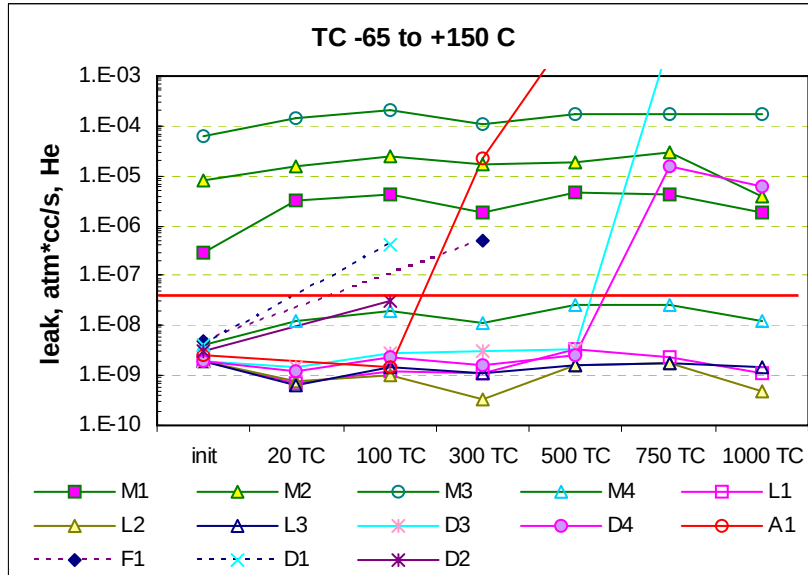
## Variations of the Leak Rate with TC

- MIL-PRF-38534 requires 3(0) after 15 TS -65 to +150 °C for package seal evaluation.
- 5 out of 31 hybrids failed after 100 TC -65 to +150 °C.
- “Leaky” hybrids do not fail:  $\tau = P_0 V/L$ .

Large-size hybrids might be more susceptible to hermeticity failures

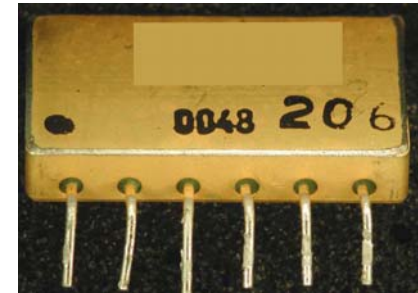
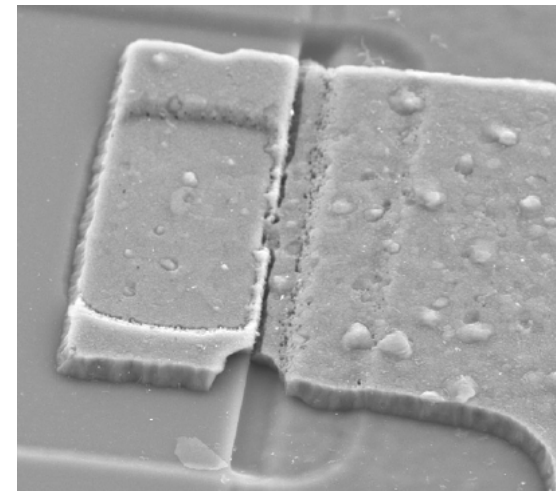
- DPA has indicated a poor die metallization step coverage.
- Thinning of die metallization is typically considered as a reliability risk due to increased current density and possibility of electromigration failures.
- The parts passed life testing, but one out of 7 hybrids failed after 300 TC between -65 °C and +150 °C.

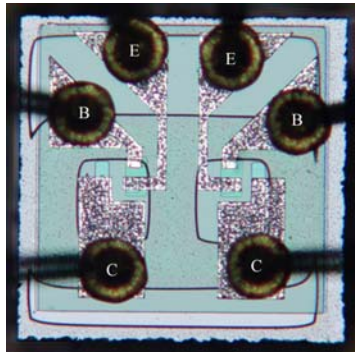
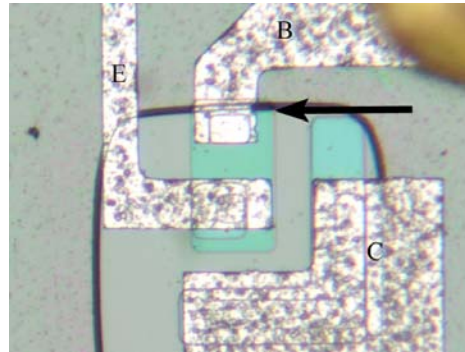
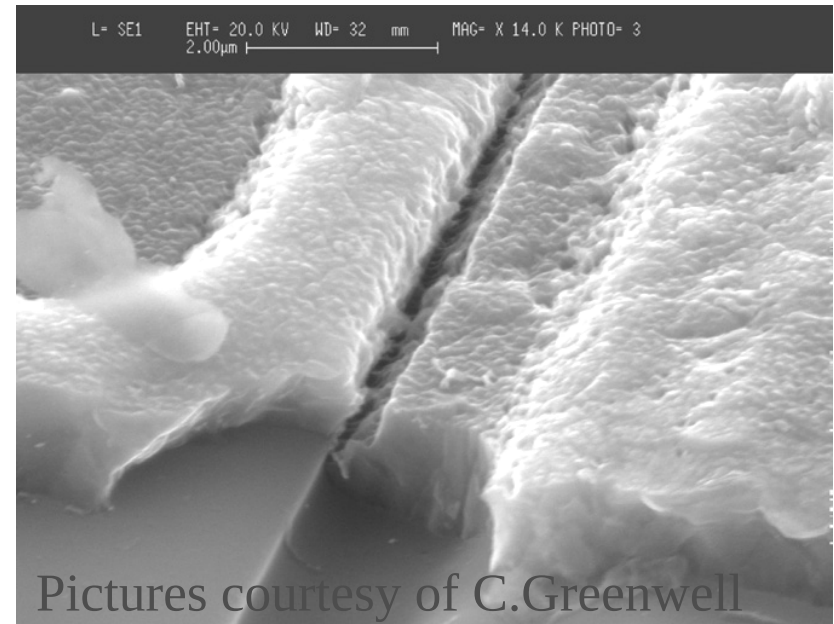
# Case IV. Results of Failure Analysis.

- The failure was due to open circuit in the base metallization of a transistor.
- Mechanical stresses during TC resulted in low-cycling fatigue cracking of Al metallization and failure of the transistor.

TC can induce enough plastic deformation in the metallization to cause an open circuit failure in case of poor oxide step coverage.

- ❑ Poor metallization step coverage might cause failures due to low-cycling fatigue cracking.
- ❑ PoP approach is useful for estimation of TC test conditions.

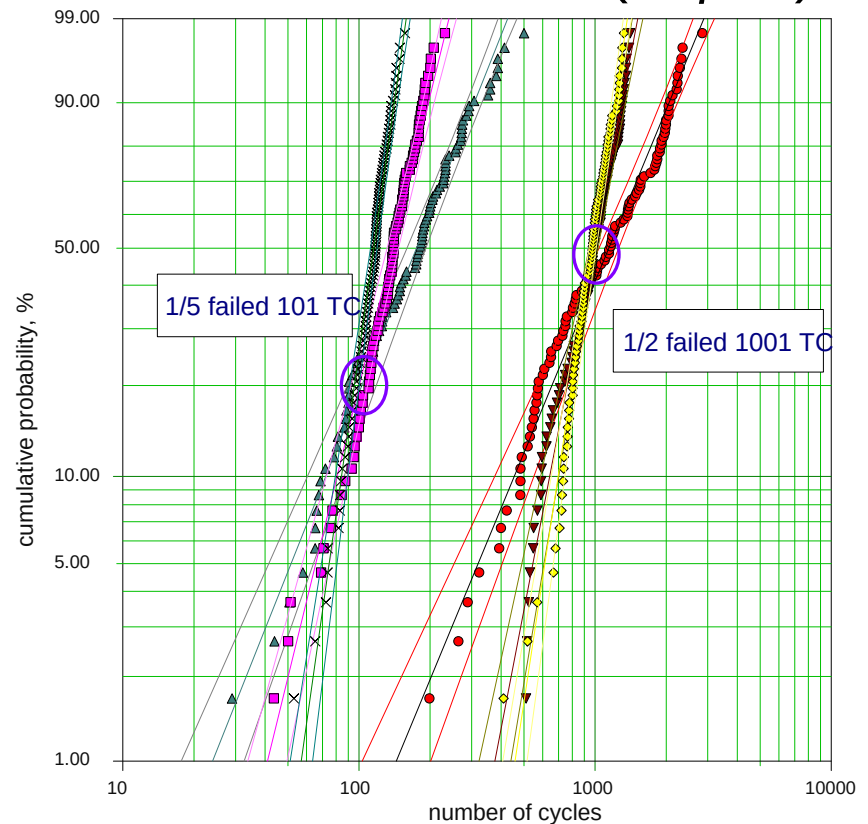
Weibull distributions of the worst case TC simulation ( $2 < \beta < 6$ )

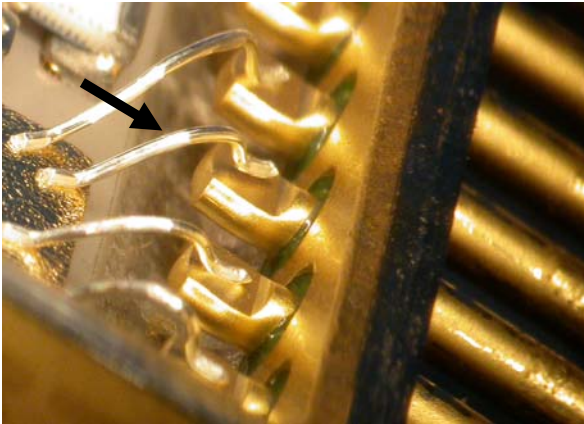
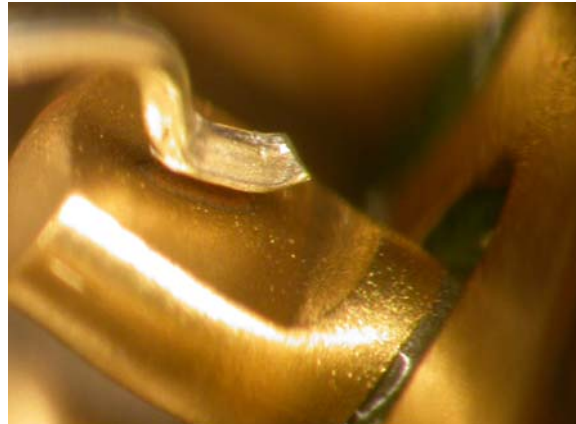
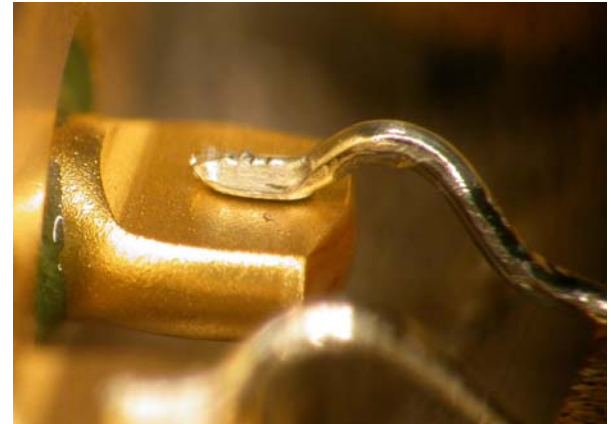
# Case V. Wire Bond Failures.

- Five hybrid solid state power controllers successfully passed life testing at 125 °C during 1000 hours.
- Additional electrical measurements after testing unexpectedly revealed open pins in two parts.
- The failures were caused by lifted 10-mil Al wires.
- Although Al wires are annealed, they are stiff and have built-in mechanical stresses, which might result in failures in bonds with weakened adhesion under minor mechanical disturbances.

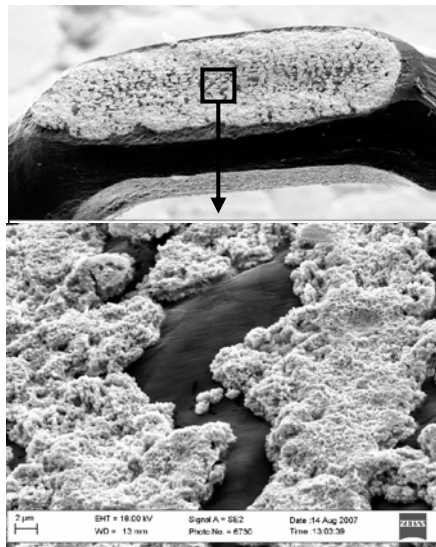
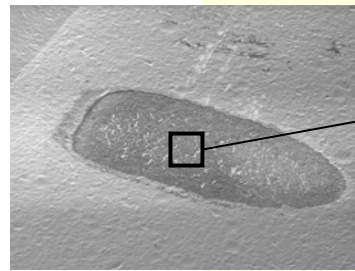
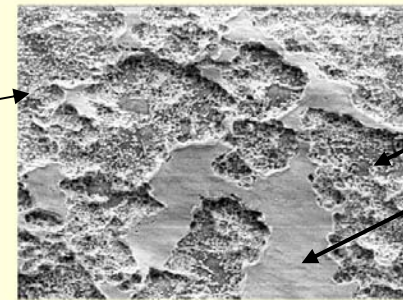
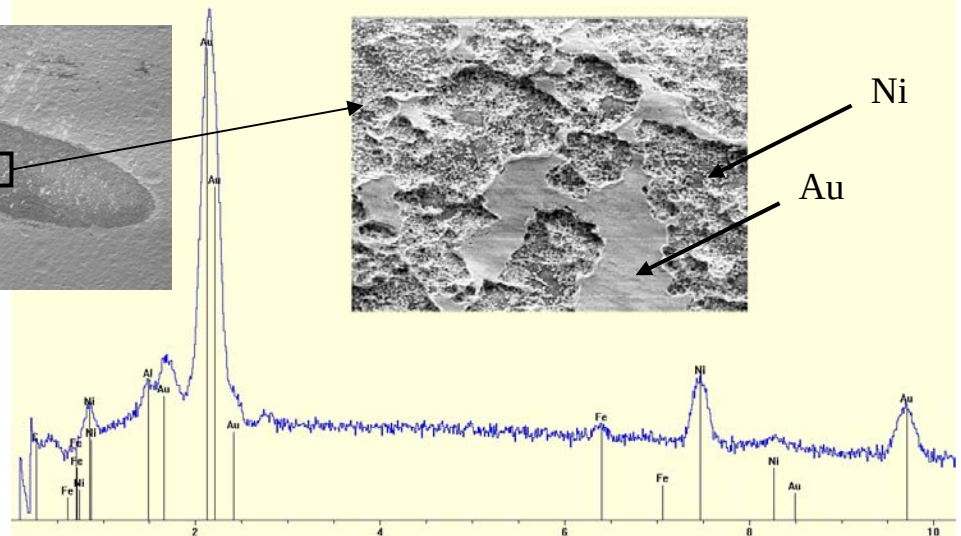
# Case V. Microstructure of Failed Bonds.

- Failed WBs were separated mostly along the nickel surface exposing relatively minor areas covered by gold.
- Most Au/Al IMC remained attached to Al wires and mating surfaces were ~80% covered with IMC thus indicating that the WBs were formed properly initially.
- No significant amount of contamination was observed during X-ray microanalysis of the failed bonds.

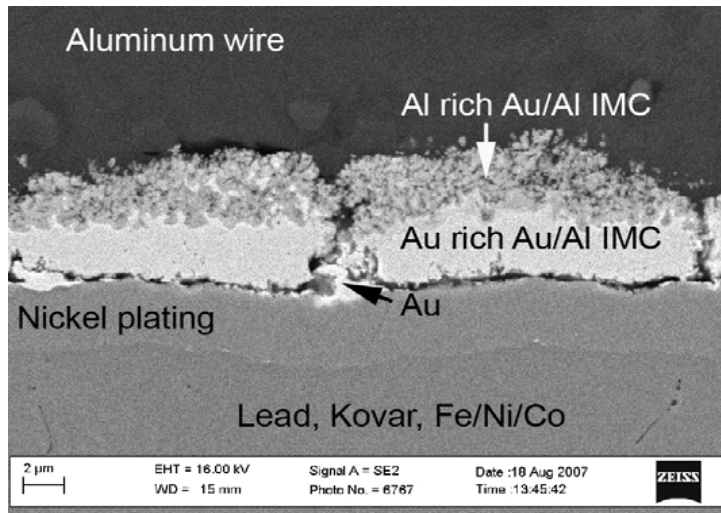
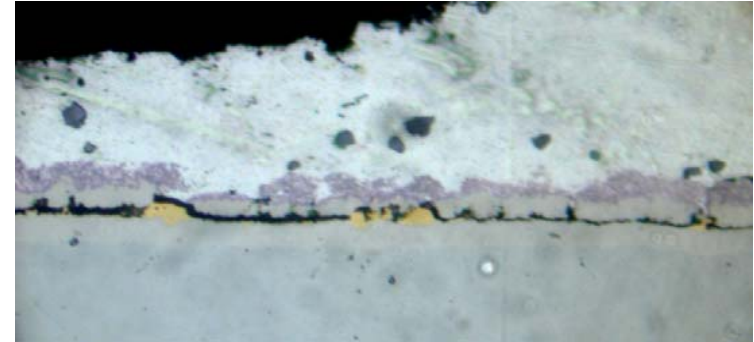
Cross section of Al wire-to-post bond

Purple and tan colors of the Au/Al IMC represent aluminum-rich,  $\text{AuAl}_2$ , and gold-rich,  $\text{Au}_4\text{Al}$  IMC.

- Formation of Au/Al IMC at the Al/Au interface is a normal phenomenon.
- Au/Al IMC grow with time. At 125 °C all Au plating ( $\sim 1 \mu\text{m}$ ) is consumed in a few hours and a Ni/IMC contact is formed.
- In the presence of contaminations (Tl, Pb, As) Kirkendall microvoids accumulate resulting in failures (Horsting mechanism).
- Even a very low concentration of contamination (below the level of EDS sensitivity) might be sufficient to cause failures.

- ❑ Al wire-to-Au-plated-post interconnections might fail due to accelerated IMC growth and microvoiding even at contamination levels below EDS sensitivity.

- ❑ To avoid failures in Au/Al interconnections, a highly accelerated aging test per MIL-STD-883, TM 2023 should be performed not only for substrate-to-substrate, but for substrate-to-package WBs as well.

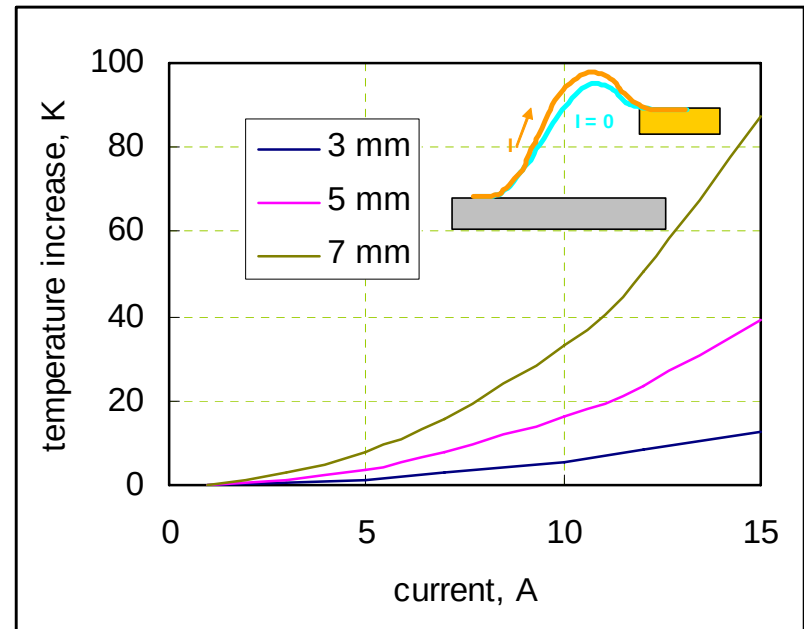
$T_{\text{max}}$  in wires of different length

- In power hybrids the risk of WB failures increases due to self-heating of wires.
- Overheating of wires causes deformation and stress in the bonds.
- Estimations show that for 5 mm long 10-mil Al wire at  $I = 15$  A the temperature might rise on 40 K, which would increase the wire length on  $\sim 4 \mu\text{m}$ .
- Power cycling might cause low-cycling fatigue in wire bonds.

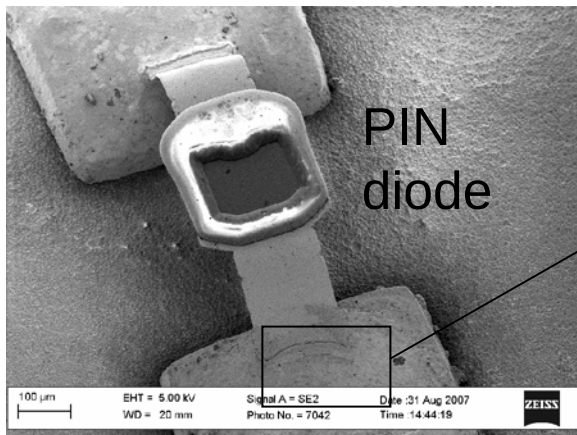
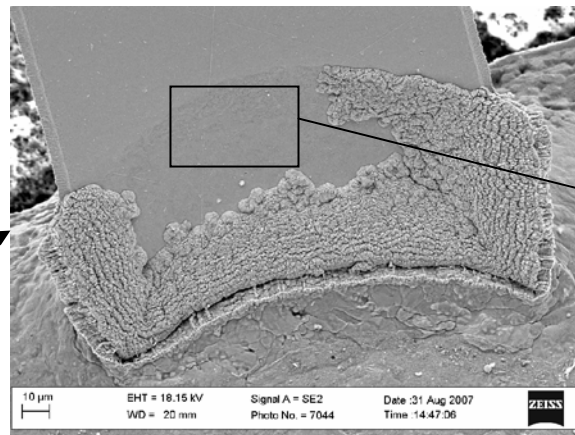
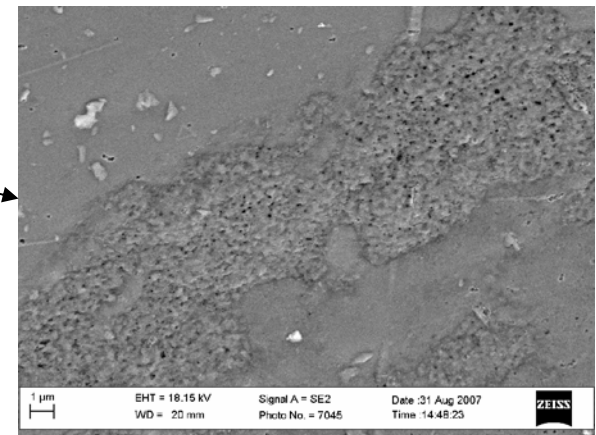
- Microwave hybrids passed qualification testing including HTOL at 90 °C for 600 hrs.
- PIN diodes with gold beam leads (170  $\mu\text{m}$  X 5  $\mu\text{m}$ ) are installed using an indium-base solder, 80In/15Pb/5Ag.
- To evaluate the effect of In/Au IMC growth on mechanical strength of solder joints, the diodes were pull tested before and after HTS at 125 °C for 110 hrs.

Growth of IMC after 600 hrs at 90 °C occurs by diffusion of Au and In atoms across the thickness of the gold beam lead.

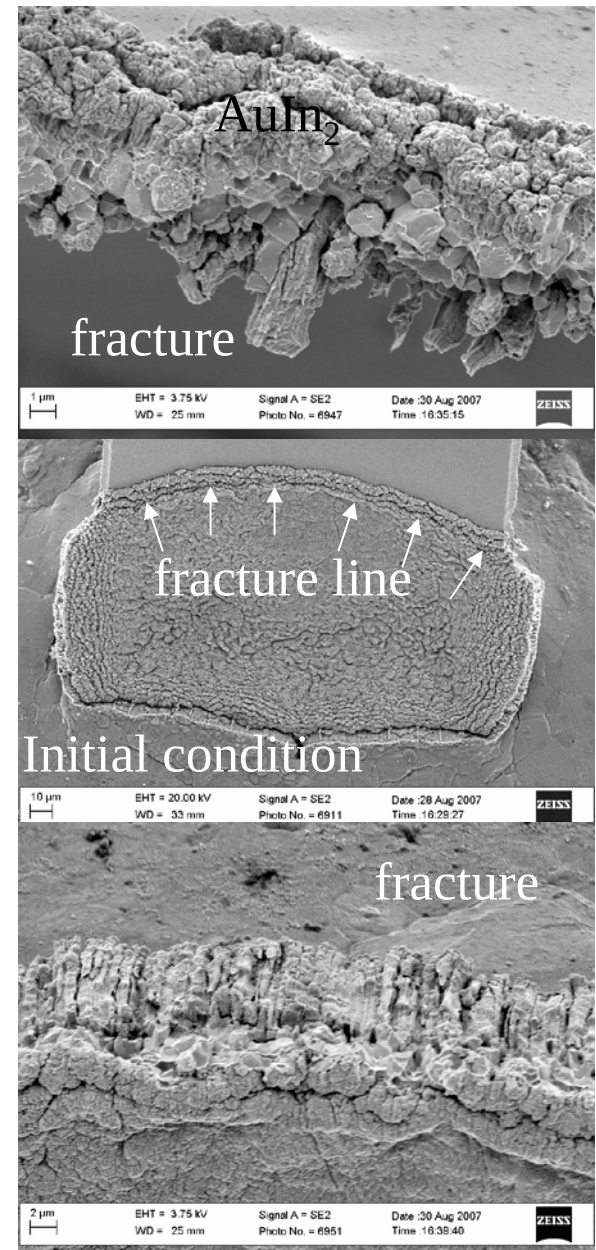
Pull test results

- Fractures occur along IMC growth.
- 3 out of 7 diodes failed after HTOL and 5 out of 7 diodes after HTS.
- The central area of the Au leads was completely converted into a grainy and fragile  $\text{AuIn}_2$  composition.

Note: the calculated strength of the Au beams is ~13 g-f and the failure criteria is 4 g-f.

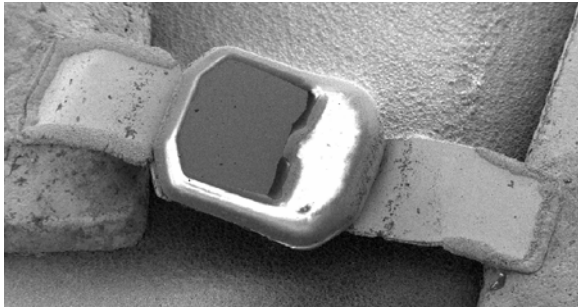
A diode in an initial condition and after HTS testing.

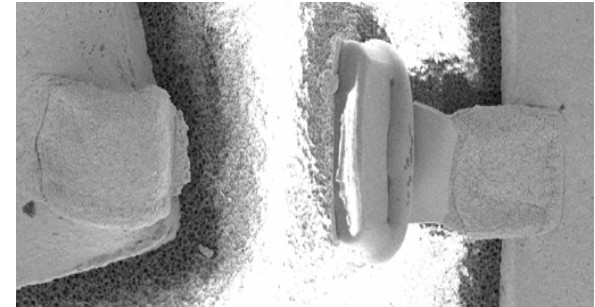
Pull test  
failure at  
0.26g after  
HTS

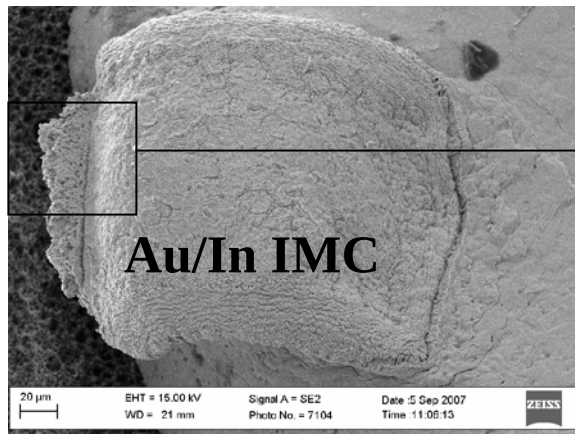
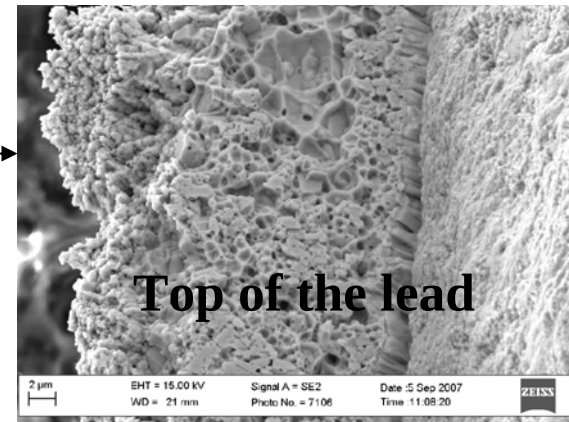
Close-up views of the fractured lead. The gold lead is completely converted into Au/In intermetallics after 110 hrs at 125 °C.

- ❑ There is a significant reliability risk in using In-based solder to attach thin Au wires or ribbons. This attachment should be avoided in high-reliability systems.

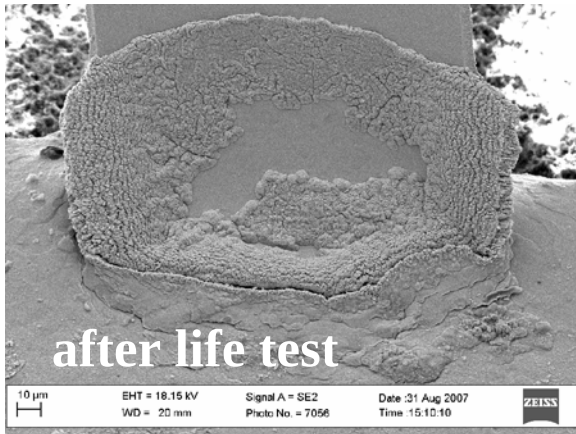
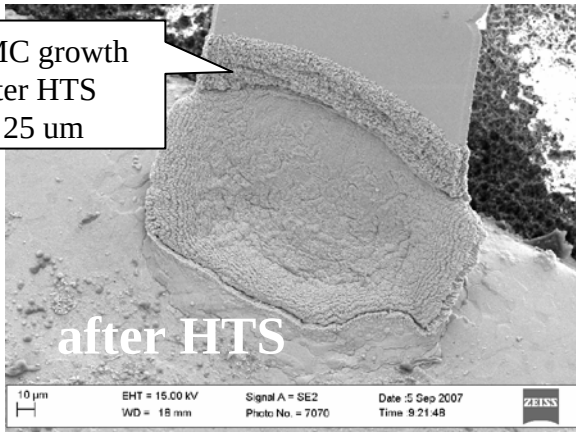
after life test

IMC growth on beam leads was estimated at RT, 90 °C, and 125 °C

- Results of this experiment (Au - In/Pb/Ag solder) are in agreement with literature data.
- Time to convert a gold beam of a thickness  $h$  into Au/In IMC is  $t = h/2r$ . At RT  $t = 1.6$  year.

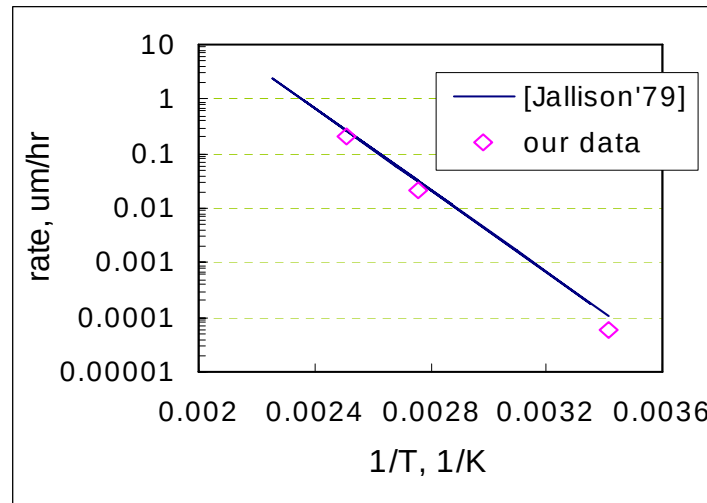
IMC growth  
after HTS  
~ 25 μm

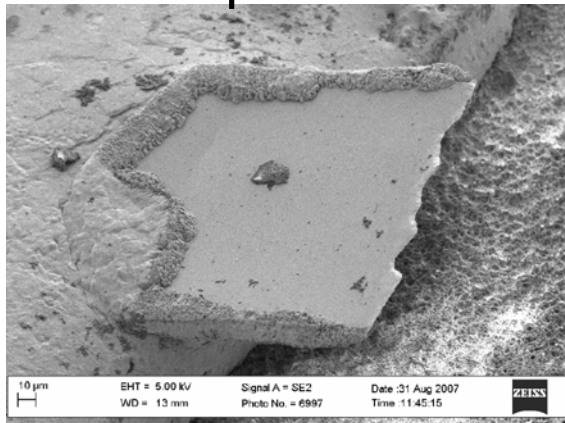
after pull test

A beam-lead fractured at 11.7 g.

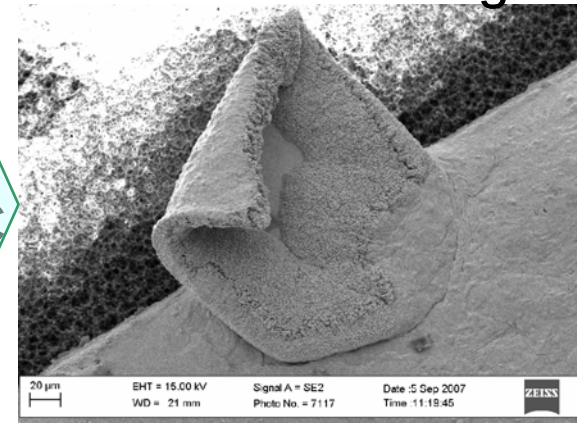
after HTS testing

Significant deformation is caused by IMC growth

- Au/In IMC are electrically conductive, but fragile and have reduced strength -> high risk of failure due to TC and/or mechanical disturbances (shock, vibration, etc.)
- A substantial volumetric changes caused by IMC growth (~4X) result in built-in stresses and can cause failures even without external mechanical distortions.
