# MITIGATING AND PREVENTING THE GROWTH OF TIN AND OTHER METAL WHISKERS ON CRITICAL HARDWARE

Stephanie Barr

The Aerospace Corporation, 2525 Bay Area Blvd, Houston TX 77058 USA, email: [Stephanie.e.barr@aero.org](mailto:Stephanie.e.barr@aero.org)  
© 2007 The Aerospace Corporation

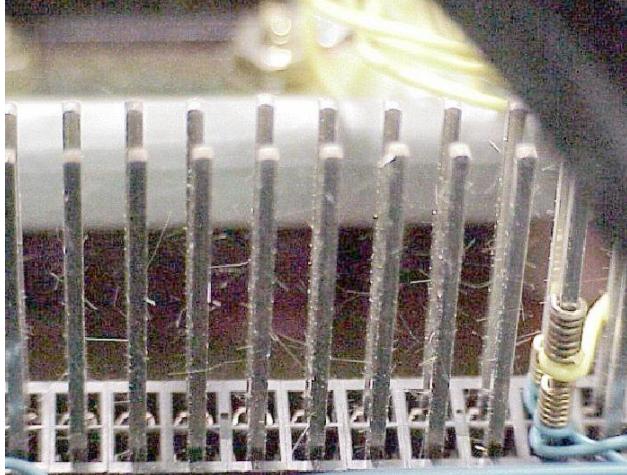
*Figure 2: Tin whiskers growing from pure tin plated connector pins after ~10 years. Courtesy of GE Power Management [2].*

Theories on what causes these whiskers are not universally accepted, but many theories focus on stresses of some sort that lead to their growth, such as residual stresses within the tin plating itself or externally applied stresses. Other theories include whiskering being the result of nicks or damages, recrystallization, or grain growth processes. No single process has been conclusively proven just as no environment has been found that precludes tin whisker growth, nor any reliable way of predicting when tin whiskers will grow, how fast they will grow and how long they will become. There is often a dormancy period before whiskers begin to grow, but with dormancy periods ranging from days to years, and with no hard data to predict the length, it is very challenging to predict when whiskers will grow, even from items of identical design and usage [1]. Figs. 2-4 show some examples of tin whiskering.

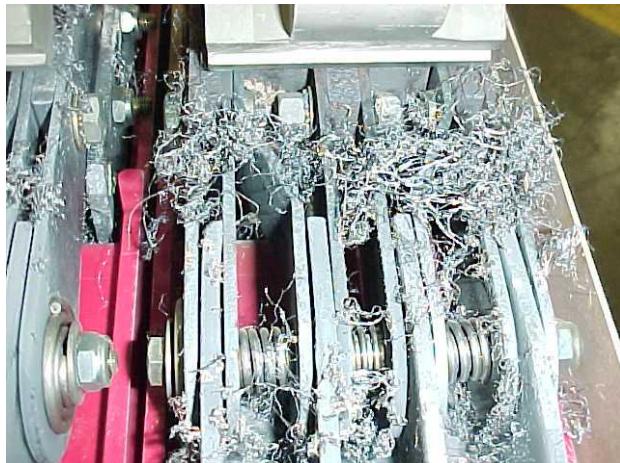
*Figure 5: Silver whiskers appear to have a different formation mechanism than tin and zinc whiskers, but can grow extremely fast. These whiskers (shown here on a circuit breaker) can grow 60-80 mm in a month or two with even a low concentration of hydrogen sulfide. Courtesy of Dr. Bella Chudnovsky (Schneider Electric/Square D) [7].*

Nor is tin the only plating metal prone to whisker growth. A number of plating metals, including zinc, cadmium, silver and even gold, can whisker. Although silver “whiskers” have been linked with particular environments (sulphur), the speed with which silver whiskers grow is remarkable, much faster than the growth of tin and zinc whiskers, and can be a serious reliability issue for equipment in that kind of environment (See Fig. 5) [7].

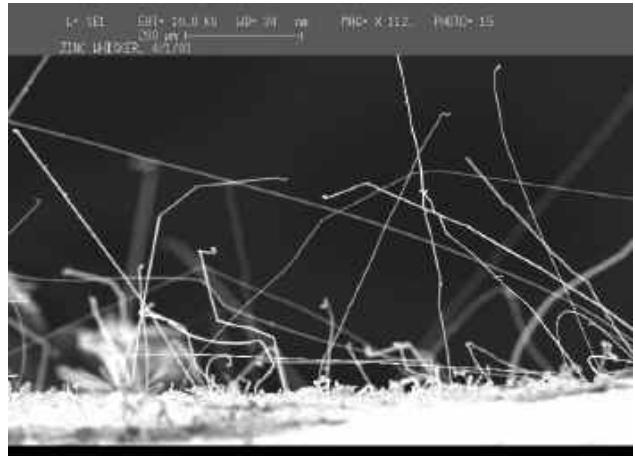
*Figure 6: SEM photography of zinc whiskers growing from the bottom of a raised (aka “access”) computer floor tile, courtesy of NASA Electronic Parts and Packaging (NEPP) Program <http://nepp.nasa.gov/whisker>.[1]*

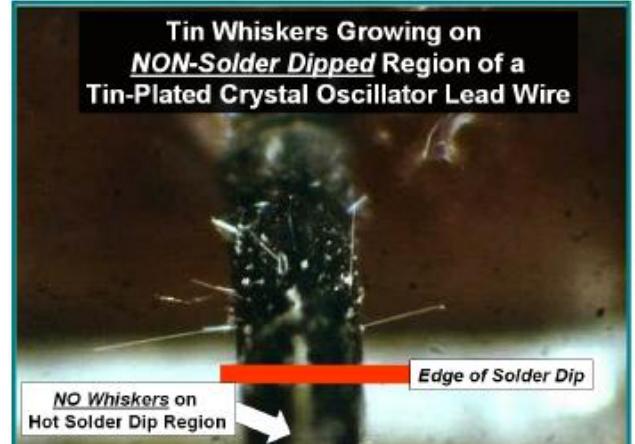
*Figure 7: Tin whiskers on Tin-Plated Kovar Terminal having a Nickel Barrier Plating. Whiskers formed on region that was NOT encompassed by the Tin-Lead (Sn-Pb) solder applied during hot solder dip operation. Photo shows how solder dip can help reduce tin whiskers, but also demonstrates one of the limitations as mitigation with whiskering still prevalent on the undipped portion.*

may still leave some of the original tin surface susceptible to whiskering as shown in Fig. 7. Other methods that have the potential to reduce whisker growth include thicker platings, silver underlay, controlling grain structure, or etching copper underlays. Some of these methods or materials have non-whisker-related limitations such as susceptibility to a corrosive environments or being too brittle for high stress or vibration environments. Many of these methods have little data to validate them, though they may hold potential. Of course, finding definitive data with the variations in whisker growth may take considerable time and still involve uncertainty.

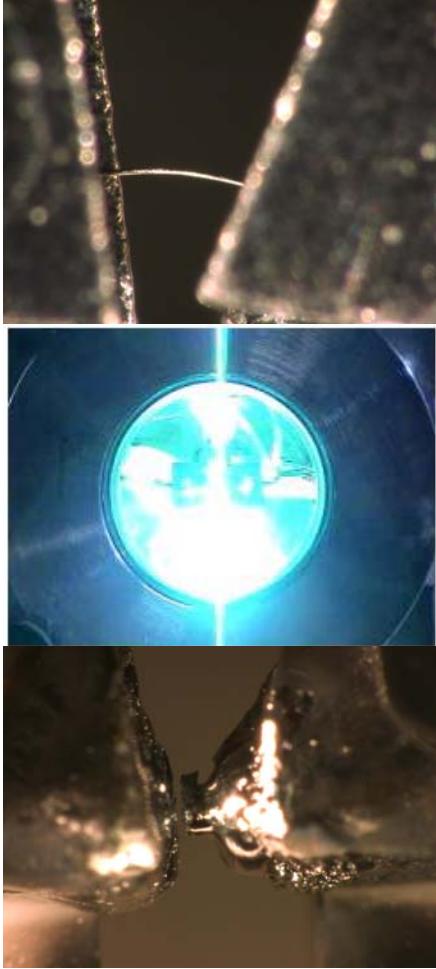
*Figure 9: Before, during and after test pictures showing the original wire, the energy of the metal vapor arc and the destruction that took place in ~0.5 s [9].*

The following photos (Fig. 9) show the wire before, during and after the test, including the melted tin that fractured after it cooled. It is this molten/vaporized material that feeds the arc. (Note: Although extruded wires are used for most tests, rolled down to 25-50 microns in diameter, actual tin whiskers have been used without an appreciable difference in result; wires are much easier to handle and obtain than harvested tin whiskers.)

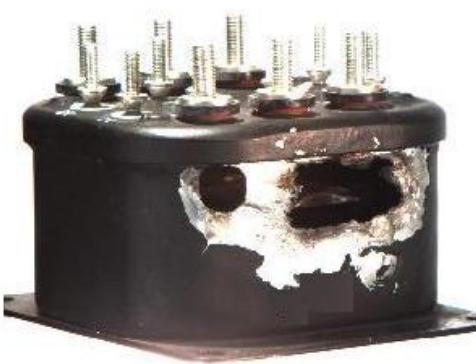
Figure 11: Relay destroyed by a metal vapor arcing event. Courtesy of Northrup Grumman [3].

After ten years at considerably less capacity than their rating, these relays failed, burning through their casings until control circuitry shut them down. The relays should have been good for 70 years as designed. Fig. 11 shows the relay after the MVA incident [3].
