# Metal Whiskers

# Discussion for the Nuclear Procurement Issues Committee (NUPIC)

June 19, 2008

Nuclear Procurement Issues Committee (NUPIC) Meeting

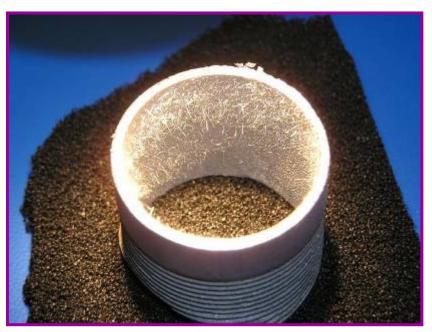
Zinc Whiskers on <u>Hot Dip Galvanized</u> Steel Pipe

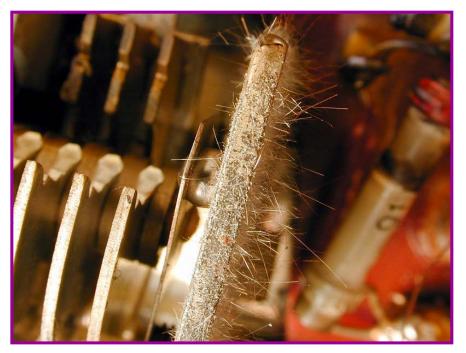
H. Cobb (Aircraft Radio Corp.)
   publishes earliest "known" account of
   CADMIUM whiskers on cadmium coated variable air capacitor plates.
   Whiskers induced electrical shorting
   in military equipment. These events
   occurred during WW II (~1942 1943)
- 1952: Tin and Zinc Whiskers Since Cadmium coatings resulted in shorting, Tin and Zinc were used instead. But then K.G. Compton, A. Mendizza, and S.M. Arnold (Bell Labs) reported shorting caused by whiskers from these coatings too!

*Tin Whiskers on 1960's Era Variable Air Capacitor*

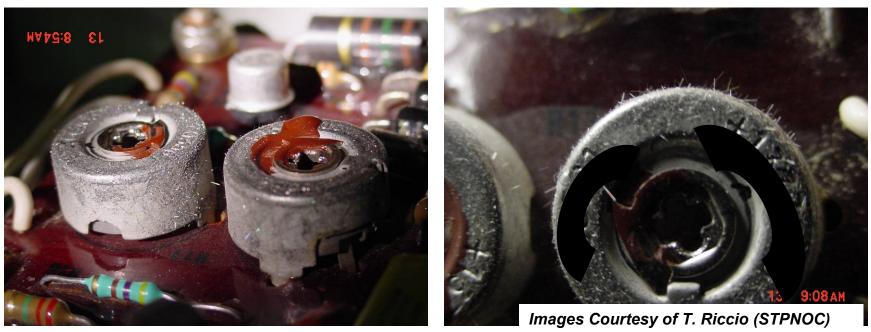
#### Metal Whiskers on External Case of Potentiometers

- No electrically insulating materials were used on the metal cases
- Metal whiskers bridging between the cases or from case to adjacent components can cause circuit malfunction

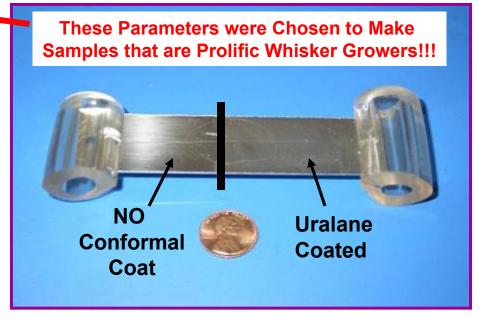
## NASA Goddard Whisker Mitigation Study Conformal Coat (Uralane 5750\* Polyurethane) ~9 Years of Office Ambient Storage

- 1" x 4"x 1/16" Brass 260
- Tin-Plated 200 microinches
- A few intentional scratches created after plating to induce localized whisker growth

- Uralane 5750 on ½ of sample
- Nominal Thickness = 2 mils
- Locally THIN Regions also examined

Office Ambient ~ 9 years

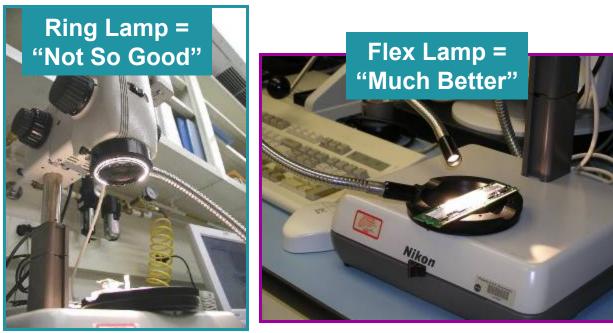
- Basic Equipment:
  - Binocular Microscope
  - Light Source: Flex Lighting PREFERRED over Ring Lamp
- Freedom to tilt sample and/or lighting to illuminate whisker facets is VERY IMPORTANT

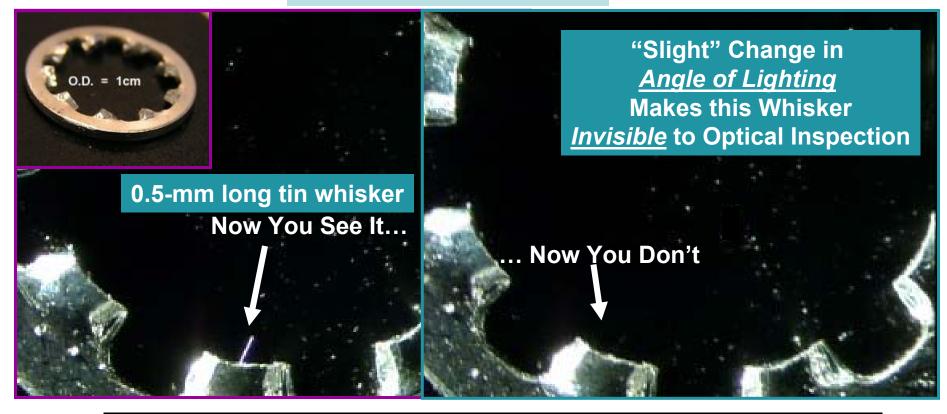
#### **Tin-Plated Lock Washer**

#### The absence of evidence is NOT evidence of absence

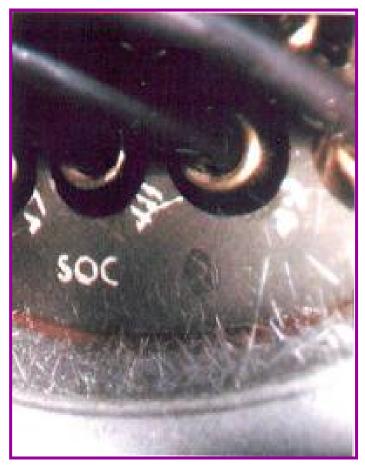
Zinc-Coated Computer Room Floor Tiles Zinc Whiskers Cadmium-Plated Connector Shell Cadmium Whiskers

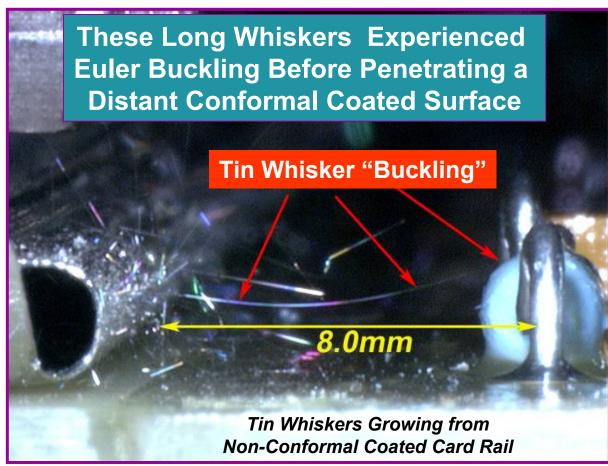
### Thank Goodness for Euler Buckling and Conformal Coat on this PWB!!!
