Evaluation of Microchip Tantalum Capacitors

Alexander Teverovsky

Parts, Packaging, and Assembly Technologies
Office, Code 562, GSFC/ Dell Perot Systems

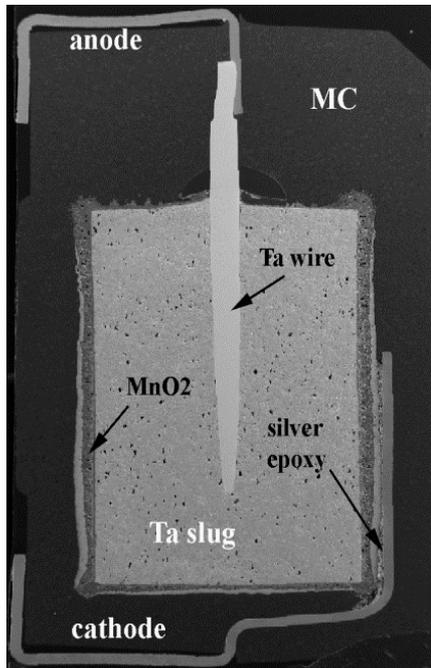
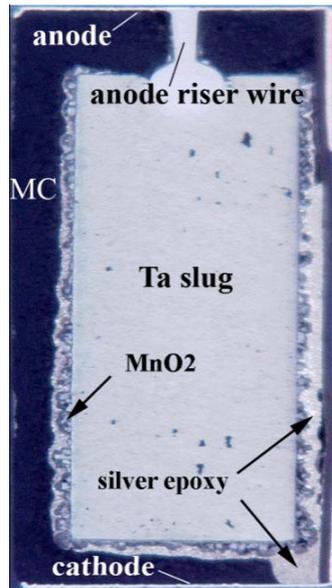
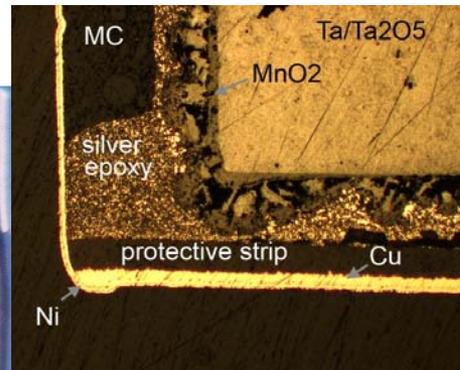
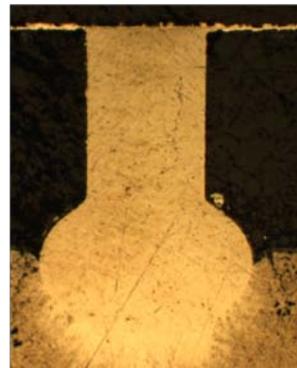
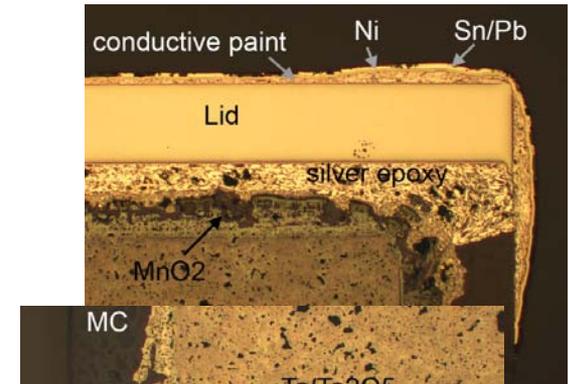
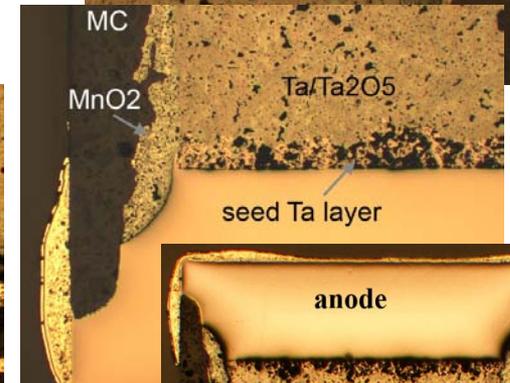
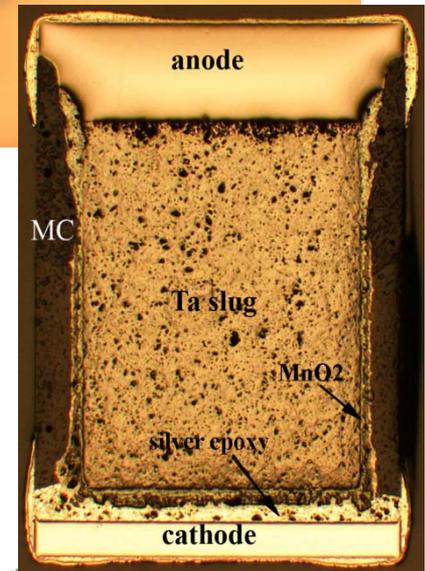
Design of Microchip Capacitors

- ❑ No welding interconnections. Increase in efficiency from ~30% to more than 50%.
- ❑ Protective strip and wafer-base designs.
- ❑ Drawback: no stress relief during soldering.

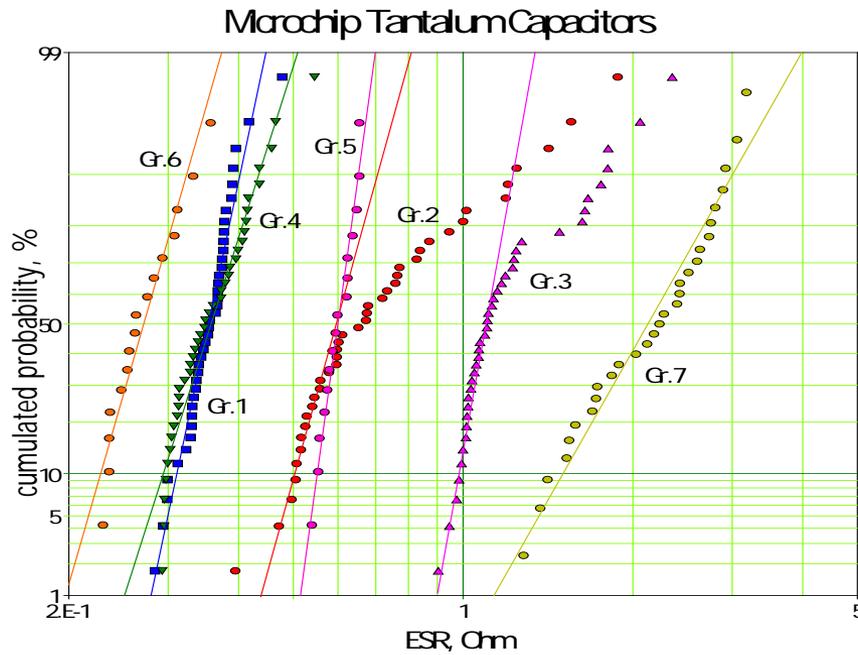
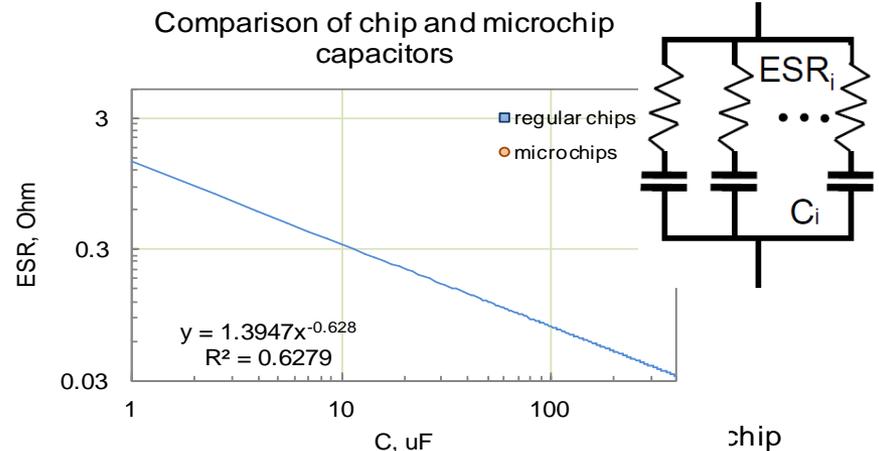
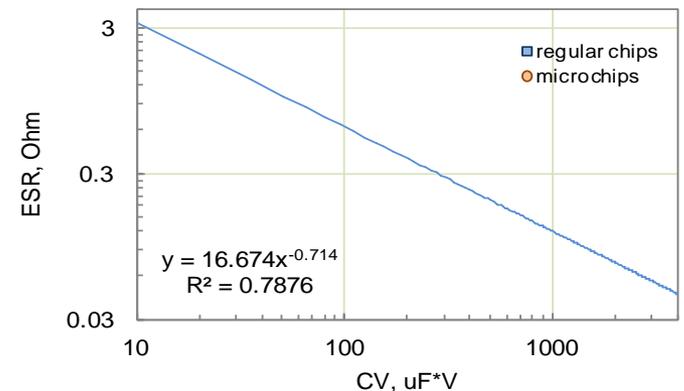
Performance: ESR

- ❑ Some lots have outliers.
- ❑ Microchips have ESR close regular chips.
- ❑ Larger ESR – better resistance to surge currents.
- ❑ ESR decreases with capacitance.
- ❑ A better fit: $ESR = f(CV)$.

$$ESR = \frac{16.64}{(C \times V_R)^{0.71}}$$

2. Values of ESR for microchips are close to the equivalent molded chip capacitors. An increase of ESR and fractures were observed during surge current testing in some lots.

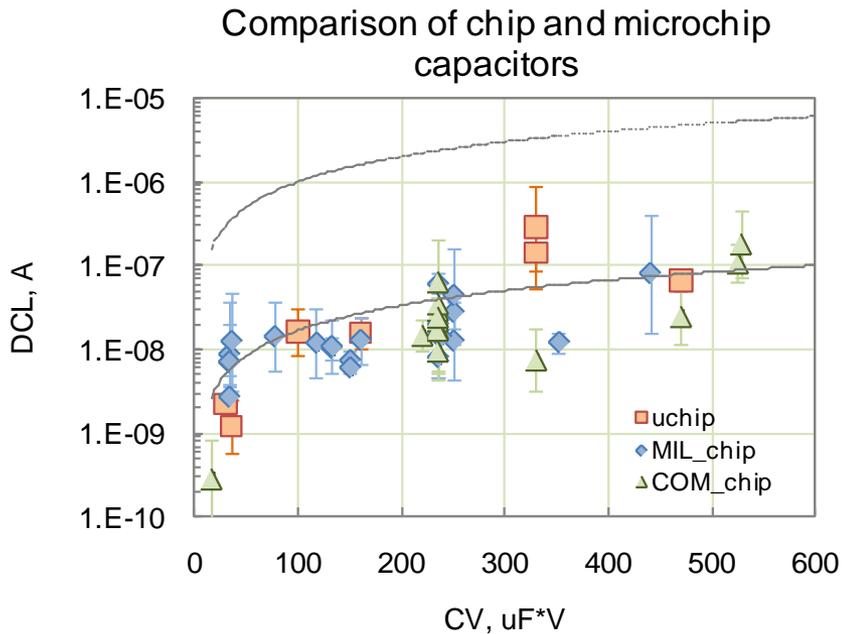
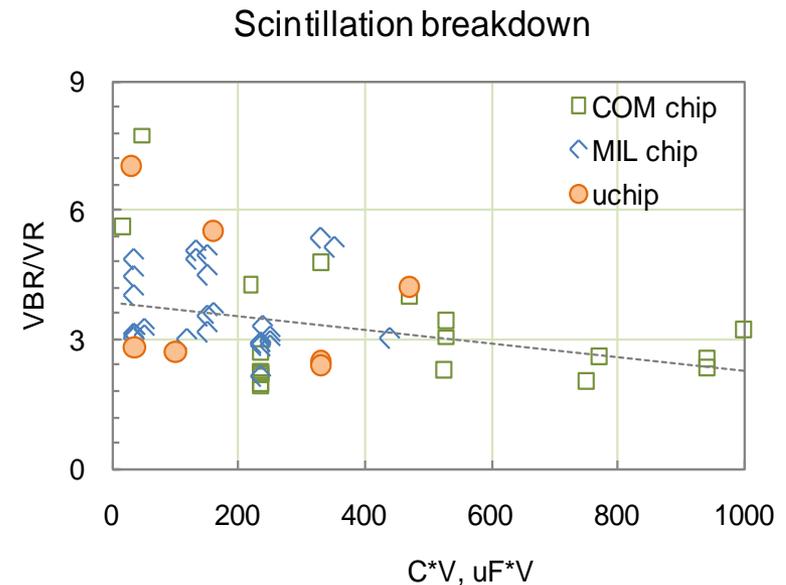
Performance: DCL and VBR_scint

- ❑ All microchips, except for two lots, had DCL within the range that is typical for regular chips.
- ❑ Margins of VBR_scint for all microchips exceeded 50% that is typical for high quality regular chip capacitors.

1. All AC and DC characteristics of microchips were within the specified limits and 5 out of 7 lots had VBR and DCL margins that are typical for high quality chip tantalum capacitors.

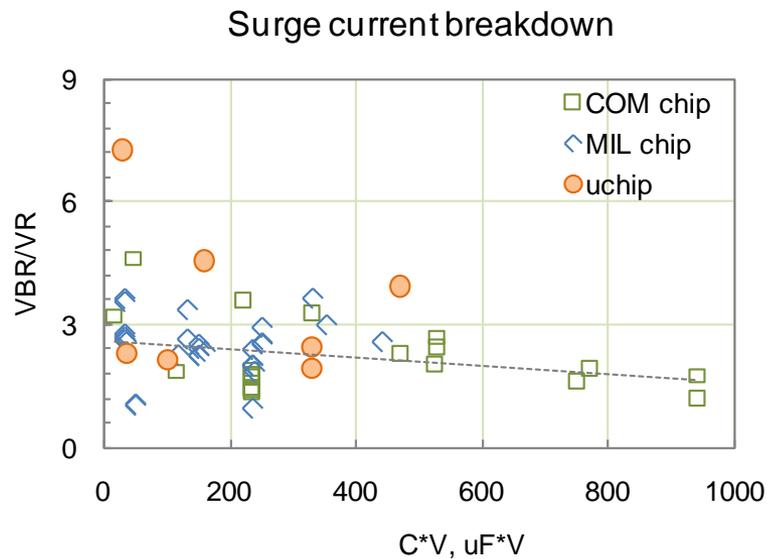
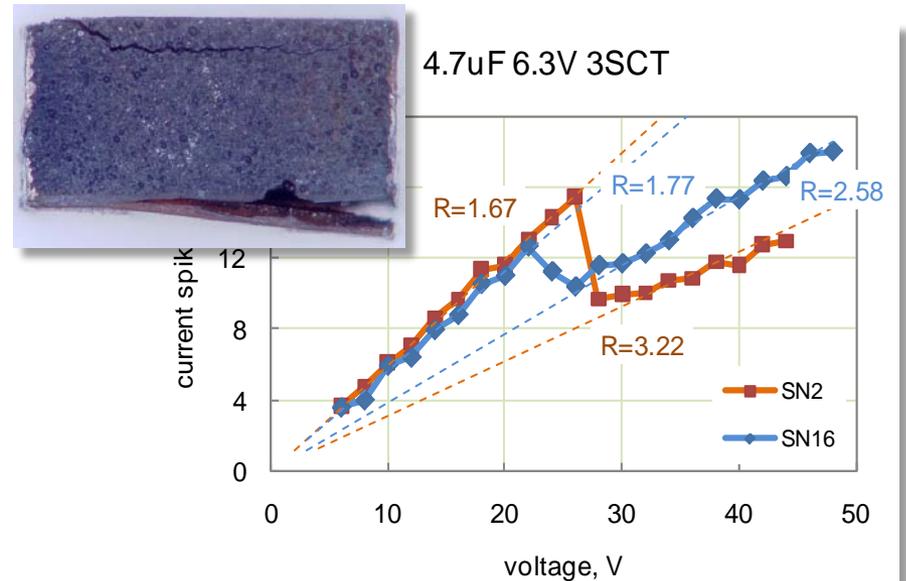
Performance: Surge Current Breakdown

- ❑ Some lots had VBR_SCT margins in the range from 170% to 330% that exceeds performance of military-grade capacitors.
- ❑ Fracturing resulted in ESR increase and open circuit failures.
- ❑ Increase in ESR and fracturing are prevailing in small-size parts because thin packages do not create compressive stresses large enough to suppress tensile stresses caused by SCT.

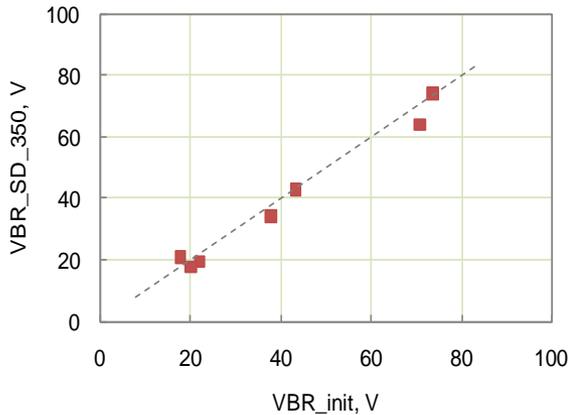
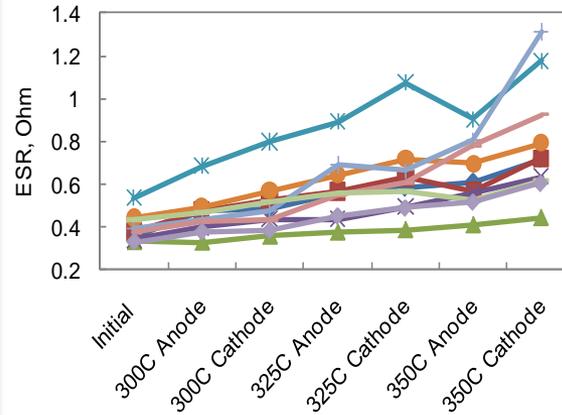
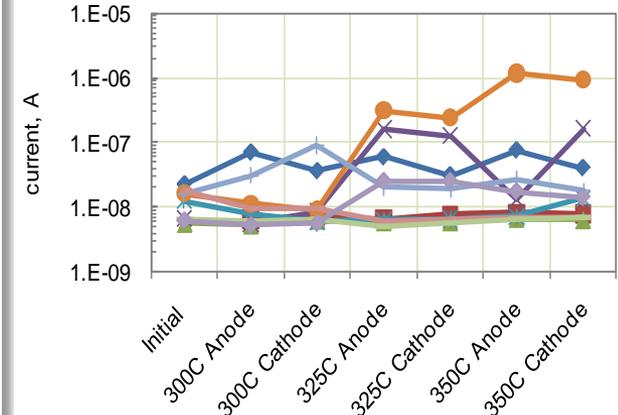
Effect of SD_350 on 3SCT

Gr.1 33uF 10V

Gr.4 10uF 10V

- ❑ All lots passed SCT at rated voltages and no substantial variations in distributions of VBR was noted.
- ❑ Degradation of ESR was greater during cathode side solder dipping compared to the anode side.
- ❑ Degradation of leakage currents occurred mostly after anode side solder dip testing.

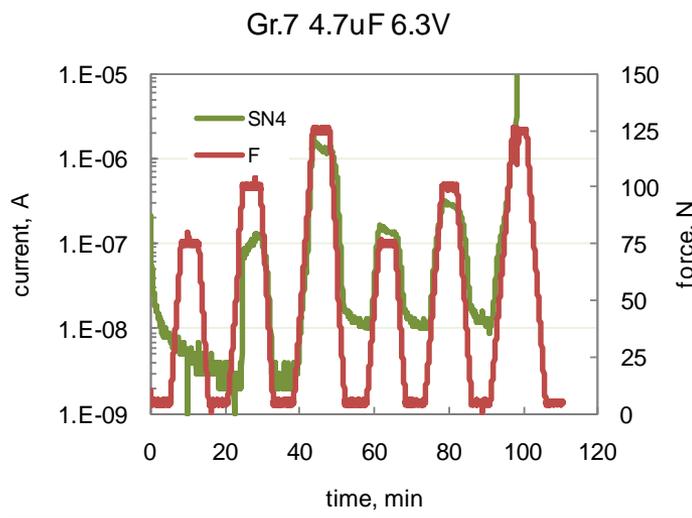
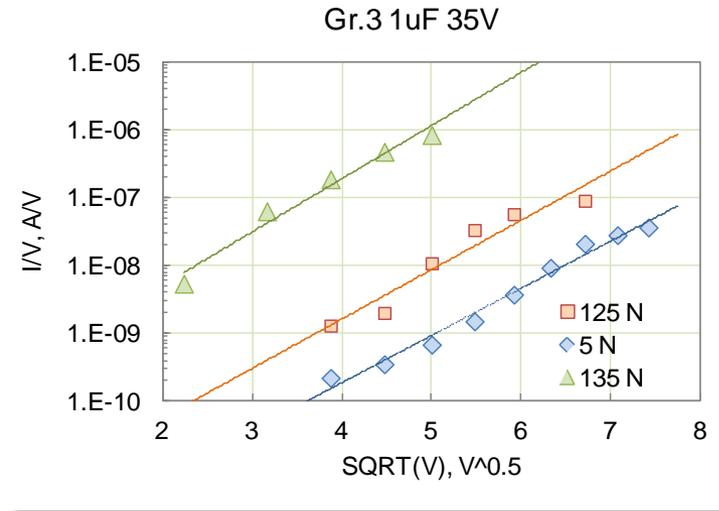
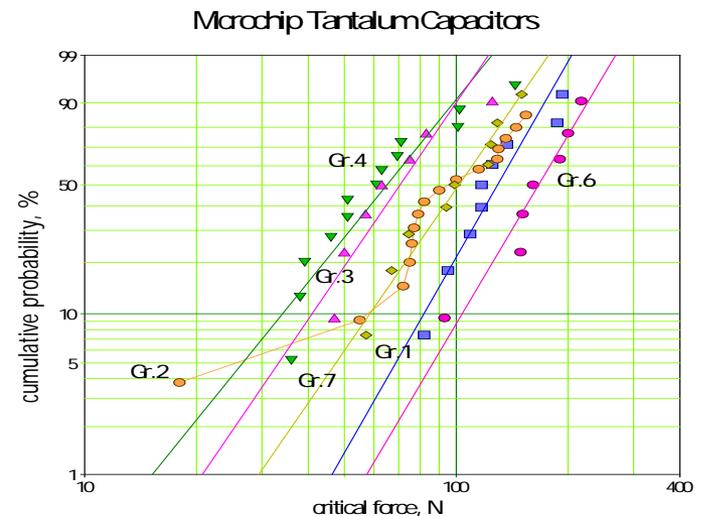
Effect of Mechanical Stresses

- ❑ Compressive stresses might cause degradation in the parts.
- ❑ Stress-induced traps generation increases Poole-Frenkel conductivity.
- ❑ Stress-induced degradation is reversible.
- ❑ Some parts might be “out of family” degrading at relatively low stresses.

3. Microchips can be robust enough to sustain manual soldering TS. However, different lots have different susceptibility to degradation.
4. Microchips are sensitive to compressive stresses. Lots with excessive sensitivity might cause failures after soldering.

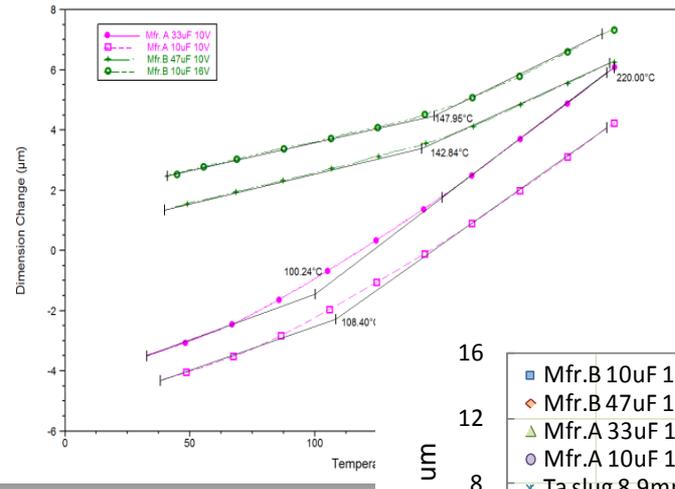
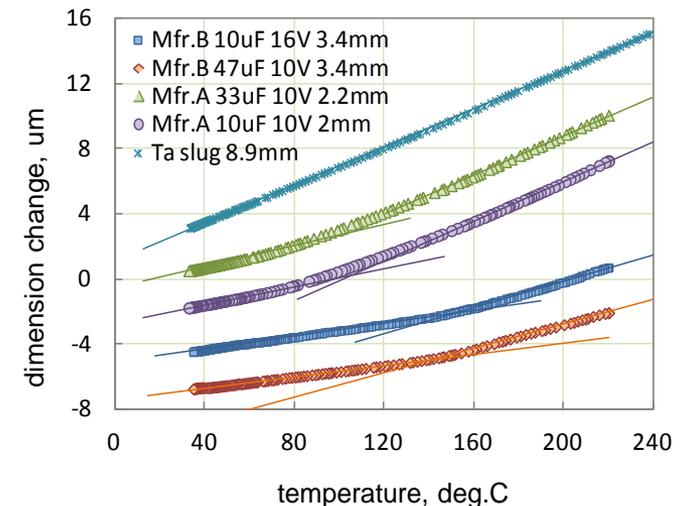
Thermo-Mechanical Characteristics

❑ Tantalum slug:
CTE ~ 6.2 ppm/ $^{\circ}\text{C}$.

❑ Mfr. A:
 $T_g \sim 100$ $^{\circ}\text{C}$
CTE1 ~ 12 ppm/ $^{\circ}\text{C}$ at $T < T_g$.
CTE2 ~ 34 ppm/ $^{\circ}\text{C}$ at $T > T_g$.

❑ Mfr. B:
 $T_g \sim 150$ $^{\circ}\text{C}$
CTE1 ~ 6.5 ppm/ $^{\circ}\text{C}$ at $T < T_g$.
CTE2 ~ 12 ppm/ $^{\circ}\text{C}$ at $T > T_g$.

❑ Substantial CTE mismatch between
MC and tantalum slug might cause failures during TC.

5. Different types of microchips have different CTE and T_g. Large CTE might cause damage to the dielectric and fractures in the attachment.
6. Failure rate for microchips can be as low as for T-level (0.001%/1000hr) MIL-PRF-55365 parts.

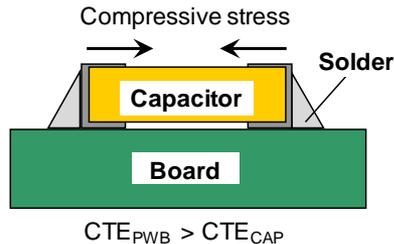
Effect of Mechanical Stresses, Cont.

$$\sigma = \frac{(\alpha_{PWB} - \alpha_{cap}) \times (T_g - T_r)}{(E_{cap})^{-1} + \left(E_{PWB} \times \frac{A_{PWB}}{A_{cap}} \right)^{-1}}$$

Characteristic	FR4	PI	μ chips
T _g , °C	145	230	
CTE, ppm/°C	15	12.4	5.6 to 14
E, GPa	17.5	23.5	10

- ❑ For both, PI and FR4 boards, the level of stresses is relatively low, and there is no risk of degradation for normal quality parts.
- ❑ Some microchips might degrade at relatively low stresses.
- ❑ To assure that soldering will not cause damage and failures of the parts a qualification testing at a stress of 10 MPa is recommended for high-reliability applications.

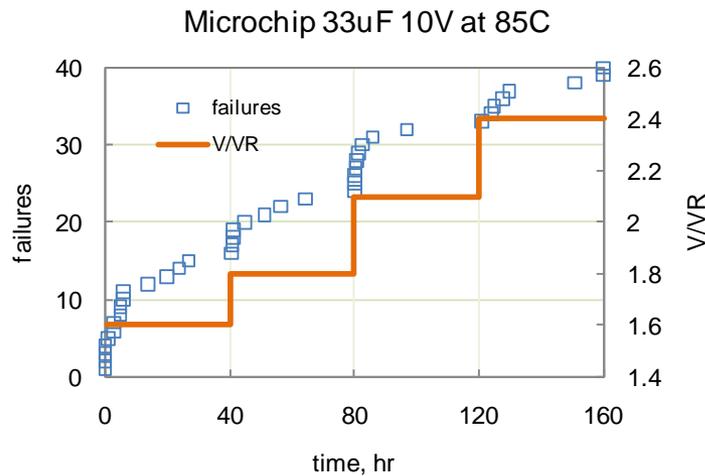
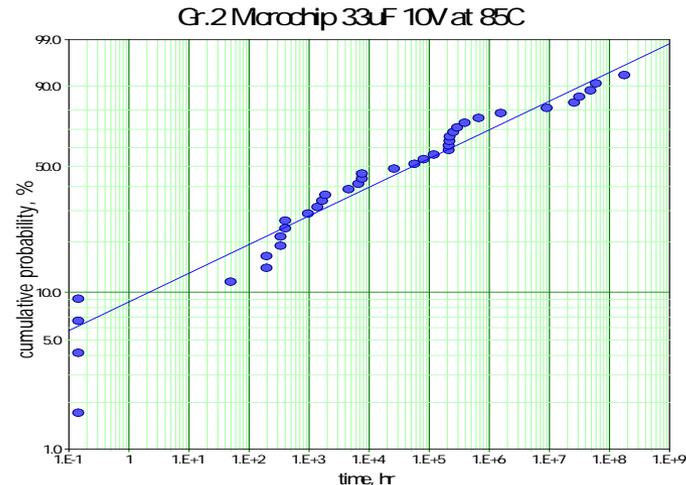
Life Step Stress Testing

- Weibull-exponential cumulative damage model.
- Step duration 20 to 40 hrs.
- Testing at 22 °C, 85 °C, and 125 °C allows for estimation of the voltage acceleration constant (B) and effective activation energy (Ea).

$$\eta = \exp\left(\alpha_0 + \alpha_1 \times \frac{V}{V_R}\right)$$

$$AF_V = \frac{\eta(V)}{\eta(V_R)} = \exp\left[\alpha_1 \times \left(\frac{V}{V_R} - 1\right)\right] = \exp(B \times u)$$

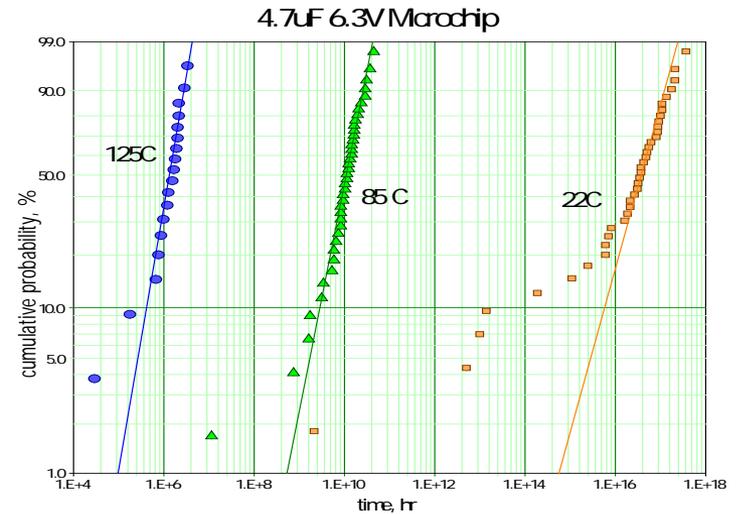
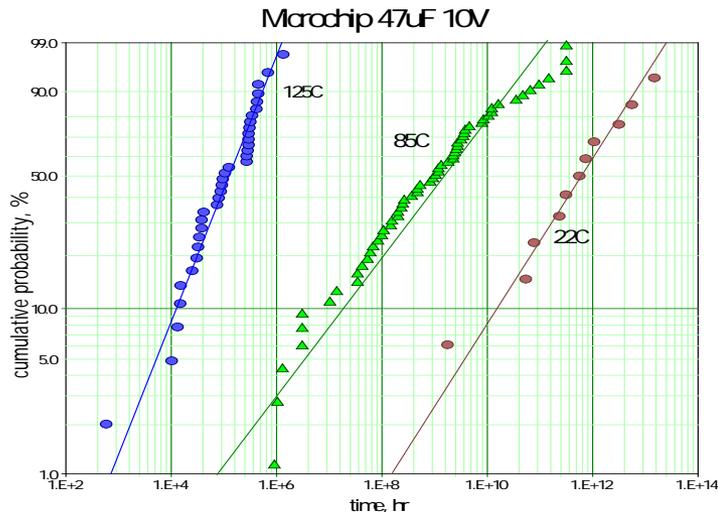
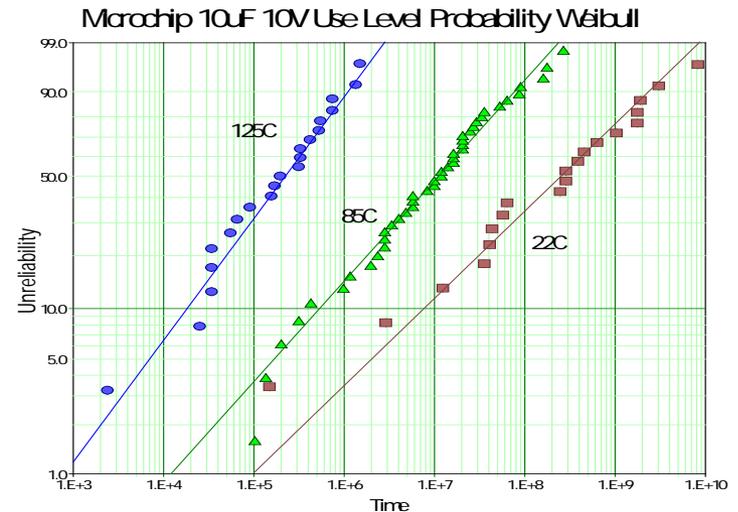
Life Step Stress Testing, Cont.

- ❑ In one group had $\beta > 1$, \Rightarrow wear-out.
- ❑ Inception time ~ 100 years at $125\text{ }^\circ\text{C}$ and $>10^{10}$ years at RT.
- ❑ This group had high VBR \Rightarrow high quality dielectric.
- ❑ Early failures were likely due to defects in the oxide.

- At 85 °C $6 < B < 18$. Some lots deviate substantially from the accepted standard constant ($B_s = 18.77$).
- FR calculated at conditions simulating Weibull grading test per MIL-PRF-55365 showed that microchip capacitors can be screened to a high FR levels up T-level (0.001%/1000hr).

7. At 85 °C the acceleration constant varies from 6 to 18. The value of AF_V should be determined for each part type for accurate FR grading.
