# Twelve channel optical fiber connector assembly: from commercial off the shelf to space flight use

Melanie N. Ott, Swales Aerospace/ Code 562 Goddard Space Flight Center<sup>a</sup>  
Joy Bretthauer, Code 561 Goddard Space Flight Center  
Greenbelt MD 20771

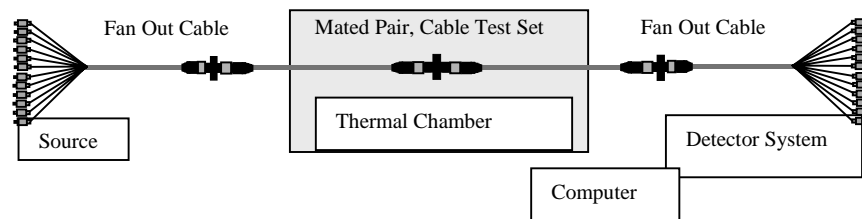
**Figure 6: Thermal cycling experimental test set up.**

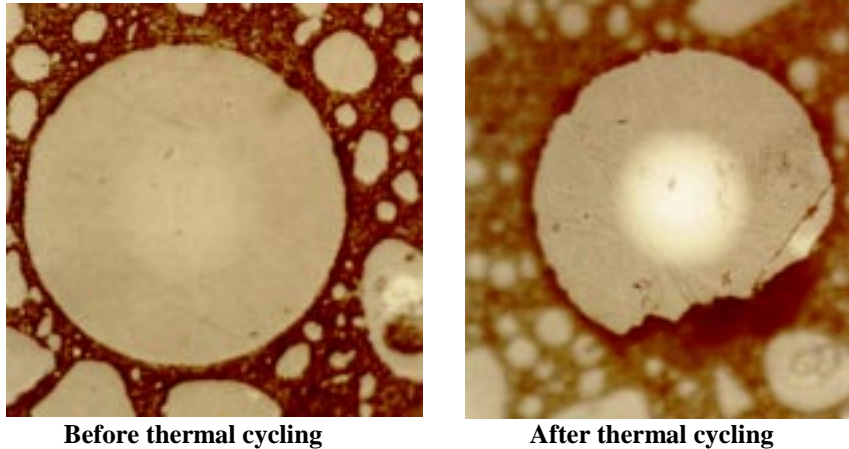
**Figure 12: Before and after photographs of the optical fiber endface channel 12, cable set 2.**
