Electromigration Failure in Au and Joule Heating Induced Oxidation in Cu Conductors - Part 1

In this work, electromigration of copper and gold conductors targeted for microinductor System on a Chip (SoC) applications is studied. We intend to use this study to predict:

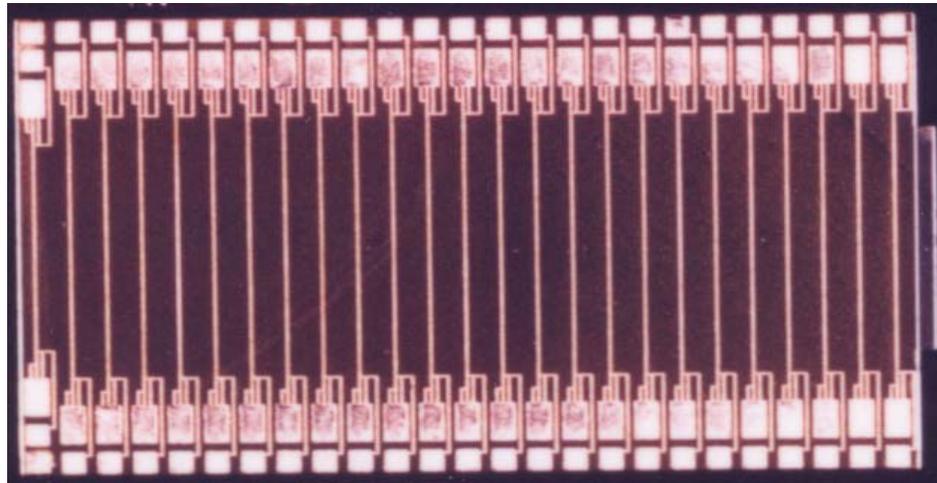
Figure 1. Copper or gold electromigration test structure (Size is 2.5 by 4.5 mm)

The electromigration test structures were fabricated alongside the microinductors on glass substrates and on a silicon wafers. They consist of planar copper or gold patterns sandwiched between two ferromagnetic layers, 6.75- μm permalloy (NiFe). Isolation is achieved through an AZ5214 (bottom) and an SO-3 (top) dielectric layer of about 0.5 μm thickness each. The copper is electroplated on a Cr/Au seed layer in SO-3 trenches to a thickness of about 20 μm . In the electromigration test structure, the upper ferromagnetic layer is omitted to allow visual observation of electromigration damage. The size of the electromigration test structure is 4.5 mm by 2.5 mm. The structure contains 24 test lines (1.41 mm long) and one temperature monitor line (left in Fig. 1). The Cu interconnects lines are 3.75 μm thick.

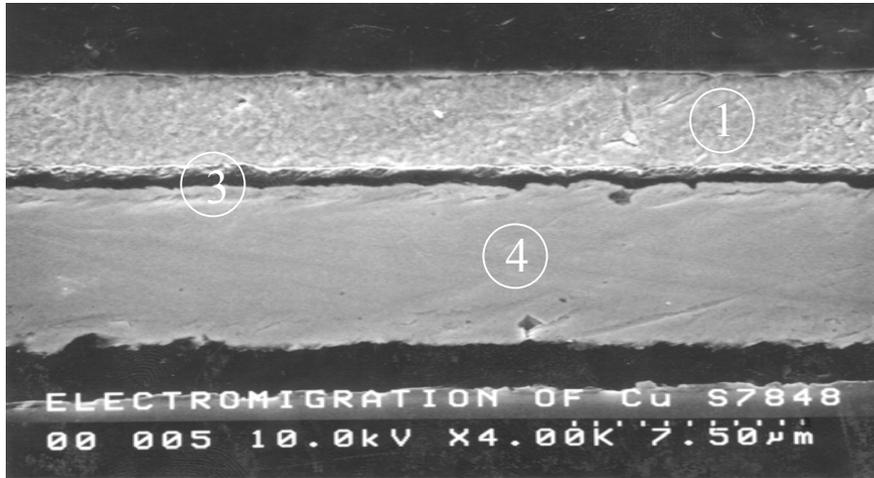
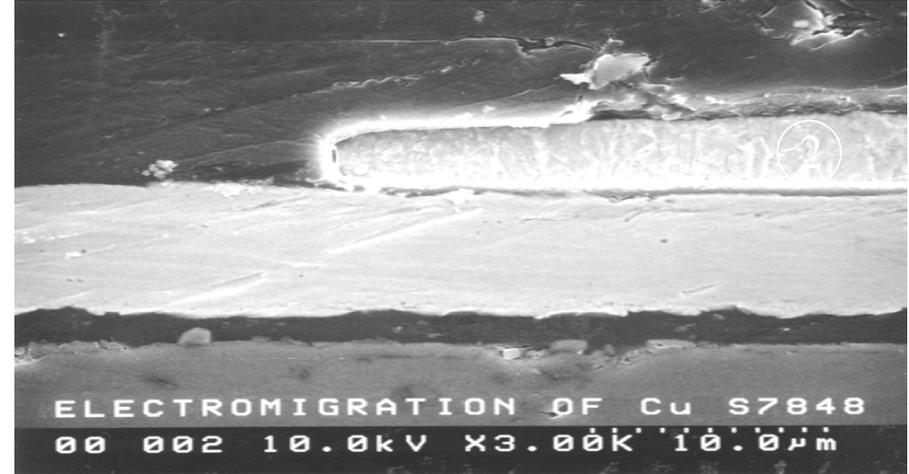
Cross sectional area micrograph of Cu structure; (a) cross section of Cu line; (b) cross section under bonding pad. Standard cross-sectioning techniques using mechanical grinding with light etchings were used to image the structure in cross-section.

1. Gold or Copper conductor.
2. Gold or Copper bond pad.
3. Dielectric layer between metal (Cu or Au) and NiFe permalloy layer.
4. NiFe permalloy layer.

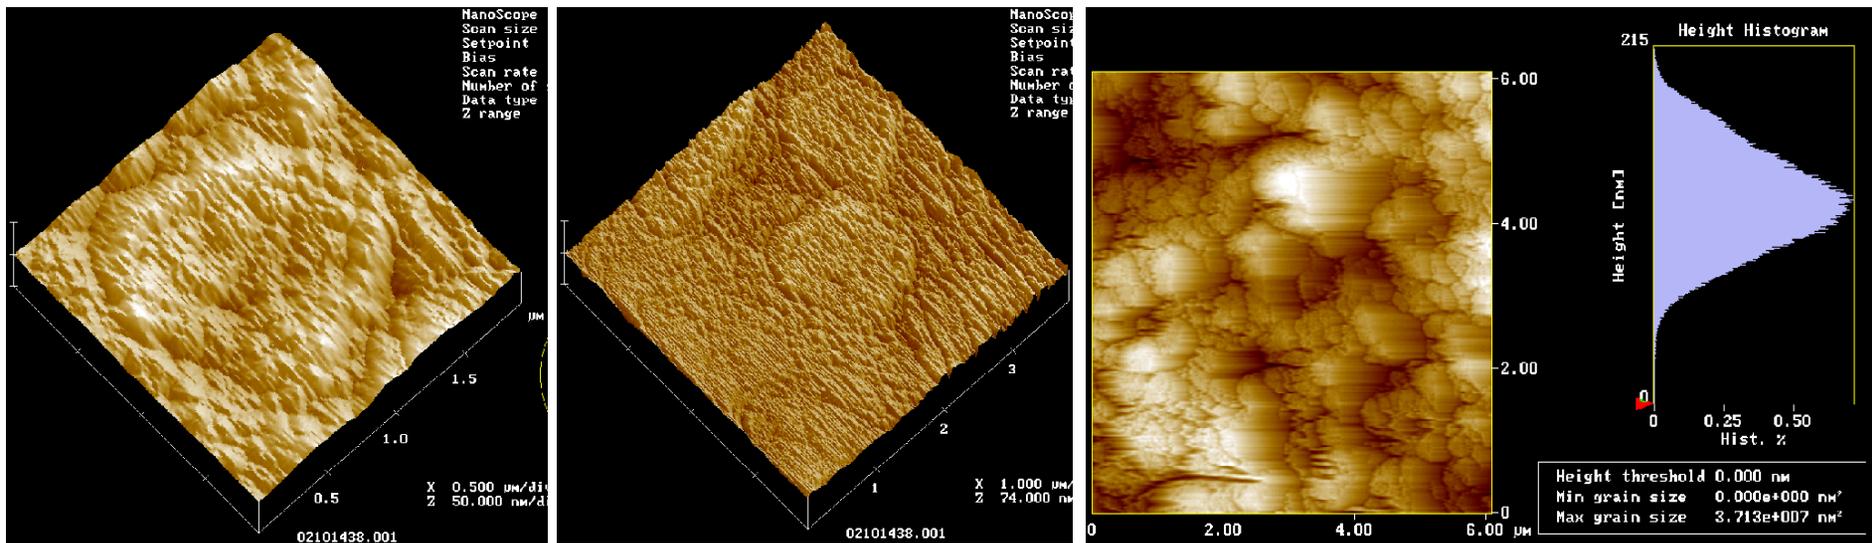
(a) And (b) Deflection AFM image in contact mode. (c) shows a lower magnification AFM height image of a larger area which depicts a typical bond pad microstructure in the SoC microinductor metallization structures.

The electromigration structures were analyzed under an Atomic force microscope, where the maximum Cu grain size in the interconnects (bond pads) was found to be about 6-7 μm , the average grain diameter is roughly 1 μm , and the surface roughness ~ 32.5 nm.

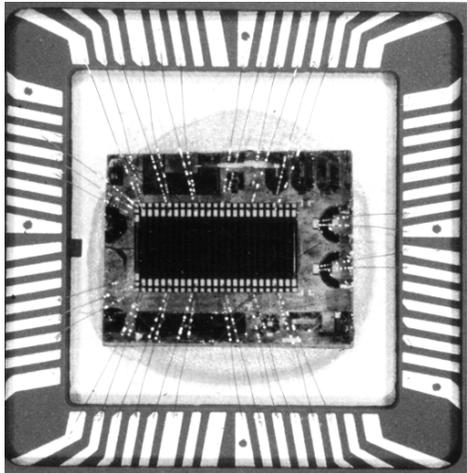
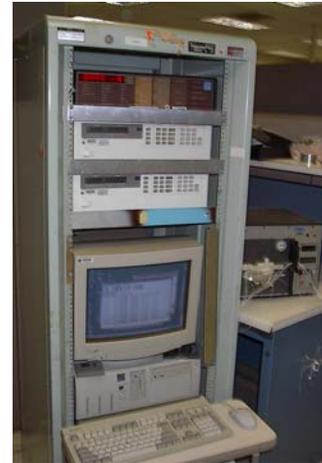
- **Electromigration structures were mounted wire bonded to a 64 pin package.**
- **Digital acquisition of resistance data vs time at various temperatures was done using two independent calibrated power supplies and digital volt meters.**
