# APPLICATION OF THERMO-MECHANICAL MEASUREMENTS OF PLASTIC PACKAGES FOR RELIABILITY EVALUATION OF PEMS

## Abstract

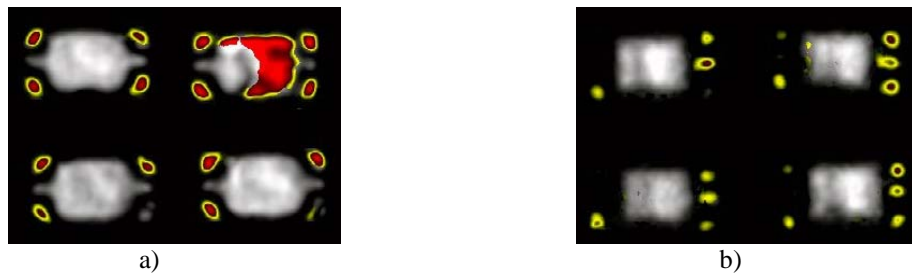
Multiple failures due to delaminations were observed after HAST at 130 °C/85% RH for 96 hours in comparator microcircuits encapsulated in plastic SOT-23-5 packages. The parts had normal electrical characteristics; however, delaminations, which were observed mostly at the lead finger-tips (see Figure 1), were considered critical due to the wire bond integrity concerns.

Fig. 1. Example of delaminations at the finger-tips on the top (a) and the bottom (b) of the SOT-23-5 packages after HAST.

The results show that samples with DC 0018 after HAST and after screening had similar T<sub>g</sub> and CTE values; however, the hysteresis was much larger for the HAST parts, indicating swelling of the molding compound. This swelling is most likely the major reason of excessive delaminations observed after HAST.

Delaminations after HAST testing were observed on parts that passed screening. This indicates that similar defects potentially can develop with time due to moisture-induced swelling and creep in molding compound, even in samples that initially had no delaminations.

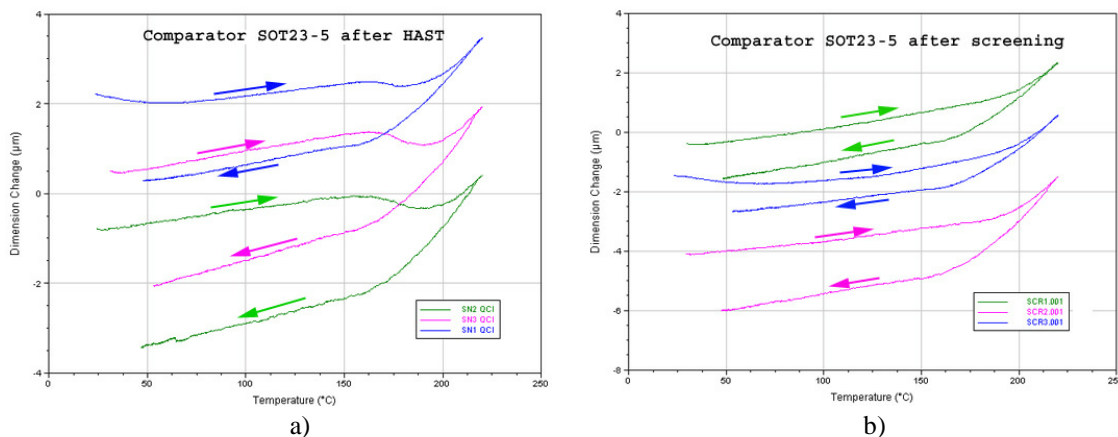
Fig. 2. Temperature dependence of package deformations for three samples: a) after HAST, b) after screening.

Note that all samples after HAST had a significant hysteresis, with the increasing branch of the TMA curves being much higher than the decreasing one. The value of this hysteresis was evaluated by a relative deformation (dL/L) calculated at 50 °C. Results of these calculations are also shown in Table 1.

The TMA testing was performed in ~1,000 hours after HAST. With the thickness of parts,  $h = 1.15$  mm, the characteristic time of moisture diffusion, which also indicates the time necessary to dry out the package, can be estimated as  $\tau = h^2/4D$ , where  $D$  is the diffusion coefficient. Calculations yield  $\tau \approx 520$  hours at room temperature. This means that most of the moisture absorbed during HAST should have been released from the package by the time of TMA measurements. The observed excessive hysteresis suggests that the exposure to high-temperature/high-humidity conditions during HAST has resulted in irreversible deformations of the molding compound and formation of delaminations.

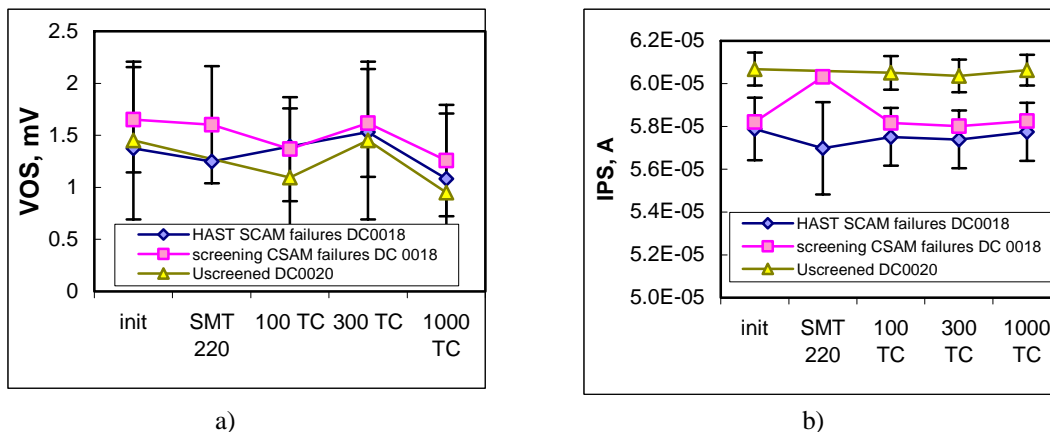
To evaluate the risk related to the presence of delaminations in these devices, all samples in the three groups were subjected to preconditioning according to JEDEC standard JESD22-A113 (three runs through the solder reflow chamber) and temperature cycling from -55 °C to 125 °C. The parts were tested after 100, 300, and 1,000 cycles. No failures were observed during this testing, and the parts manifested only minor changes in their electrical characteristics, as shown in Figure 3.

Fig. 3. Effect of temperature cycling on electrical characteristics of the parts: a) offset voltage (VOS), b) power supply current (IPS).

The results indicate that gold-to-silver bonding, which typically is used as a secondary bond in PEMs, is strong enough and can provide reliable connection even in the presence of delaminations.

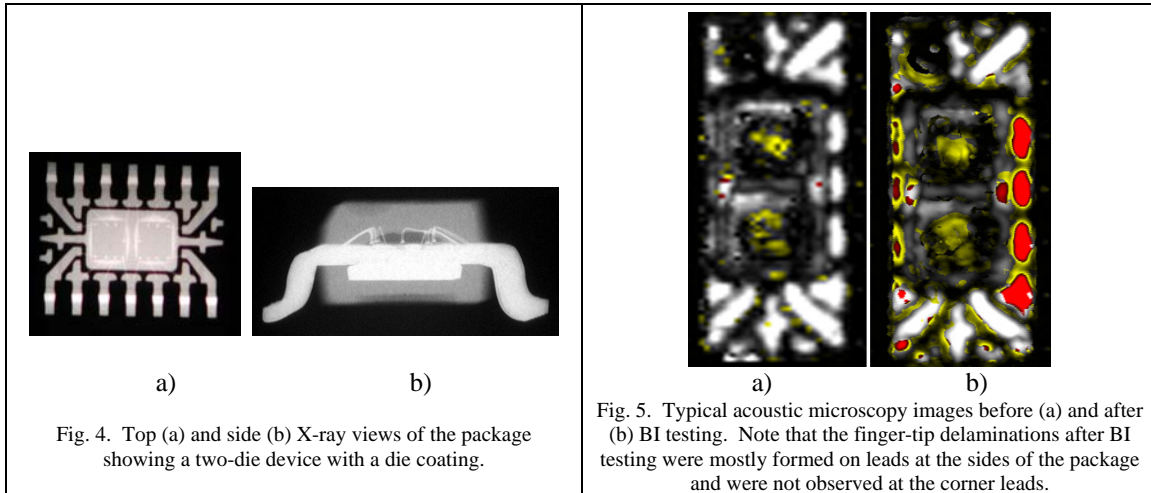
Quad operational amplifiers encapsulated in 14-SO-style packages failed acoustic microscopy screening after BI testing, which was carried out at 85 °C for 590 hours, due to excessive delaminations at finger-tips in the secondary bond areas. Figure 4 shows X-ray views of the device, and Figure 5 shows typical acoustic microscopy images (C-SAM mode) of these devices before and after BI testing. Radiography and the following destructive physical analysis (DPA) showed that the device had two dice protected with a silicone die coating.

The results allow for the following explanation of formation of the delaminations. At room temperature, the MC creates significant compressive stresses on the lead frame, and no delaminations are present. As the temperature increases, these stresses are decreasing while still remaining compressive at  $T < T_g$ . A long-term storage at 85 °C results in physical aging of MC and significant relaxation of the compressive stresses. The expansion of silicone coating increases the tensile stresses, resulting in development of forces repelling the MC from the LF at the leads, which are close to the coating. Creeping of MC caused by these forces creates delaminations with time of high-temperature aging. Possible redeposition of low molecular weight components, which typically are present in the silicone, onto the LF during curing of the coating reduces the adhesion of the MC and facilitates delaminations.

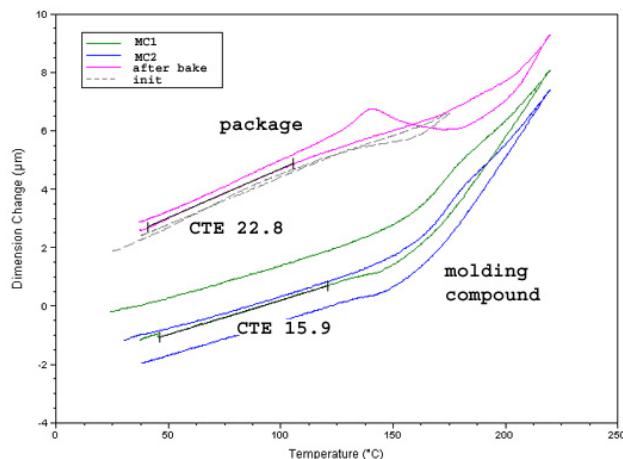
Thermo-mechanical characteristics of the molding compound used in these parts and deformations of the package are shown in Figure 6. The MC had  $T_g$  of 160 °C and CTE of 15.9 ppm/°C, which is typical for o-cresol novolack epoxy materials widely used for encapsulation of microcircuits. However, the effective CTE value calculated using deformations measured on the packages above the die locations were much larger, 22.8 ppm/°C. This is most likely due to the presence of the silicone coating, which has much larger CTE than the epoxy MC.

Fig. 6. Thermo-mechanical measurements of the molding compound and plastic packages used in the quad operational amplifiers.

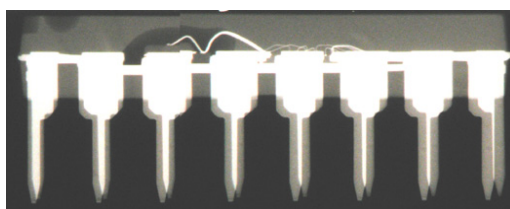
Multiple failures were observed during temperature cycling of sensors encapsulated in standard plastic 16-lead dual in-line packages (DIPs). Figure 7 shows an X-ray view of the part indicating a thick layer of die coating.

Fig. 7. Side X-ray view of the part.

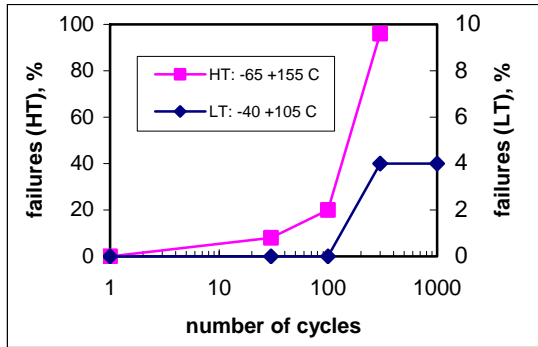
Temperature cycling was performed on two groups of parts, 25 samples each, at the following two conditions: low-temperature range (-40 °C to +105 °C) and high-temperature range (-65 °C to +155 °C). Electrical characteristics of the parts were measured after 100, 200, 500, and 1,000 cumulative cycles in the first case; and after 30, 100, 200, 300, 500, and 1,000 cumulative cycles in the second case. Results of these measurements are shown in Figure 8.

Fig. 8. Proportion of failures (%) versus number of temperature cycles.

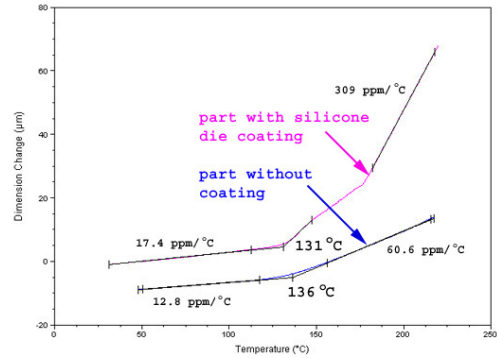
Results of TMA for the MC and the package are shown in Figure 9. Similar to what was observed in Case II, the presence of silicone coating increased CTE in a glassy state of the polymer from 12.8 to 17.4 ppm/°C. However, substantial changes occurred in a rubbery state, where the effective CTE increased from 60.6 to 309 ppm/°C. The molding compound used had a relatively low Tg of approximately 134 °C, which explains the anomaly of large deformations at high temperatures and the high level of failures during the HT TC.

Fig. 9. Thermo-mechanical measurements of the molding compound and plastic packages used in sensors encapsulated in DIP-16 packages.

The TMA data indicate significant deformations of the silicone, which might result in fracture of the wire bonds. Internal examination of the failed parts (see Figure 10) confirmed that all observed failures were due to broken gold wires in the parts.

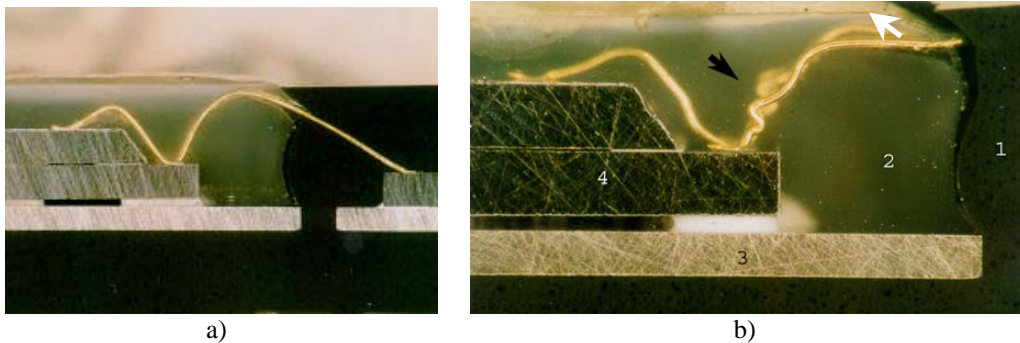
Fig. 10. Cross-section of a normal (a) and a failed (b) part showing a twisted and fractured wire: 1 – molding compound, 2 – silicone coating, 3 – lead frame, 4 – die. White arrow points at a broken wire.

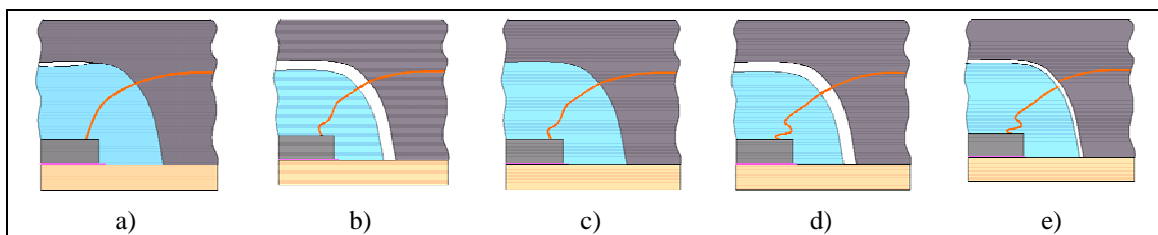
Based on the observed data, the following failure mechanism can be suggested. As the temperature decreases, silicone shrinks, “clamps” the wire, and pulls it away from the MC. During temperature increase, the clamp is released, and the silicone expands and creeps along the wire towards the boundary with the MC. As the temperature decreases during the next cycle, the process repeats, thus twisting the wire and increasing its deformation. Eventually this process can lead to a fracture of the wire, as it is illustrated schematically in Figure 11.

Fig. 11. The schematic of wire bond failures in PEMs with a relatively thick silicone die coating. Initial condition (a), at first cooling (b), at high temperature (c), repeat cooling (d), and a fracture after reaching the limit of gold wire deformation (e).

Note that to break a gold wire, a tensile deformation of ~4% to 6% has to be reached. Obviously, this deformation cannot be reached just by cooling a package with a relatively thin silicone die coating. However, with a relatively thick coating, multiple cycling might be capable of creating sufficient deformation to break the wire by the clamp-pull-and-creep mechanism.
