EXPERIMENT TEST PLAN FOR DETERMINING LOW VOLTAGE FAILURE
MECHANISMS IN CERAMIC CAPACITORS

Experiment Test Plan

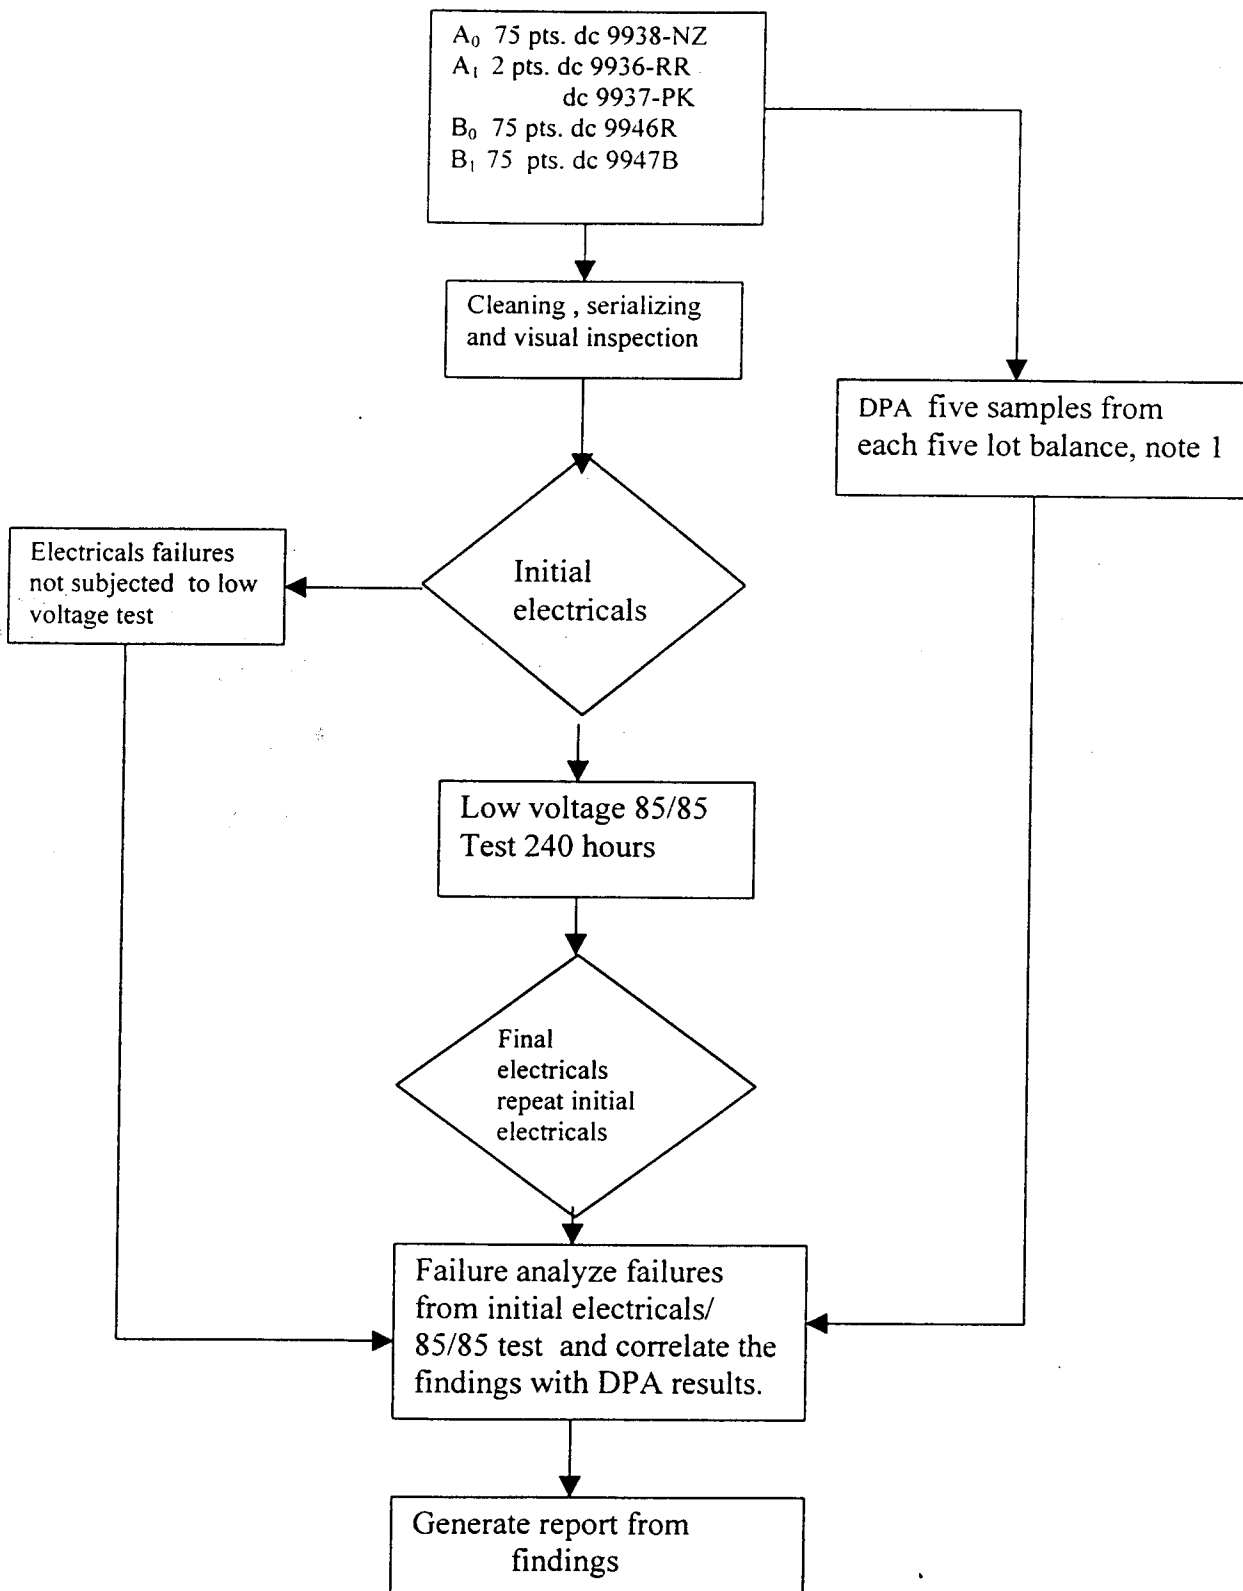
EXPERIMENT FLOW CHART

2. Experiment Description, Table 1, and flow chart
Table 1

Title	Standard	Test Method	Test Condition
Cleaning			Wash in deionized water, rinse with alcohol and dry.
Serialize			Identify all parts with Serial numbers.
Visual inspection			@ 10X ---
Destructive Physical Analysis (DPA) on a five sample size from each of the five capacitor lots (from "note 1 above").			Using in-house procedures

Initial electrical (i. e.) @ 25 ⁰ C:			
Capacitance	MIL-STD-202F	305	1 KHz, 0.1 volt
Dissipation Factor	MIL-STD-202F	306	1 KHz, 0.1 volt
Insulation Resistance	MIL-STD-202F	302	3 volts, 2 minutes
Low voltage humidity test	MIL-C-123		Paragraph 4.6.16.1
For final electricals, repeat Initial electricals			
Failure analyze initial electrical and 85/85 test failures, then correlate the finding DPA results.			Using standard in-house procedures.
Report			Develop an abstract Report investigating The failure mechanisms (phenomena) and how they cause low voltage failures.
