Using Infrared Imaging to Evaluate Bond Uniformity in Si Structures: JPL Meso-Gyro Failure Analysis Study

Joanne Wellman, Karl Yee, – *Jet Propulsion Laboratory, Pasadena, CA*

November 30, 2002

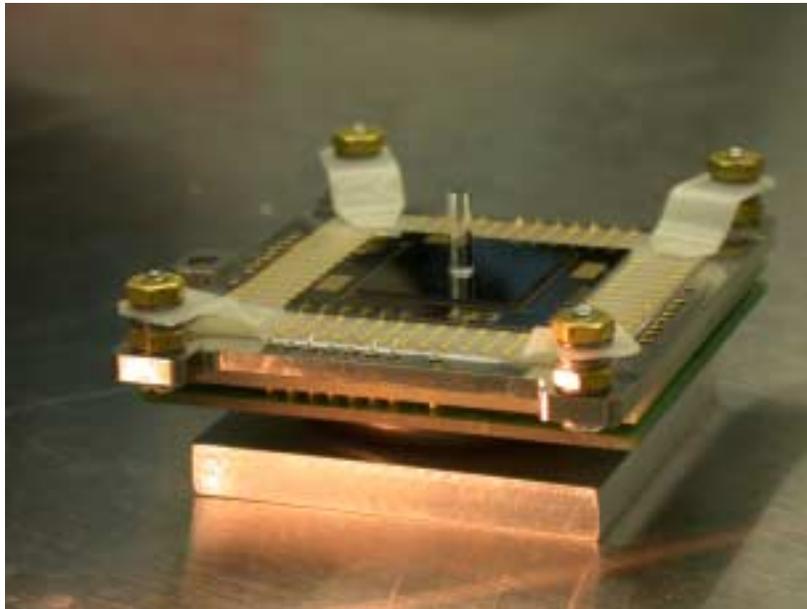
Figure 2. Gyro mounted to test fixture.

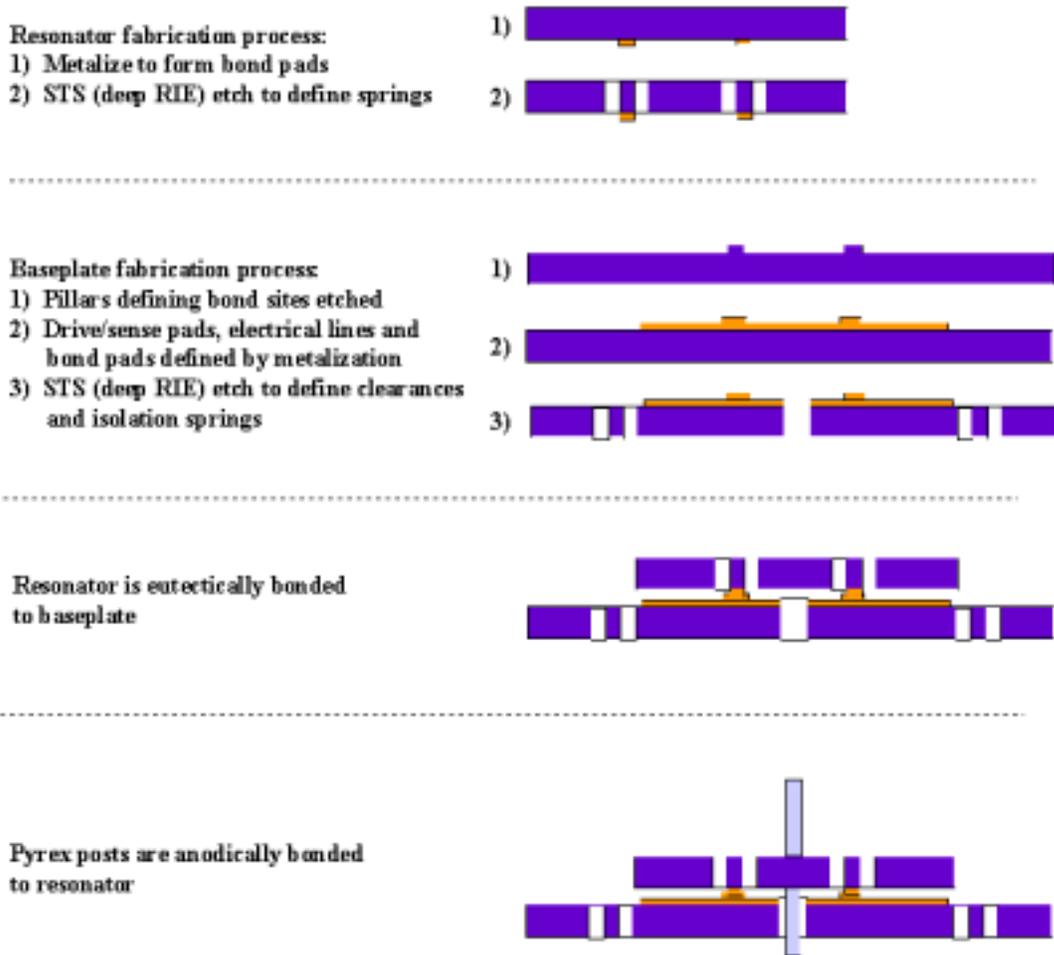
Figure 3. JPL Meso-gyro fabrication process.

The sensor part of the meso-gyro is fabricated using standard bulk micro-machining techniques. Two silicon wafers (the resonator and the baseplate) are wet etched and plasma etched to define the geometry of the gyro. They are then metalized to form the drive and sense pads, the electrical lines and the bond pads. The resonator and base plate are then bonded together at four points, which are the only points of contact between the resonator and base plate. (This resonator/base plate bond is the interface of interest in the infrared imaging study.) Pyrex posts are then anodically bonded to the top and bottom of the resonator. The Pyrex posts are the part of the gyro that couples to the Coriolis force. The fabrication process is illustrated in Figure 3.

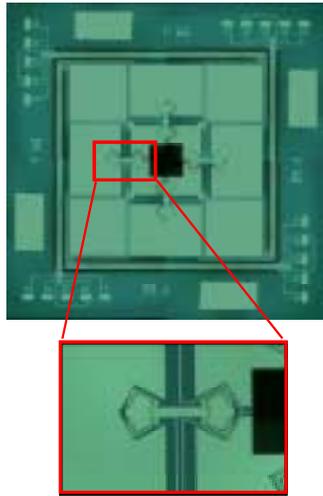
Metalization pattern of baseplate, with close-up of bond site

Figure 4. Resonator/baseplate bond geometry.

The geometry of the bond sites for the resonator to baseplate bond is shown in Figure 4. The initial configuration consisted of 4 bonds, one per side; also, gold-gold thermo-compression bonds were used. Partially due to feedback from the reliability analysis, the configuration was changed to 8 bonds (two per side) and the thermocompression bond was changed to a eutectic bond. The bond geometry was chosen so that the bonds

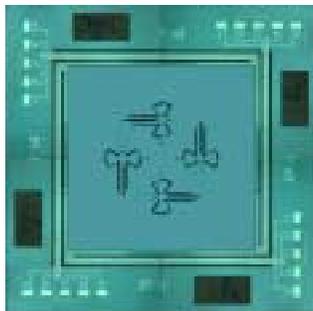
Gyro with resonator bonded to baseplate

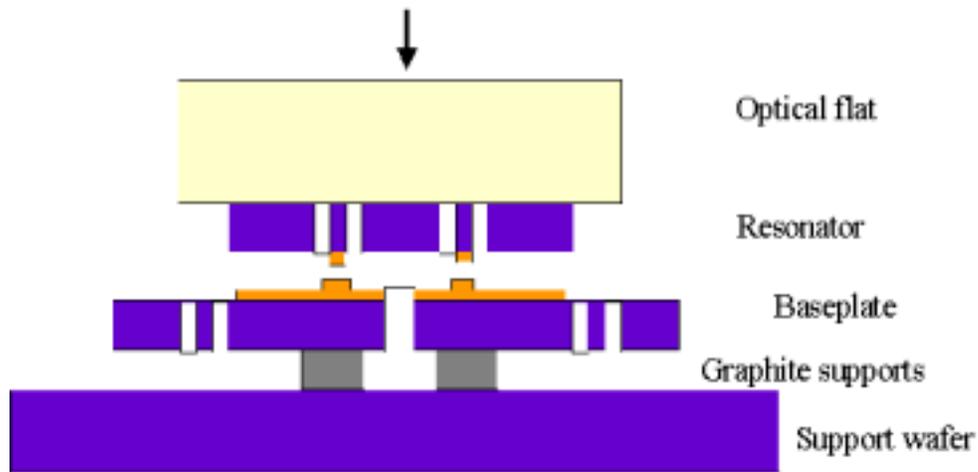
Figure 5. Resonator/baseplate bonding process

themselves would be minimally stressed during the rocking of the gyro. The layering of materials on the baseplate was: Si, SiO₂, Ti, Pt and Au. For the resonator, we have: Si, Cr and Au. No diffusion barrier was used on the resonator in this configuration so that a Au-Silicon bond could be formed. The two wafers were bonded in vacuum, under a compressive load, at high temperature (see Figure 5).

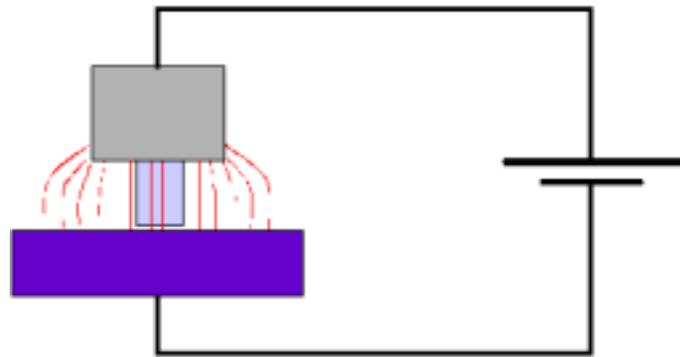
Figure 6. Si/Pyrex post anodic bonding process.

The anodic bonding of the Pyrex posts to the resonator was accomplished by heating the gyro, aligning the post to the resonator, applying a compressive load, then applying high voltage across the junction (see Figure 6).

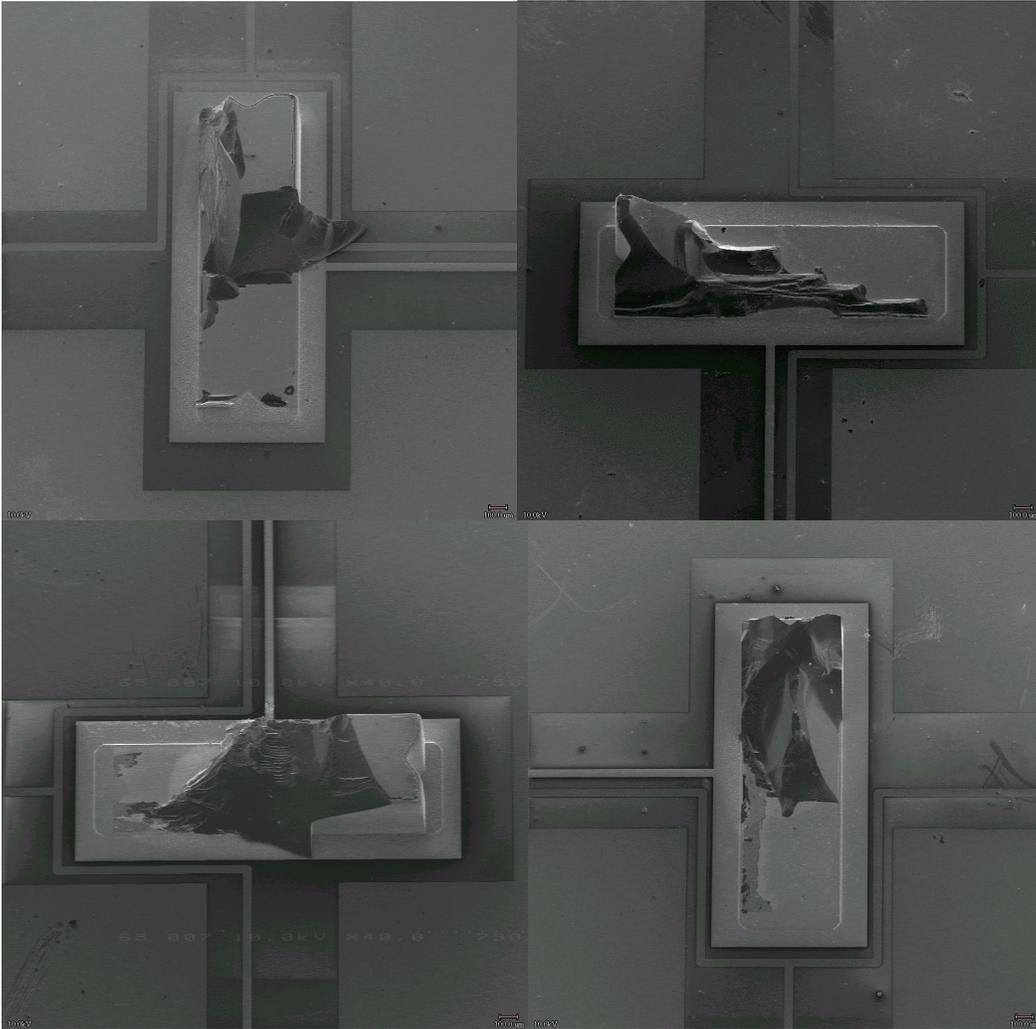
Shown below in Figure 7 are SEM micrographs of the bond sites of a typical, early design meso-gyro, where the resonator and baseplate have been pulled apart. The results clearly show that a significant fraction of the bond pad area is not successfully bonding. Complementary EDS analysis showed that the seemingly unbonded areas are primarily gold; thus, one can conclude that the bond failure occurred at the gold to gold interface between the resonator and baseplate.

Figure 7. 40x magnification SEM micrographs of the four baseplate bond pads after removal of the resonator plate

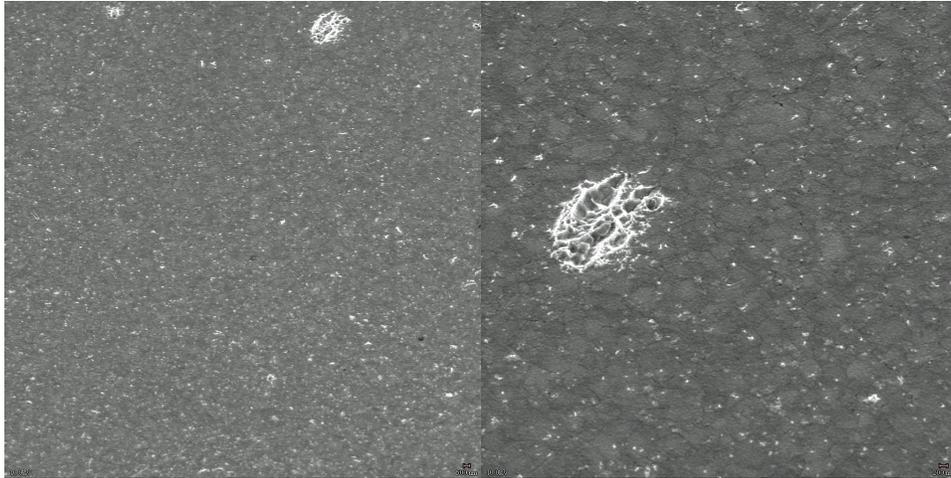
Higher magnification inspection of the bond pads revealed that the failure was due to bonding taking place only over very small, localized regions, as shown in Figure 8. These results were part of the motivation for changing the bond pad geometry, and for switching from gold to gold thermocompression bonds to Au-Si eutectic bonds.

Figure 8. 3000X and 9000X magnification SEM image of Au bond metallization after destructive pull. The light-colored feature is on the order of 1.5 microns in diameter.

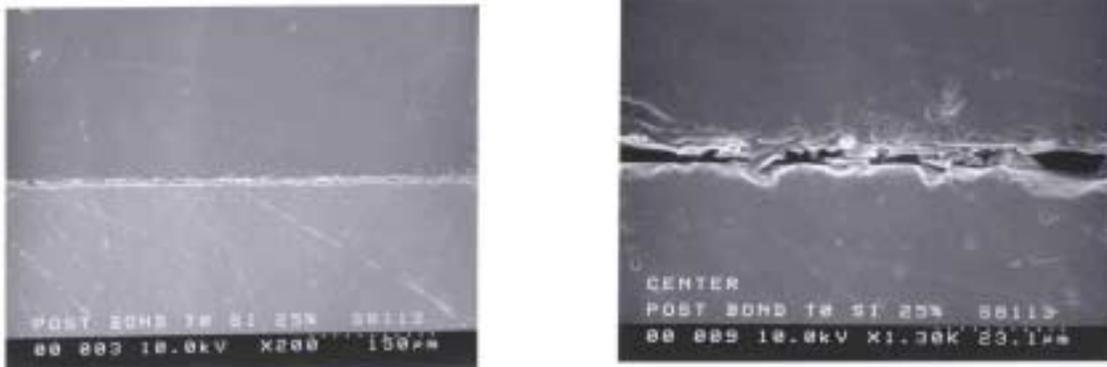
SEM micrograph analysis was also helpful in identifying a surface contamination problem, which hindered the anodic bonding process. Shown below (Figure 9 and Figure 10) are SEM images of sectioned anodic bonding samples. The first set of photos are for the sample with the surface contaminant; the second set of photos are for a sample in which a new surface cleaning procedure was used.

Figure 9. Cross section of anodically bonded pyrex post to silicon prior to new cleaning procedure (200x and 1300x magnification). Note existence of gap at the pyrex/silicon interface

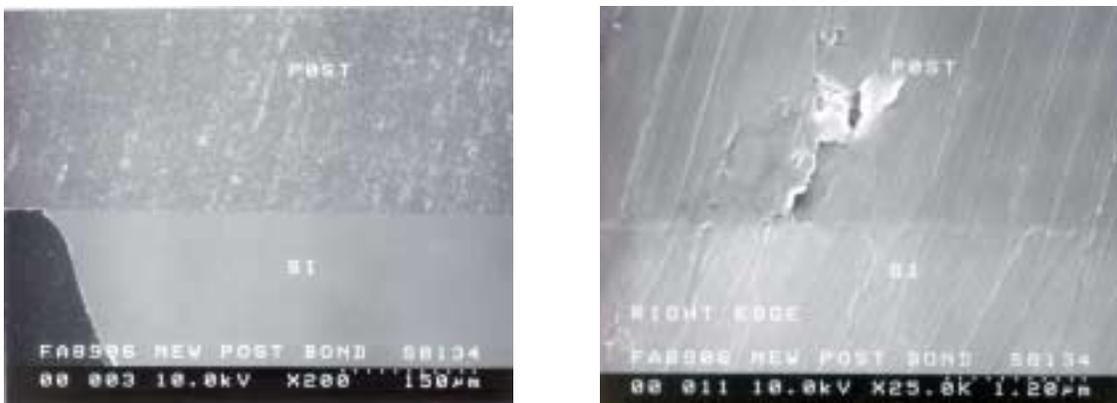
Figure 10. Cross section of anodically bonded pyrex to silicon after cleaning (200x and 2500x magnification)

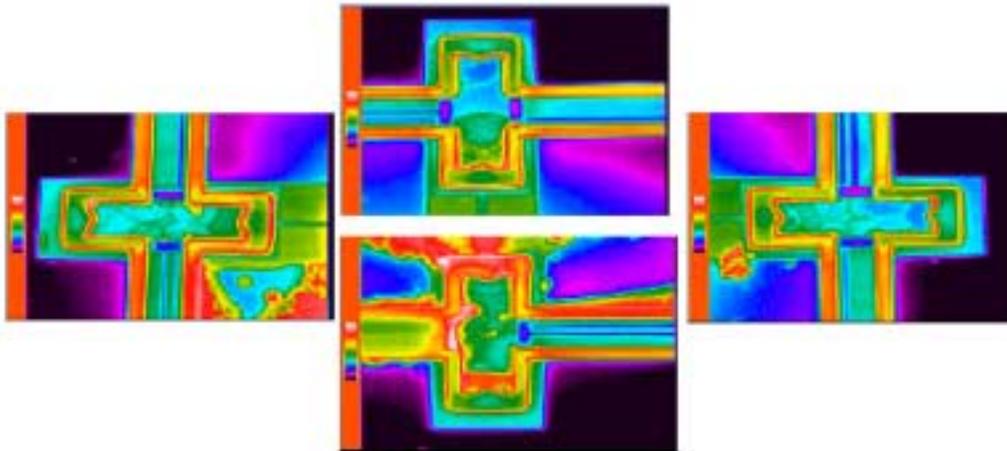
IR imaging of several meso-gyro devices in different design stages showed interesting features in the bond pad areas. For example, in the early design Au/Au thermo-compression bonded samples one can see areas of high contrast in several of the bond pads (see Figure 11). Our interpretation of this image is that these features indicate variations in the Au/Au interface, and therefore, a higher probability of non-uniform bonding across the area of the bond pad. In another case, close inspection of these contrast variations revealed that the symmetry of the IR image was broken on one bond pad: 3 of the bonds showed features on the outer radial edge while the other had features on the inside edge. This was an indication that the pressure applied during the thermo-compression bonding process was non-uniform and that the carbon chuck and the gyro were not perfectly coplanar. The carbon chuck geometry was redesigned to give more uniform pressure across the bond pad, which successfully resulted in greater bond uniformity and, consequently, improved gyro performance (lower Q).

Figure 11. Infrared images of meso-gyro Au thermo-compression bond sites taken at room temperature. Because the sample is in thermal equilibrium with the surrounding environment, the apparent temperature variations must be due to emissivity and structural variations in the bond stack.

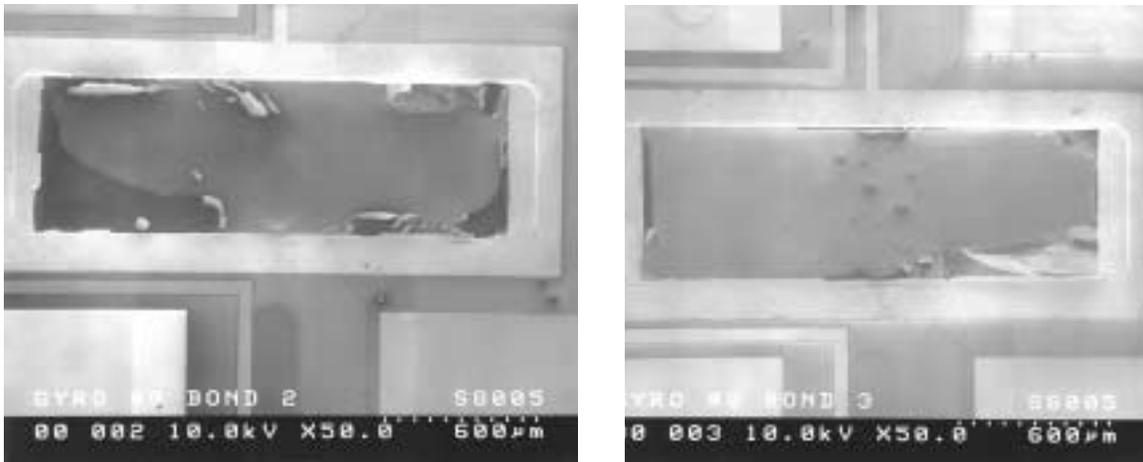
Initial eutectic bonding results for the meso-gyro were poor; IR imaging showed promise in revealing this. Figure 12 shows SEM micrographs of baseplate bond pads on an early eutectic bond attempt. This particular sample exhibited total bond failure (the resonator and baseplate fell apart when dicing was attempted to get access to the bond sites). The relatively smooth surfaces are indicative of material flow. EDS analysis (Figure 13) showed that the failure of the bond occurred at the SiO_2 interface of the baseplate. Figure 14 shows the IR images of the same sample before dicing was attempted. The data was taken after initially cooling the samples, then monitoring the evolution of temperature gradients as the samples were brought to room temperature. Apparent in the images is the existence of structure primarily at the periphery of the bond pads, indicative of bonding taking place only over a very small region.

Figure 12. SEM micrographs of bond pads of initial eutectic bond attempt

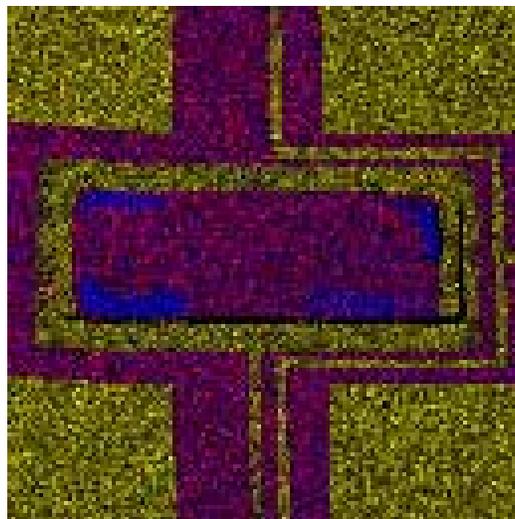
Figure 13. EDS elemental map of failed eutectic bond. Preponderance of oxygen at the surface is indicative of failure of the bond at the SiO_2 interface. Color code: Gold = Au, Blue = Si, Red = O.

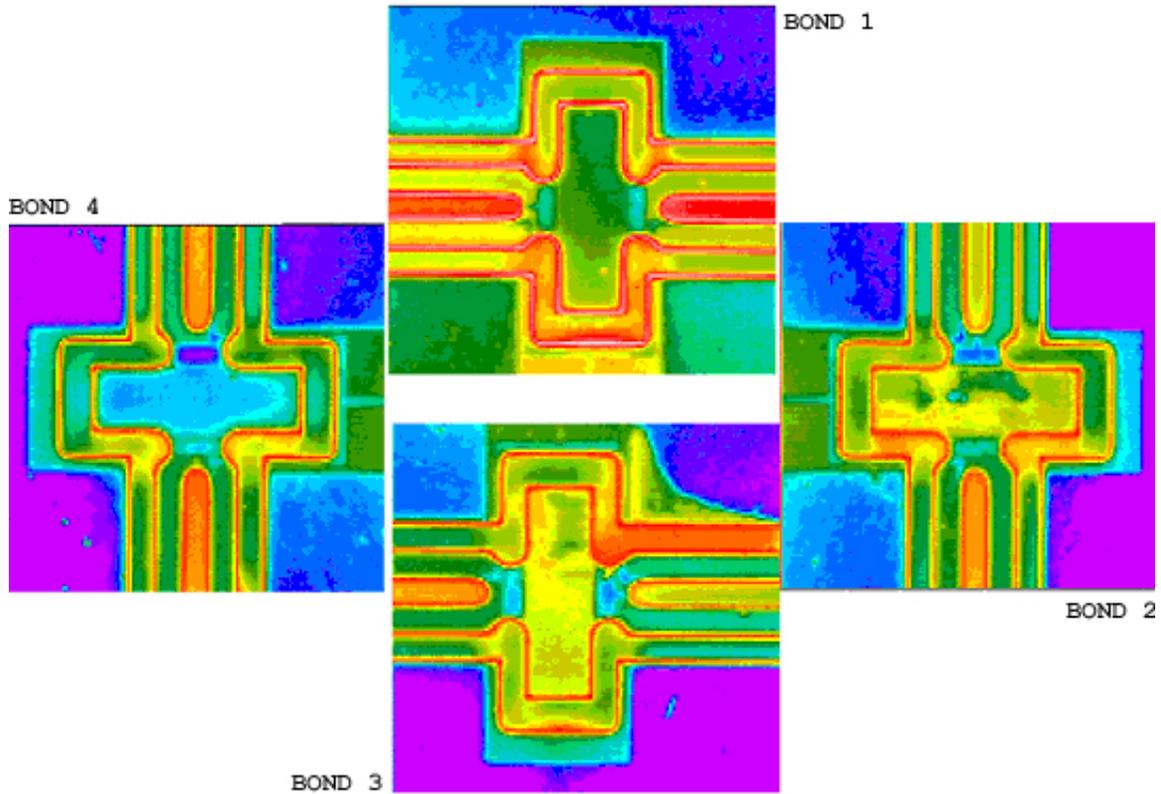
Figure 14. IR microscopy images of failed eutectic bonds. Note the absence of much of the structure seen in Figure 11. The structure seen in BOND 2 was traced back to possible contamination on the pad prior to bonding.

The problem with the IR data is that a uniform looking bond interface can either be indicative of total bond failure, or a very good bond. The two extremes are inseparable from an IR scan alone. However, IR data is useful for ascertaining a problem in situations in which incomplete uniformity exists when total uniformity is expected. An example is shown in Figure 15. Here, the corner of the gyro was inadvertently bonded during the eutectic bonding process, resulting in a dead device.

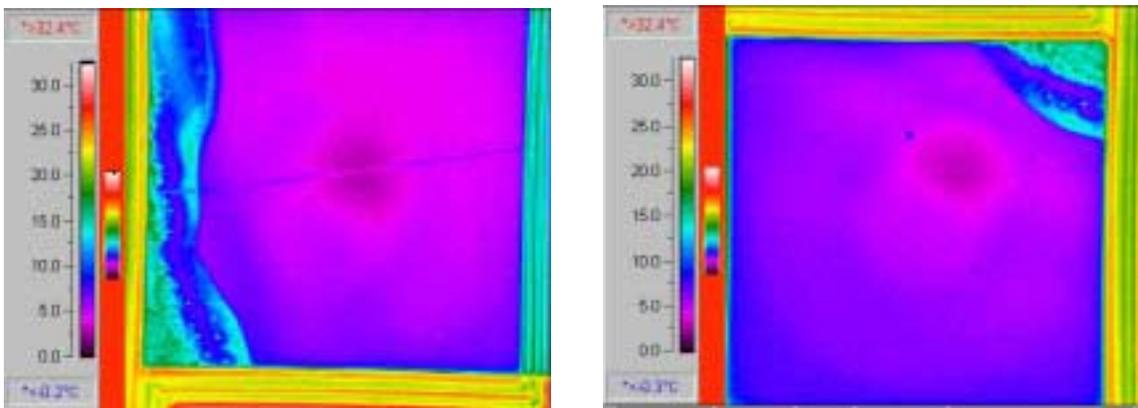
Figure 15. IR data showing bonding occurring in regions in which bonds should not exist
