4th Generation iPad Co-60 and Total Ionizing Dose (TID) Test Report

Steven M. Guertin, Gregory R. Allen
Jet Propulsion Laboratory
Pasadena, California

NASA Electronic Parts and Packaging (NEPP) Program
Office of Safety and Mission Assurance

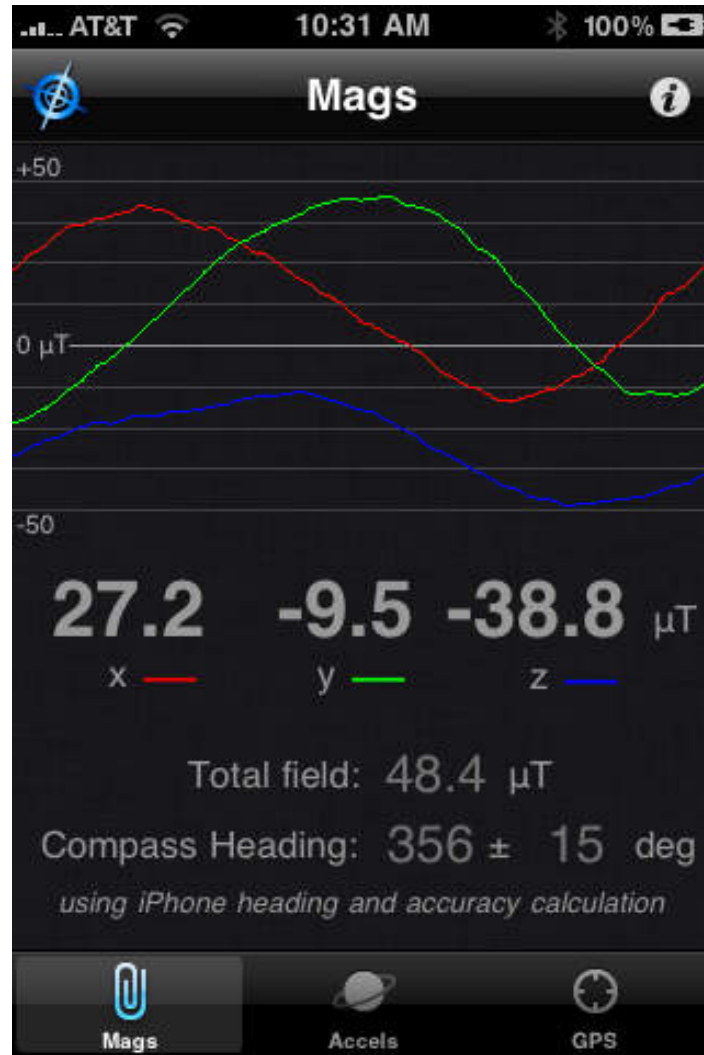
The xSensor™ by Crossbow Technology provides an easy interface to many of the sensors available in the iPad. The application screen for monitoring the magnetometers of an iPhone with xSensor is shown in Figure 4.2-1. More information can be found regarding xSensor in [5].

Figure 4.2-1. The xSensor application, monitoring the magnetometer readings, is shown.

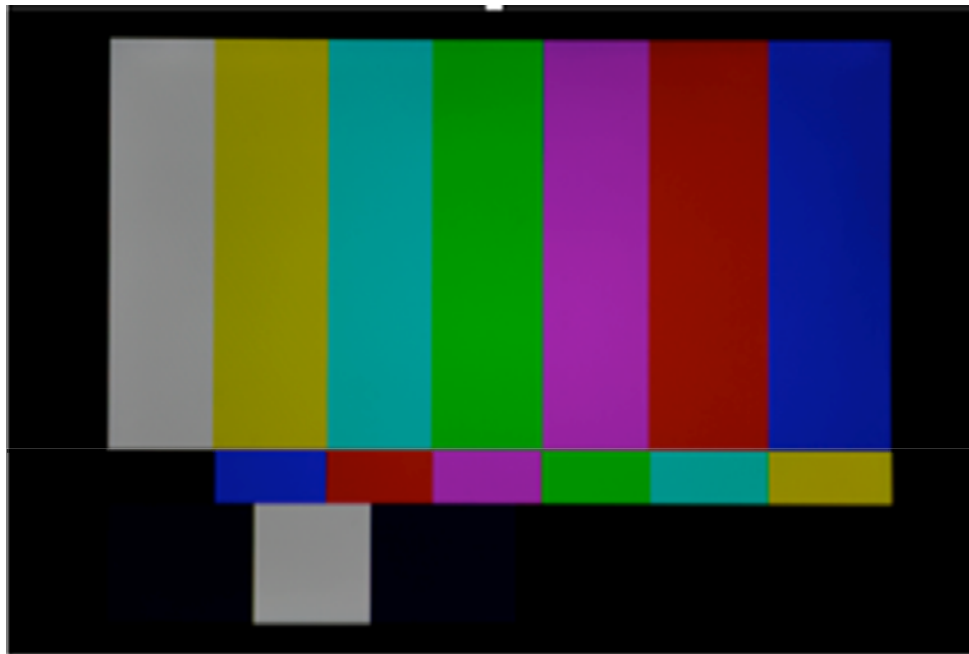
We expected the display of the iPad might have problems as a result of dose, primarily due to its use of analog drivers. As a result we defined part of the characterization approach to include calibrated photos of the screen of the iPad displaying a specific image. One of these photos can be seen in Figure 4.2-2. This photo was taken using a test jig that holds a camera a specific distance from the iPad and whose image corrections are not changed during the TID testing (so differences in the images are due to degradation of the iPad display).

Figure 4.2-2. Test image used to check the display of the iPad between irradiations.

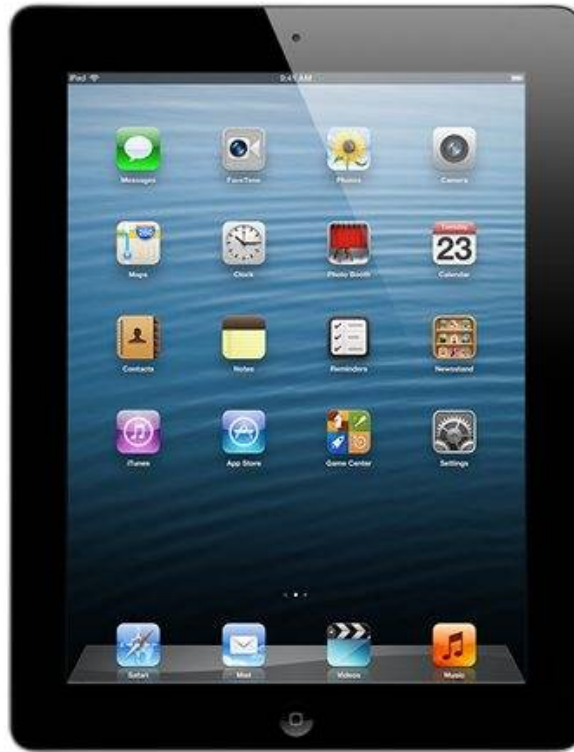
Figure 5.1-1. 4th Generation iPad used in testing.

Seven iPads were exposed for the work reported here. An image of an iPad similar to the devices studied is given in Figure 5.1-4 for reference. One additional device was used to examine the internal composition of the iPad and was destroyed.

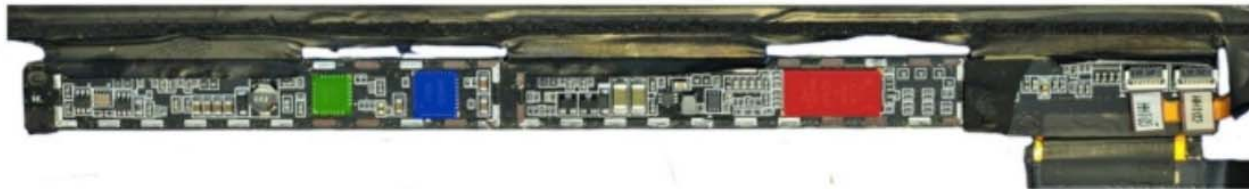
- Parade DP635
Direct Drive LCD Timing Controller
- Integrated Memory Logic (iML) iML7990
Programmable Camera Buffer
- RichTek RT9910AGQV

Figure 5.1-4. Display board components, from [3].

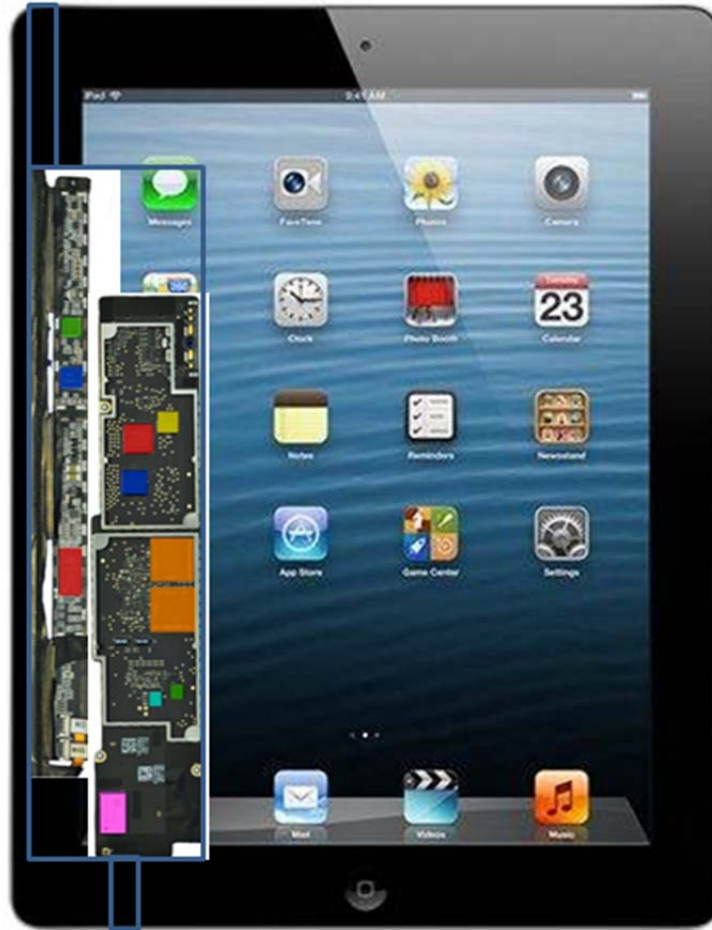
We utilized X-ray photos of the iPad and the physical disassembly to ensure appropriate beam positioning. The approximate position of the communications and display boards are shown in Figure 5.1-6.

Figure 5.1-6. Approximate position of communications and display boards.

We observed reliable loss of the WiFi signal when irradiating the iPads in position A. This is consistent with the region of the iPad identified as having the WiFi chips in Figure 5.1-6 – the region holding the Broadcom BCM4334. The signature of this behavior was the following. The exposure would begin with an active Facetime connection to the user room. Upon initiation of exposure, the connection would quickly be lost. In the user room this showed as Facetime waiting for data. But on the camera focused on the iPad it was possible to observe the WiFi signal indicator show that there was a problem and the Facetime connection was waiting. Upon entering the cave after exposure, sometimes the unit would recover the WiFi connection on its own, but the recovery response ranged all the way to a forced power-down being required to restart the WiFi.

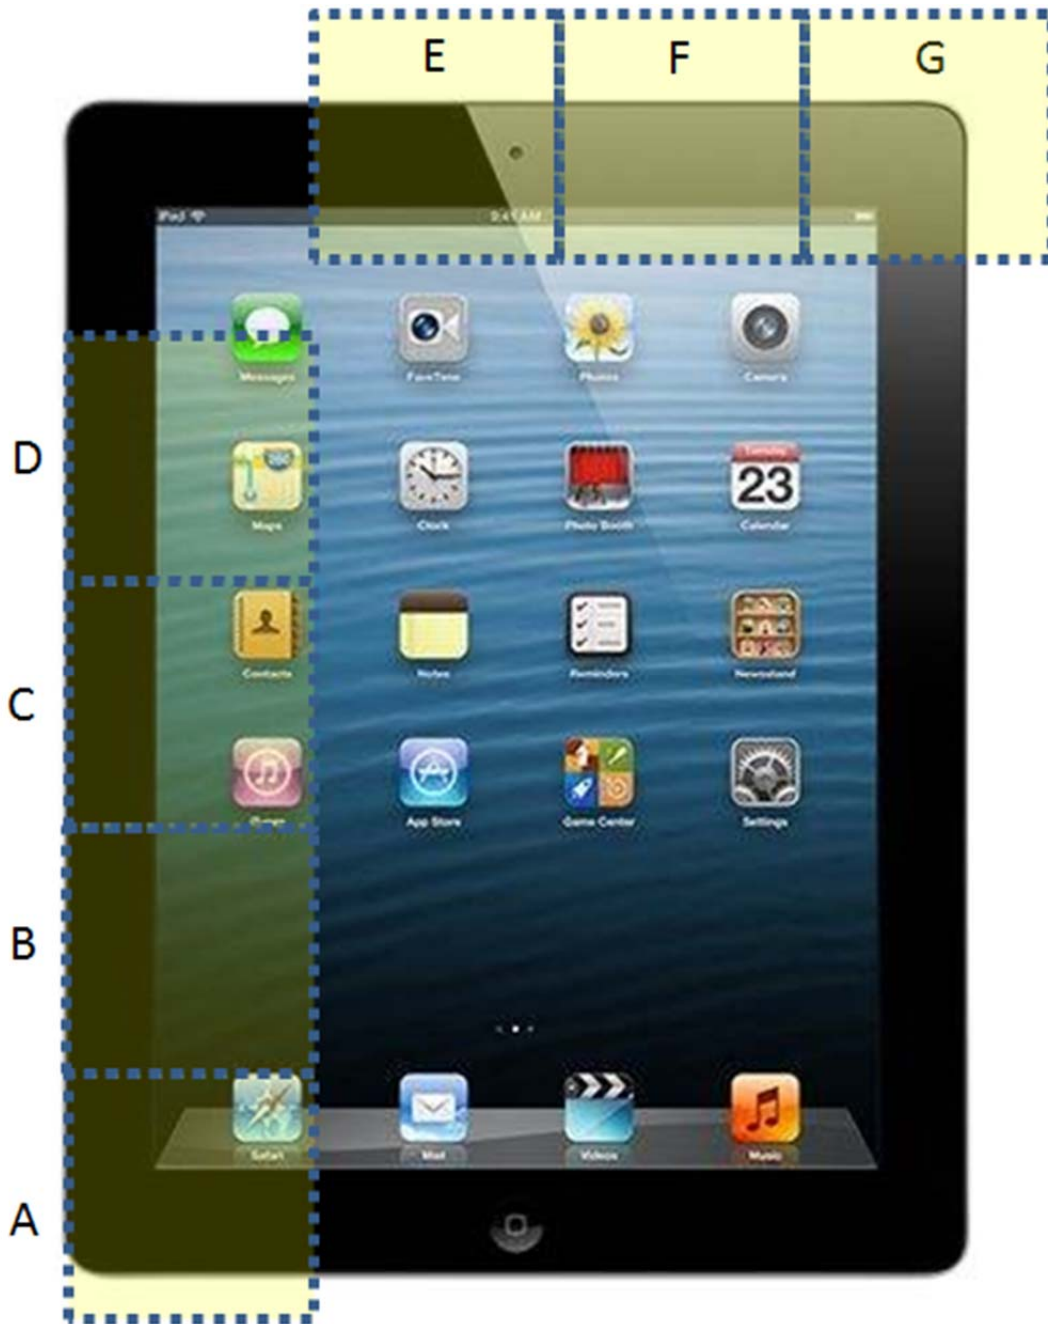
The positions used for exposure were along the left and top edges in order to expose the two circuit boards, the cameras, and another component along the top edge between the cameras. The positions used

for exposure are shown in the diagram in Figure 5.1-7, where the 2-inch (5-cm) square beam spot is superimposed for each position.

Figure 5.1-7. Beam positions used for proton exposure. The 2-inch (5-cm) square collimator was used for most exposures, and the locations reflect the beam spot size. In addition, positions A–D were alternately exposed with a 1-inch by 2-inch (2.5- × 5-cm) collimator designed to avoid exposure of the display board and battery pack.

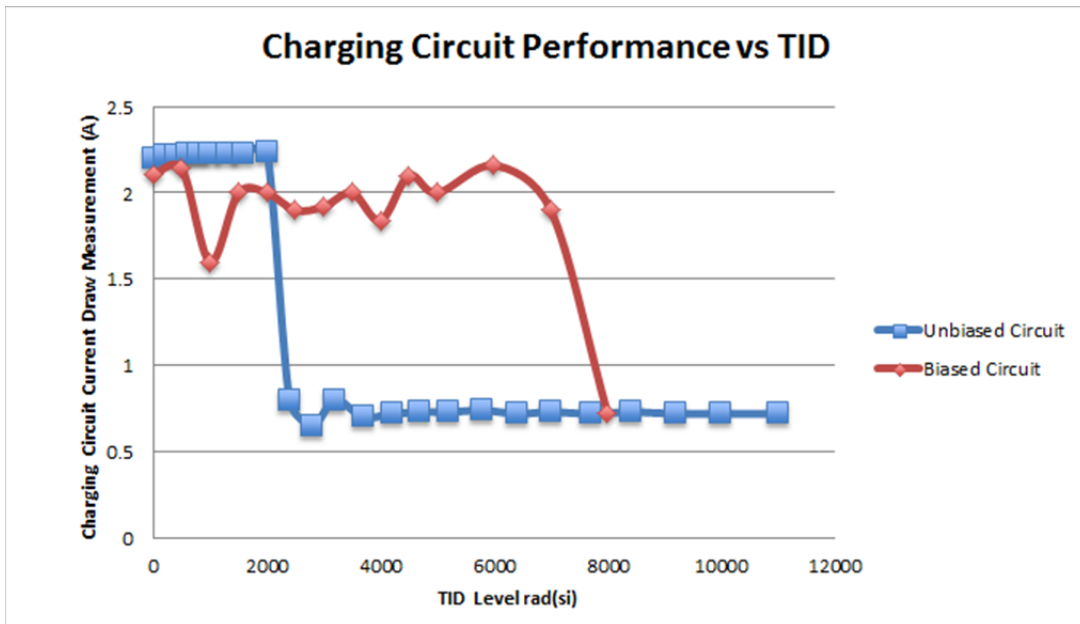
The biased testing showed essentially the same failures as the unbiased testing, but at different TID levels. For biased testing both the power and screen failures occurred at 8 krad. The combined results for biased and unbiased testing for the battery charging current are shown in Figure 6.2-2.

Figure 6.2-2 The charging current for the biased and unbiased TID testing. Results show that the charging essentially stopped abruptly at a given TID level. For unbiased this occurred at 2 krad(Si), while for biased it occurred at 8 krad.

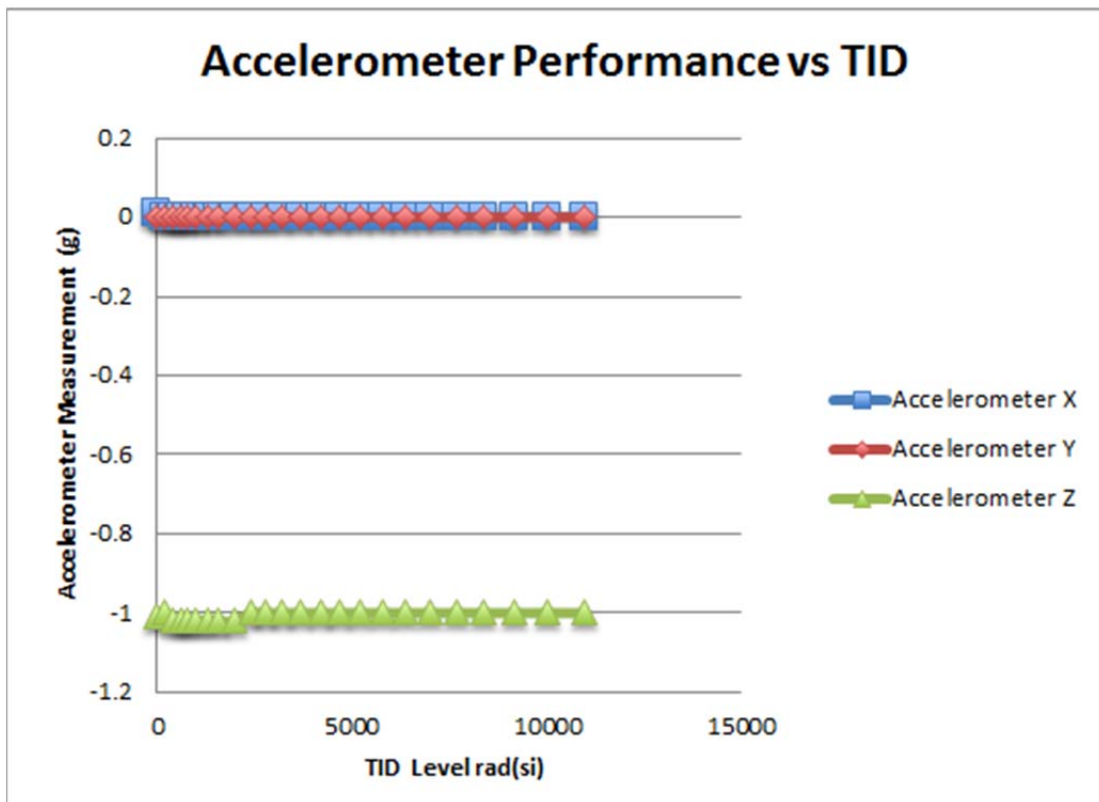
We show the results for the xSensor sensor readings taken as a function of TID as examples of the observed null results for all operations besides charging and screen functionality. These results are shown in Figure 6.2-3 and Figure 6.2-4, which show results for the unbiased iPad. There is no observable difference in the accelerometer behavior, and the change in the magnetometer performance is consistent with minor changes in orientation and the sensitivity of the magnetometer performance.

Figure 6.2-3 The response of the accelerometers in the unbiased iPad due to TID.

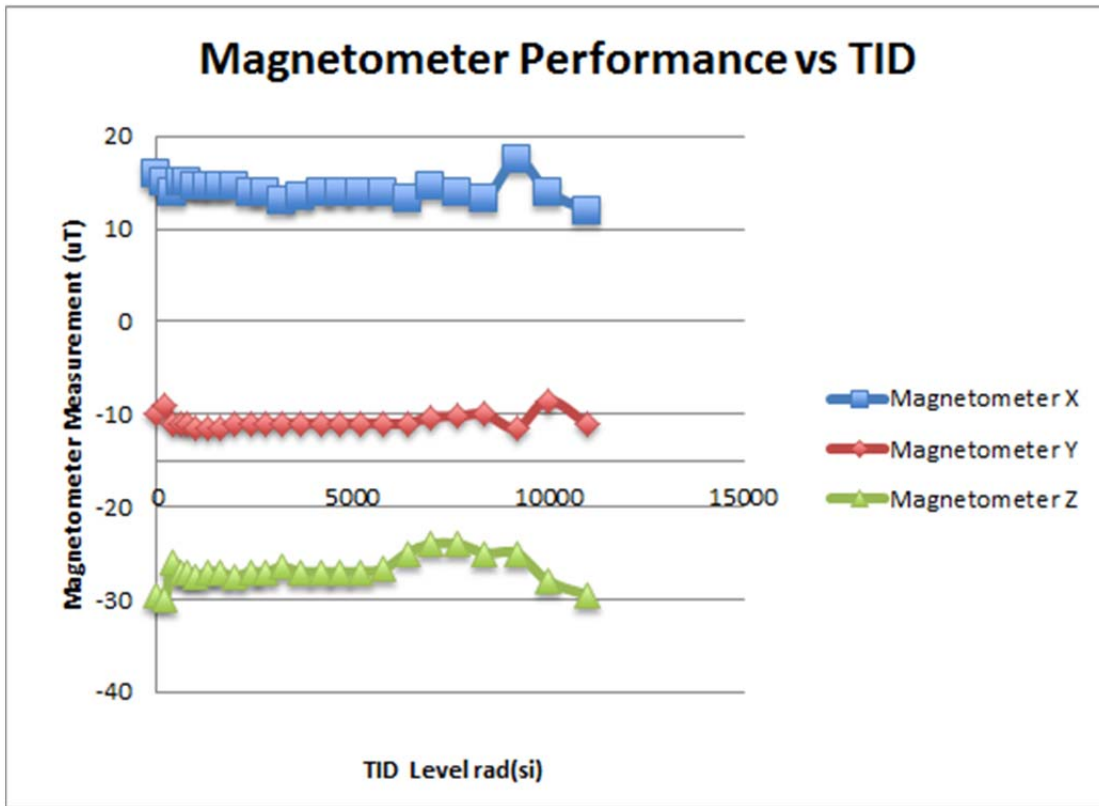
Figure 6.2-4 The response of the magnetometers in the unbiased iPad due to TID.
