Physical and Electrical Characterization of Polymer Aluminum Capacitors

David Liu
MEI Technologies, Inc.
NASA Goddard Space Flight Center
Greenbelt, MD 20771
Phone: 301-286-8573
Donhang.liu-1@nasa.gov

Michael J. Sampson
NASA Goddard Space Flight Center
Greenbelt, MD 20771
Phone: 301-286-3335
Michael.J.Sampson@nasa.gov

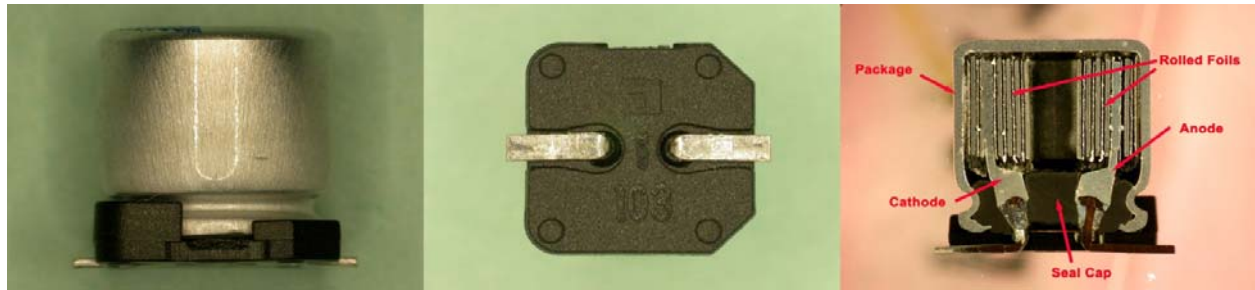
Figure 5. External and cross-section optical views of a 100 µF, 10V PA capacitor made by manufacturer C.

The construction analysis of a 100 µF, 10V capacitor made by manufacturer C is summarized in Figures 5 and 6 respectively. The results reveal that the capacitor was constructed using a traditional “wound” structure that is conventionally used for wet electrolyte aluminum capacitors. A square plastic base was assembled at the bottom of the capacitor body, so that both anode and cathode leads can be tilted 90 degrees to achieve a surface mounting capability.

As mentioned before, in order to prevent potential rubbing of cathode foil against the anode film and creating a “short-circuit” failure, a spacer is required during the foil winding. Indeed, as shown in Figure 5, the foils were wound together so loosely that a $\sim 50 \mu\text{m}$ (~ 2 mils) gap was created between each cathode and anode films. The existence of the gap makes the SEM and EDX examination almost impossible for this capacitor, since the foils keep drifting around when a high energy electron beam was applied to the foil material. The high-magnification optical examination reveals that anodized foil in this 10 V rated capacitor has a typical thickness of $\sim 82 \mu\text{m}$ with etched tunnel depth of $\sim 20 \mu\text{m}$ at both sides of the foil.

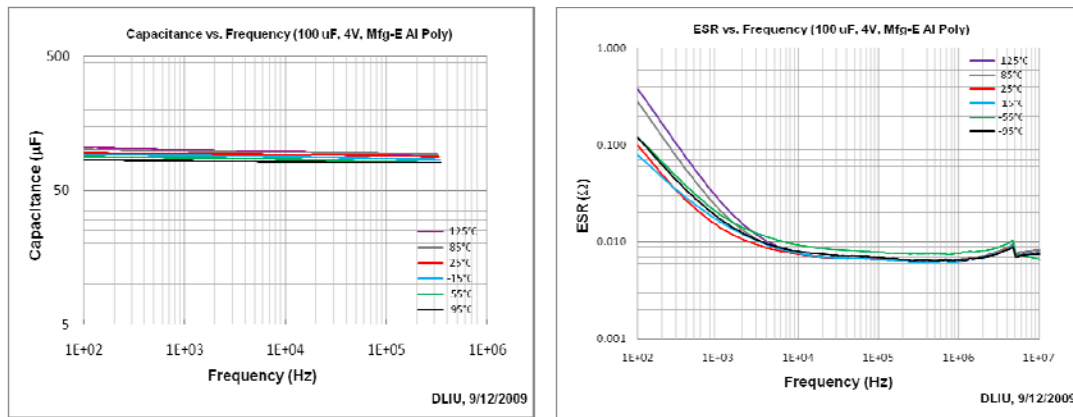
The capacitance and ESR versus frequency is shown in Figure 10 for a $100\ \mu\text{F}$, $4\ \text{V}$ capacitor with a "laminated" structure made by manufacturer E. The capacitance values at various temperatures exhibit nearly perfect straight lines versus frequency and do not change much with temperature. The capacitance at $100\ \text{kHz}$ only decreased from $93.4\ \mu\text{F}$ at $+125^{\circ}\text{C}$ to $80.8\ \mu\text{F}$ at -95°C , a 13.5% decrease with a broad temperature range of more than 200°C . The measured value of ESR of $6.4\ \text{m}\Omega$ is slightly higher than the specified value of $5\ \text{m}\Omega$, but this is not considered a significant difference. No capacitance roll-off was observed even up to $300\ \text{kHz}$. In addition, the ESR of the device shows stable low values over a board range of frequencies ($1 - 1000\ \text{kHz}$).

Figure 10. Capacitance and ESR vs. Frequency at Various Temperatures for 4V 100 μ F PA Capacitor with a “laminated” structure from Manufacturer E. Note the measured capacitance is almost completely independent of temperature and frequency.

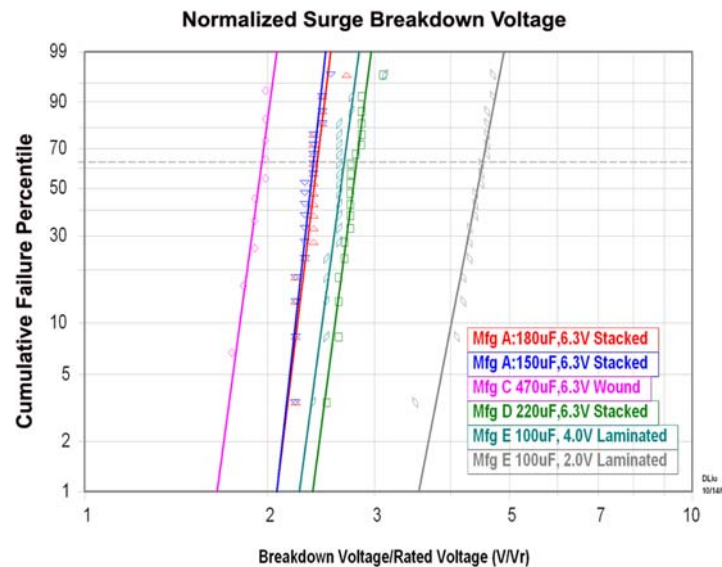
Figure 11 compares a number of PA capacitors with rated voltage of 6.3V and below made by different manufacturers with all three capacitor structures included. The worst SSST breakdown voltage is found to be the 470 μ F capacitor with a “wound” structure made by manufacturer C. The breakdown voltages in this capacitor range from 11.0V to 12.5V or 1.75 to 2.0 times of rated voltage, a range of 1.14:1. Such low values in breakdown voltage suggest that the “wound” structure is not a compelling technology for the construction of PA capacitors.

Other PA capacitors with “stacked” and “laminated” structures show breakdown voltages range from 2.2 to 3.0 times of rated voltage, or a range between 1.14:1 to 1.24:1. While the 2V rated PA capacitor made by manufacturer E, shows a range ratio of 3.5 to 4.7. One of the most interesting results showing in Figure 11 is that all capacitors exhibit nearly identical value of slope β (from 27.01 to 32.19) in the Weibull statistical plot for surge breakdown voltage, clearly indicating an identical failure mechanism in all PA capacitors.

Figure 11. Normalized SSST breakdown voltages for 6.3V and lower rated voltage PA capacitors made by different manufacturers and with different physical structures. The surge breakdown voltage shows nearly identical value of slope β (from 27.01 to 32.19).

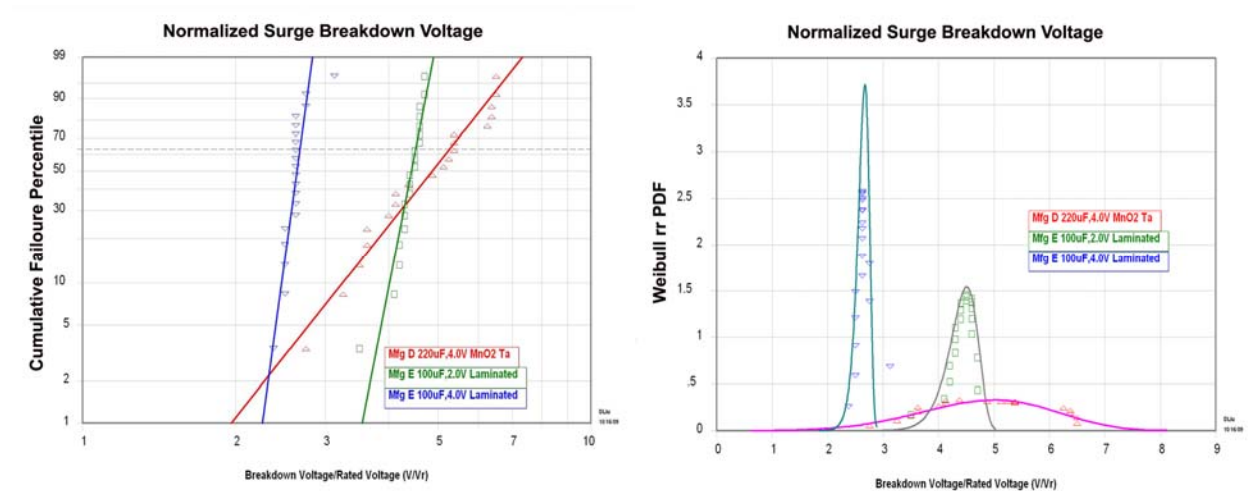
The surge breakdown voltages of 4V and 2V PA capacitors with a “laminated” structure are shown in Figure 12. The breakdown voltage data of a 4V, solid MnO_2 -based tantalum capacitor is also used for comparison purpose. The Weibull r^2 probability distribution functions (PDF) plots of three capacitors are also shown in the right in Figure 12. This plot clearly shows the tight distributions in surge breakdown voltage in PA capacitors.

On the other hand, the average surge breakdown voltage of 4V solid MnO_2 -based tantalum capacitor is higher than that of the same 4V rated PA capacitor, but with a much looser distribution, which indicates a higher probability of early failures in applications subject to current surges. On the other hand, the tight distribution of surge breakdown voltage in PA capacitors suggests that voltage de-rating may not be necessary for PA capacitors. Further investigation of the subject is in progress.

Figure 12. Normalized SSST breakdown voltages for 4V and 2V, 100 μ F PA capacitors made by manufacturer E and for 4V, 220 μ F, MnO₂-based tantalum capacitor made by manufacturer D. The Weibull probability distribution function plot (right) clearly shows the tight distribution in surge breakdown voltages in PA capacitors.
