## MEMORANDUM

SUBJECT: Evaluation of Solvent Resistance Tests for Counterfeit electrical, electronic, electromechanical (EEE) Part Detection

***This work was performed in support of the NASA Electronic Parts and Packaging (NEPP) Program***

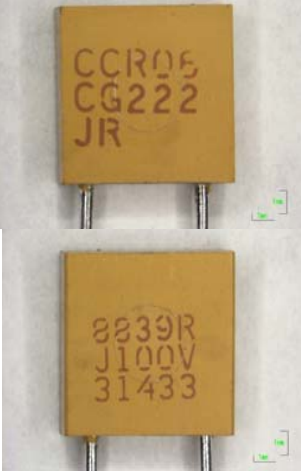
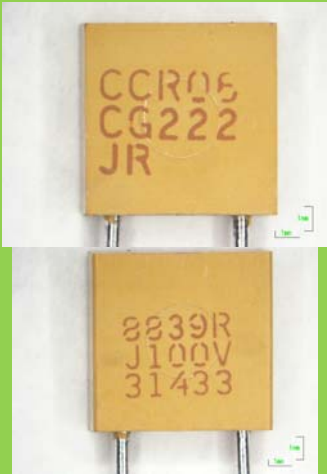
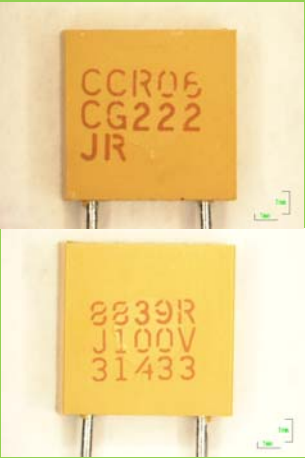
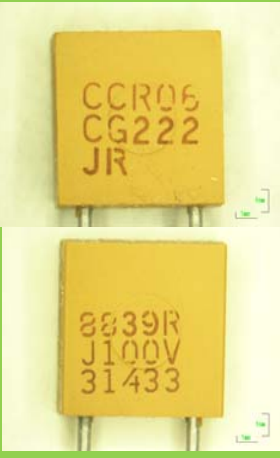
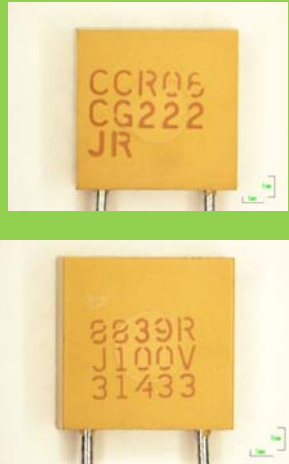
Table 4. Image Results for Line Item #1

| | <b>Solvent A</b> | | <b>Solvent B</b> | | <b>Solvent C</b> | | <b>Solvent D</b> | |
|---|---|---|---|---|---|---|---|---|
| 1 | No Effect | No Effect | No Effect | No Effect | No Effect | No Effect | No Effect | No Effect |

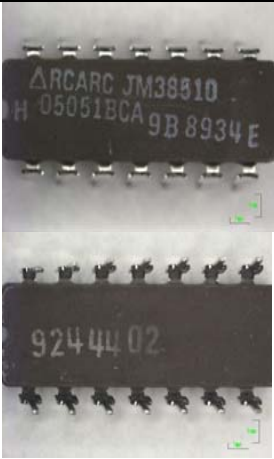
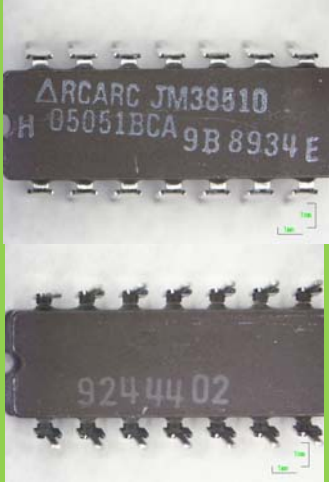
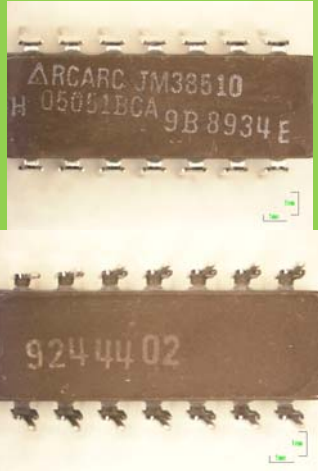
Table 5. Image Results for Line Item #2

| | <b>Solvent A</b> | | <b>Solvent B</b> | | <b>Solvent C</b> | | <b>Solvent D</b> | |
|---|---|---|---|---|---|---|---|---|
| 2 | No Effect | No Effect | No Effect | No Effect | Yes<br>See Note 3<br>See Table 5 | Yes<br>See Note 6<br>See Table 5 | No Effect | No Effect |

6. The packaging deterioration seen with line item #2, 3,4,5,6, and 8 was identified by the lifting of the packaging material during the swabbing of the device, after exposure to the solvent.

Solvent test procedure C also removed most of the part markings for device types #2 through #8. However, the acceptance criteria for solvent C allows for marking degradation since this solvent is primarily used to check for part resurfacing (i.e., package degradation) rather than remarking.

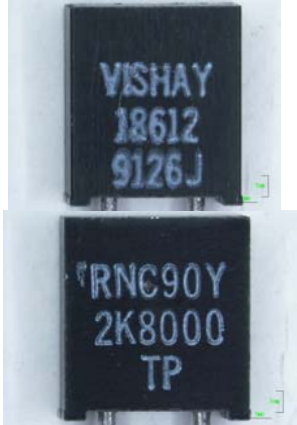
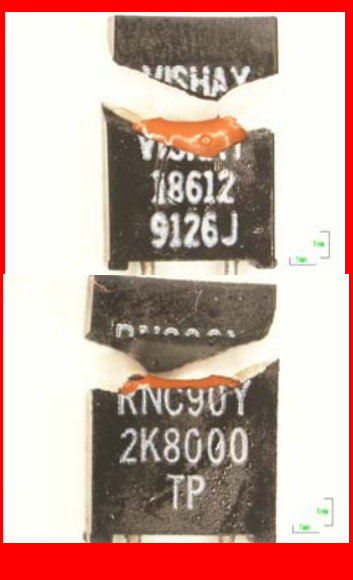
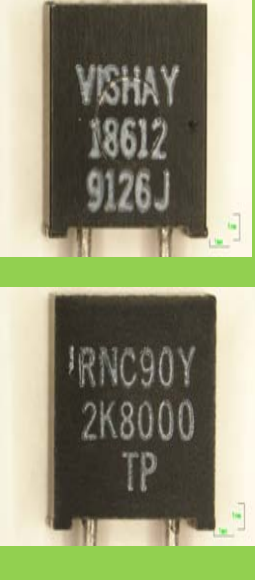
**Table 10. Image Results for Line Item #7**

| | <b>Solvent A</b> | | <b>Solvent B</b> | | <b>Solvent C</b> | | <b>Solvent D</b> | |
|---|---|---|---|---|---|---|---|---|
| 7 | No Effect | No Effect | No Effect | Package<br>Fracture<br>See Note 1<br>See Table 10 | Yes<br>See Note 3<br>See Table 10 | Partially<br>Dissolved<br>See Note 2<br>See Table 10 | No Effect | No Effect |

1. During the experiment with line item #7 and solvent B (1-Methyl 2-Pyrrolidinone), the device seemed to have experienced an external package fracture that is consistent with counterfeit properties. In order to confirm this finding, two additional line item #7 parts were tested again using the solvent B test procedure. In the initial experiment, the parts remained in the solvent after being taken off the hot plate, and while waiting for the swab wipe. In the additional tests, after the allotted time had passed, each device was removed immediately from the solvent. All three of the retested line item #7 showed no damage (Table 13). An additional line item #7 device was then retested again using the solvent B test procedure, but this time left on the hot plate for a longer amount of time (approximately 5 minutes) to determine if an increased amount of heat exposure created the external package fracture. As seen in Table 14, damage did occur to the external package.

2. The package deterioration seen with line item #7 during the Solvent C test can most likely be attributed to the aggressive nature of the Dynasolve 750. It is highly unlikely that this device is a suspect counterfeit part.

Solvent B caused fracturing of the external package for line item #7 – molded case radial leaded bulk metal foil resistor (see Table 10). However, the device had remained in the solvent for approximately 2 to 5 additional minutes after the beaker was removed from the hotplate prior to removal for the cotton swab test. The package fracture could have occurred during solvent exposure time beyond the required soak time. Retesting was performed using two additional parts from line item #7 limiting the solvent exposure time to the required 2 to 5 minutes. No package fractures occurred for these two devices (see Table 13).

Solvent C caused significant degradation of the external package for line item #7-molded case radial leaded bulk metal foil resistor (see Table 10). The external markings were completely obliterated and the external package was significantly dissolved. However, it is exceedingly unlikely that this device is a suspect counterfeit part. For this type of molding compound, solvent C appears to be overly aggressive for use to detect suspect counterfeit components (i.e., false positive results are probable).

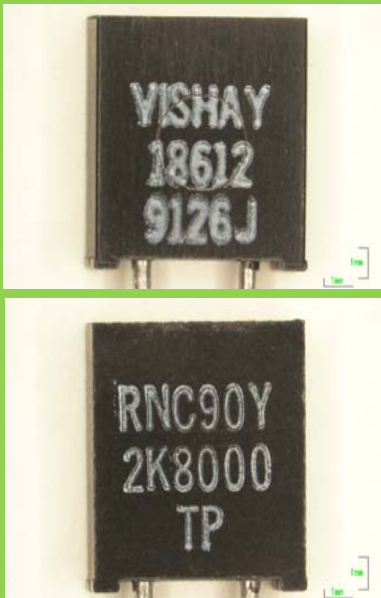
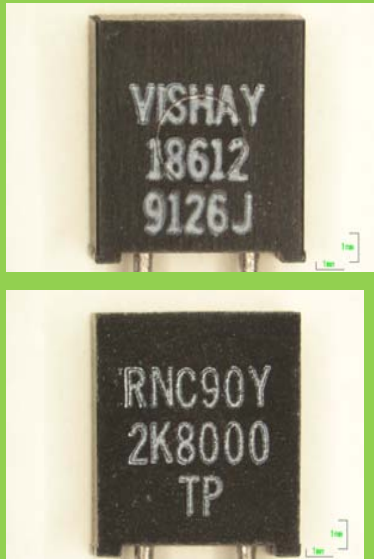
**Table 13. Image Results for Line Item #7 Retest**

*During the initial test in Solvent B, the device package for line item #7 fractured (see Table 10). However, the exposure time in the solvent exceeded the required 2 to 5 minutes by approximately 5 minutes. These two retested samples were exposed to Solvent B, and then removed immediately after the 5 minutes had elapsed.*

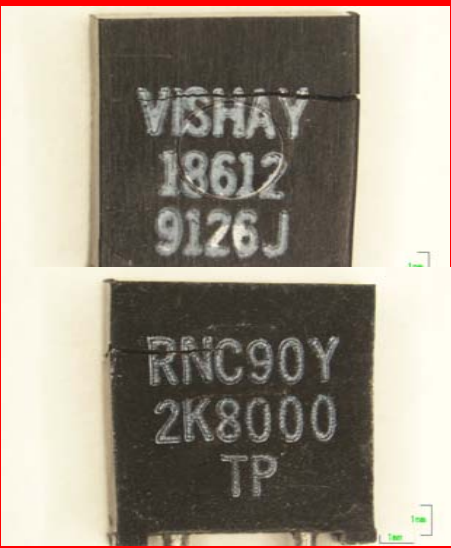
**Table 14. Image Results for Line Item #7 Retest With Increased Exposure Time (~10 minutes)**

*This retest was performed to confirm the initial test results (see Table 10) where the device package fractured after exposure to Solvent B for longer than the outlined 2 to 5 minute exposure.*

An additional device from line item #7 was then retested using the solvent B test procedure, but this time it was left on the hot plate for a longer amount of time (approximately 5 minutes) to determine if an increased amount of heat exposure created the external package fracture. As seen in Table 14, the same type of damage did occur to the external package as occurred on the first sample that was tested beyond the required test time.

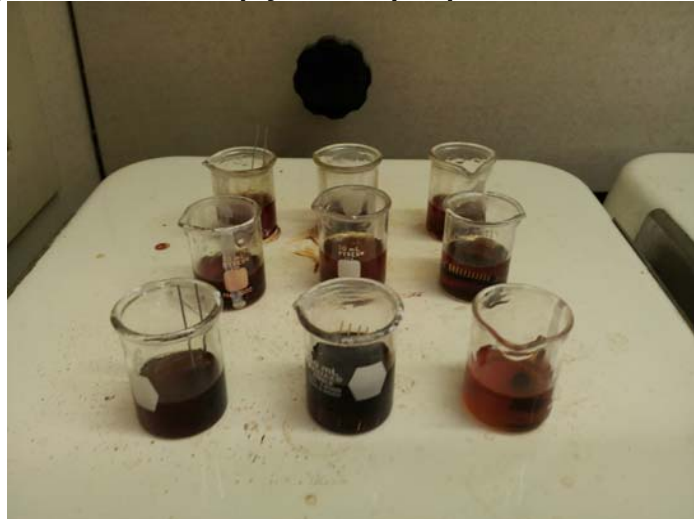
**Figure 3. Solvent C (Dynasolve) Exposure at 45 minutes**

4. The Dynasolve solvent experienced a gradual color and phase change during the exposure time while on the hot plate (Figures 1-3). At the beginning of the experiment, the solvent was bright blue in color. Over time, the solvent transitioned to a yellowish brown color, and then to a reddish brown color. At the end of the allotted exposure time, the solvent had mostly turned into a solid state of form. This, however, did not appear to have an effect on the devices.
