## NASA Electronic Parts and Packaging (NEPP) Program

NEPP Task: Guidelines for Selection of Ceramic Capacitors for Space  
Applications

# Cracking Problems in Low-Voltage Chip Ceramic Capacitors

2018

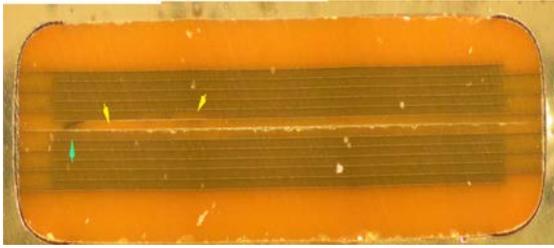
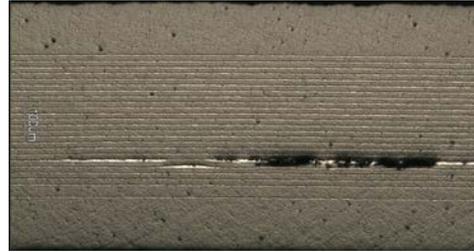
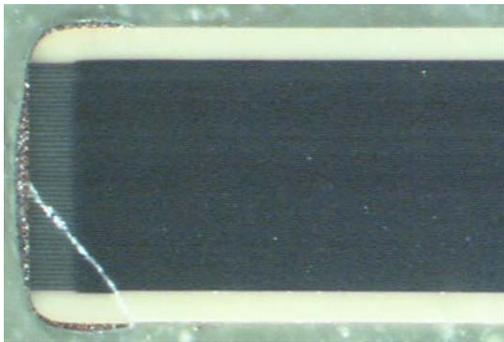
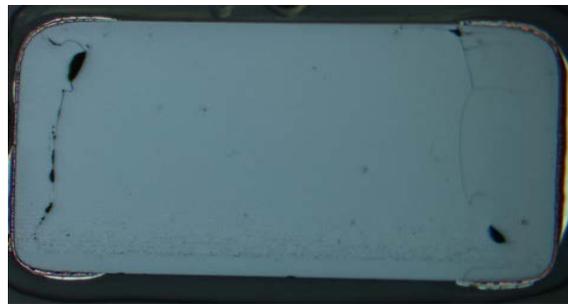
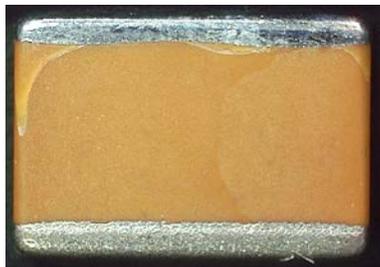
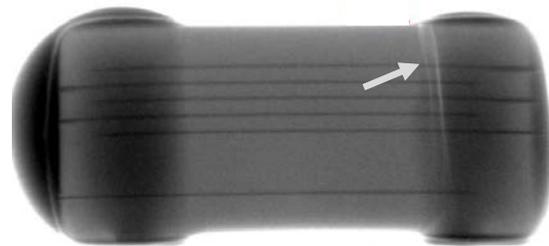
Figure 1.2. Different types of cracks in MLCCs.

a) Manufacturing defect: CDR 0.1  $\mu$ F 100 V capacitor that failed due to delamination at  $\sim$ 1.5 kohm during board-level testing

b) Manufacturing defect: voids and delaminations (knot line cracks).

c) Assembly-related defect: flex crack.

d) Assembly-related defect: thermal shock cracking.

e) Cracking caused by manual soldering.

f) Cracking caused by touch-up after reflow soldering.

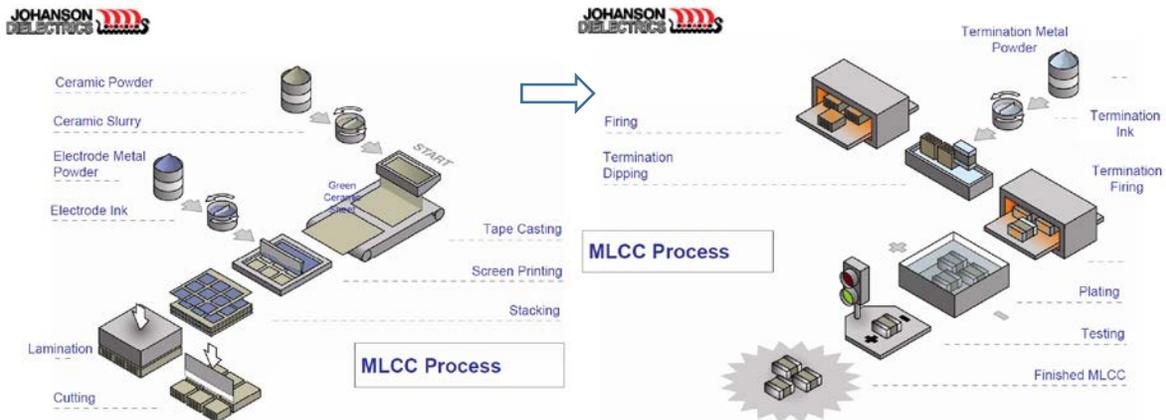
Figure 2.1. Schematic of the processes of MLCCs manufacturing [17].

All MLCCs are manufactured using a ceramic slurry (a mixture of ceramic powder, dispersant, solvent, and organic binder) and a paste for metal electrodes (see Fig.2.1). The dielectric layers are formed by the casting process and then electrodes are formed by applying the paste by screen printing. Dry or wet stacking processes are used depending on conditions of the layers used for lamination. During the wet process, the next layer of the ceramic slurry and electrode paste are laid down on the top of the previous layer and then the stack is dried out to remove the binder (at ~ 400 °C). During the dry process the layers are casted on a Mylar or stainless steel belt, then dried out, removed from the belt, stacked, and laminated at elevated temperature under pressure. It is considered that the wet process that is typically used to manufacture precious metal electrode (PME) capacitors allows for a better interlayer bonding that results in less delamination.

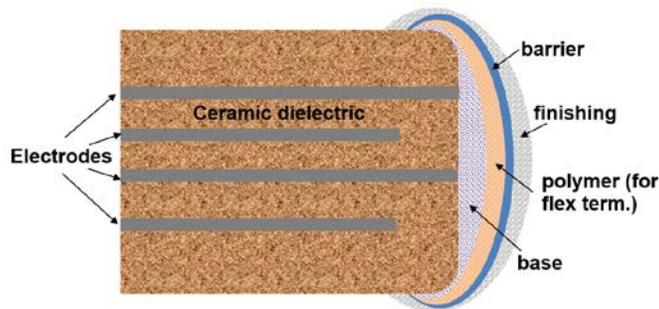
Figure 2.2. Schematic of a low-voltage MLCC.

Fig.2.2 shows a typical construction of a low-voltage (below 200 V) MLCC. The major elements of the part are ceramic dielectric, metal electrodes, and terminations. Respectively, the type of capacitors depends on materials used in these elements (see Table 2.1). Different types of ceramic materials can be used with different types of metal electrodes and terminations resulting in a large variety of types of MLCCs. This variety further increases considering different sizes and outlines of the parts. Standard design low-voltage MLCCs have two terminals, but for some applications, in particular, for decoupling in microcircuits (e.g. FPGA), a design is changed to reduce inductance of the parts.

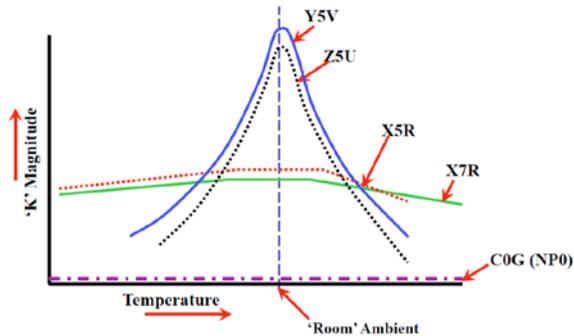
Figure 2.3. Comparative temperature dependencies of dielectric constant in different types of materials J. Prymak, KEMET tutorial [20].

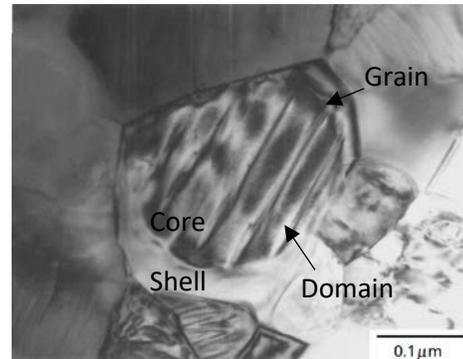
Figure 2.4. TEM image of a BaTiO<sub>3</sub> ceramic showing core-shell structure of a grain [21].

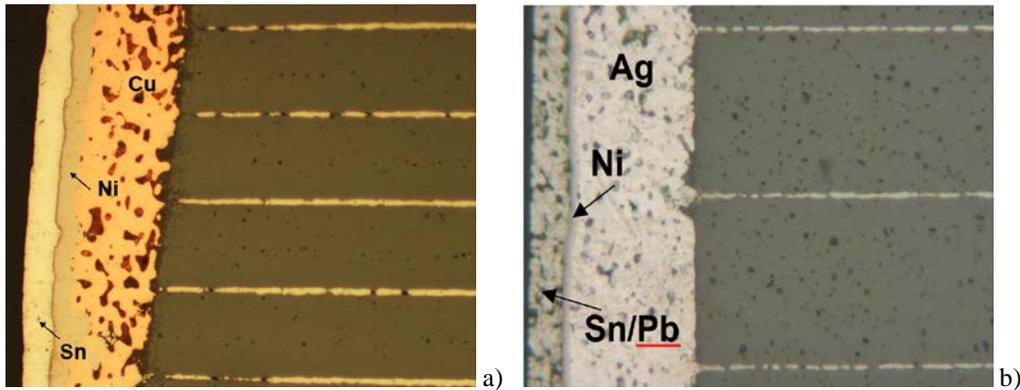
Figure 2.5. Terminations in BME (a) and PME (b) 50 V capacitors.

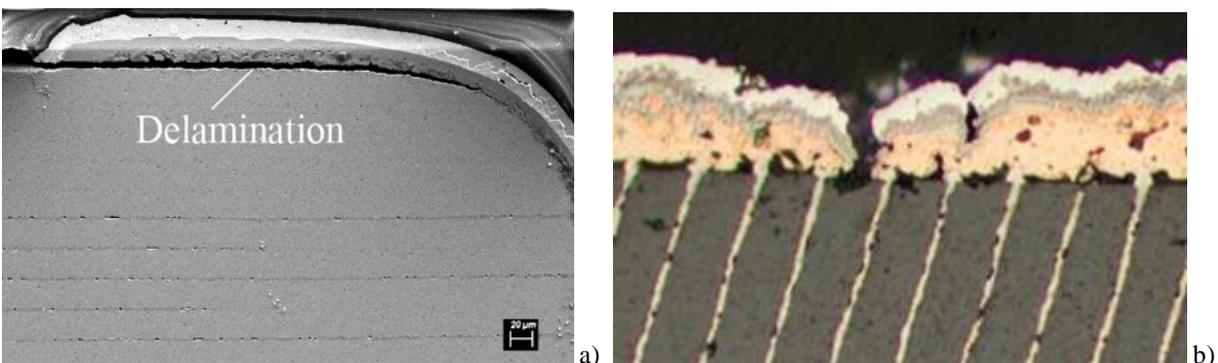
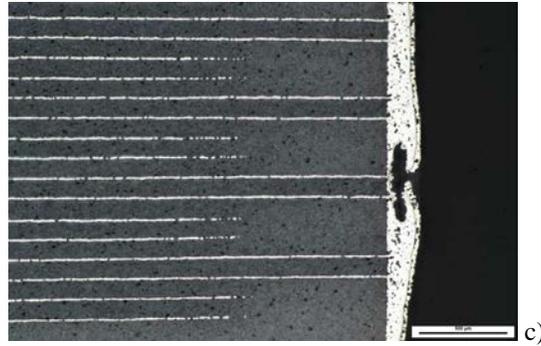
Figure 2.6. Example of termination defects. a) delamination in a PME capacitor and pinholes in BME (b) and PME (c) capacitors.

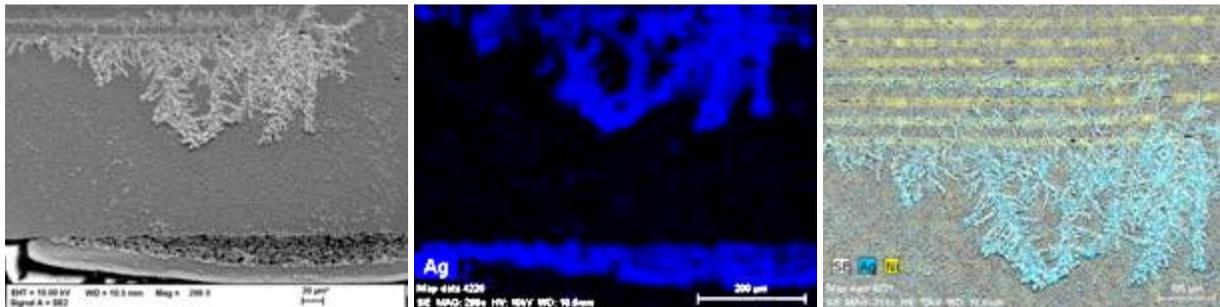
Figure 2.7. Silver dendrites on the surface of a cross-sectioned BME flex-termination capacitor after low-voltage humidity testing at 1.5 V (HSSLV).

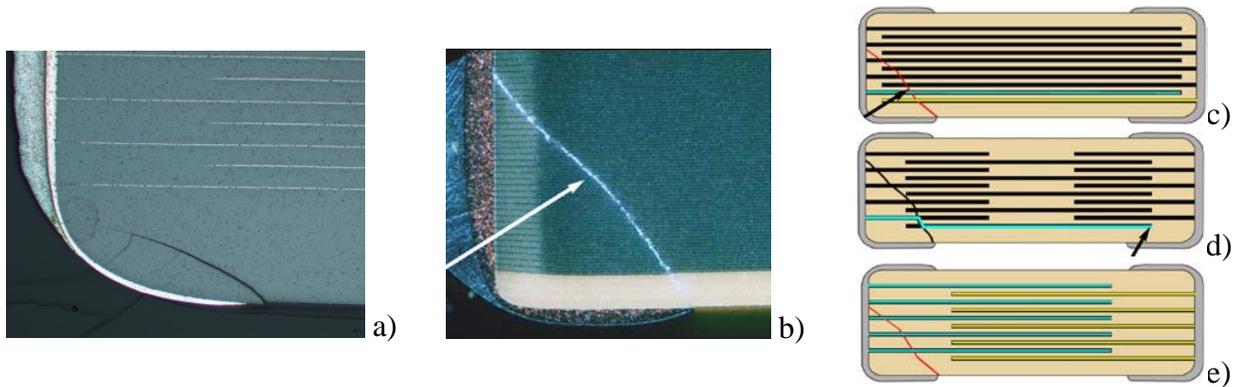
Figure 2.8. Soldering related cracks in MLCCs and schematics of a standard part (c), floating electrode capacitor (d), and Open Mode design (e) [38]. Yellow and blue lines in (c-e) represent electrodes with different polarity.

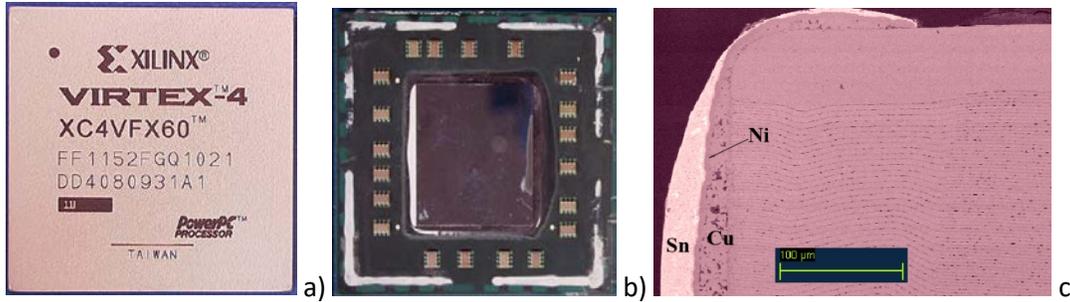
Figure 2.10. Overall external (a) and internal, after lid removal, (b) views of a XILINX VIRTEX-4 FPCA showing IDC-type ceramic capacitors mounted inside the package. Figure c) shows a cross-section of the termination area of IDC capacitors with dielectric thickness of  $\sim 2 \mu\text{m}$ .

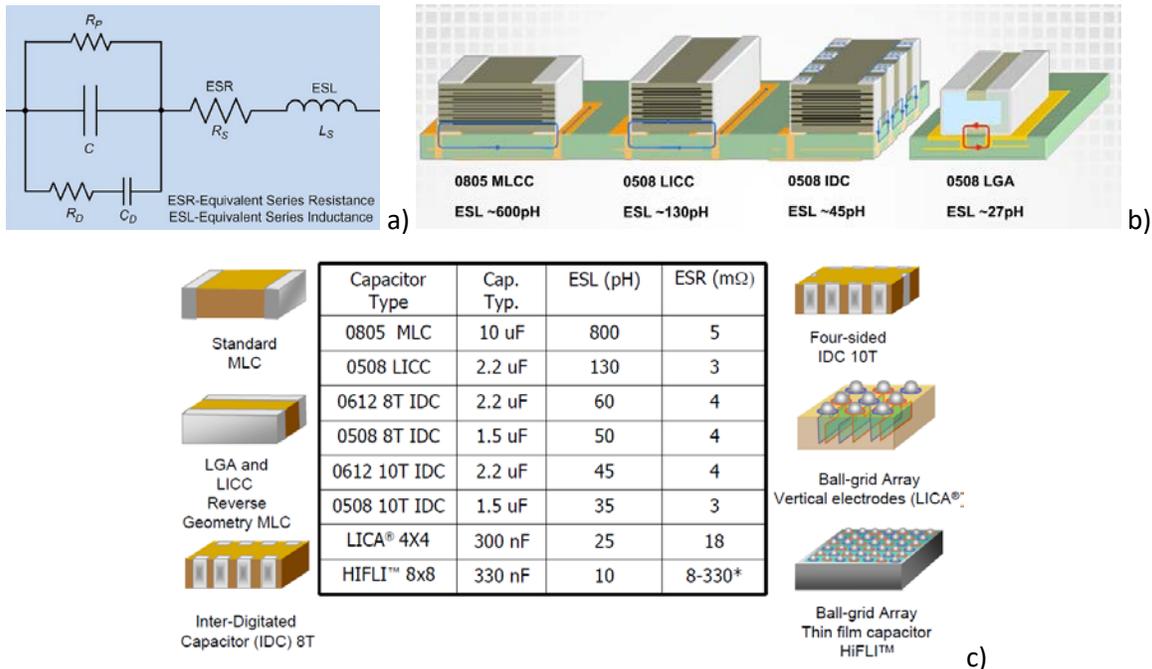
Figure 2.11. Equivalent circuit of a capacitor at high frequency(a) a schematic of the AC current flow in capacitors (b), J.Marshall [37], and types of low inductance MLCCs, R.Demko (c), [20].

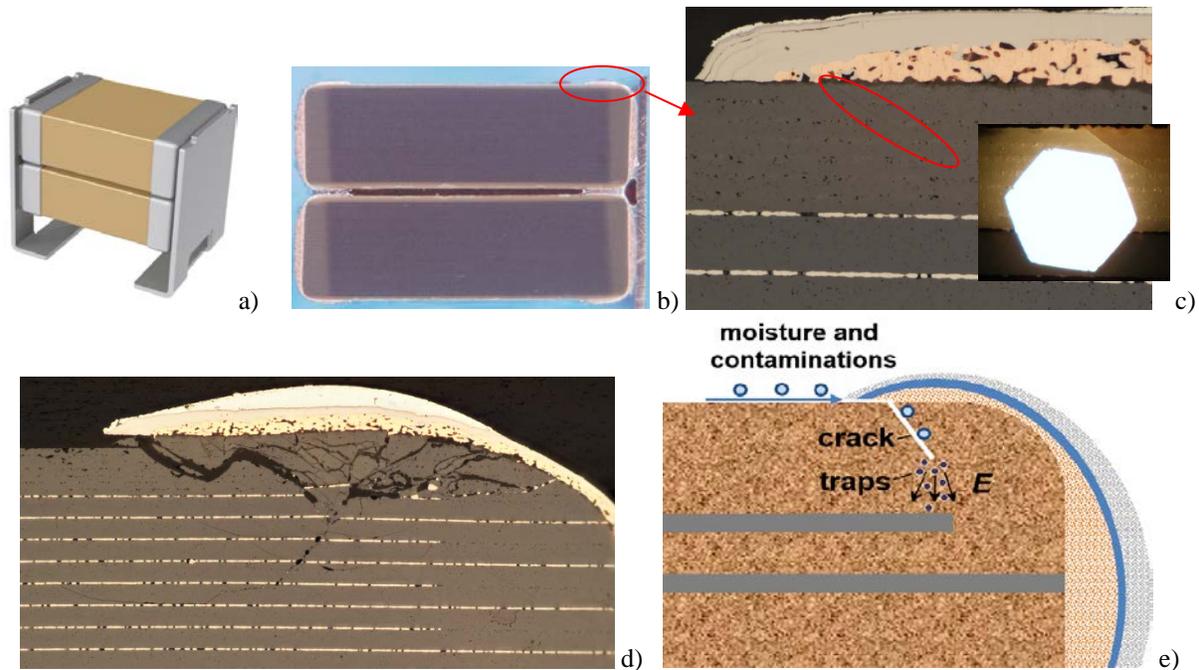
Figure 2.12. An overall view of a stacked capacitor (a), cross-sectioning showing a thin cover plate (b) and a shallow crack under the termination (c). Fig. d shows cross-sectioning of a capacitor that failed during life testing and (e) is a schematic of the TDDB mechanism of failure.

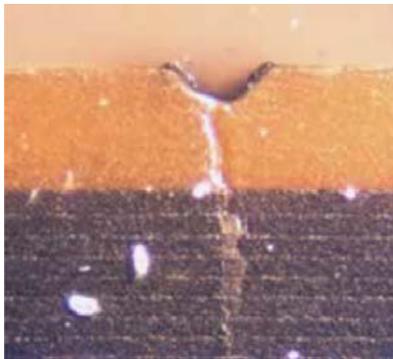
Figure 2.13. A capacitor damaged due to excessive power of laser marking machine.

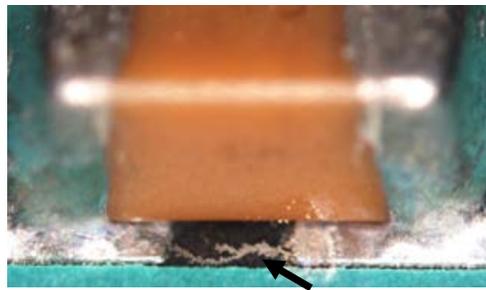
Figure 3.1. External Metal Dendrite on PWB beneath the MLCC that resulted in false short circuit failure.

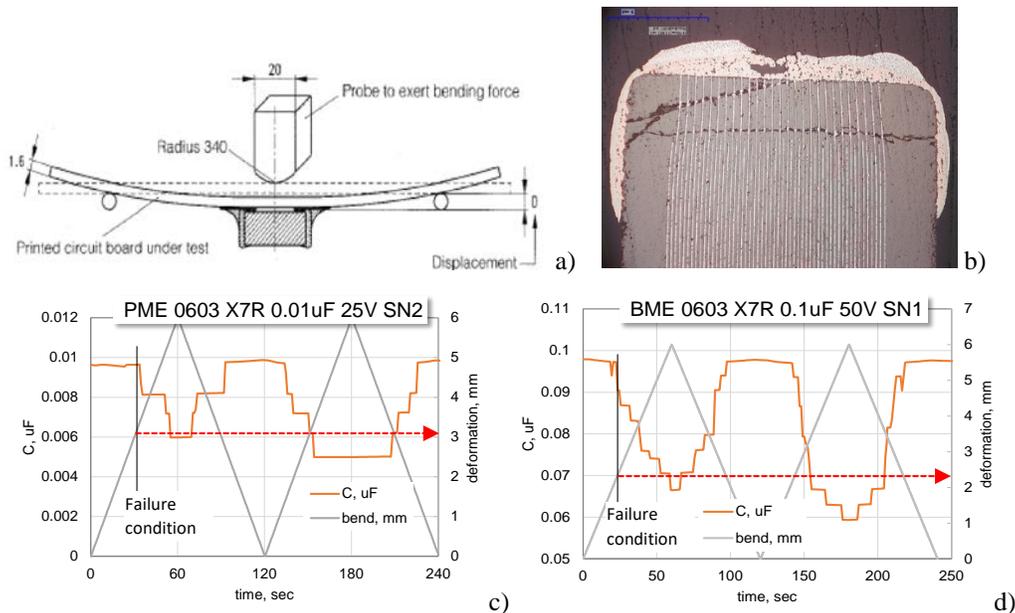
Figure 3.2. Schematic of the flex testing (a), cross-sectioning of a capacitor failed flex testing (b), and variations of capacitance and deflection with time for a PME (c) and BME (d) capacitors.

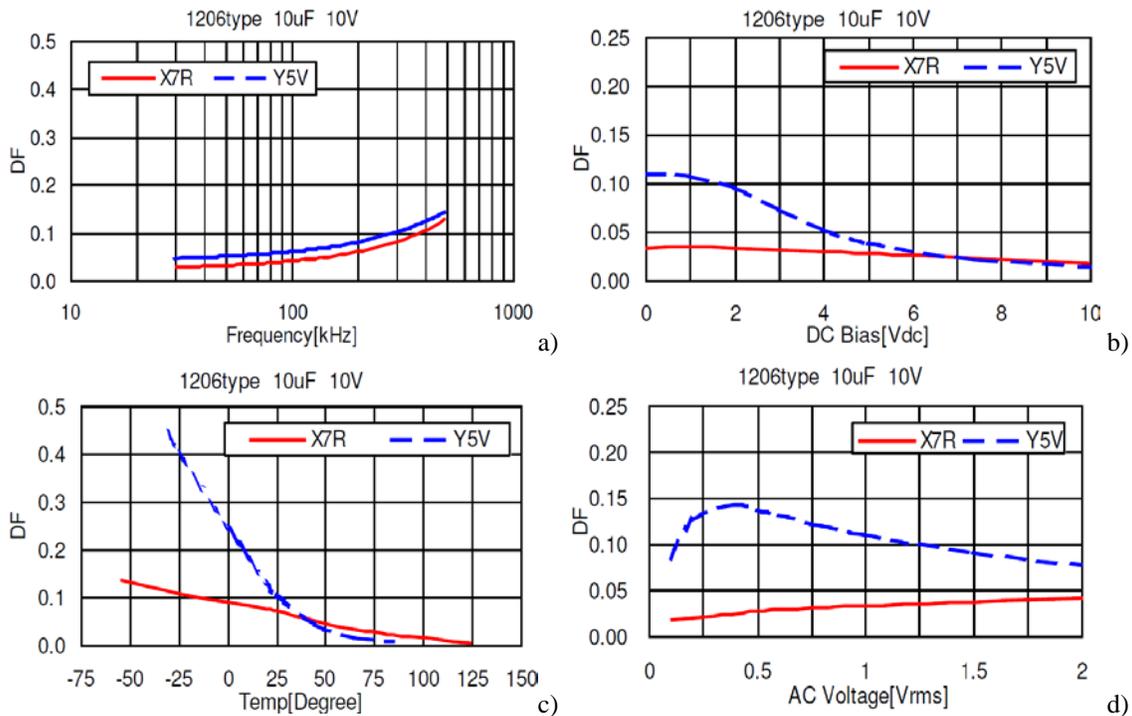
Figure 4.1. Variations of dissipation factor in 10  $\mu\text{F}$  10 V X7R and Y5V MLCCs with frequency (a), DC bias (b), temperature (c), and AC voltage (d) [70].

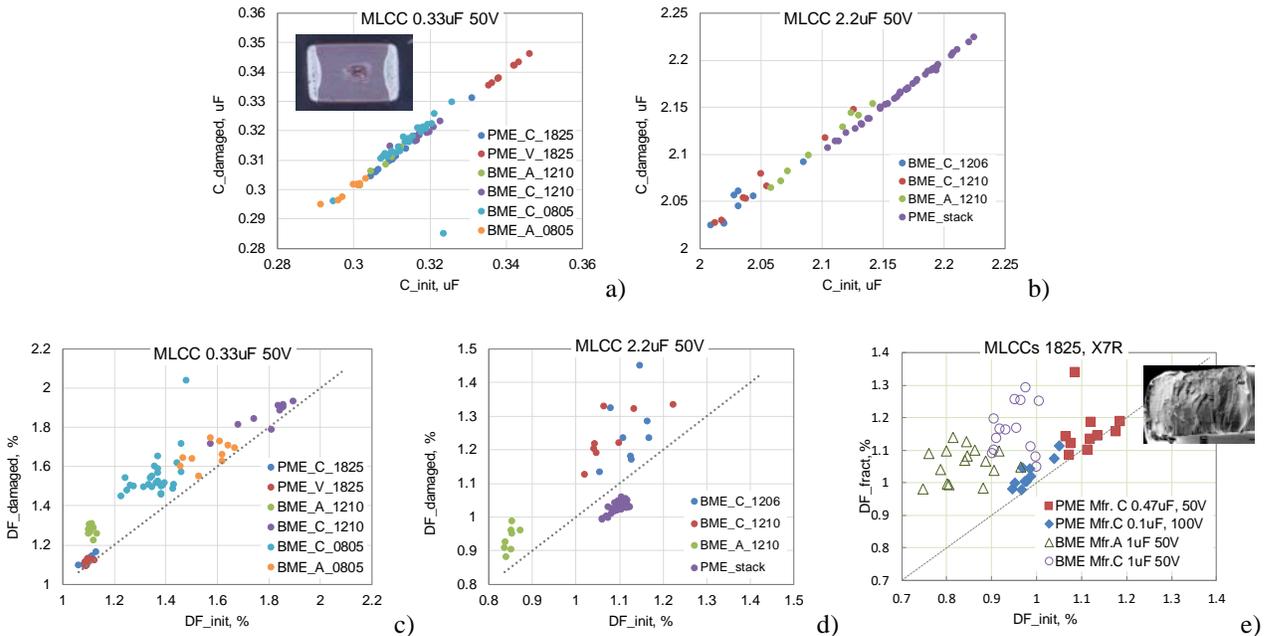
Figure 4.2. Effect of cracking on capacitance (a, b) and dissipation factors (c-e) of different types of MLCCs.

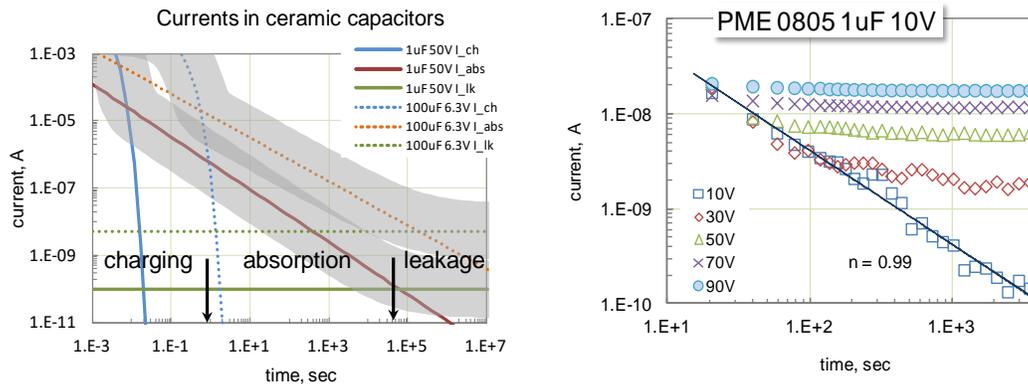
a) Currents in high-value MLCCs after voltage application. Gray area shows a typical range of current variations.

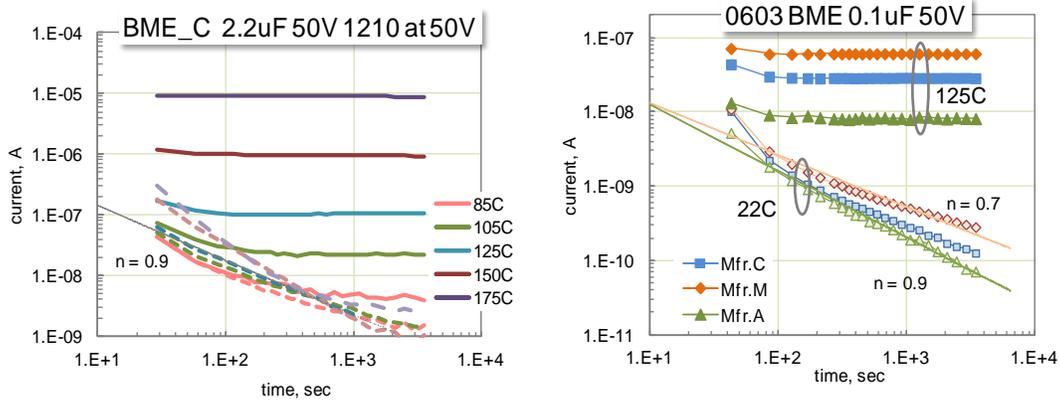
c) Dashed lines indicate depolarization, solid lines - polarization currents. Increasing  $T$  rises intrinsic currents exponentially and does not affect depolarization currents.

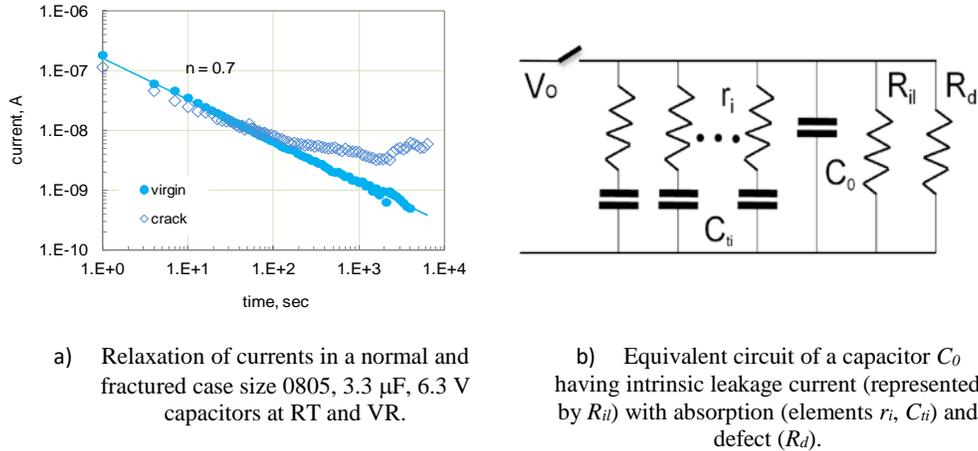
Figure 4.4. Effect of cracking on relaxation of leakage currents (a), and an equivalent circuit of a capacitor with cracks (b).

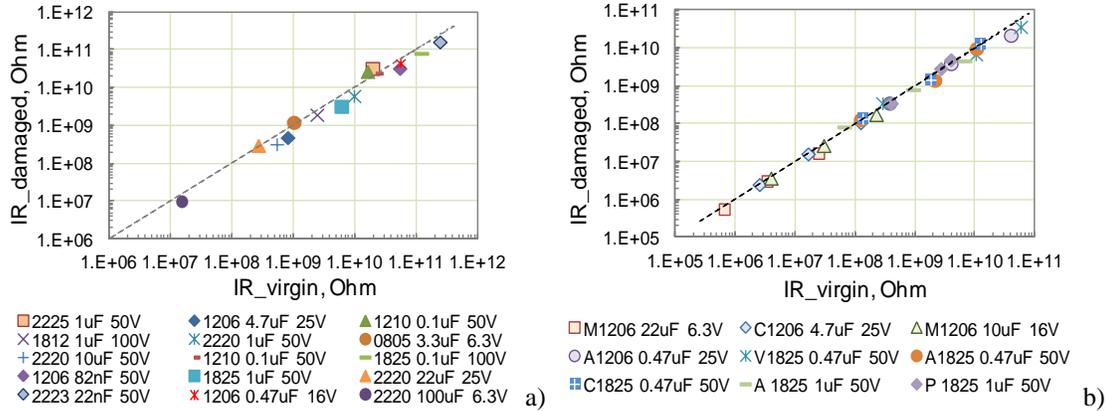
Fig. 4.5. Effect of cracking on insulation resistance in different types of ceramic capacitors. The IR measurements were carried out using a standard technique: 120 seconds of electrification at rated voltages. The dashed line corresponds to no-change values. (a) Room temperature measurements. (b) Measurements at 85 °C, 125 °C, and 165 °C.

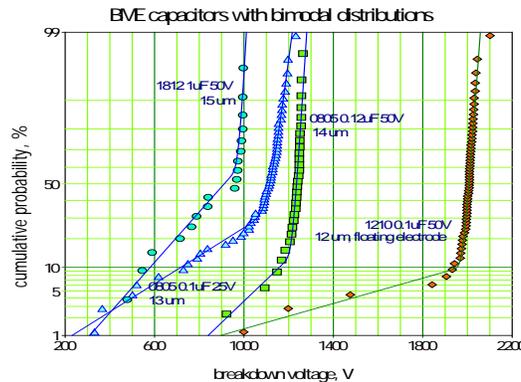
Figure 4.6. Examples of distributions of VBR for different types of BME MLCCs rated to 25 and 50 V.

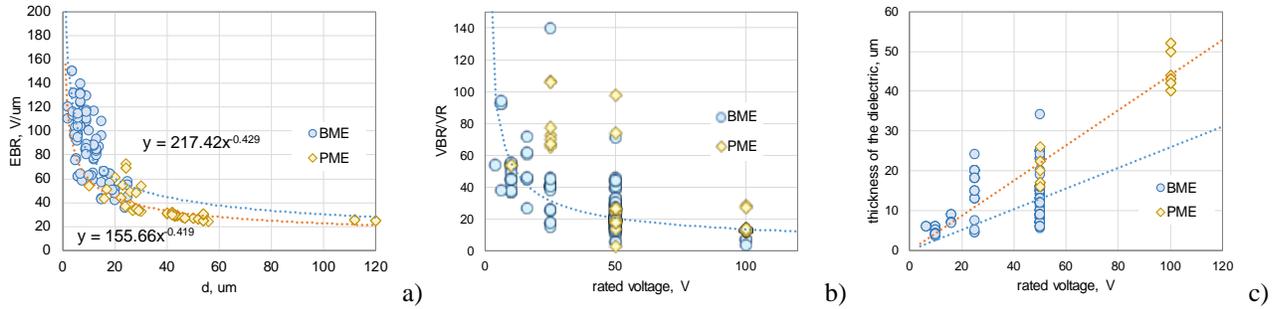
Figure 4.7. Relationship between breakdown field and thickness of the dielectric (a), normalized breakdown voltage vs. rated voltage (b), and variations of the thickness of the dielectric with VR (c) in different types of MLCCs.

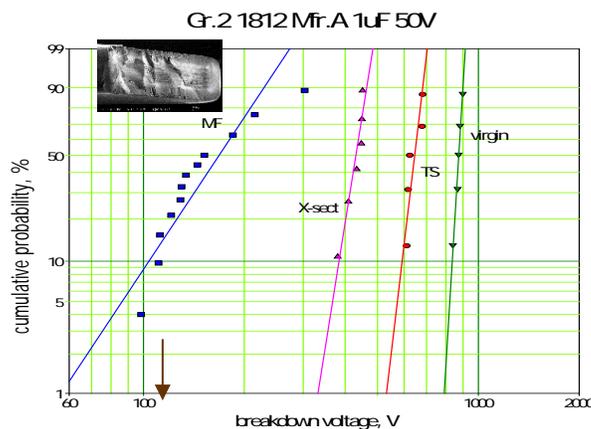
Figure 4.8. Distributions of VBR for case size 1812 1 uF 50V capacitors in a virgin condition (virg), and with cracks introduced by mechanical fracture (MF), cross-sectioning (X-sect), and thermal shock (TS). The insert shows fractured capacitor, and the error indicates voltage during DWV testing.

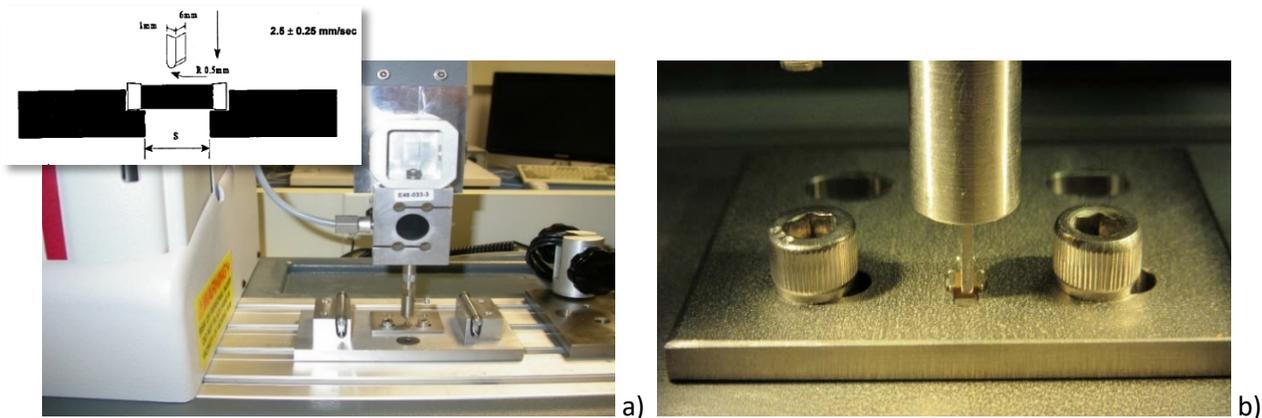
Figure 4.9. An overall view of the set-up for the flexural strength testing (a) and a close -up view of the fixture (b).  
 Insert shows a schematic of the test per AEC-Q200-003

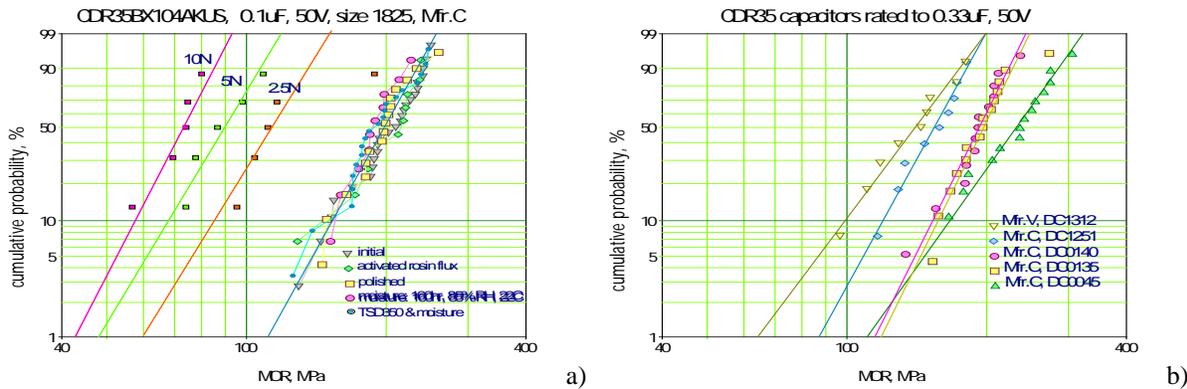
Figure 4.10. Weibull distributions of MOR for CDR35 capacitors after different treatment before testing (a) and different lot date codes and vendors (b).

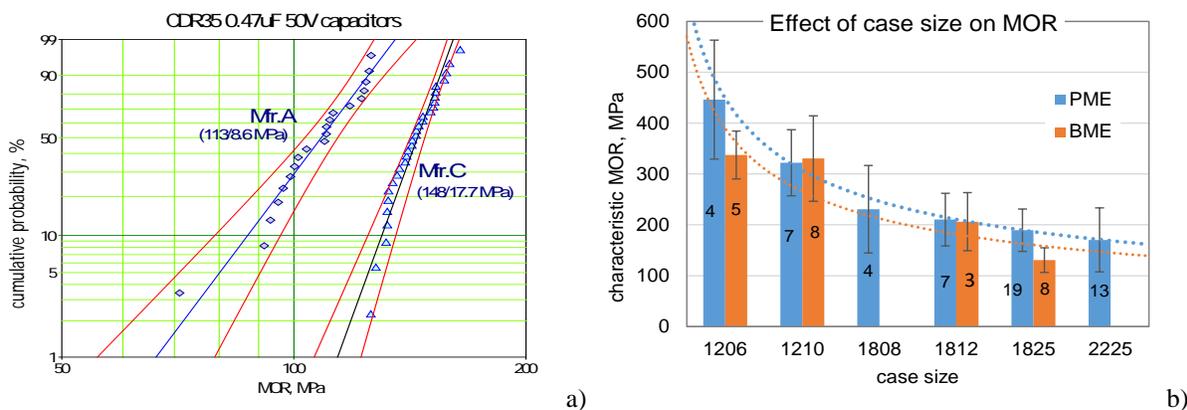
Figure 4.11. Distributions of the flexural strength (MOR) for Mfr.A capacitors that caused flight failures and reference, Mfr.C, capacitors (a) and characteristic MOR values of the relevant Weibull distributions for different lots of MLCCs (b). Red lines in (a) indicate 90% confidence bounds; error bars in (b) correspond to the standard deviations and numbers indicate quantity of the tested lots.

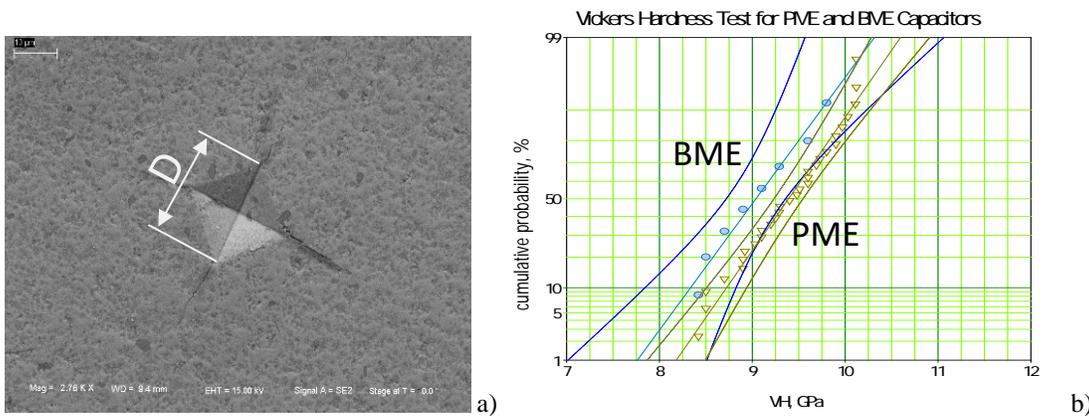
Figure 4.12. An example of the footprint during Vickers hardness testing (a) and distributions of average  $VH$  values for different lots of PME and BME capacitors. Dashed lines in (b) indicate 90% confidence range.

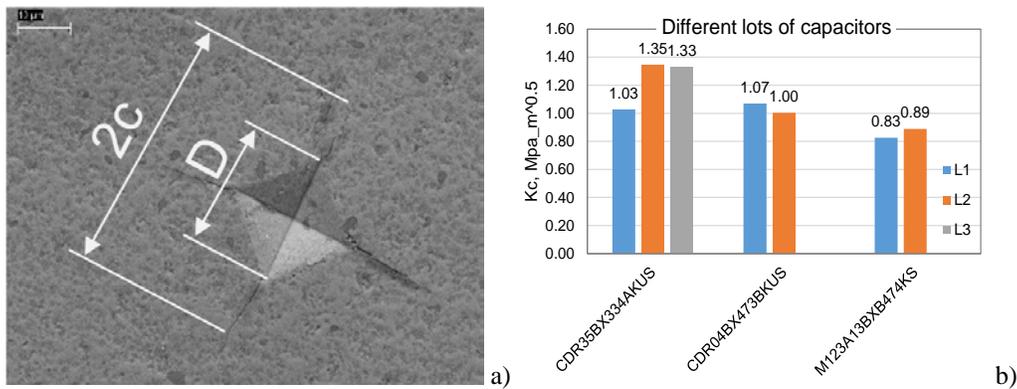
Figure 4.13. An example of the footprint during indentation fracture toughness testing (a) and Fracture toughness for different lots (L1, L2, and L3) for three types of military grade capacitors.

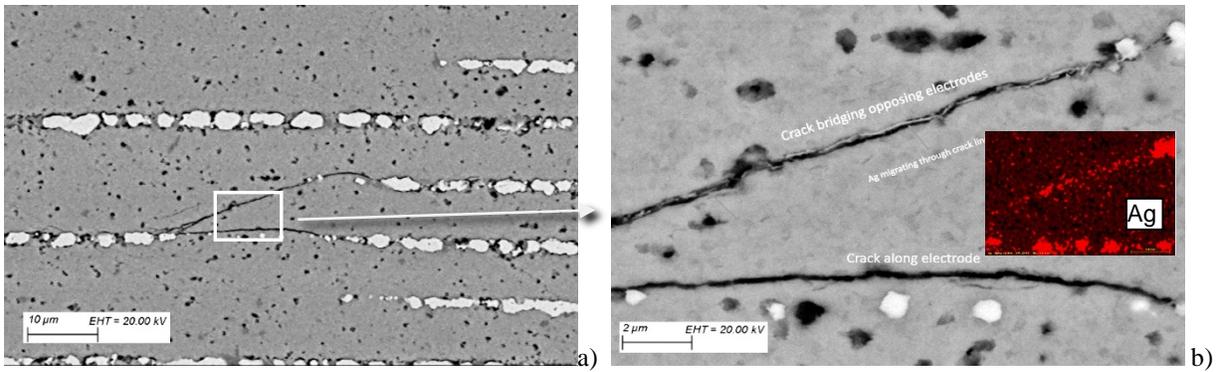
Figure 5. An overall (a) and close-up (b) views of a shorting crack in 0.1  $\mu\text{F}$  16 V PME capacitor. The part was tested at 6 V and started showing increased and unstable leakage currents after 110 hr at room temperature and then failed eventually short circuit due to silver electromigration after 50 hr at 60 °C. (Pictures courtesy of Ron Weachok, Jacobs Technology Inc.)

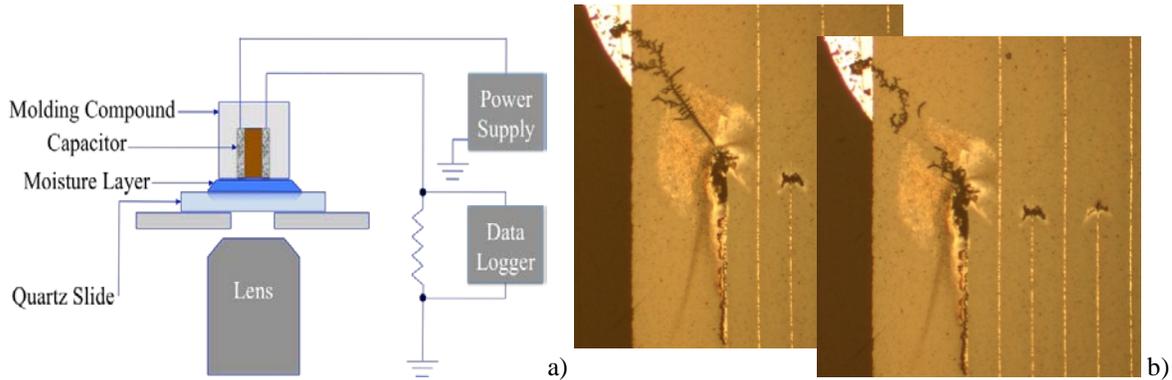
Figure 5.1. Schematic of the water layer test set-up (a) and an example of dendrites formed between the termination and the tip of the negatively biased electrode on the surface of 1825 0.1  $\mu\text{F}$  100 V PME capacitor that was shorted after 3.6 min at 1.3 V and blown after shorting (b).

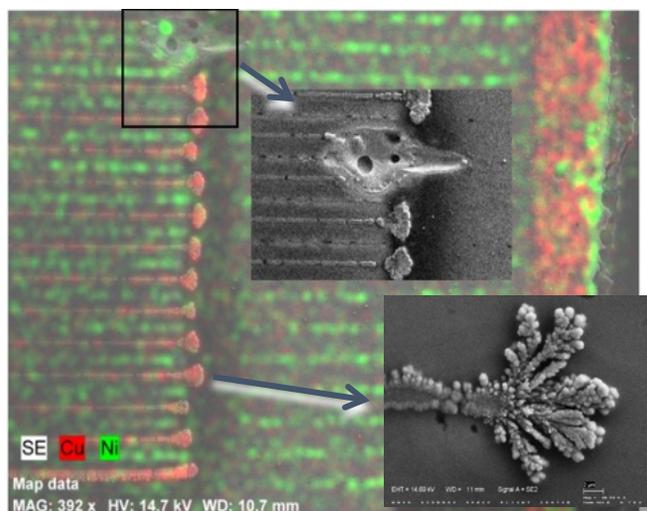
Figure 5.2. An example of a catastrophic failure caused by copper dendrites growth on a surface of a BME, 1  $\mu\text{F}$  50 V, case size 1812, capacitor. These dendrites grew for 5 min at 3 V, 95% RH, but the short circuit failure occurred when a rated voltage was applied after the testing. An overall SEM image is overlapped with EDS mapping and the top insert shows the area of a blown dendrite resulted in damage of ceramic, and the bottom shows a close-up of a copper dendrite.

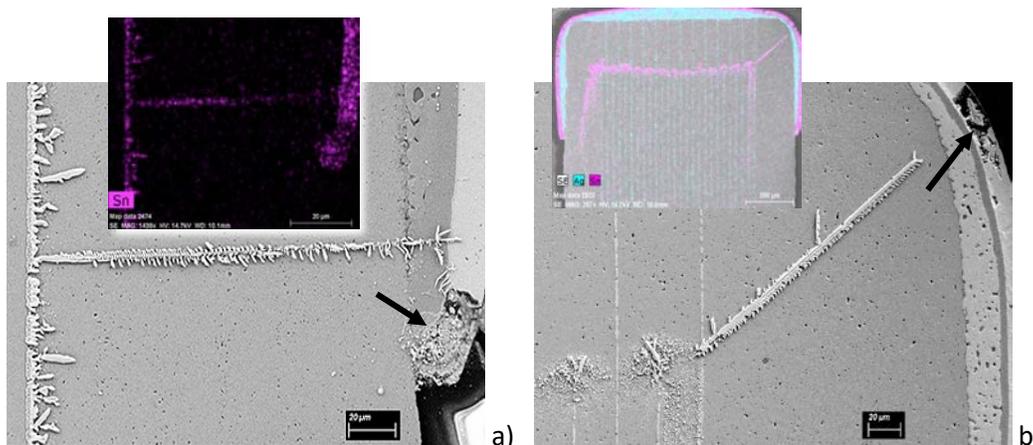
Figure 5.3. Growth of tin dendrites at the edge cathode electrodes in a BME 1825 0.47 $\mu\text{F}$  50V capacitor that failed at 0.8 V after 23 minutes of testing (a) and in a PME capacitor that failed short circuit after 18 min at 0.8V (b). Errors indicate location of anodic dissolution of tin in the termination. Inserts show EDS mapping of the dendrites.

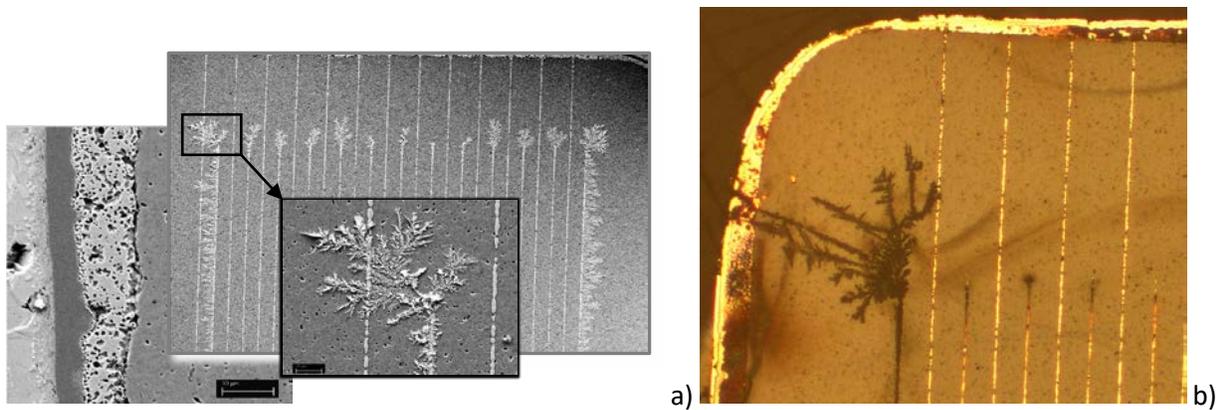
Figure 5.3. Dendrite growth during WLT at 1.3V in PME (a) and BME (b) 0.47 uF 50 V MLCCs. Silver dendrites were formed after 2.5 min in PME (a) and copper dendrites were formed after 8 min in the BME capacitor (b). Note pitting corrosion in the Ag (a) and Cu (b) base metal terminations for PME and BME capacitors respectively.

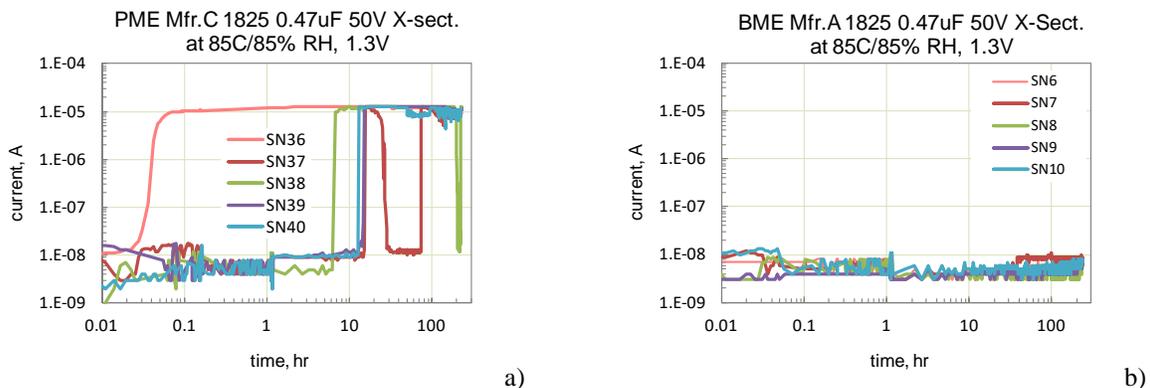
Figure 5.4. Variations of leakage currents with time during HSSLV testing of PME (a) and BME (b) 0.47uF 50V cross-sectioned MLCCs. Note that the currents were limited to  $\sim 10^{-5}$  A by external resistors.

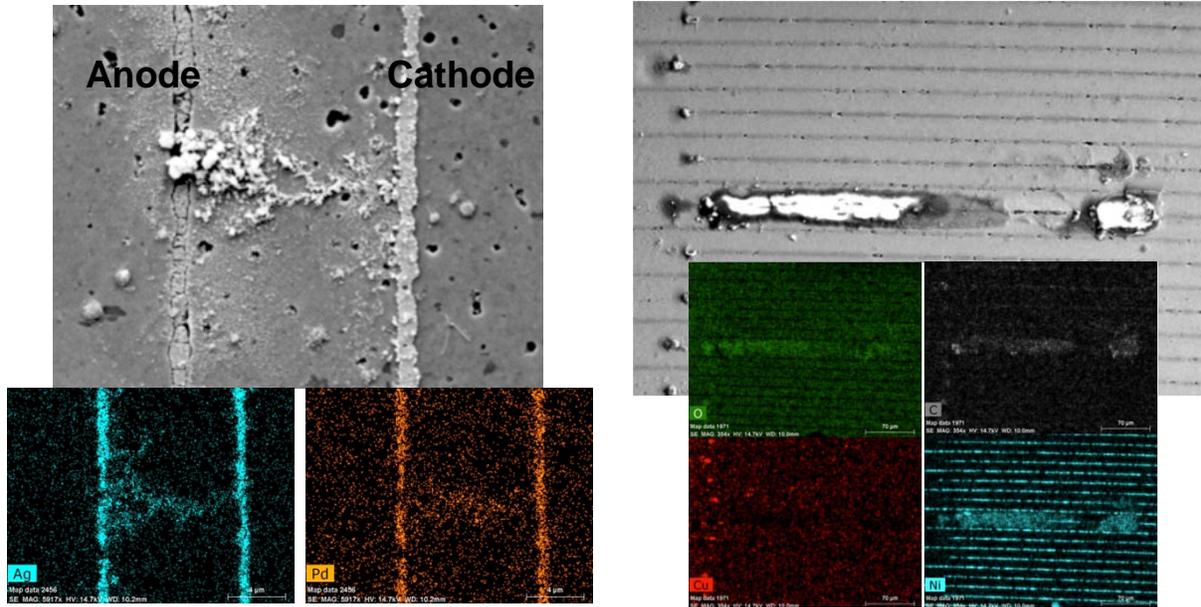
a) Ag/Pd dendrites on the surface of a PME capacitor failed after HSSLV testing. Note erosion of the anode electrode indicating the source of metal ions used to form dendrites.

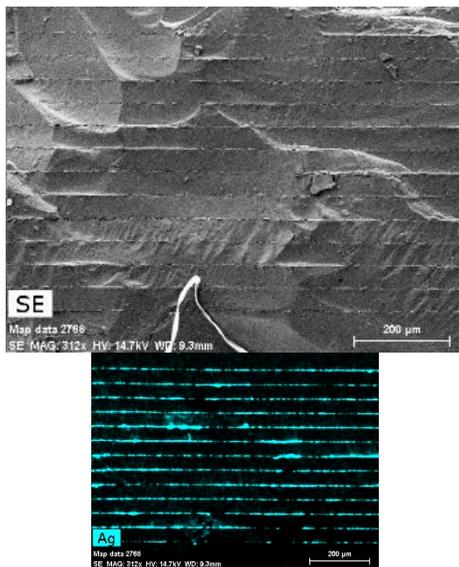
c) PME, case size 1825, 0.1  $\mu$ F, 100 V capacitor, after testing at 22  $^{\circ}$ C, 85% RH, and 5 V. Although Ag dendrites were not found, EDS mapping indicates the presence of silver deposits between electrodes.

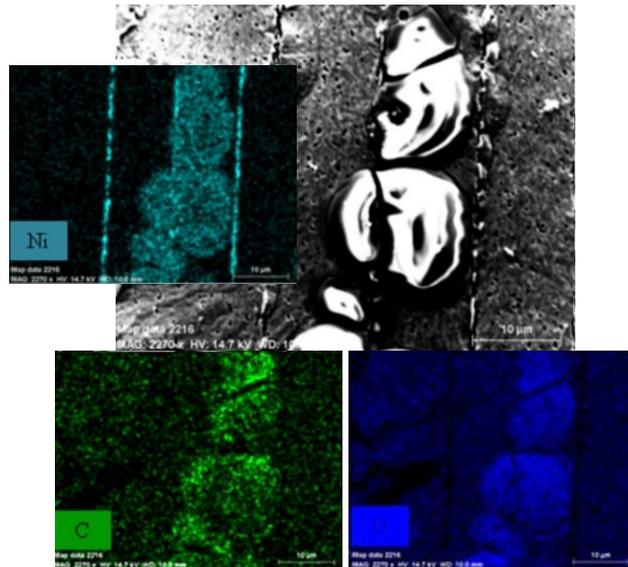
d) BME, case size 1825, 1  $\mu$ F, 50 V, capacitor, after testing at 22  $^{\circ}$ C, 85% RH, and 15 V for 300 hours. High-resistivity Ni/C/O formations at anode electrodes are similar to Fig.b.

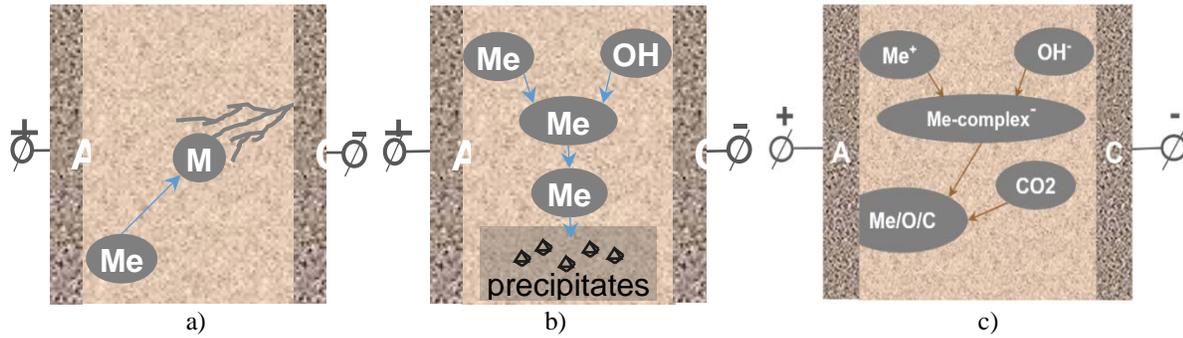
Figure 5.6. Simplified schematic of electrochemical processes in MLCCs: cathode dendrites growth (a), formation of precipitations (b), formation of anode deposits (c).

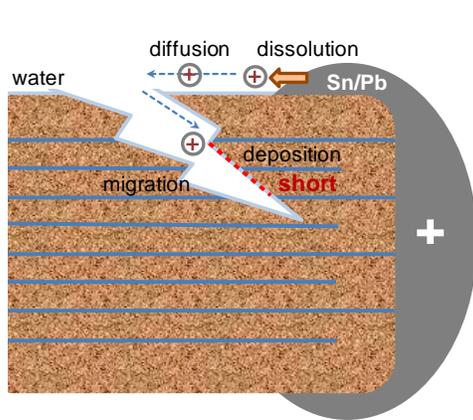
Figure 5.7. Schematic of failures in MLCCs with cracks caused by migration of ions that are anodically dissolved from terminations.

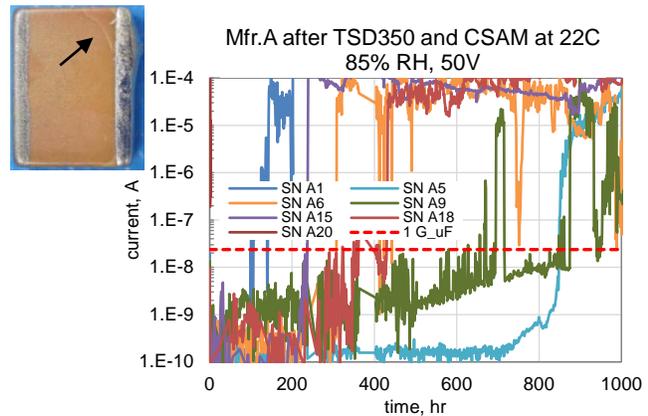
Figure 5.8. Leakage currents in CDR35 0.47  $\mu$ F 50 V capacitors during 1000 hour testing at 22  $^{\circ}$ C, 85% RH, and 50 V. An insert shows example of cracks formed by TSD350.

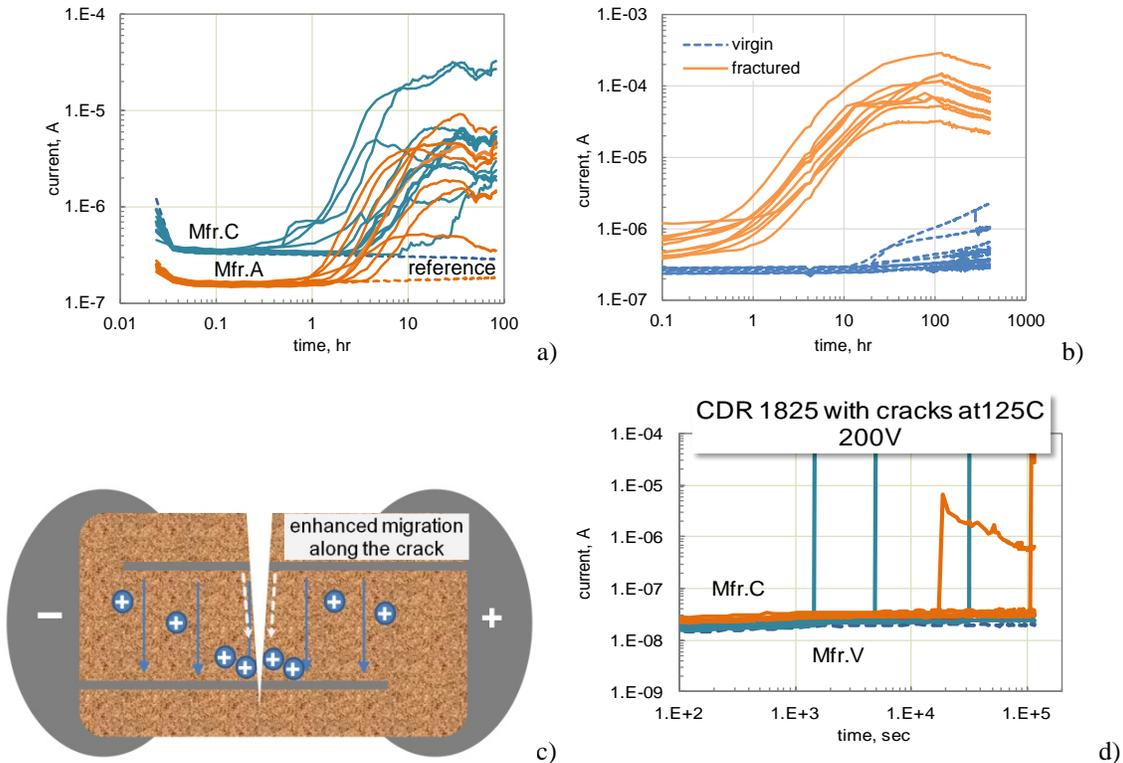
Figure 5.9. Variations of currents through HALT testing in BME (a, b) and PME (d) capacitors with cracks. BME capacitors, 0.33  $\mu\text{F}$  50 V (a) and 1  $\mu\text{F}$  50 V (b) were tested at 125  $^{\circ}\text{C}$ , 100 V and PME capacitors, 0.47  $\mu\text{F}$  50V, at 125  $^{\circ}\text{C}$  and 200 V. Dashed lines correspond to virgin and solid lines to capacitors with cracks introduced by Vickers indenter. Fig.c shows a schematic of degradation processes in BME capacitors with cracks.

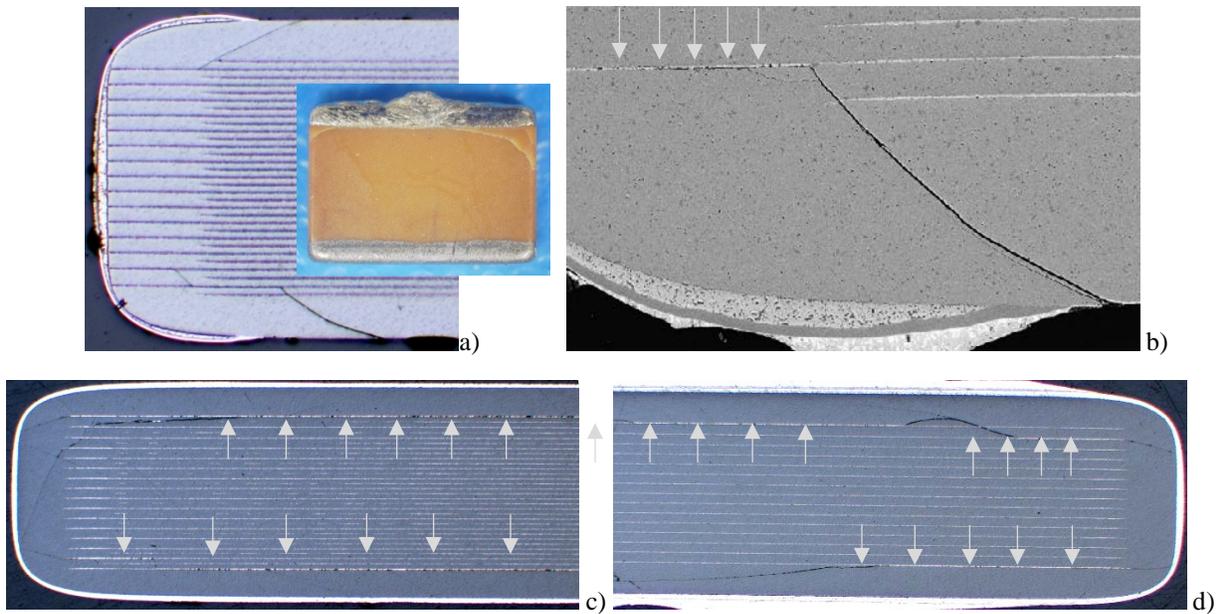
Figure 6.1. Crack revealed in MLCCs after TSD350 cross-sectioning across (a, b) and along (c, d) terminals.
