## NASA Electronic Parts and Packaging (NEPP) Program

NEPP Task: Guidelines for Selection of Ceramic Capacitors for Space  
Applications

# Cracking Problems in Low-Voltage Chip Ceramic Capacitors

2018

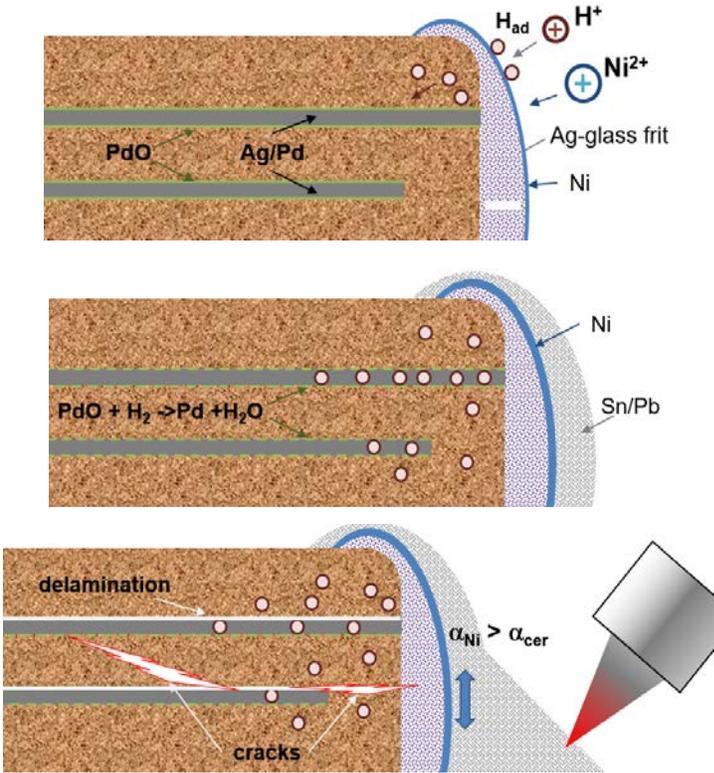
a) Electroplating of Nickel results in hydrogen generation at the surface and its diffusion inside the capacitor at the terminals.

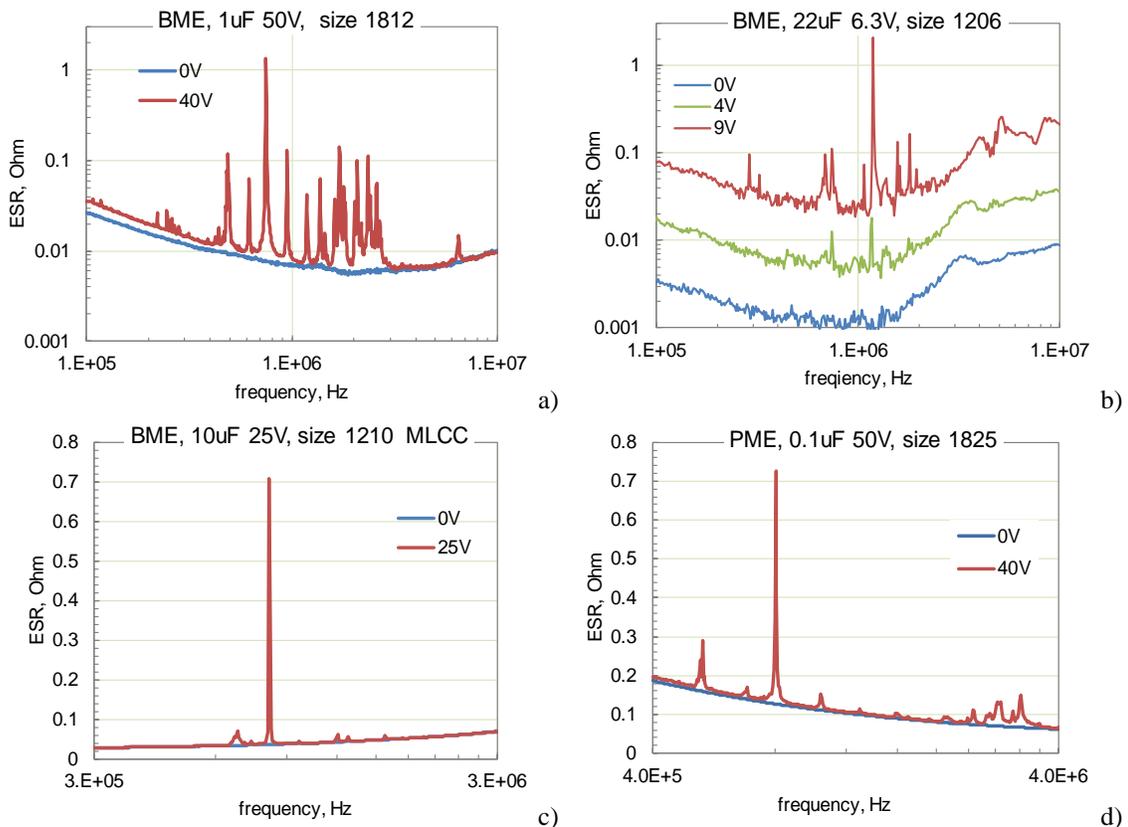
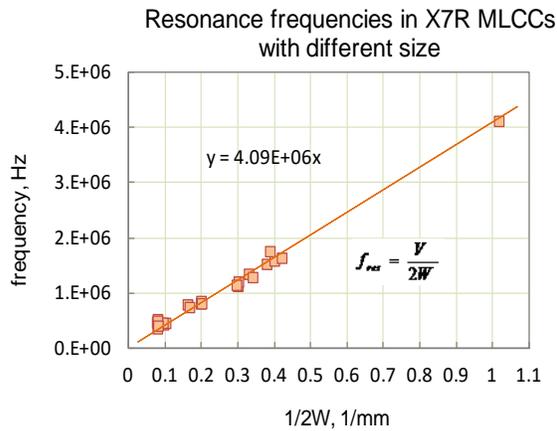
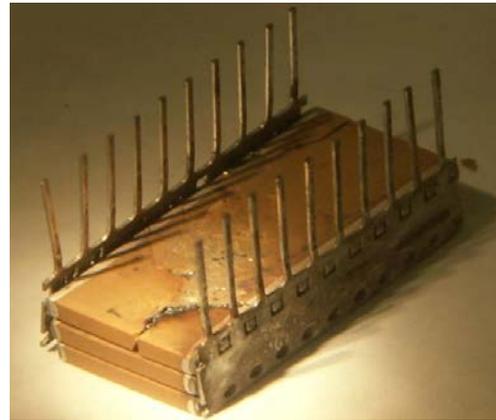
Figure 6.3. ESR spectrums for different types of X7R capacitor with and without DC bias (a-d), variation of the major resonance frequency with the width of capacitors (e), and a 9  $\mu\text{F}$  300 V stacked ceramic capacitor that has been damaged when operating frequency was close to  $f_{res}$  (f).

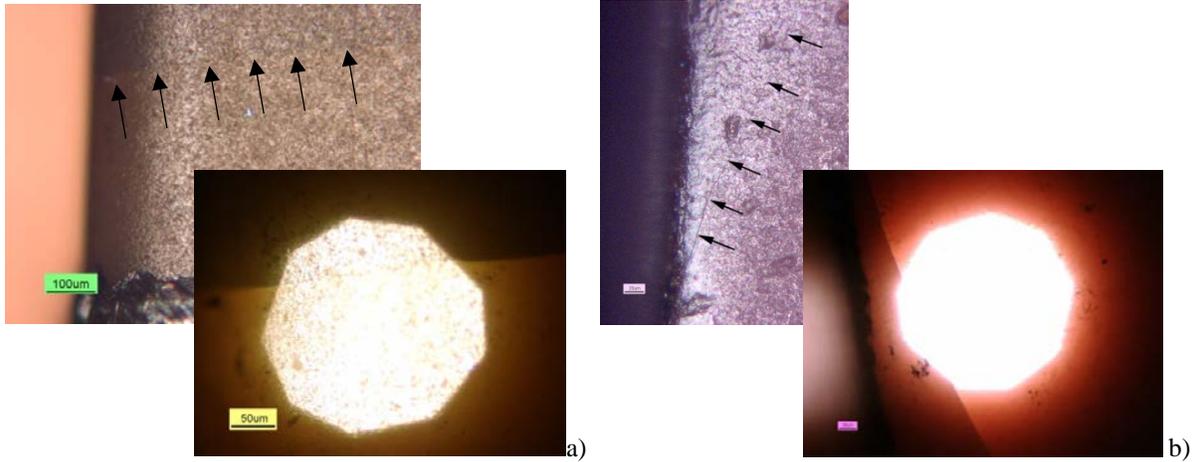
Figure 7.1. Examples of cracks exposed in MLCCs by the vicinal illumination technique. Top images show regular dark field high-power (X200 magnification) images of the cracks indicated by errors, and bottom images were obtained using vicinal illumination.

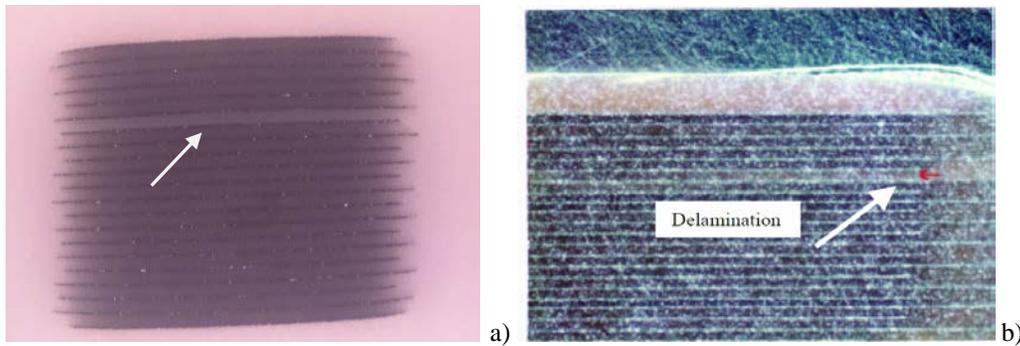
Figure 7.2. Discoloration in a dielectric layer of MLCCs revealed by a dark field inspection during DPA a) attributed to stresses [26], b) attributed to delamination [114].

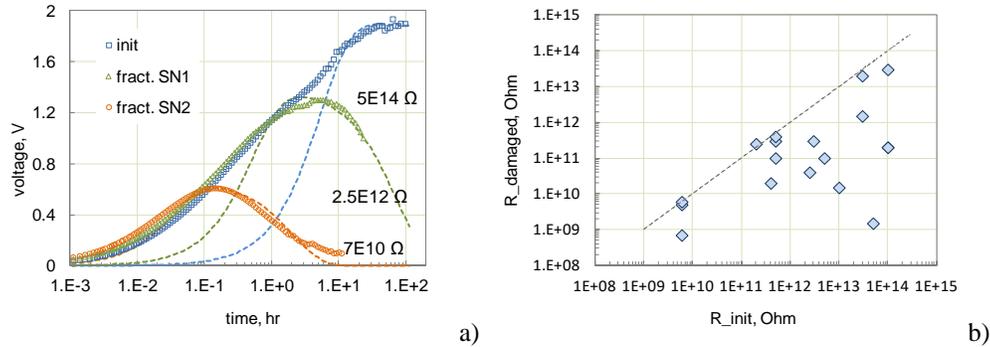
Figure 7.3. Absorption voltages in normal and damaged case size 1825, 0.1  $\mu\text{F}$  100 V capacitors (a) and effect of fracturing on IR, calculated based on absorption voltage model for 20 different types of capacitors (b). Dashed lines in (a) are calculations at the indicated values of IR and in (b) the dashed line corresponds to no-change values.

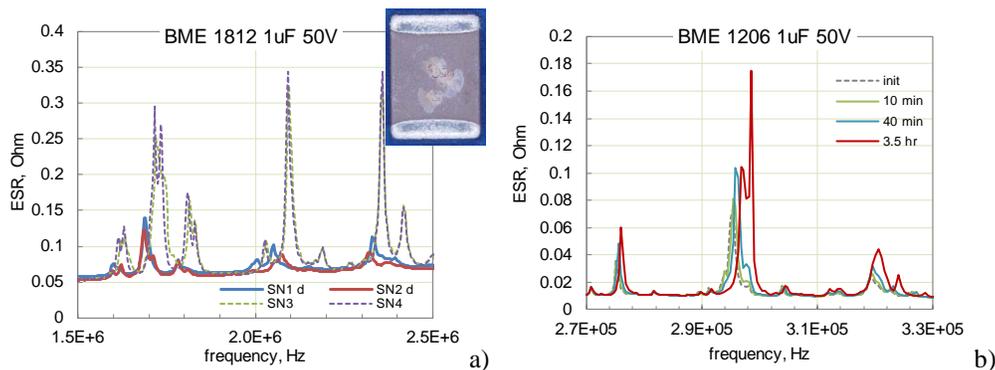
Figure 7.4. Electromechanical resonance spectra. a) virgin (dashed lines) and capacitors with introduced cracks (solid lines). b) Spectrums in a virgin capacitor measured with time under 40 V bias.

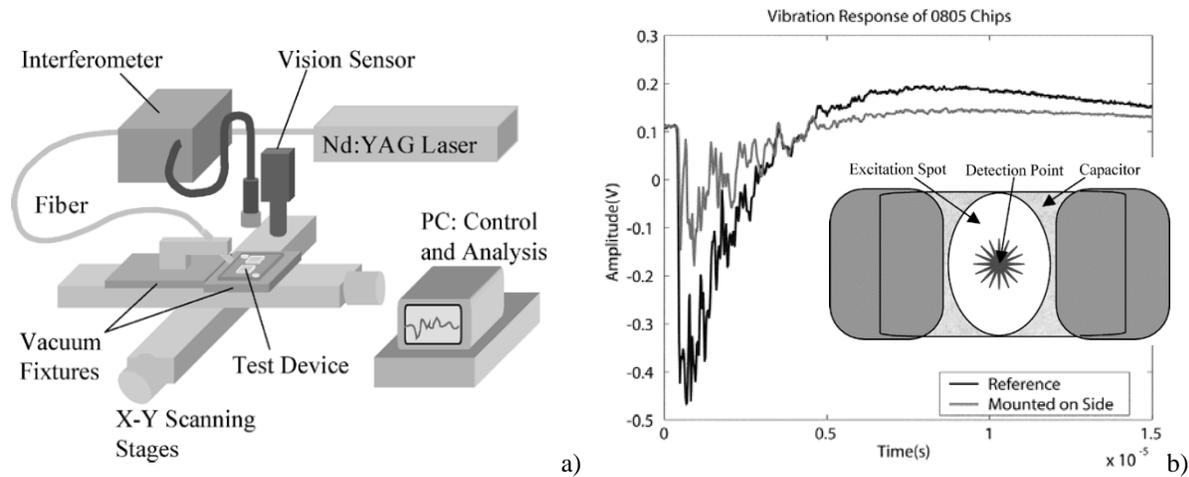
Figure 7.5. Set-up of the laser ultrasonic quality inspection system (a) and a time-domain vibration response (b). The insert shows a capacitor with laser excitation and measurement spots.

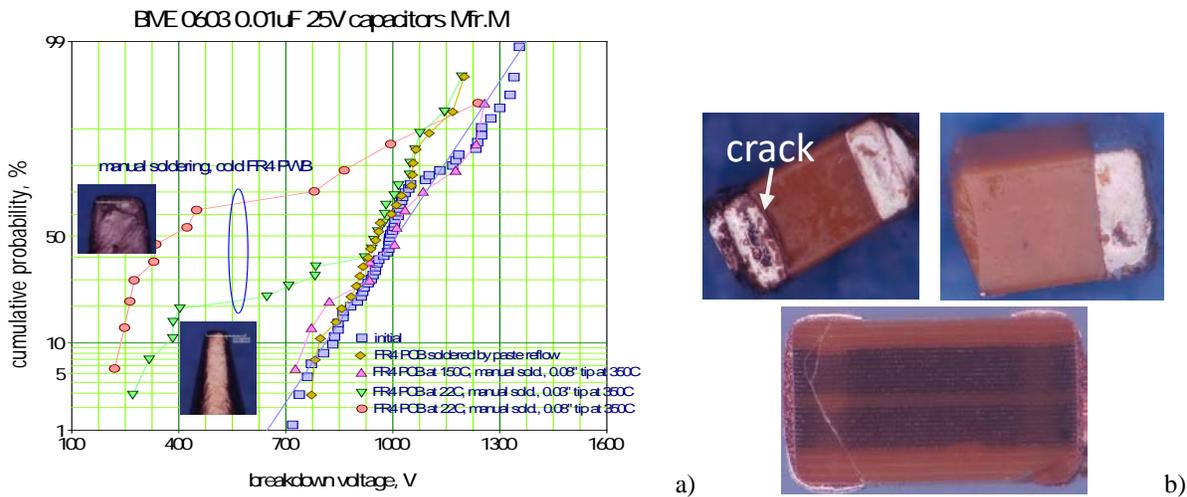
Figure 8.1. Distributions of breakdown voltages in 25 V, size 0603 capacitors (a) and examples of failed parts (b). MLCCs have been soldered onto FR4 boards using four methods: (i) standard reflow, (ii) assembly onto a PWB preheated to 150 °C using a soldering iron with 0.08" tip at 350 °C, (iii) manual soldering onto a cold PWB using a 0.08" tip at 350 °C, and (iiii) manual soldering onto a cold PWB using a 0.03" tip at 350 °C.

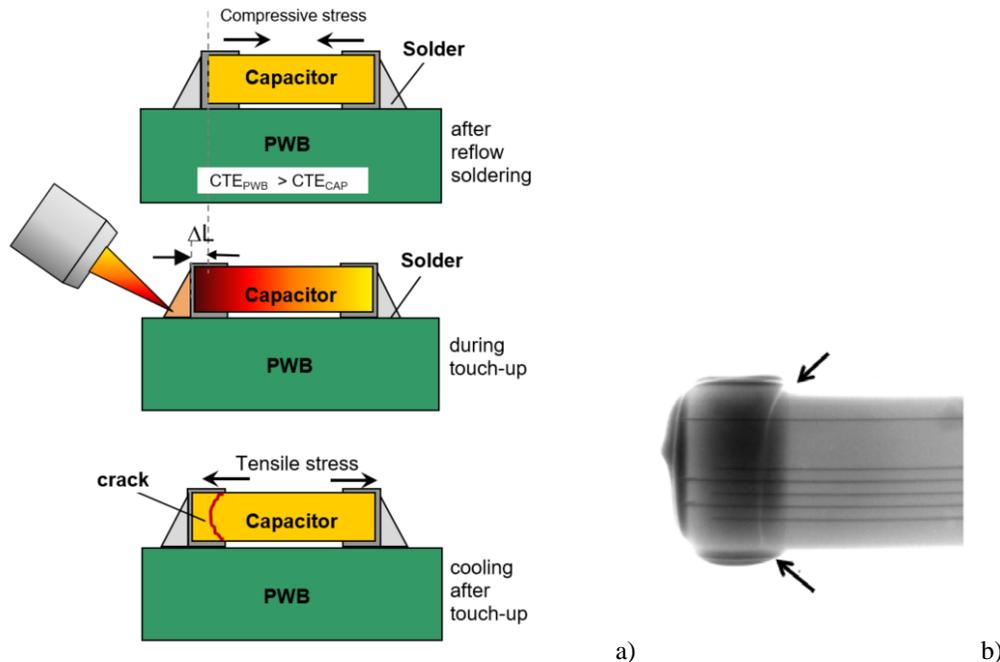
Figure 8.2. Formation of cracks caused by touch-up with a soldering iron (a) and an example of cracks formed by touch-up in X7R case size 0402 1000 pF 50 V capacitors (b).

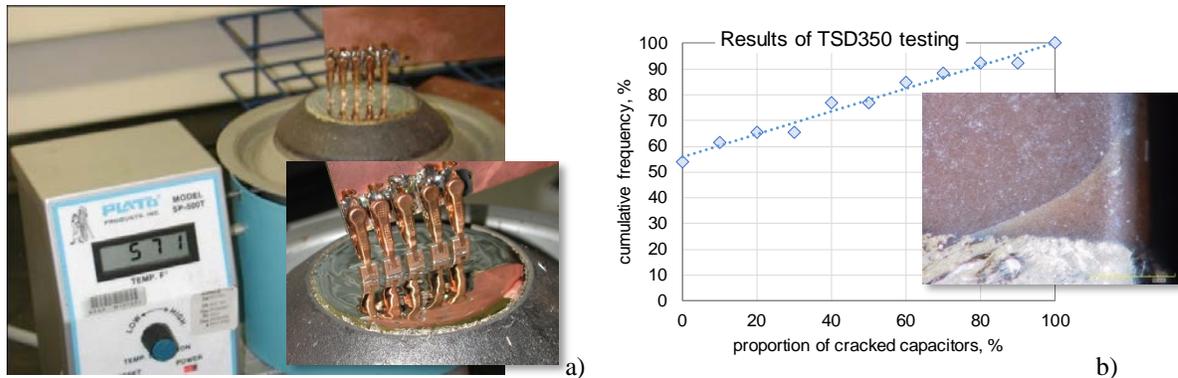
Figure 8.3. A set-up for terminal solder dip testing with a simple fixture that can be used to test 5 samples at a time (a) and distribution of the percentage of lots of capacitors having a certain proportion of cracks after TSD350 based on testing of 26 lots (b). The insert in (b) shows a typical crack caused by TSD350 testing.

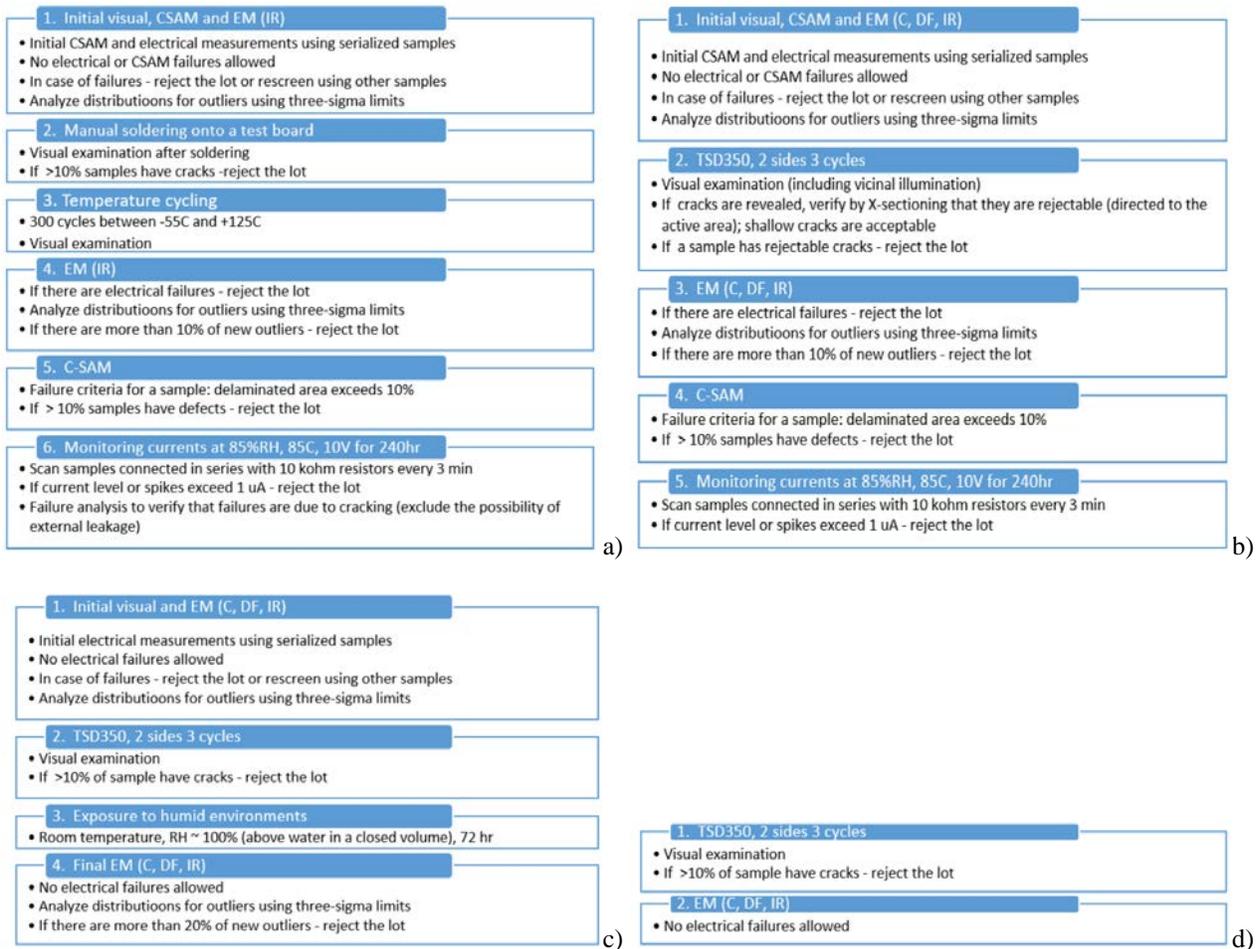
Figure 8.4. Test flows for the resistance to manual soldering testing for different level projects: L1 (a) –preferred, (b)-optional, L2 (c), and L3 (d) projects.
