Proton Testing of AMD e9173 GPU

E.J. Wyrwas¹

NASA Goddard Space Flight Center
Code 561.4, Radiation Effects and Analysis Group
8800 Greenbelt RD
Greenbelt, MD 20771

Test Date: 2 June 2019
Report Date: 22 July 2019

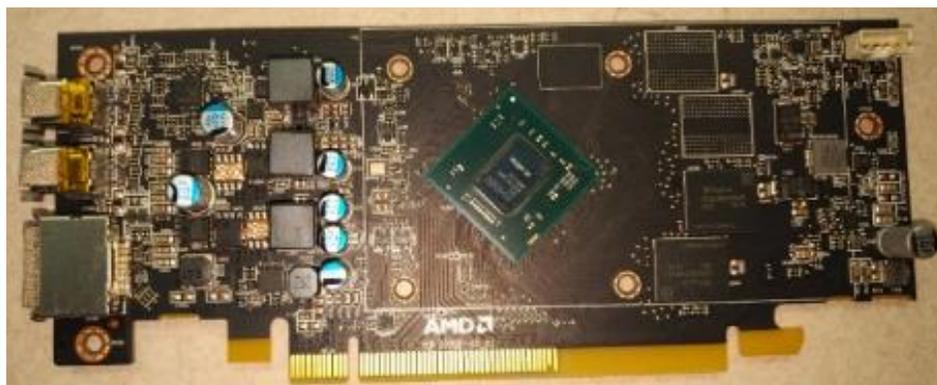
Figure 2: AMD e9173 GPU as-tested

The AMD e9173 GPU is a graphic coprocessor for use in a modern commercial off the shelf (COTS) computer. It was cannibalized from a Dell Wyse 5070 thin client computer. The carrier board is connected to the computer motherboard via a PCI-e x16 slot. The GPU die, itself, is the device under test (DUT) and is located underneath the unit's heat sink. Figure 1 shows pictures of the graphics card without its heatsink. Table 1 gives information on this part.

Quantity	1
Part Model	e9170
Board Model	e9173 AMD Radeon Embedded
REAG ID	19-022
Manufacturer	TSMC
Technology²	14nm FF
Packaging	Flip Chip, BGA

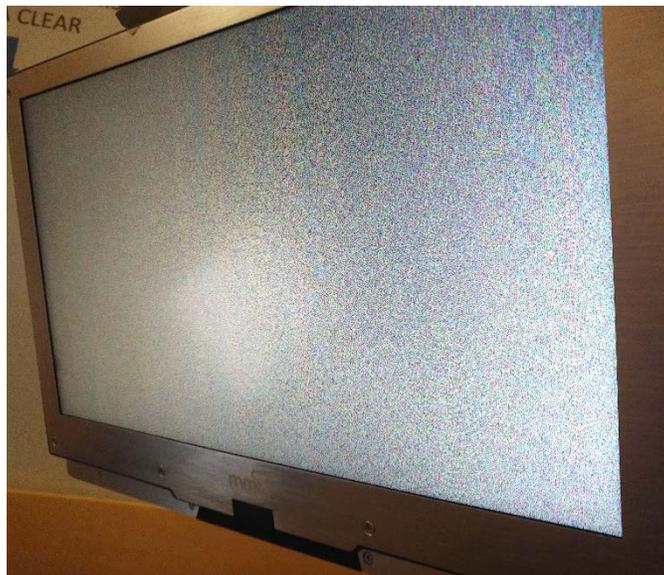
Figure 4: Examples of Pixel Artifacts

The fourth event type are pixel artifacts. When the display output to the monitor is not as expected, then the behavior is generically categorized as pixel artifacts. An example of this behavior is shown below. The display should show the Windows’ desktop. Instead, it shows a rainbow colored snow pattern.

Five (5) runs were performed. Each run resulted in pixel artifacts and a Single Event Functional Interrupt (SEFI) of the test system. The electrical measurements from the fifth run reflected a latch-up type of event. Further post-processing of data is required to determine root cause of failure. It is also worth noting that upon power cycling the test system, the device behaved normally. Further, no drift in temperature was noted other than a negligible increase due to computational loading. Table 3 and Table 4 show the results of this testing campaign.
