EVALUATION OF CONFORMAL COATINGS AS A TIN WHISKER MITIGATION STRATEGY, PART II

Thomas A. Woodrow, Ph.D. and Eugene A. Ledbury
The Boeing Company
Seattle, WA, USA
thomas.a.woodrow@boeing.com

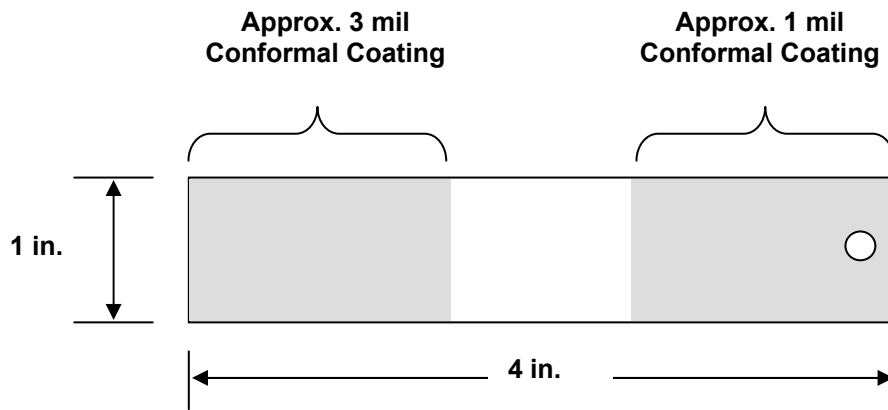
Figure 1. Test Coupon (Brass 260 Plated with 154 Micrometers of Bright Tin)

The coatings were applied to the test coupons as shown in Figure 1. One end of each coupon was coated with approximately 1 mil of coating and the opposite end of each coupon was coated with a thicker layer (approximately 3 mil) of coating. The middle of each coupon was left uncoated to serve as a control. The exception was the coupon coated with Parylene C. The Parylene C was applied over the entire surface of the coupon (0.4 – 0.5 mil thick) leaving no control area.

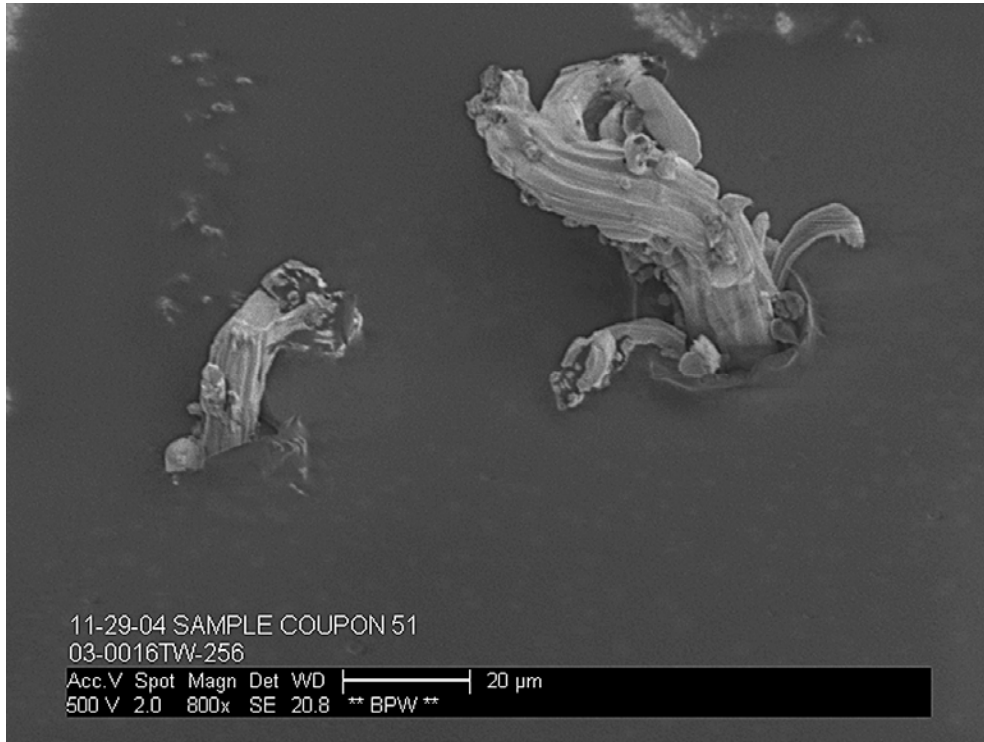
Figure 27. Whiskers Penetrating Coating D – 1.2 Mils (401 Days at Ambient + 347 Days in 25°C/97%RH)

Close examination of Figures 13, 23, 27, 28 and 33 reveal that the thickness of each coating penetrated appears to be less than the average coating thickness as measured optically. This suggests that these whiskers were able to penetrate because they had found a thin spot in the coatings. This same phenomenon was observed in the prior 50°C/50%RH test²⁶.

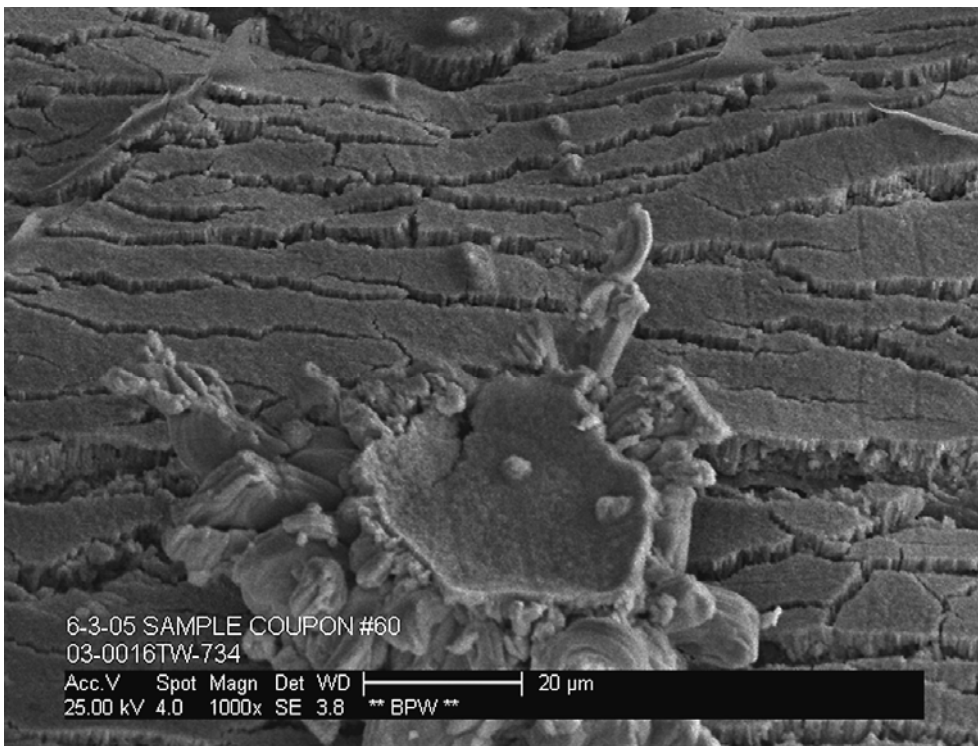
Figure 41. Close Up of the OSE from Figure 40

Many of the OSE's growing under Coating E were capped with a large platelet of "crust" (see Figures 39 – 41). EDX analysis of this "crust" showed the presence of tin, zinc, and oxygen (Figure 42). Figure 43 shows a side view of an OSE capped with "crust". The "crust" is surprisingly thick, i.e., it is approximately as thick as the original tin plating.
