# The Continuing Dangers of Tin Whiskers and Attempts to Control Them with Conformal Coating

Jong S. Kadesch  
Orbital Sciences Corporation/NASA  
Jong.S.Kadesch.1@gsc.nasa.gov  
301-286-2785

Jay Brusse  
QSS Group, Inc./NASA  
Jay.A.Brusse.1@gsc.nasa.gov  
301-286-2019

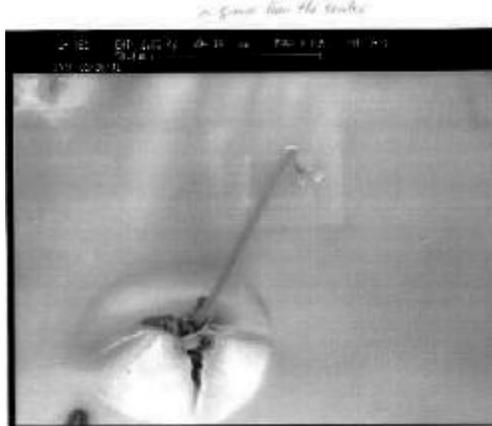
Figure 1. SEM photo of a tin whisker breaking out from beneath conformal coating (x625)

Figure 1 shows the most extreme observation we have recorded to date where a tin whisker has actually grown through the conformal coating approximately 2 years after application of the conformal coat. Attempts to measure the actual thickness of the coating at this location have been difficult because this area of the test specimen has a relatively thin layer of conformal coat. Estimates of the coating thickness in this location are on the order of 1/4 mil. After emerging from the coating, the tin whisker can become a risk for inducing short circuits. As noted previously, there are numerous other whisker growths beneath the thicker areas of conformal coating (~ 2 mil thick) that we anticipate will eventually penetrate the conformal coating. With some NASA missions extending over 10 years, and a few to 20 years, it is possible (but not confirmed experimentally) that coatings even as thick as 10 mils may not prevent whiskers from protruding.

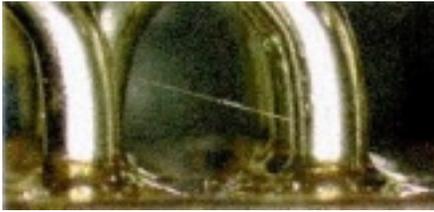
Electromagnetic relay terminals  
*Photo courtesy of NASA GSFC*

Ceramic chip capacitor termination  
*Photo courtesy of Ericsson*

Hybrid microcircuit lid  
*Photo courtesy of JPL*

Figure 2. Examples of Tin Whiskers Growing on Pure Tin Plated Electronic Components

The growth of tin whiskers on pure tin plated electronic components and associated hardware has been documented for decades. Notable examples of pure tin plated components that have exhibited tin whisker formations include electromagnetic relays, transistors, hybrid microcircuit packages, terminal lugs and very recently ceramic chip capacitors. A few such examples are shown below in figure 2:

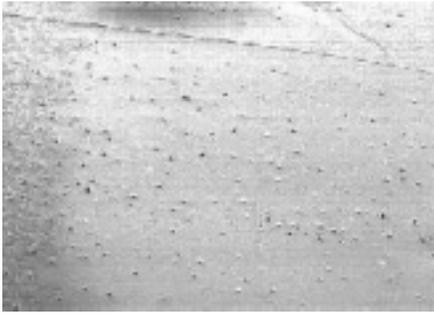
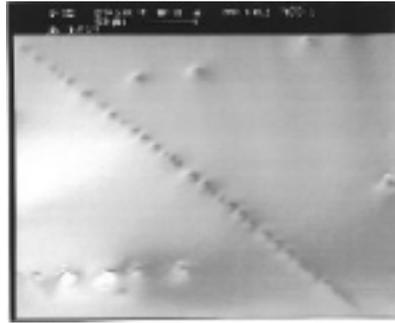
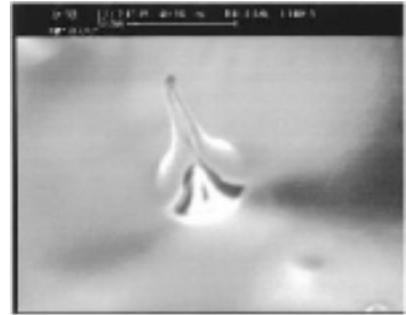
10X magnification

43X magnification

670X magnification

Figure 3. SEM photos of tin domes forming beneath conformal coating

Figure 3 shows the formation of tin nodules beneath the conformal coat on several specimens. Such growths under the conformal coating are common on all of the specimens regardless of storage conditions (room temperature vs. 50°C). In these SEM images the tin whiskers resemble a spike being pushed into a rubber membrane, deforming the surface into a sharp-tipped cone. It is interesting to observe that many of the whiskers in Figure 3 formed along a surface scratch or defect in the substrate that was NOT intentionally introduced. These minor defects were most likely present on the substrate prior to plating or were introduced through the handling of the specimens just prior to initiation of the experiments. This observation raises the concern that basic handling during manufacturing or user assembly may impart stresses to the plating surface which become nucleation sites for whisker growths.

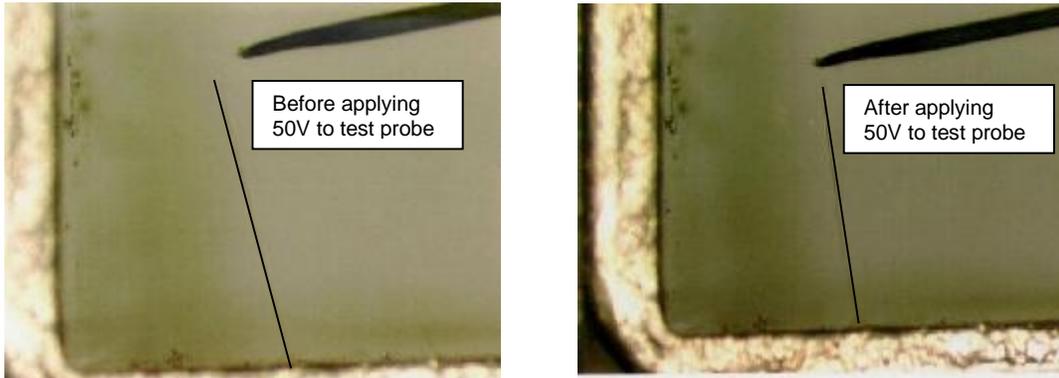
Figure 4. Optical photo of tin whisker movement due to electrostatic attraction  
 (Note: Photo has been graphically enhanced to aid in observation of the thin whisker)

Theoretical calculations predict that a whisker that emerges from a coated surface and then comes in contact with a 2<sup>nd</sup> coated surface will buckle before being able to penetrate that surface.<sup>(1)</sup> However, short circuits caused by tin whiskers growing outward through a conformal coating are **still a real risk**. Suppose two whiskers emerge from beneath separate conformally coated surfaces at different electrical potentials. **The electrostatic force generated by the potential difference between the whiskers will attract them towards each other thus significantly increasing the likelihood of the whiskers shorting together.** Figure 4 shows tin whisker growing from a mounting tab of a pure tin plated relay. In this GSFC experiment, the mounting tab (and thus the tin whisker) was electrically grounded. A test probe (used to simulate a 2<sup>nd</sup> whisker) was brought into close proximity (~ 1 mm) of the whisker, but situated such that physical shorting was not possible. The test probe was then placed at 50 V relative to the whisker. As can be seen from this enhanced photo, the tin whisker bends as a result of electrostatic force generated by the potential difference between the whisker and the test probe. After removal of the test potential, the whisker bends back to its original position. This experiment was repeated hundreds of times without causing the whisker to break. Further experiments to study this behavior are planned.

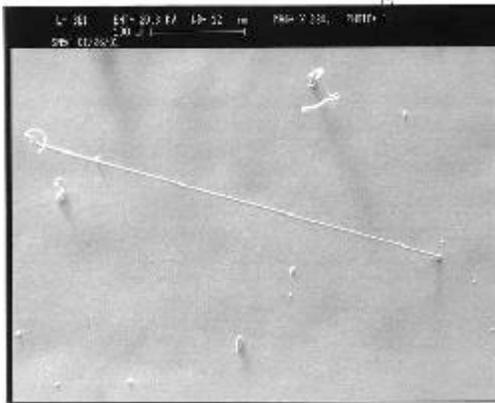
A. Typical needle-like whisker (x230)

Some photographs documenting growth behaviors of tin whiskers on non-conformally coated specimens are shown in Figure 5.

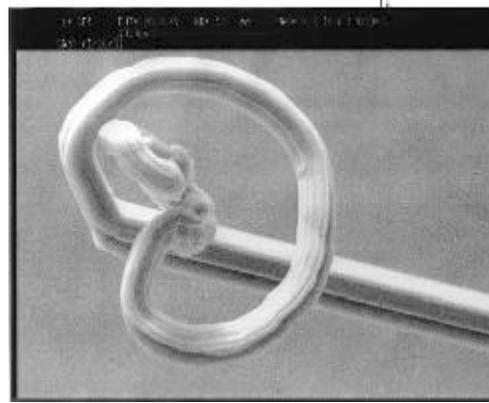
B. Tip of a whisker shown in A. (x3200)

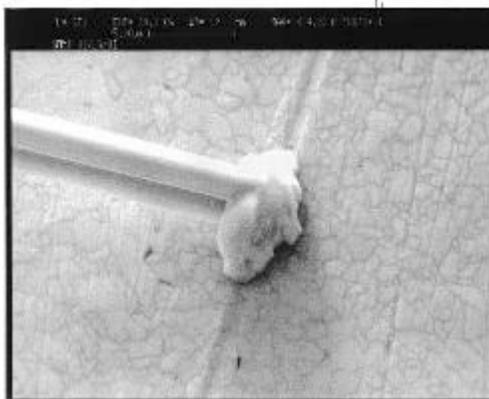
C. Base of whisker shown in A (x4220)

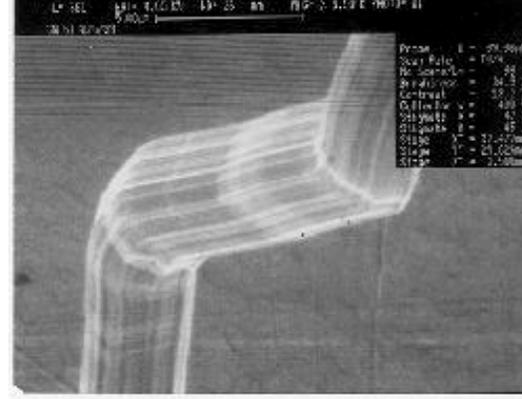
D. Kinked area of a whisker (x6500)

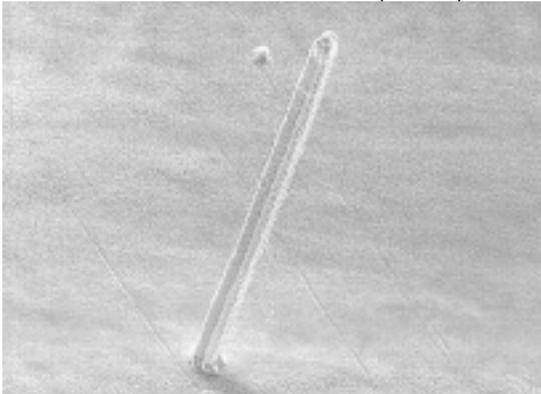
E. Typical straight whisker (x450)

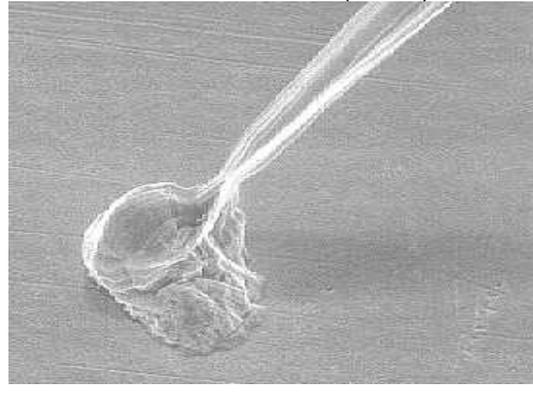
F. Thinning of a whisker (x2200)
