Evaluation of Conformal Coatings as a Tin Whisker Mitigation Strategy

Thomas A. Woodrow, Ph.D.
The Boeing Company
Seattle, WA

Abstract

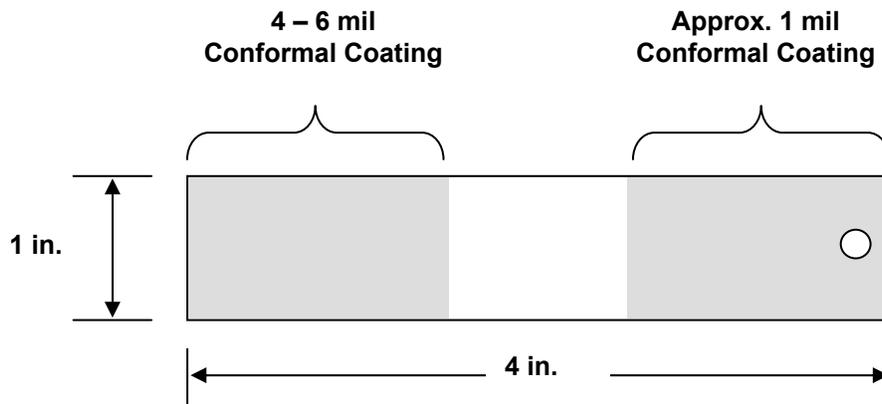
Figure 1. Test Coupon (Brass 260 Plated with 154 Microinches of Bright Tin)

The coatings were applied to the test coupons as shown in Figure 1. One end of each coupon was coated with approximately 1 mil of coating and the opposite end of each coupon was coated with a thicker layer (4 – 6 mil) of coating. The middle of each coupon was left uncoated to serve as a control. The exceptions were the coupons coated with Coating B (the silicone) and Parylene. The silicone was applied in only one thickness (1.5 mils). The Parylene was applied over the entire surface of the coupons (0.8 – 1.0 mil) leaving no control areas. A separate coupon was used as the Parylene control. The control coupon was exposed to the Vichem 600A etching step but was not coated with Parylene.

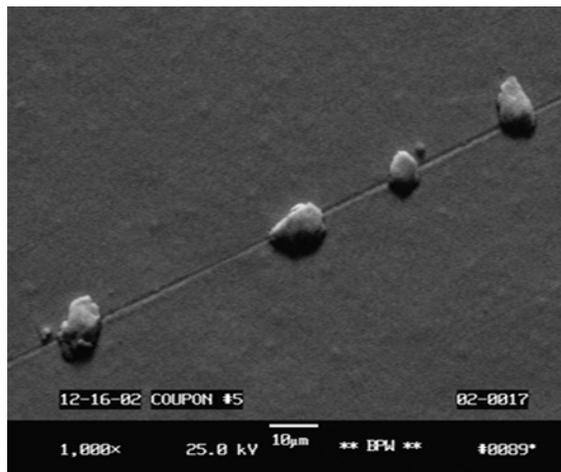
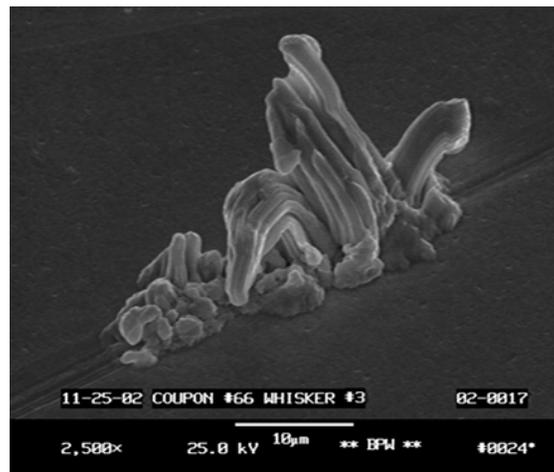
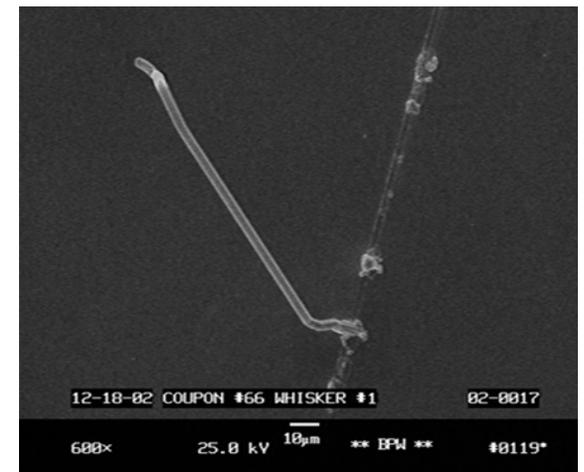
Nodule

Odd Shaped Eruption (OSE)

Whisker

Figure 2. Different Types of Growths

microscope (SEM) and any growths were noted (see Table 2). Figure 2 shows how the different types of growths observed were classified, i.e. nodules; odd shaped eruptions (OSE's); and whiskers. Photographs were taken to document any changes in the tin plating during testing.

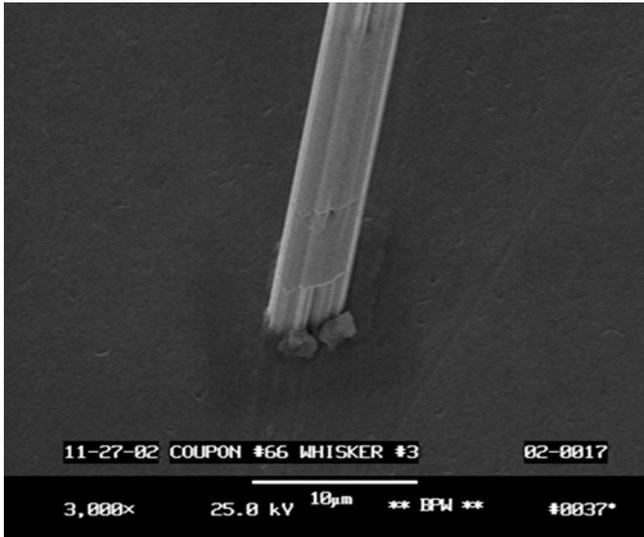
Figure 3. Organic? Material on Whisker

It was noted that some of the whiskers growing on the control areas were covered with unusual patches of a substance that traveled along with the whisker as it grew (Figure 3). This substance seemed to be exuded from within the tin plating and may be residual organics from the plating process. The presence of this substance was fortuitous as it allowed the growth rate of the whisker to be accurately measured (see Figure 4, measured growth rate of this whisker was approximately 10 Angstroms/minute). Additional work is ongoing to identify the composition of the substance.

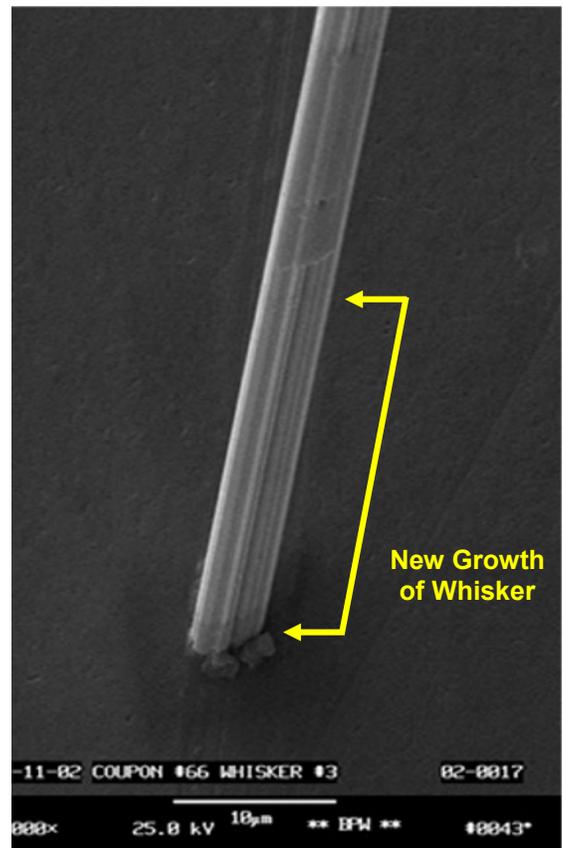
Figure 4. Same Whisker as Shown in Figure 3. (Note New Growth of Whisker after 14 Days and that Organic? Material Moves with Whisker)

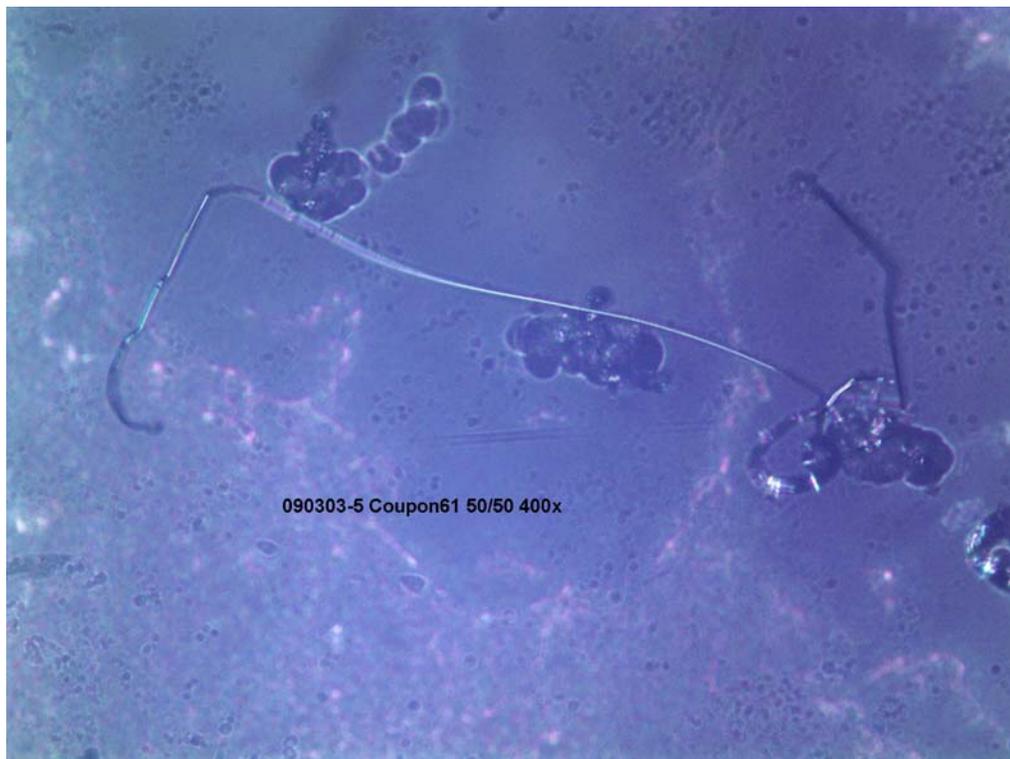
Figure 5. 300 Micron Whisker Growing under Coating E – 1.3 Mils (278 Days at Ambient + 46 Days in 50°C/50%RH)

After 63 days in the 50°C/50%RH environment, the acrylic coating (Coating C) had odd shaped eruptions (OSE's) and whiskers growing under both the thin and the thick coated areas. The whiskers pushed the conformal coating up to form "tents". Similarly, Coating E had a few whiskers under both the thin and the thick coated areas. Some of these whiskers were as long as 300 microns (see Figure 5).

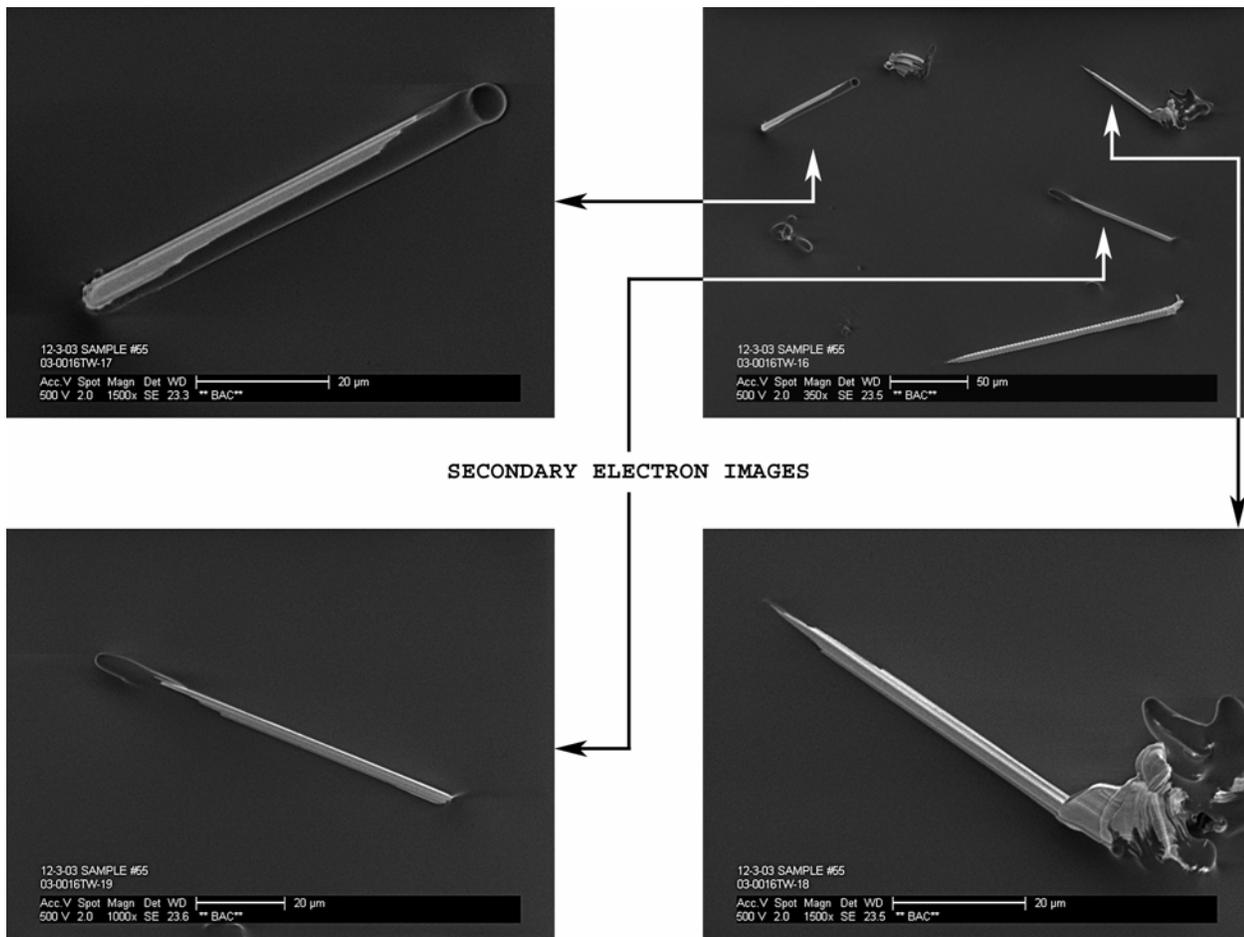
Figure 6. Whiskers Penetrating Coating C – 0.6 Mils (278 Days at Ambient + 119 Days in 50°C/50%RH)

After 119 days in the 50°C/50%RH environment, the thin acrylic coating (0.6 mils of Coating C) had been penetrated by whiskers (see Figure 6). Note the whisker whose tip is still covered with conformal coating that has ripped away from the bulk material (Figure 6, upper left hand photo). Also note that some whiskers appear to have re-penetrated the coating. The thicker acrylic coating (3.9 mils) was not penetrated by whiskers although there were many whiskers "tenting" the coating (Figure 7). The 1.1 mils of Coating D was penetrated by OSE's and whiskers (see Figures 8 and 9). The OSE's that penetrated the coating emanated from the serial number that was scribed onto the coupon before plating. This may be an example of how stresses induced into the substrate by mechanical means can trigger the formation of growths in a tin plating applied later. The 4.6 mils of Coating D had one whisker under, but not penetrating, the coating.

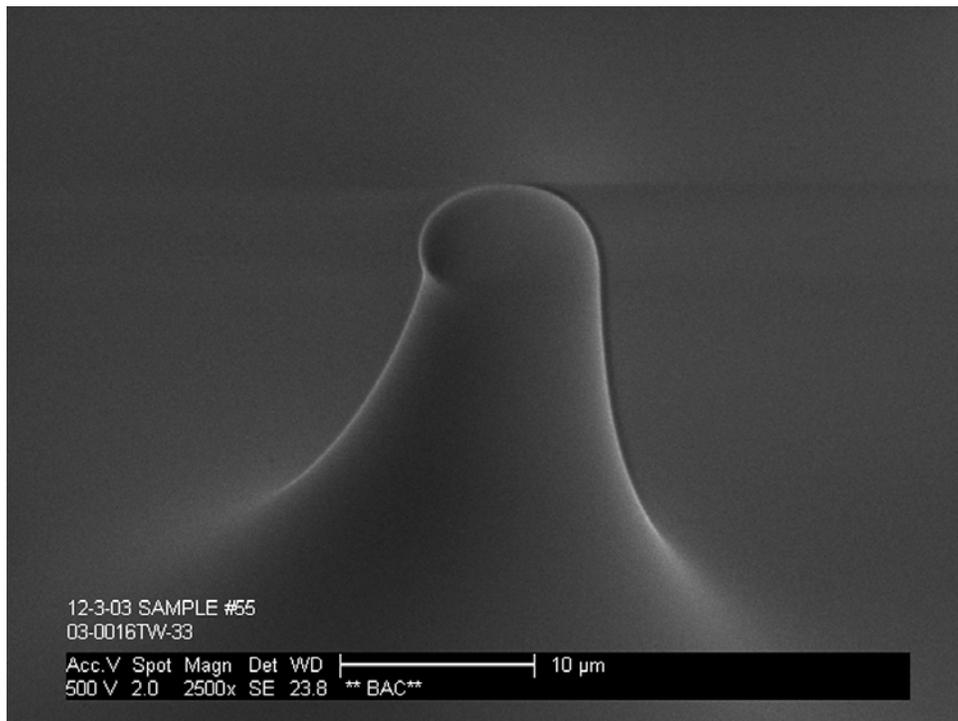
Figure 7. “Tenting” of Coating C – 3.9 Mils (278 Days at Ambient + 137 days in 50°C/50%RH)

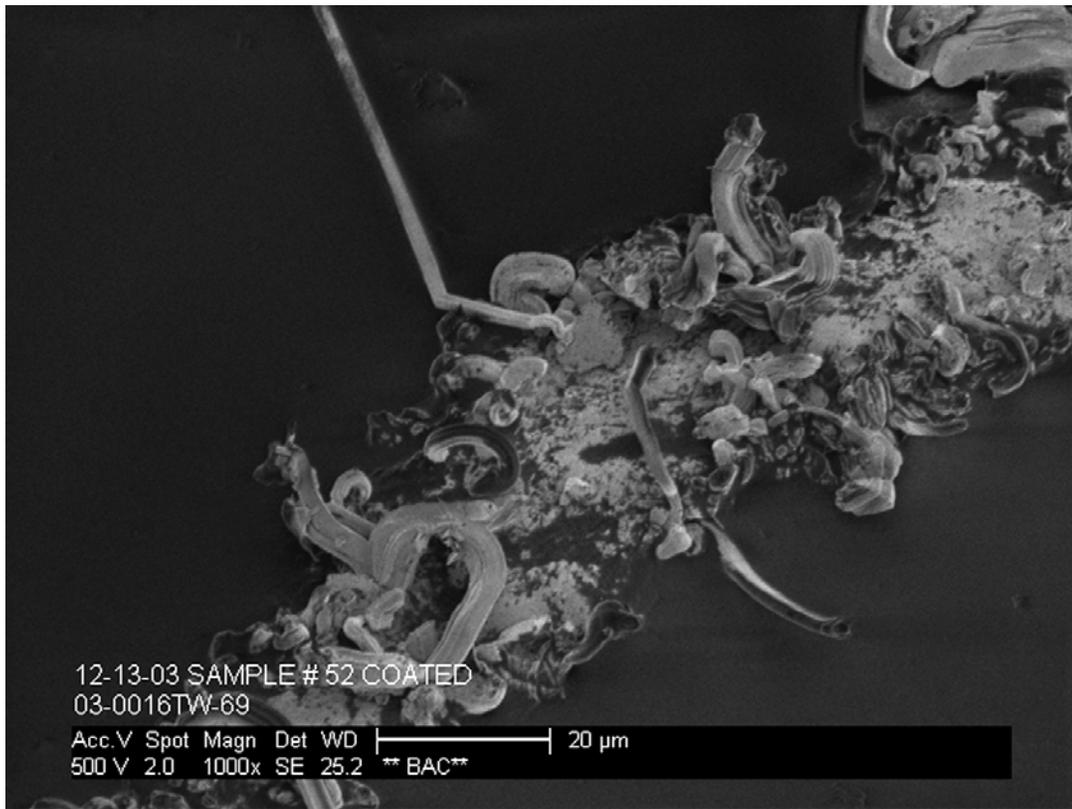
Figure 8. OSE's and Whiskers Erupting through Coating D – 1.1 Mils (278 Days at Ambient + 147 Days in 50°C/50%RH)

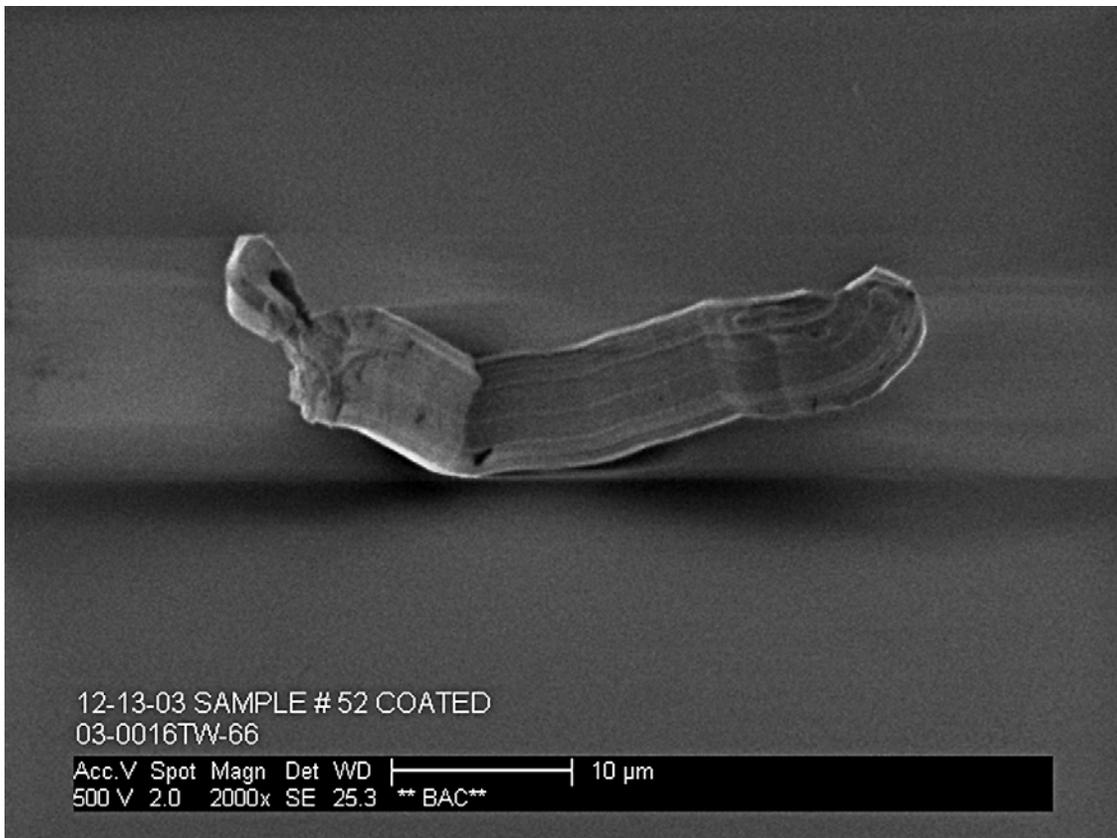
Figure 9. Whisker Penetrating Coating D – 1.1 Mils (278 Days at Ambient + 147 Days in 50°C/50%RH)

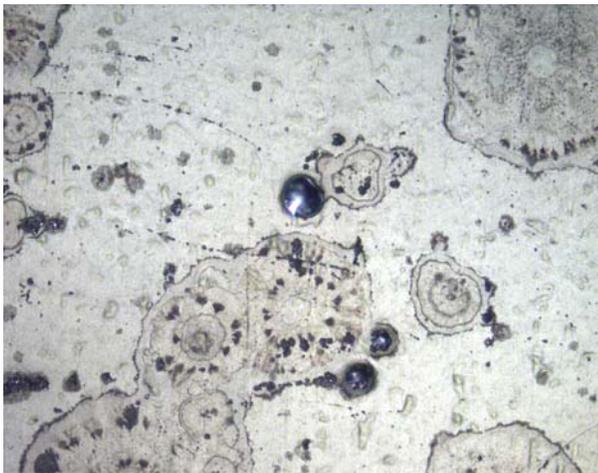
Figure 10. Optical Microscope Image of Coating B Showing Example of OSE's in Bubbles – 1.5 Mils (278 Days at Ambient + 419 Days in 50°C/50%RH)

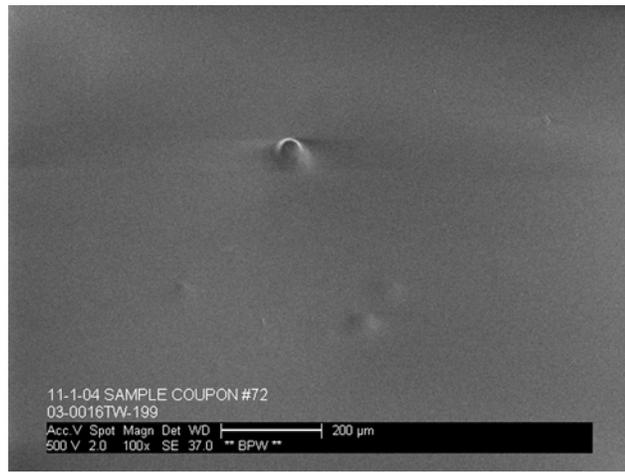
Figure 11. SEM Image of Same Area as Figure 10

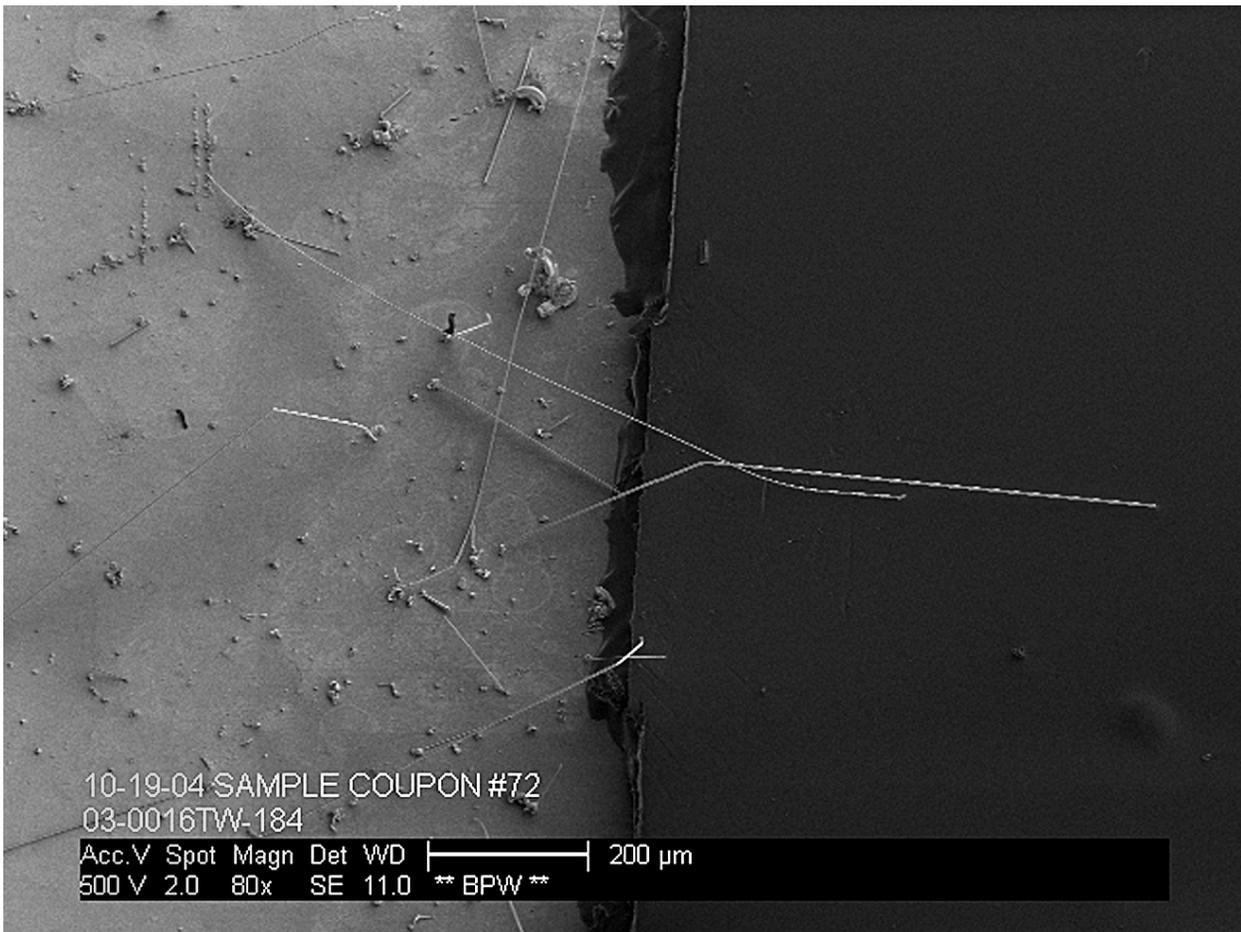
Figure 12. Coating B – Demarcation Line between Coated Area (1.5 Mils) and Uncoated Control Area (278 Days at Ambient + 419 Days in 50°C/50%RH)

After 336 days in the 50°C/50%RH environment, the thinner applications of Coatings B, E, and Parylene C were also penetrated by whiskers and/or OSE's (see Figures 12-22). The Parylene had only a few growths under the coating (Figure 20) but several whiskers had formed and had penetrated the coating (Figures 21 and 22). Coating A was the only coating that was not yet penetrated by whiskers, however, there were many OSE's in bubbles under the coating and whiskers were growing on the OSE's (see Figure 23). Coating D also had many OSE's in bubbles at this point (Figure 24).

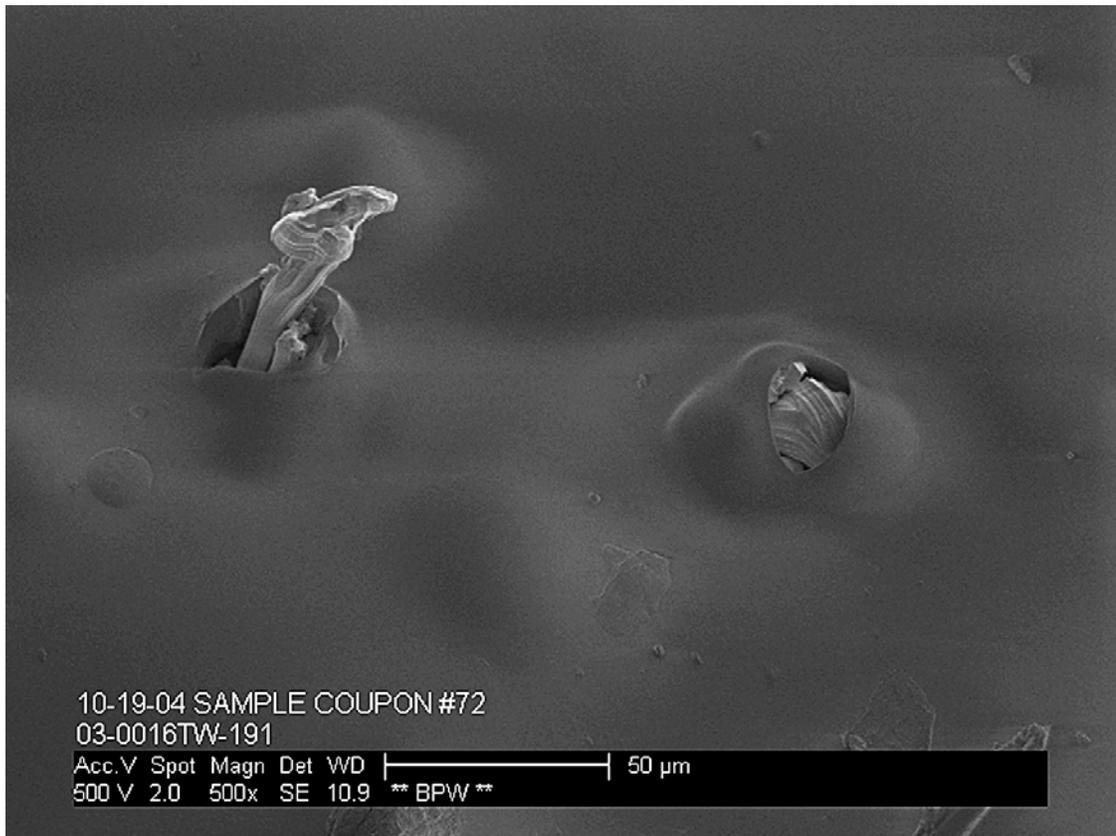
Figure 13. Whisker Penetrating Coating B – 1.5 Mils (278 Days at Ambient + 419 Days in 50°C/50%RH)

However, once whiskers and OSE's had formed under the coatings, the thinner coatings (0.6–1.5 mils) were generally not effective at preventing penetration by the whiskers and/or OSE's. Close examination of Figures 13-15 and 19 reveal that the thickness of each coating penetrated appears to be less than the average coating thickness as measured optically. This suggests that the whiskers that penetrated were those that had found a weak spot in the thinner coatings.

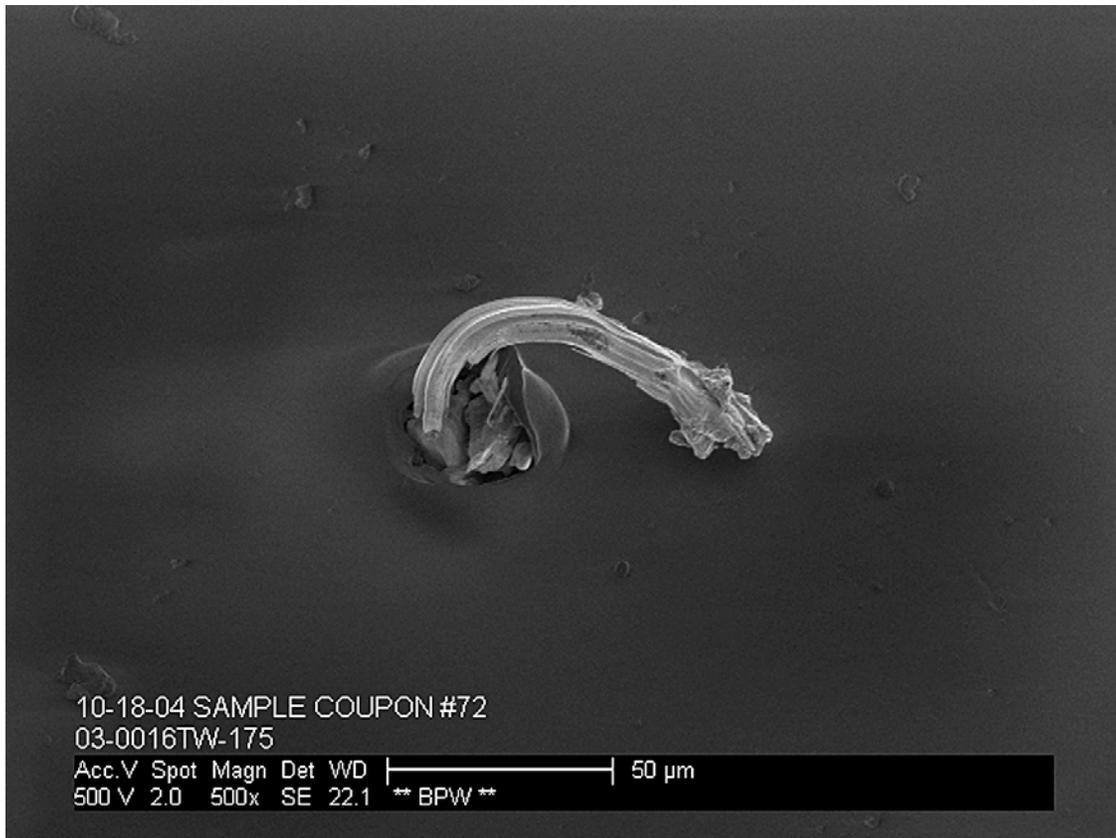
Figure 14. Whisker Penetrating Coating B – 1.5 Mils (278 Days at Ambient + 419 Days in 50°C/50%RH)

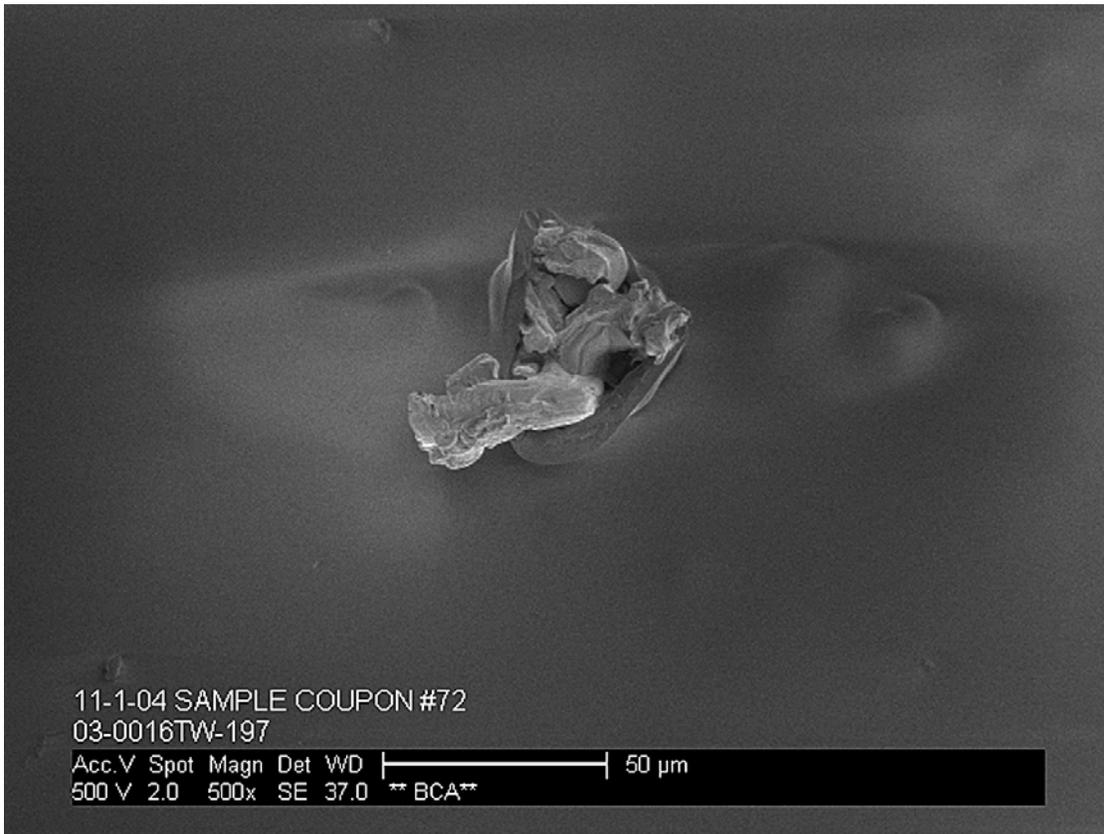
Figure 15. Whisker Penetrating Coating B – 1.5 Mils (278 Days at Ambient + 419 Days in 50°C/50%RH)

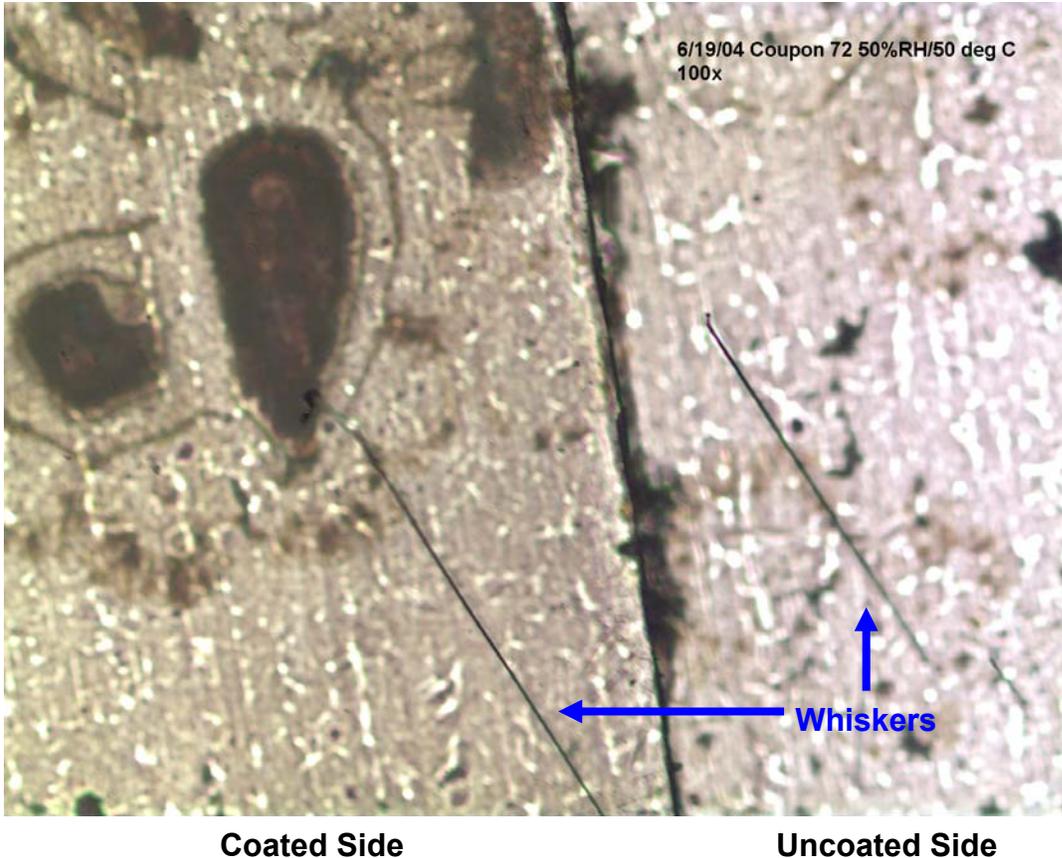
Figure 16. Coating B – 1.5 Mils (278 Days at Ambient + 336 Days in 50°C/50%RH)

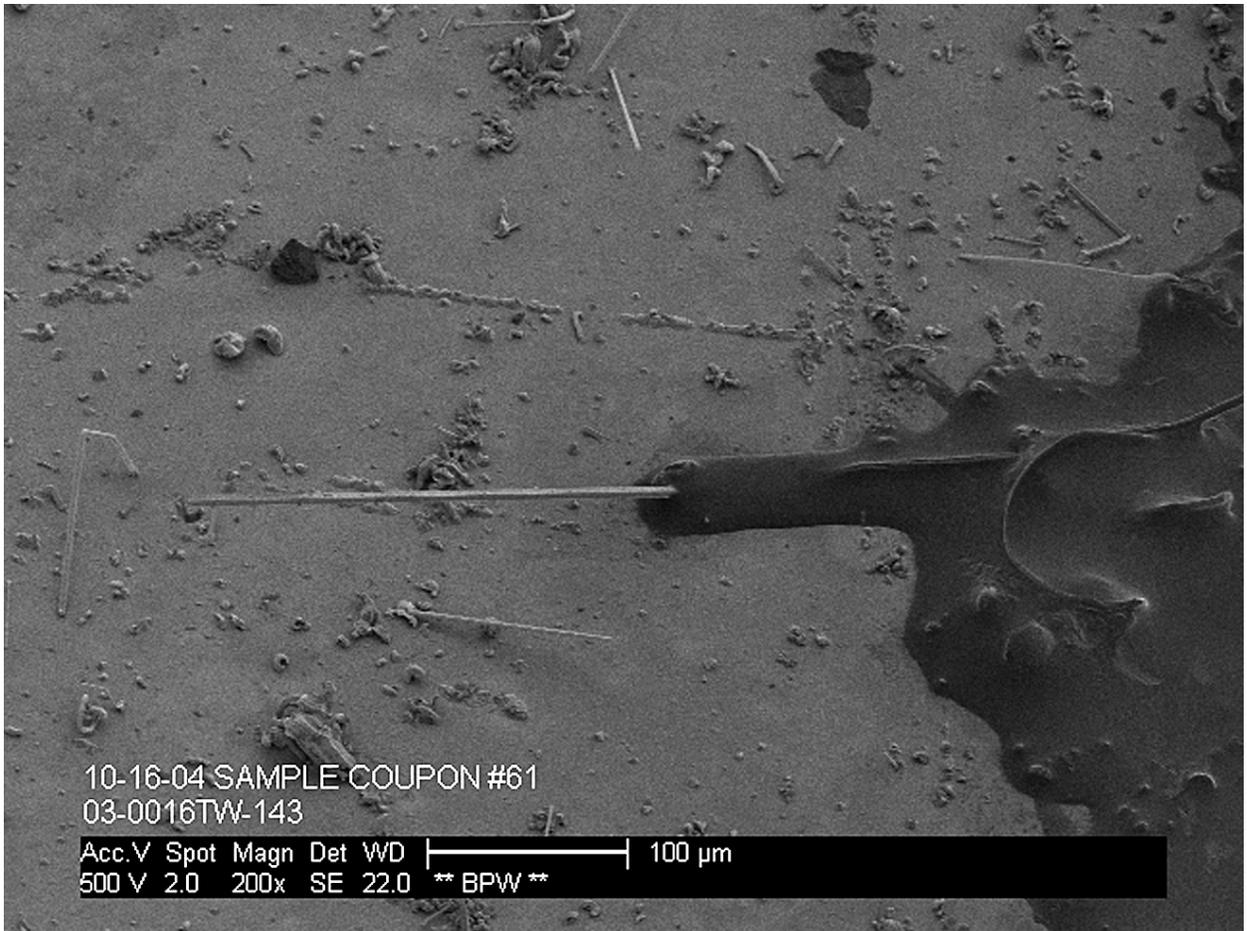
Uncoated Side

Coated Side

Figure 17. Control Area for Coating E (278 Days at Ambient + 419 Days in 50°C/50%RH)

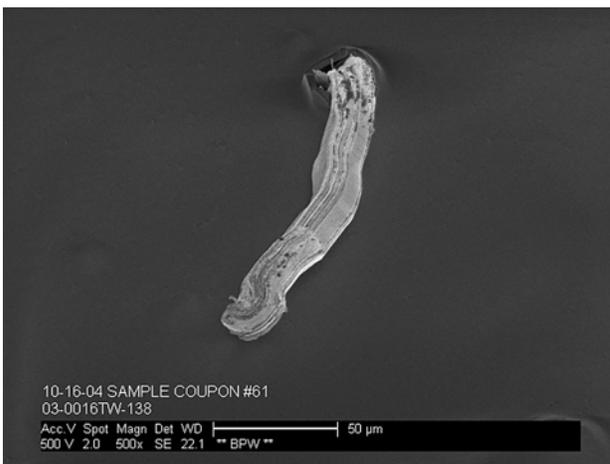
Figure 18. Whisker Penetrating Coating E – 1.3
Mils (278 Days at Ambient + 419 Days
in 50°C/50%RH)

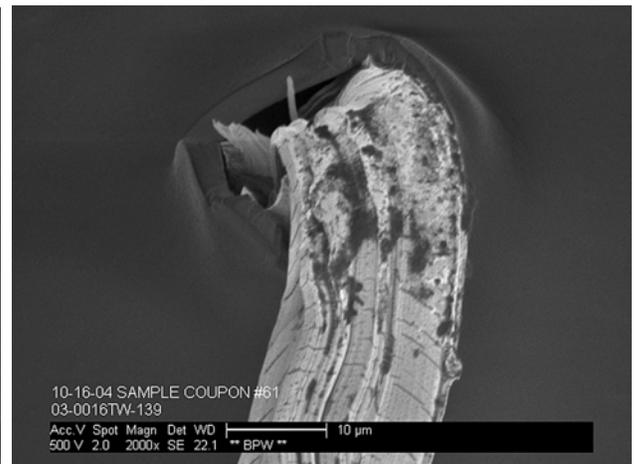
Figure 19. Whisker Penetrating Coating E –
Enlargement of Figure 18

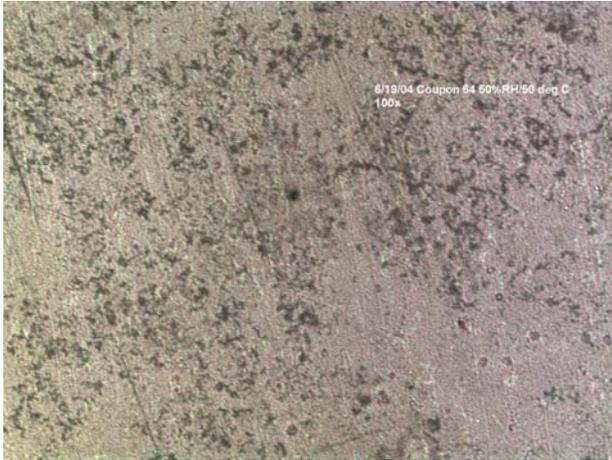
Figure 20. Parylene C – 0.8 Mils, Note Mottling of Tin Plating but No Growths (278 Days at Ambient + 336 Days in 50°C/50%RH)

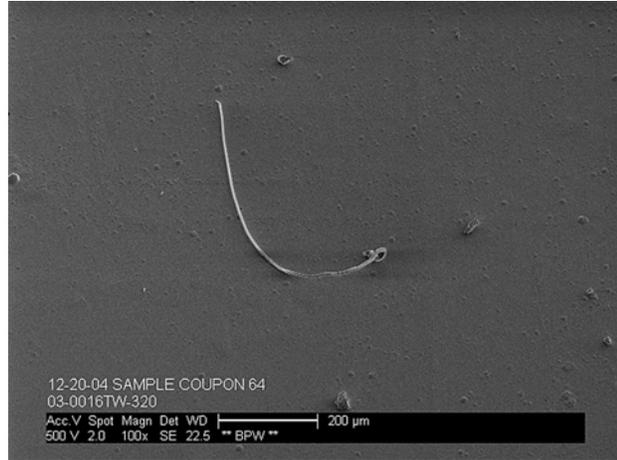
Figure 21. Whisker Penetrating Parylene C – 0.8 Mils (278 Days at Ambient + 419 Days in 50°C/50%RH)

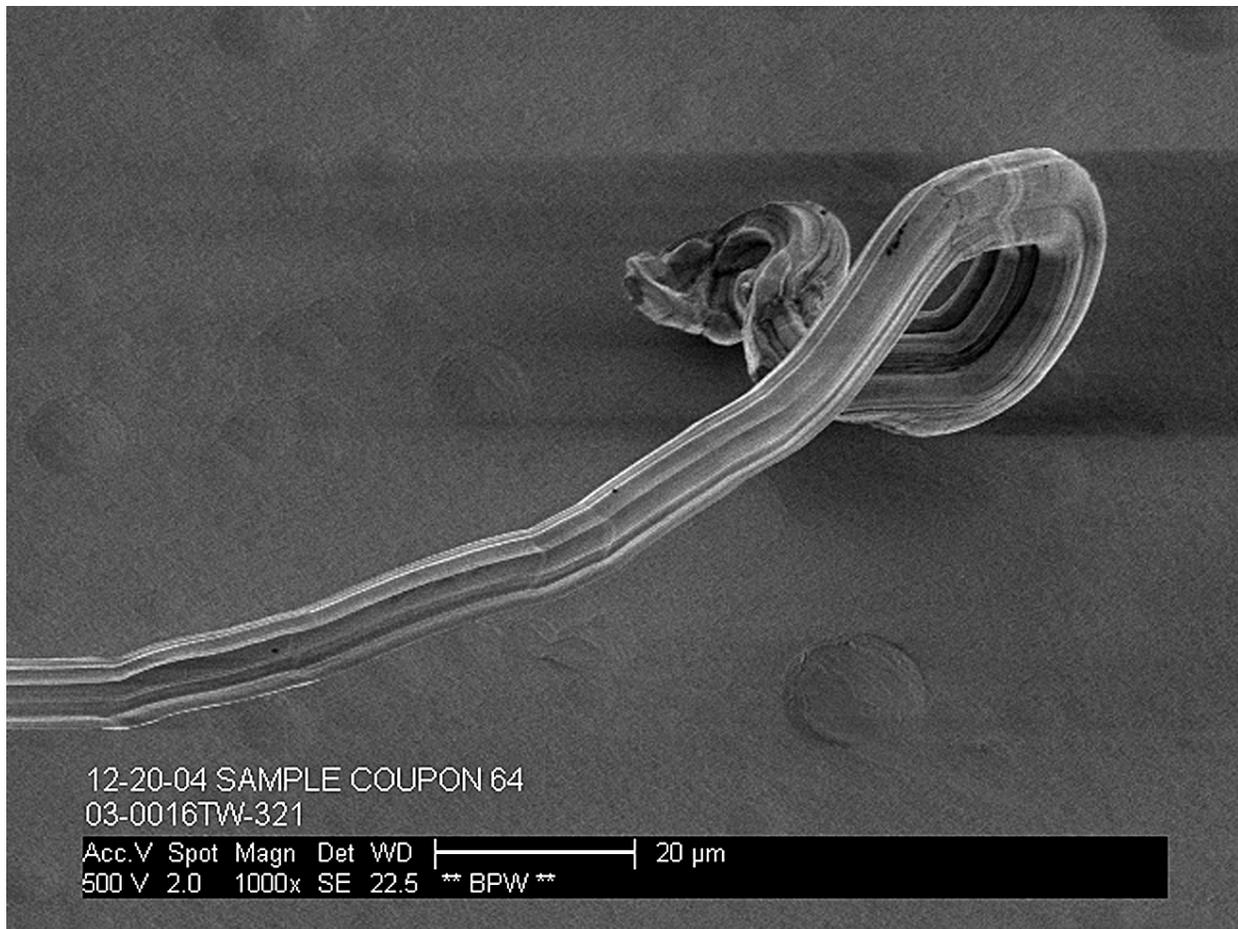
Figure 22. Whisker Penetrating Parylene C – Enlargement of Figure 21

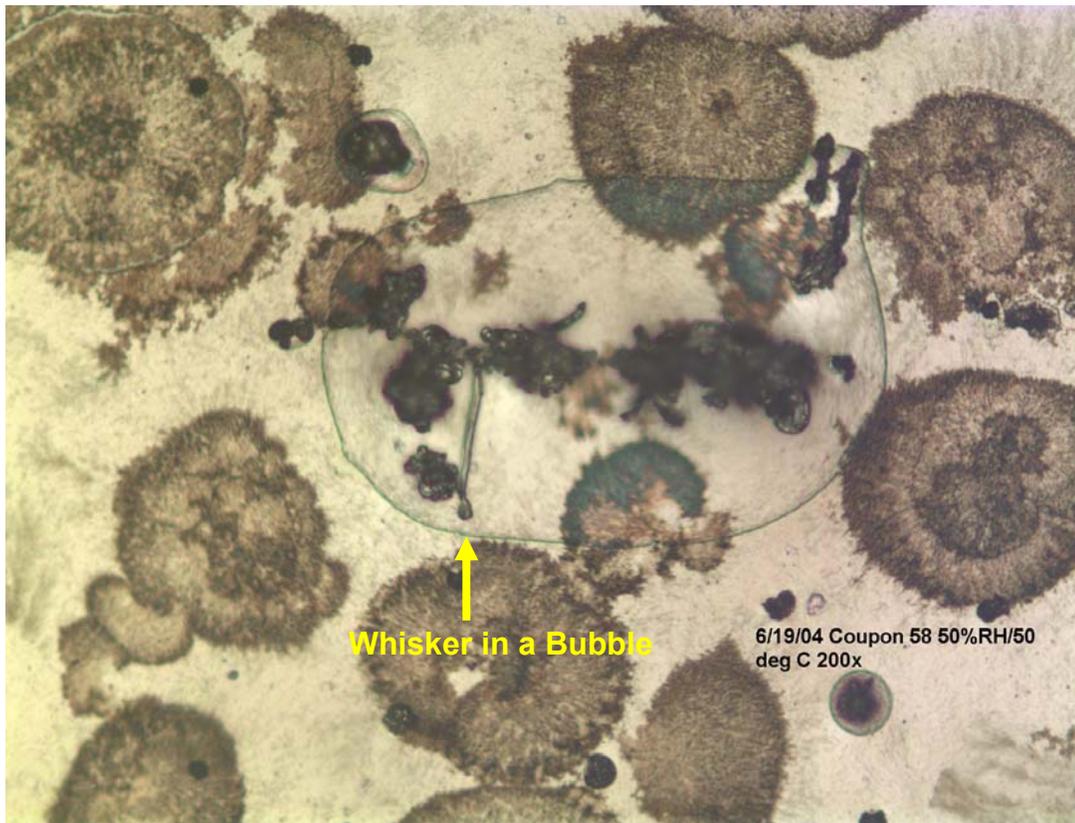
Figure 23. Coating A – 6.0 Mils (278 Days at Ambient + 336 Days in 50°C/50%RH)

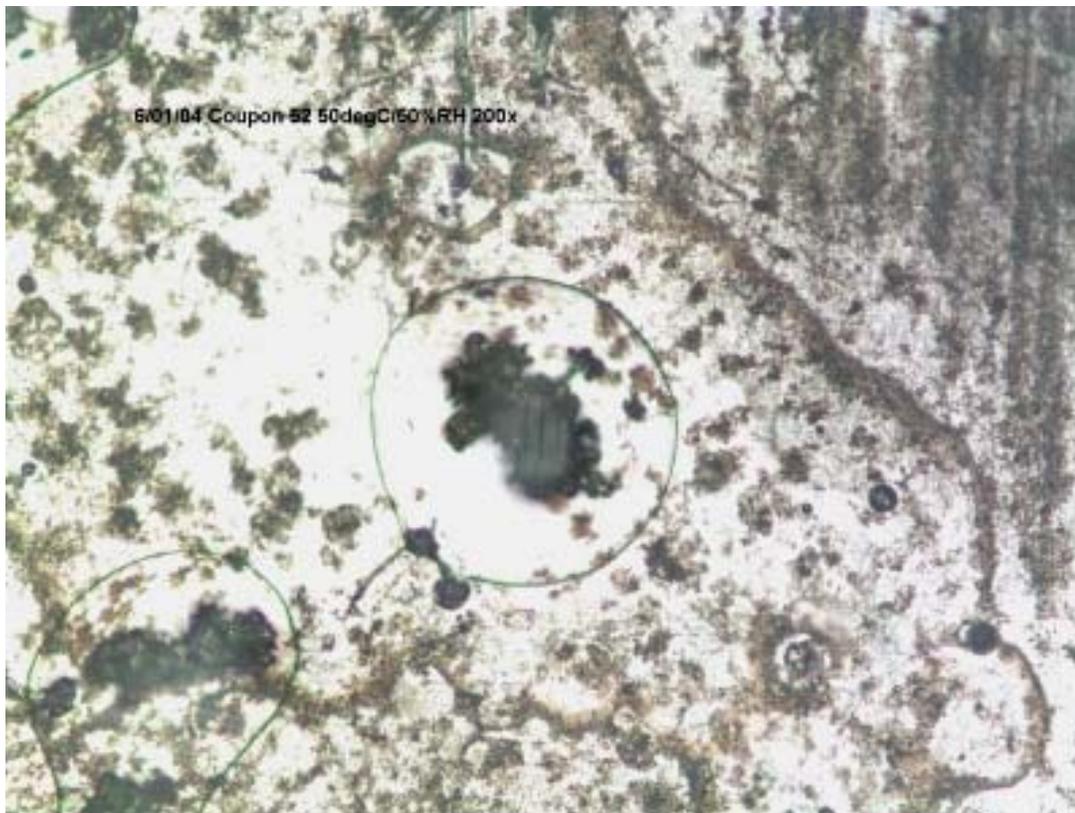
Figure 24. Coating D – 4.6 Mils, OSE's and Whisker in a Bubble (278 Days at Ambient + 318 Days in 50°C/50%RH)

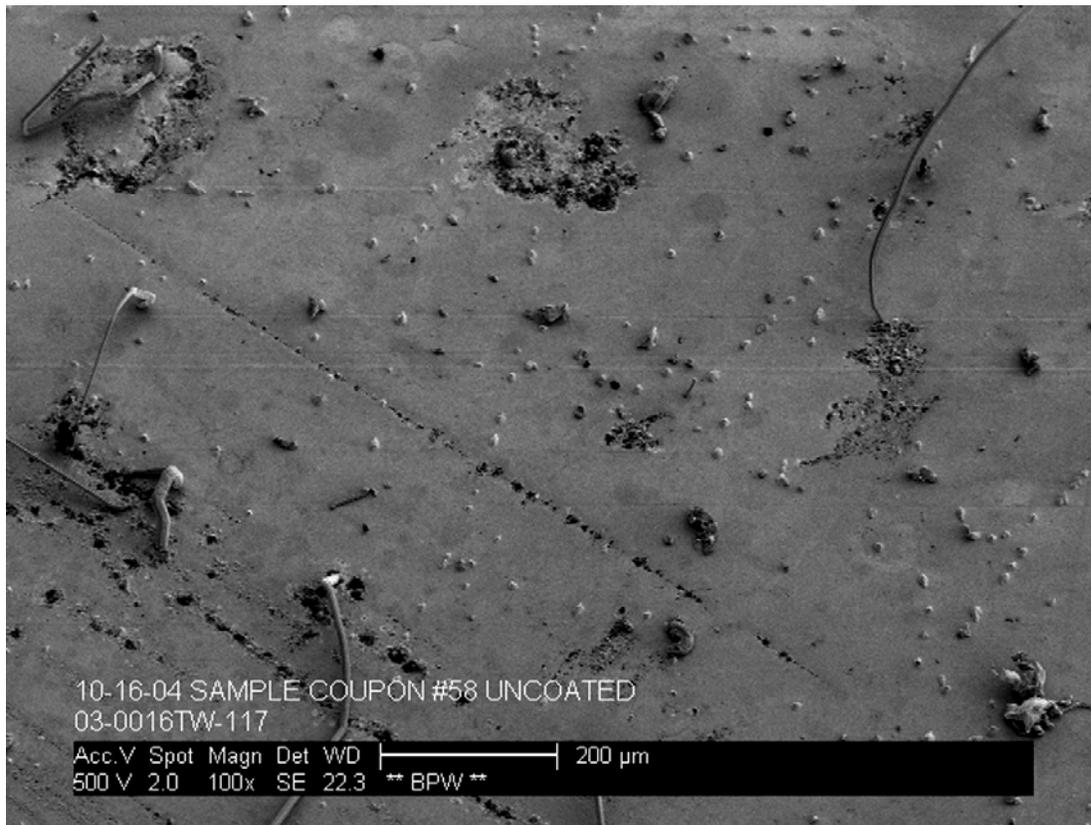
Figure 25. Control Area for Coating A (278 Days at Ambient + 419 Days in 50°C/50%RH)

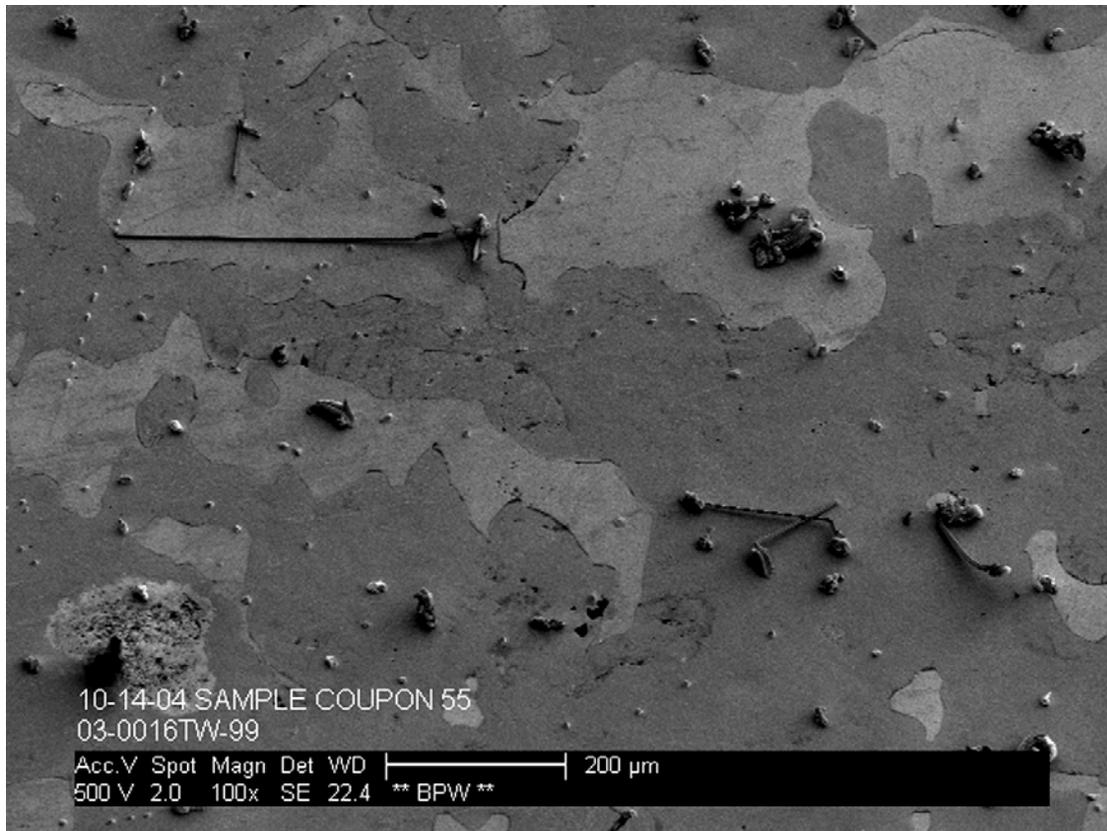
Figure 26. Control Area for Coating C (278 Days at Ambient + 419 Days in 50°C/50%RH)

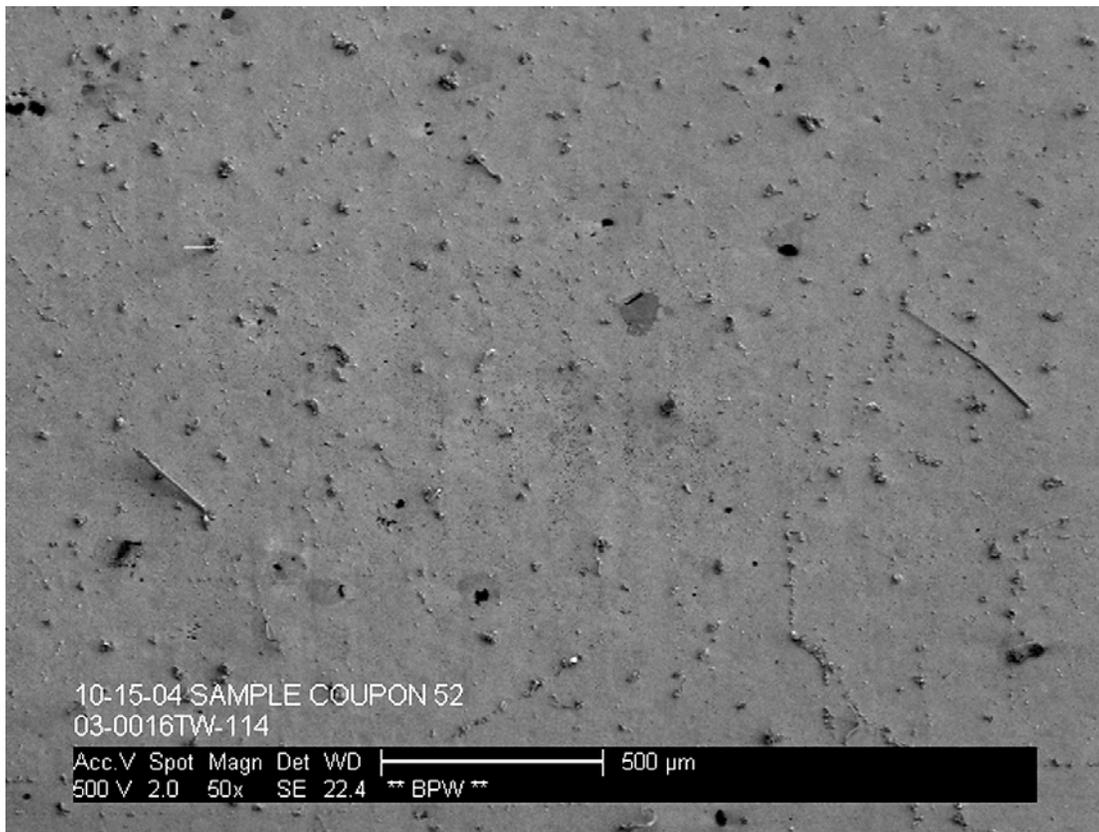
Figure 27. Control Area for Coating D (278 Days at Ambient + 419 Days in 50°C/50%RH)

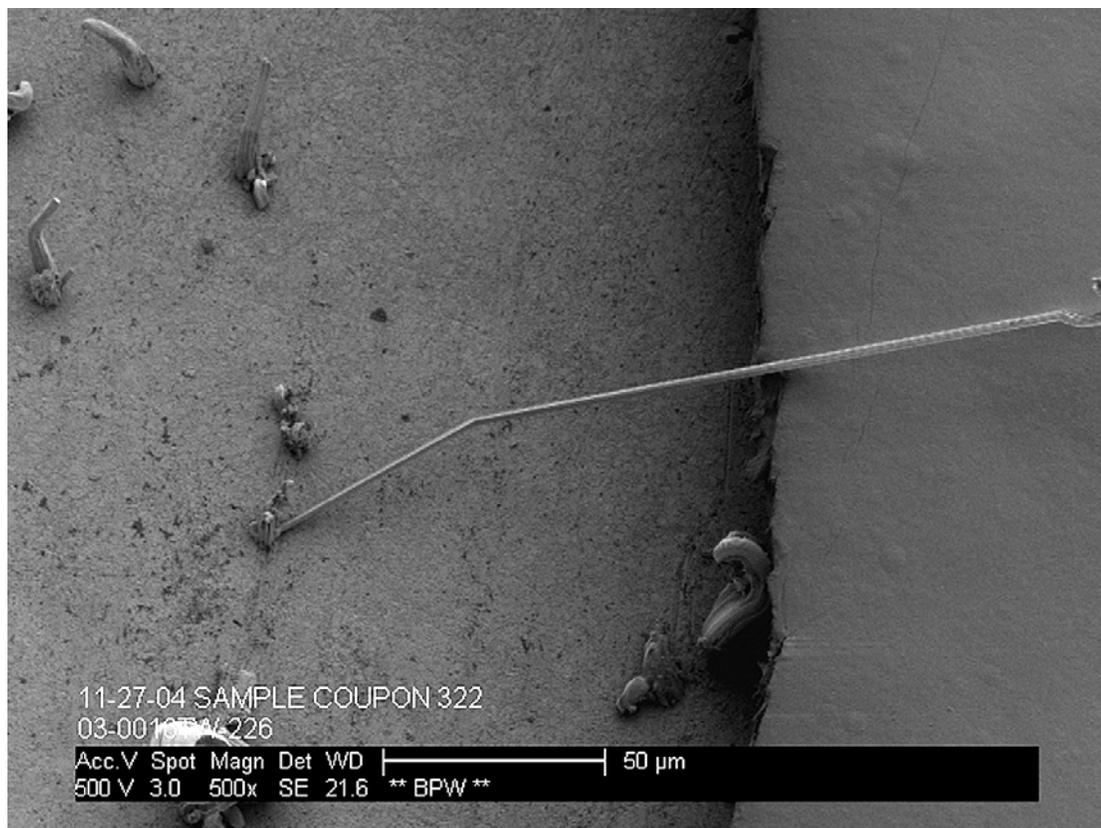
Figure 28. Control Area for Parylene C – Chemically Etched but not Coated (177 Days at Ambient + 84 Days in 50°C/50%RH)
