Evaluation of Conformal Coatings as a Tin Whisker Mitigation Strategy

Thomas A. Woodrow, Ph.D.
The Boeing Company
Seattle, WA

Abstract

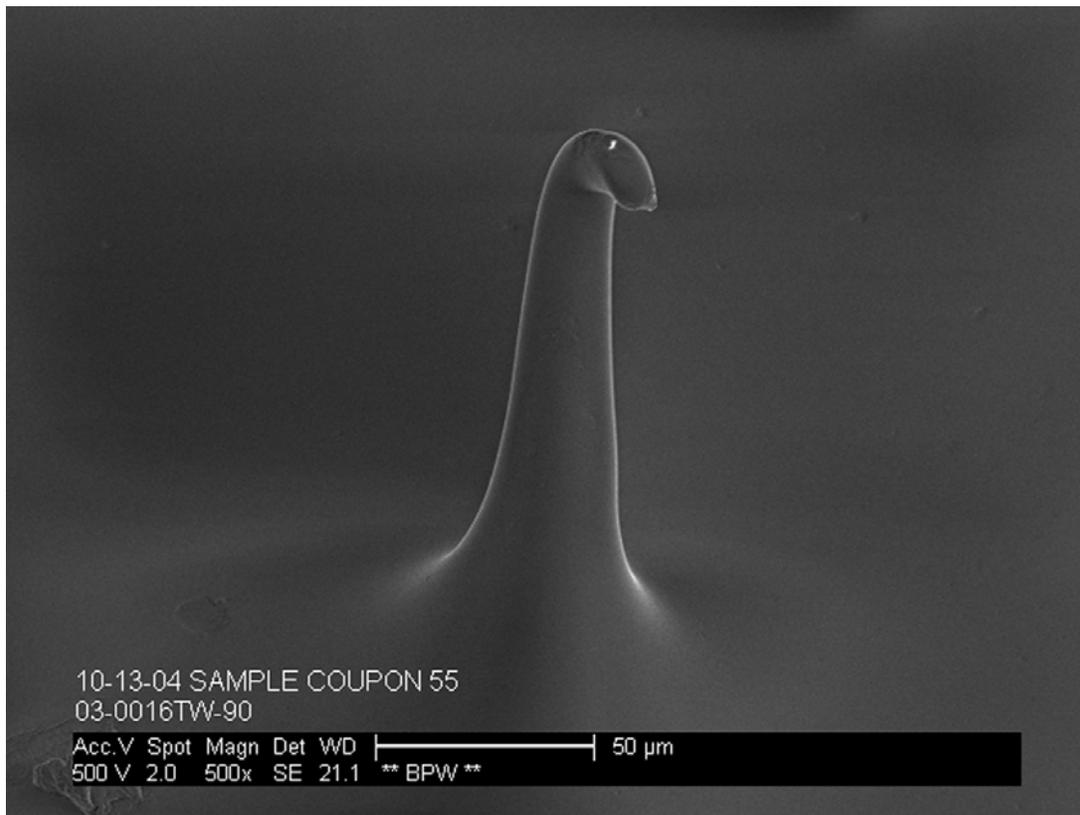
Figure 29. Coating C – 3.9 Mils (278 Days at Ambient + 419 Days in 50°C/50%RH)

All of the conformal coatings tested suppressed the formation of tin whiskers when compared to the uncoated controls. The controls all grew massive amounts of whiskers that were long enough to penetrate the coatings in test (see Figures 12, 17, 25-28). The coating that best suppressed the formation of growths under the coating was Parylene C. At the end of 336 days of 50°C/50%RH, the tin plating under the Parylene was almost free of nodules, OSE's and whiskers. Coating B (the silicone) was also very good at preventing the formation of OSE's and whiskers. The worst coating for suppressing growths was the acrylic (Coating C) which had numerous whiskers severely "tenting" the thicker acrylic

coating (Figures 29 and 30) and penetrating the thinner acrylic coating. All of the other coatings fell somewhere in between Parylene and the acrylic in their ability to suppress OSE and whisker growth.

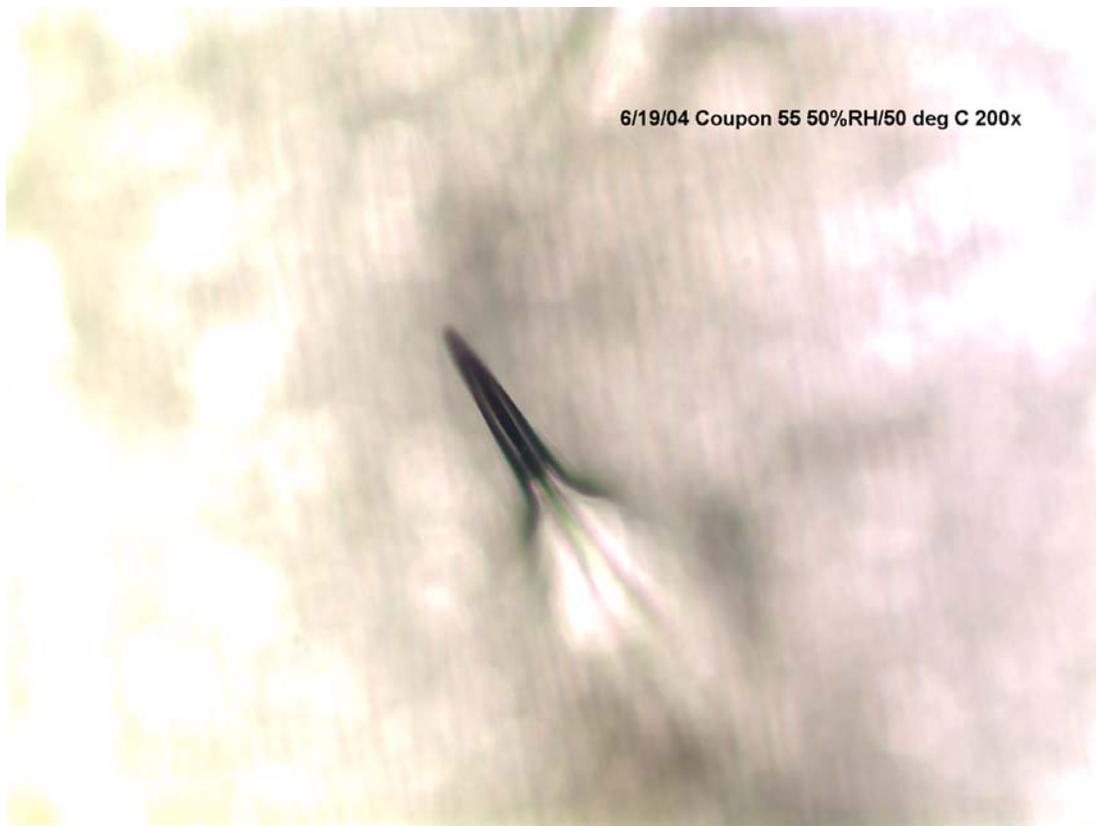
Figure 30. Coating C – 3.9 Mils (278 Days at Ambient + 336 Days in 50°C/50%RH)

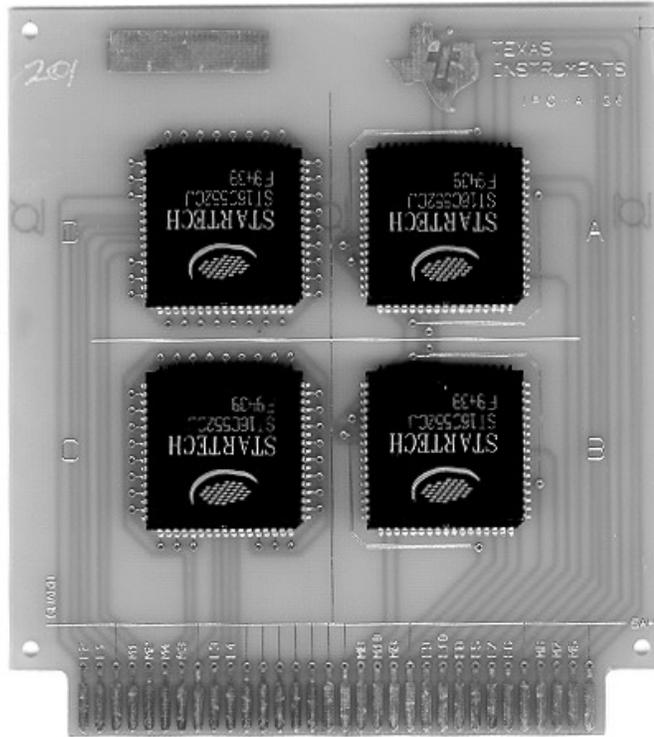
Figure 31. PLCC64's Used to Evaluate Conformal Coating Coverage on Leads

to test boards and the boards were then coated with conformal coatings (Figure 31). Three conformal coatings were evaluated (Coating D, Coating E and Parylene C). The electrical resistance of each coating on the PLCC leads was evaluated using a digital ohmmeter with blunt probes in order to determine if the coating had adhered to the lead or if it had run off during application of the coating. Coatings D and E were so thin on the leads that they provided no electrical insulation at all (on the front or backside of the leads, see Table 3). In contrast, the Parylene C provided a fully insulating barrier on both sides of the leads. It was obvious from this experiment that Coatings D and E were so thin on the leads that they would provide no protection if a whisker were to grow on the leads or if they came into contact with a whisker growing from an adjacent lead. This thinning of the coating on component leads will probably be encountered with most conformal coatings applied by spraying. Parylene C is unique in that it is applied by a vacuum deposition process which produces a very uniform coating on all surfaces.

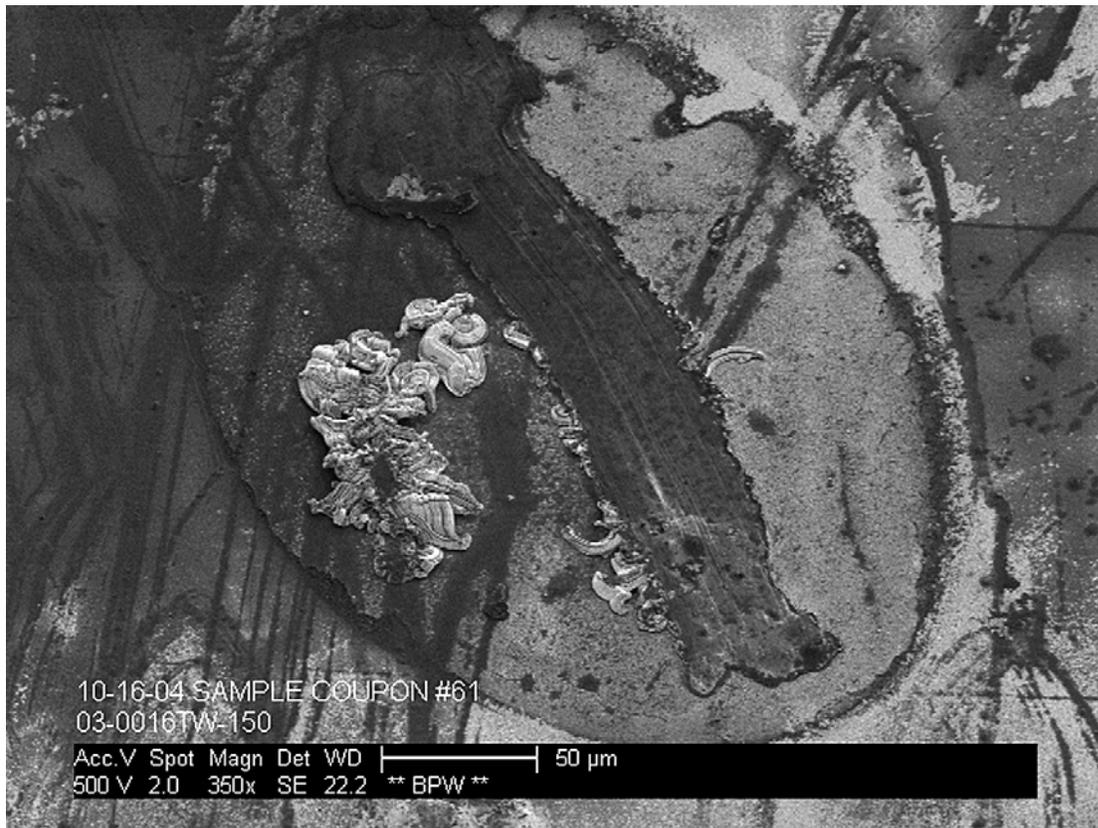
Figure 32. Coupon after Removal of 1.3 Mils of Coating E (278 Days at Ambient + 419 Days in 50°C/50%RH), Note Oval Demarcation Line Where Bubble Was

Some of the growths under Coating E were different in appearance from the typical odd shaped eruption. In some cases it looked as if whiskers had grown but had then coiled up when they were unable to penetrate the coating (Figures 32 and 33).

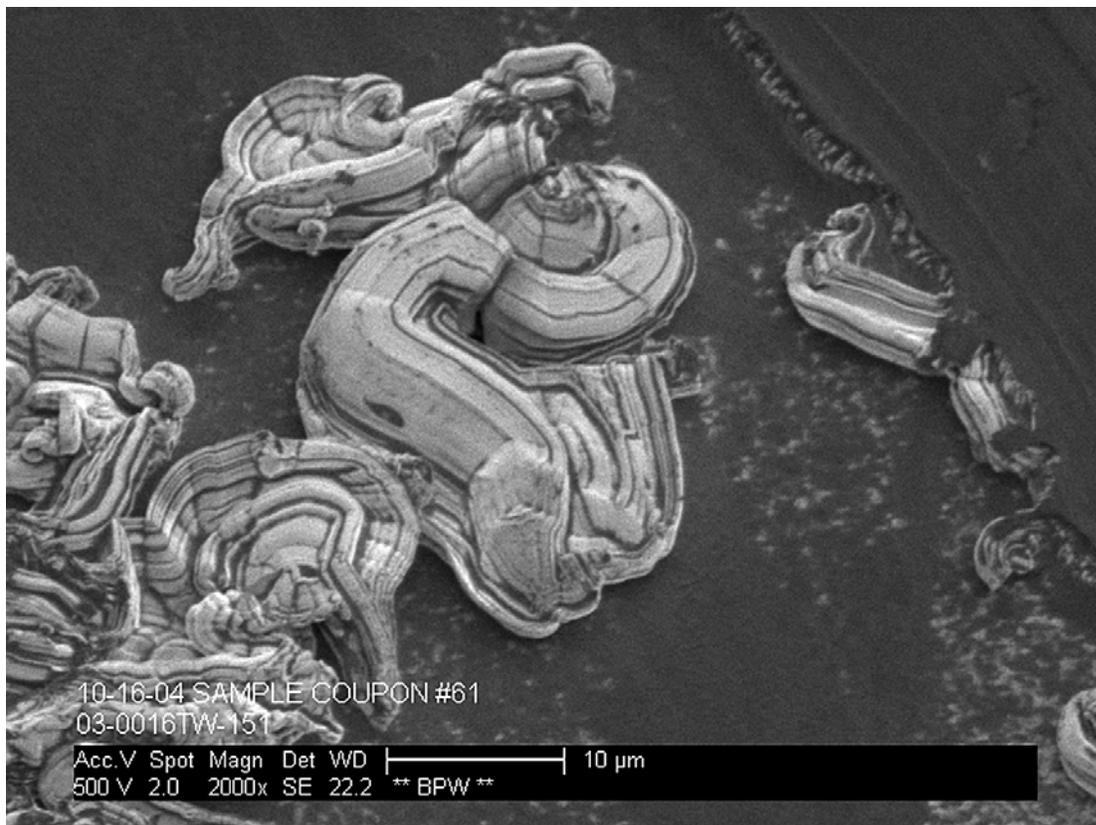
Figure 33. Enlargement of Figure 32

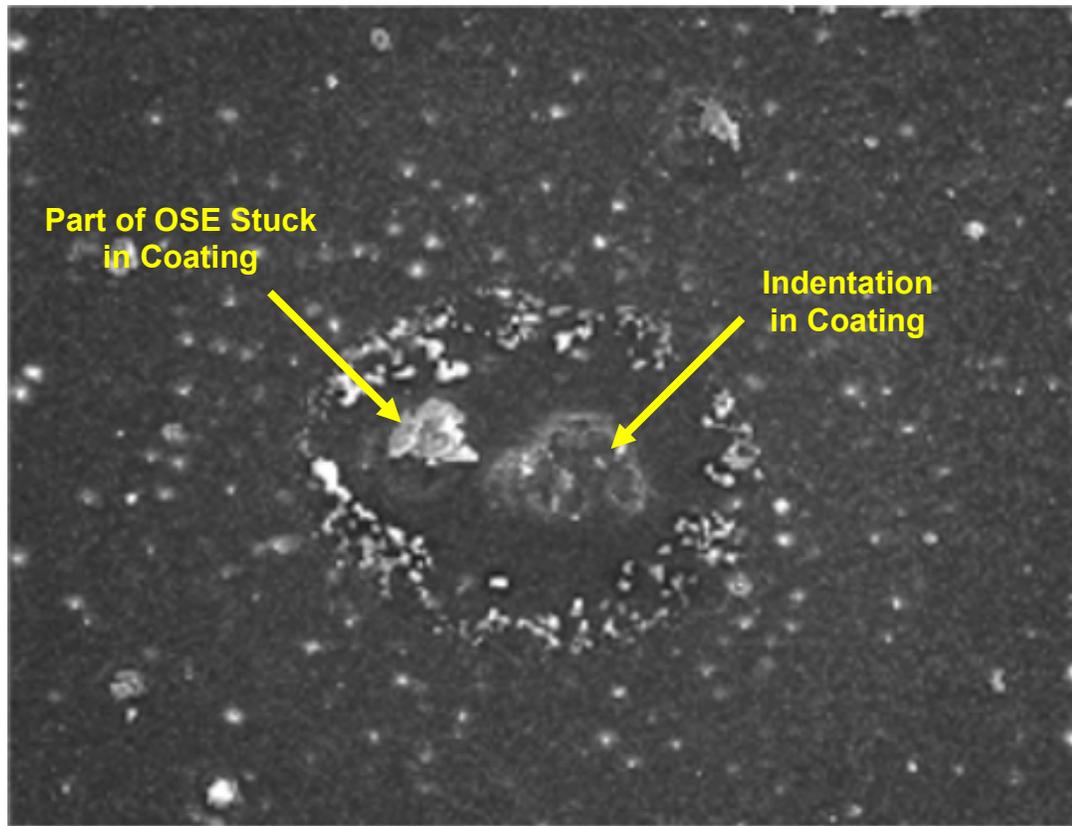
Figure 34. Coating E (4.0 Mils Thick) after Removal from Coupon

A piece of delaminated Coating E was sputtered with iridium and examined in the SEM. Figure 34 shows a bubble in the coating and how the coating has pulled material off of the tin plating. The bubble once enclosed an OSE on the surface of the coupon. EDS (energy dispersive x-ray spectroscopy) examination revealed an unusual formation of zinc around the perimeter of the bubble ("zinc ring", Figure 35). Figures 36 and 37 demonstrate that part of the OSE has been removed by the coating and is surrounded by the "zinc ring". Oxygen is intimately associated with the zinc.

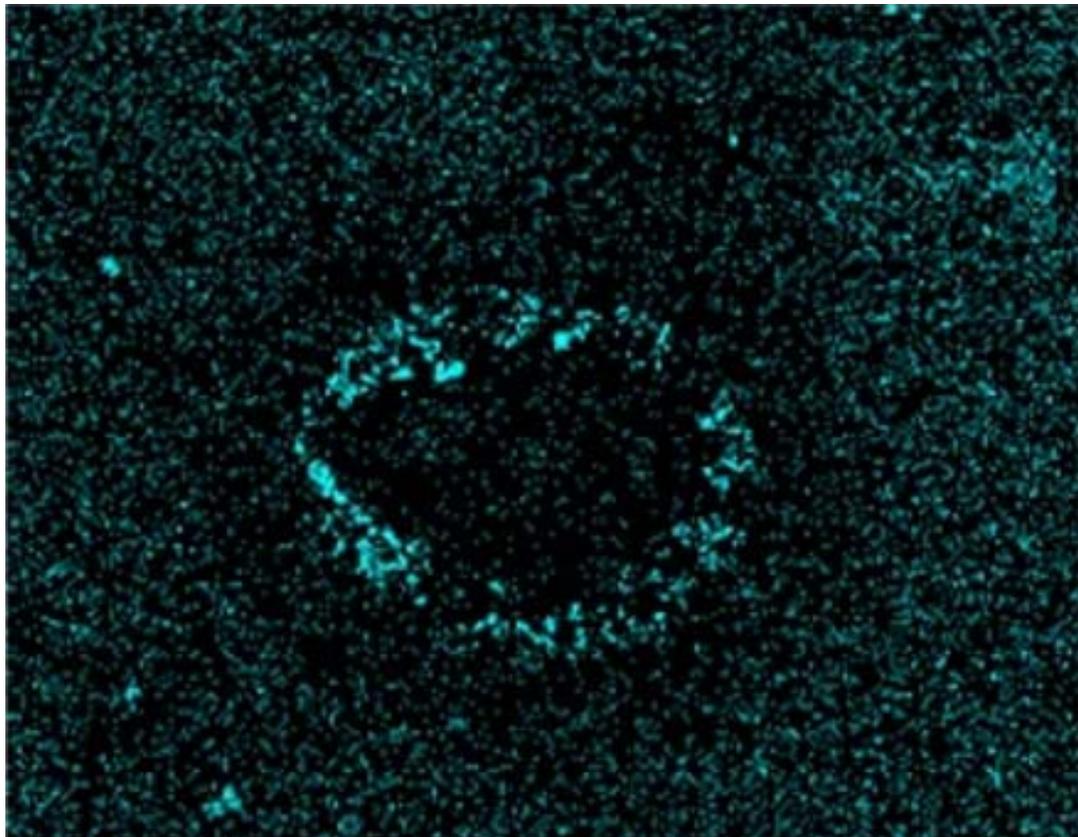
Figure 35. Zinc EDS Map of Coating in Figure 34 Showing "Zinc Ring"

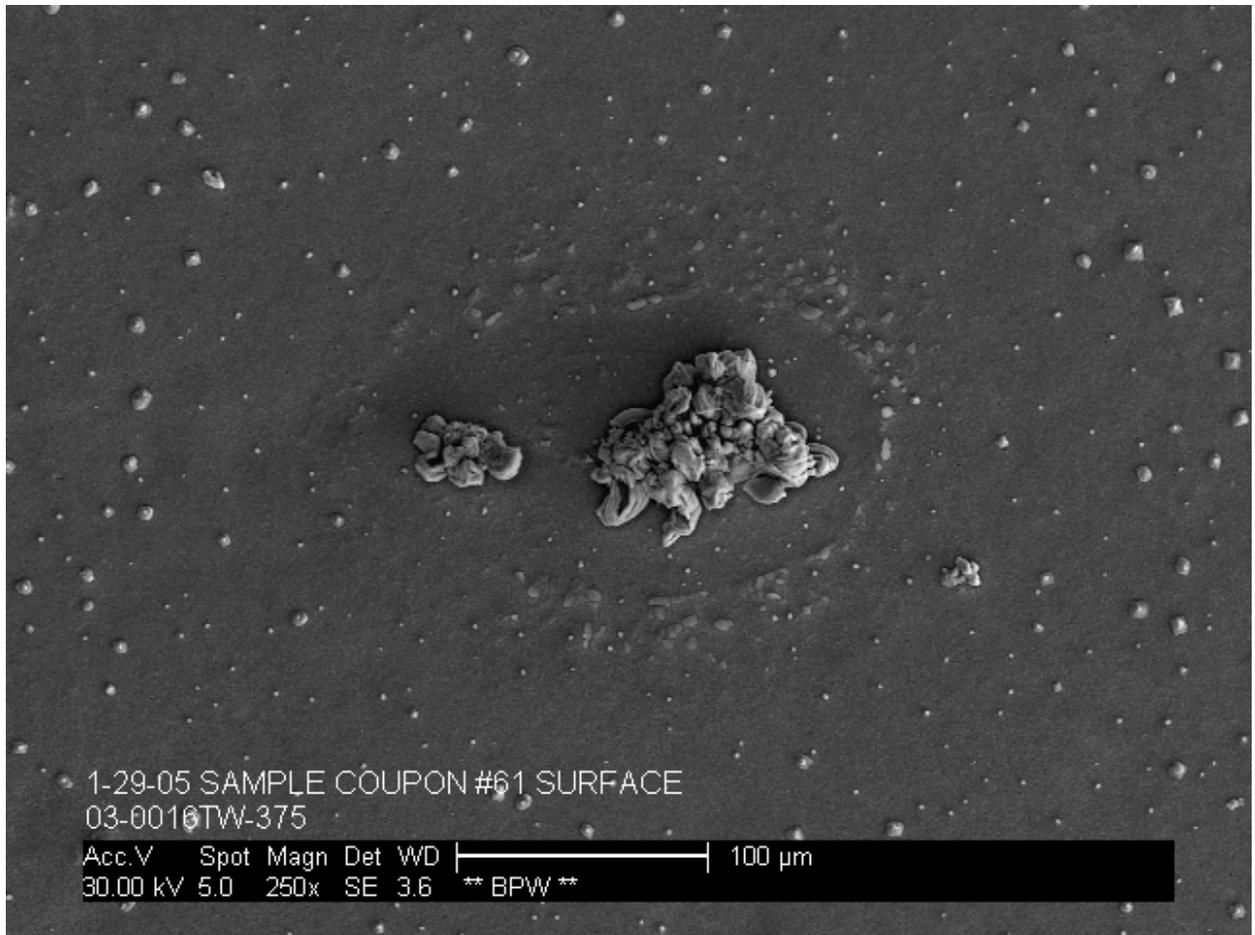
Figure 38. Surface of Coupon that Matches Up with Coating in Figure 34

The area on the coupon that mates with the coating shown in Figures 34-37 was located and examined (Figure 38). EDS again showed the presence of the "zinc ring" around the centralized OSE's (Figure 39). The "zinc ring" on the coupon has had most of the zinc removed on one side by adhesion to the coating. This demonstrates that the zinc is mostly on the surface of the tin. By comparison, no "zinc ring" was observed around OSE's on the uncoated control area

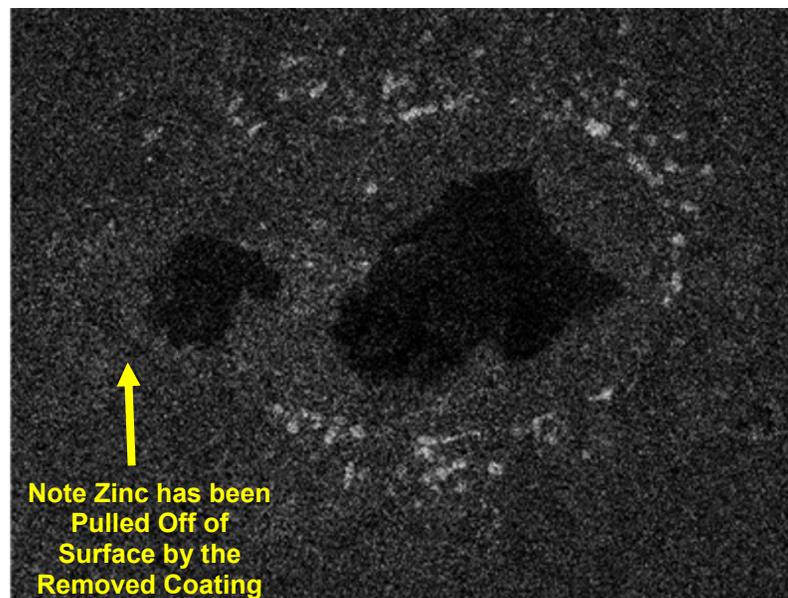
Figure 39. Zinc EDS Map of Coupon in Figure 38 Showing “Zinc Ring”
