**Traditional EEE Part Testing  
versus  
"Higher Assembly" Validation Tests**

*Is Better the Enemy of Good Enough?*

NEPP Workshop: EEE Parts for Small Missions 2014

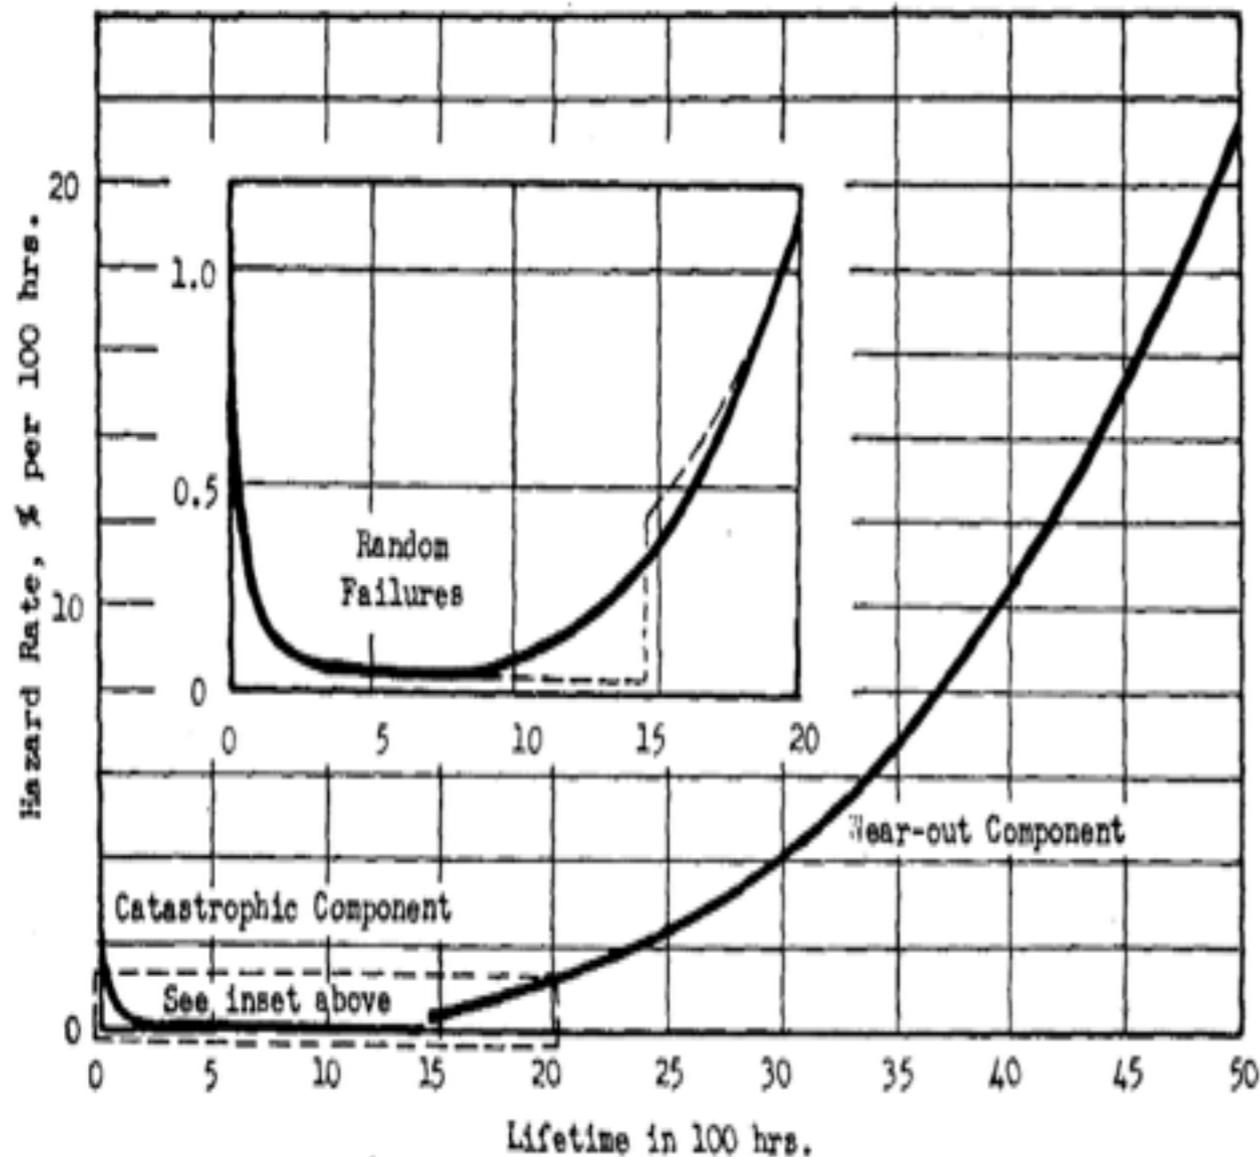
# The olden days --- vacuum tubes

- The hazard (failure rate) of vacuum tubes shows “**infant mortality**” --- it is large at first, and then drops.
- The hazard also shows “**wear out**” --- it is small at first, and then explodes with aging.
- And they just do not live very long --- a few thousand hours is typical.
